Subject: ANS: Q campaign [redacted] for 10/27/2008

Attachments: [redacted] [_iste Triebwerksschäden CP4 24 10 08.xls](#)
[EHC_0444_V2 \[redacted\] Audi CP4 Entwicklungsaktivitäten zur Reduktion von Triebwerksschäden, 22-10-2008.ppt](#)
[20081024110635241.pdf](#)
[Übersicht HDP.pdf](#)
[EHC_0443 \[redacted\] Audi CP4 Fertigungsaktivitäten zur Reduktion von Triebwerksschäden, 20-10-2008.pdf](#)

I have attached the following documents on the Q campaign:

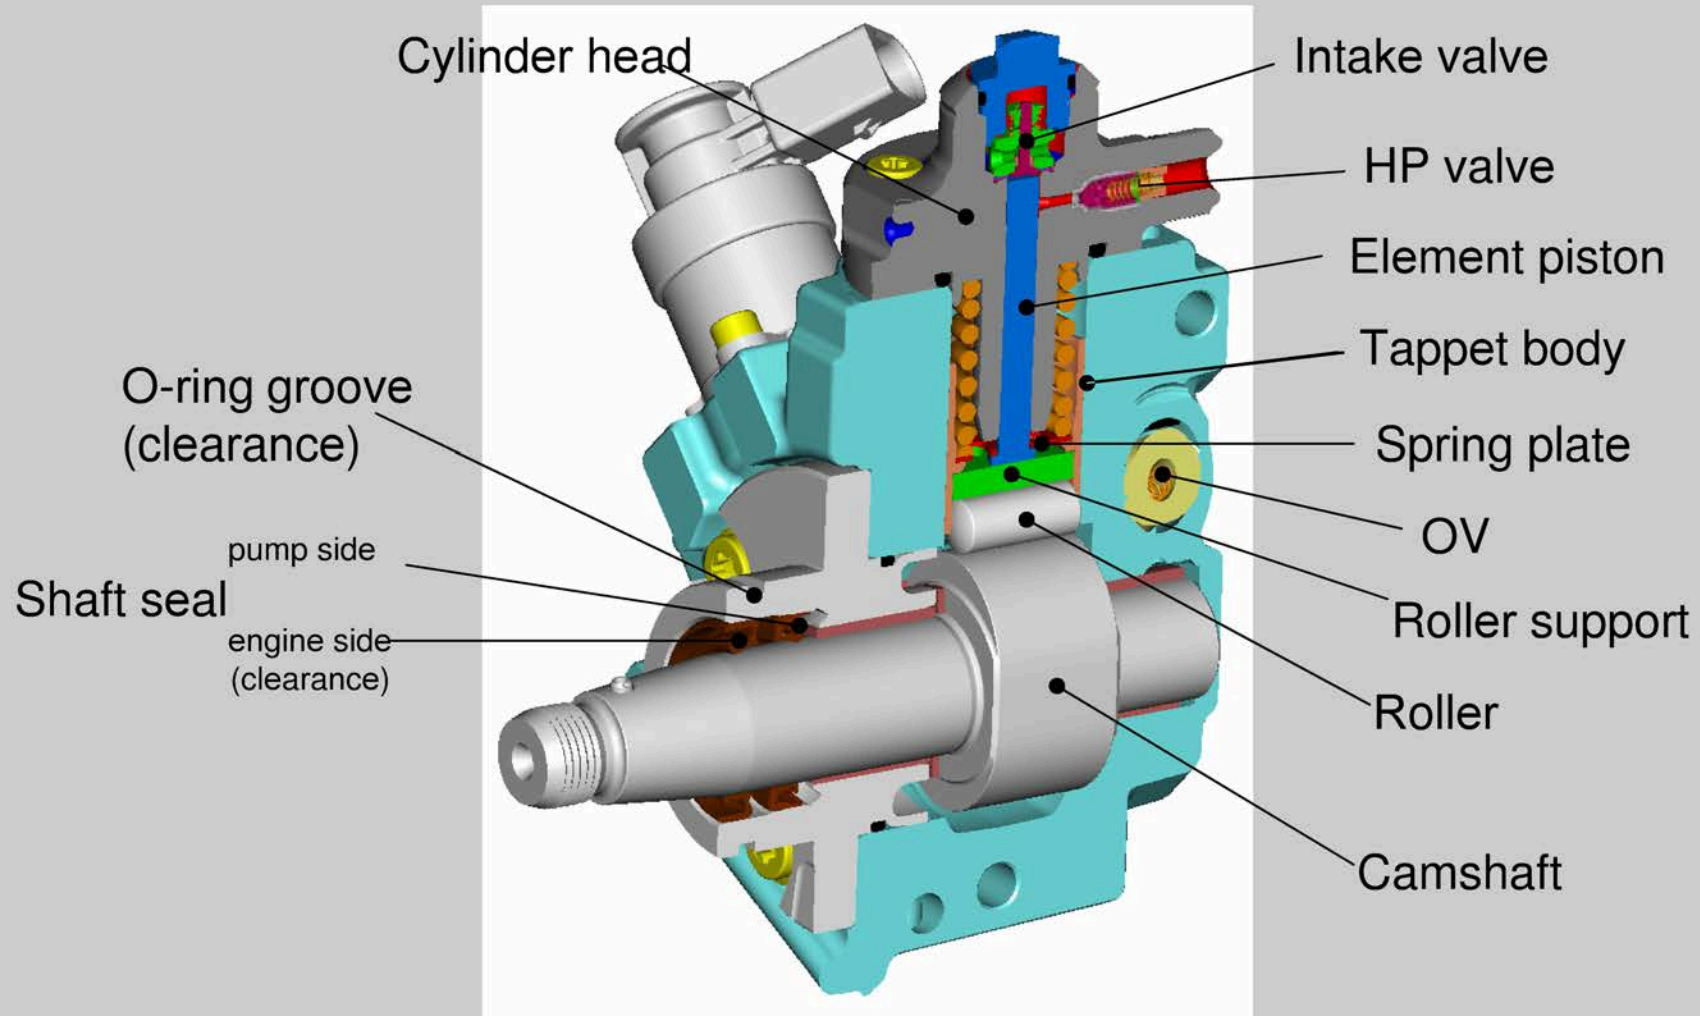
Technical information CP4.1

Audi A4 / A5 CR High pressure fuel pump CP4 failure focuses

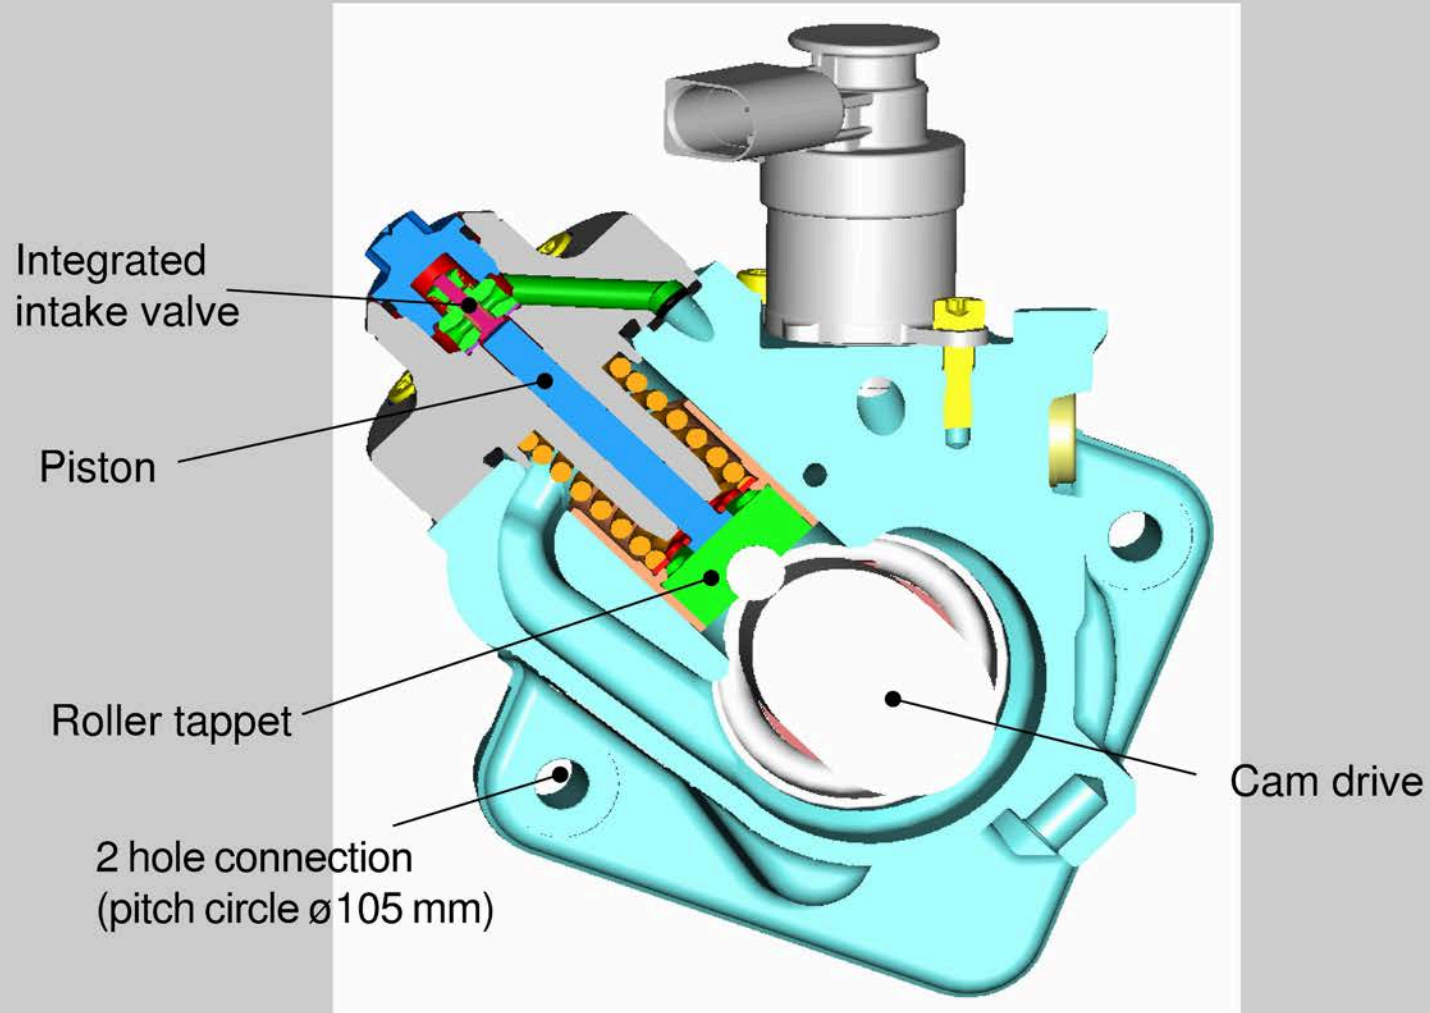
Technical information CP4.1

Audi A4 / A5 CR High pressure fuel pump CP4 failure focuses
