# Quality status of injection components "US07" projects

Q status CP4.1 - 03L 130 755 A - Jetta 1/1

# 1. Review Field Launch Support

## VW-BOSCH for R4 2.0I CRS 3.2

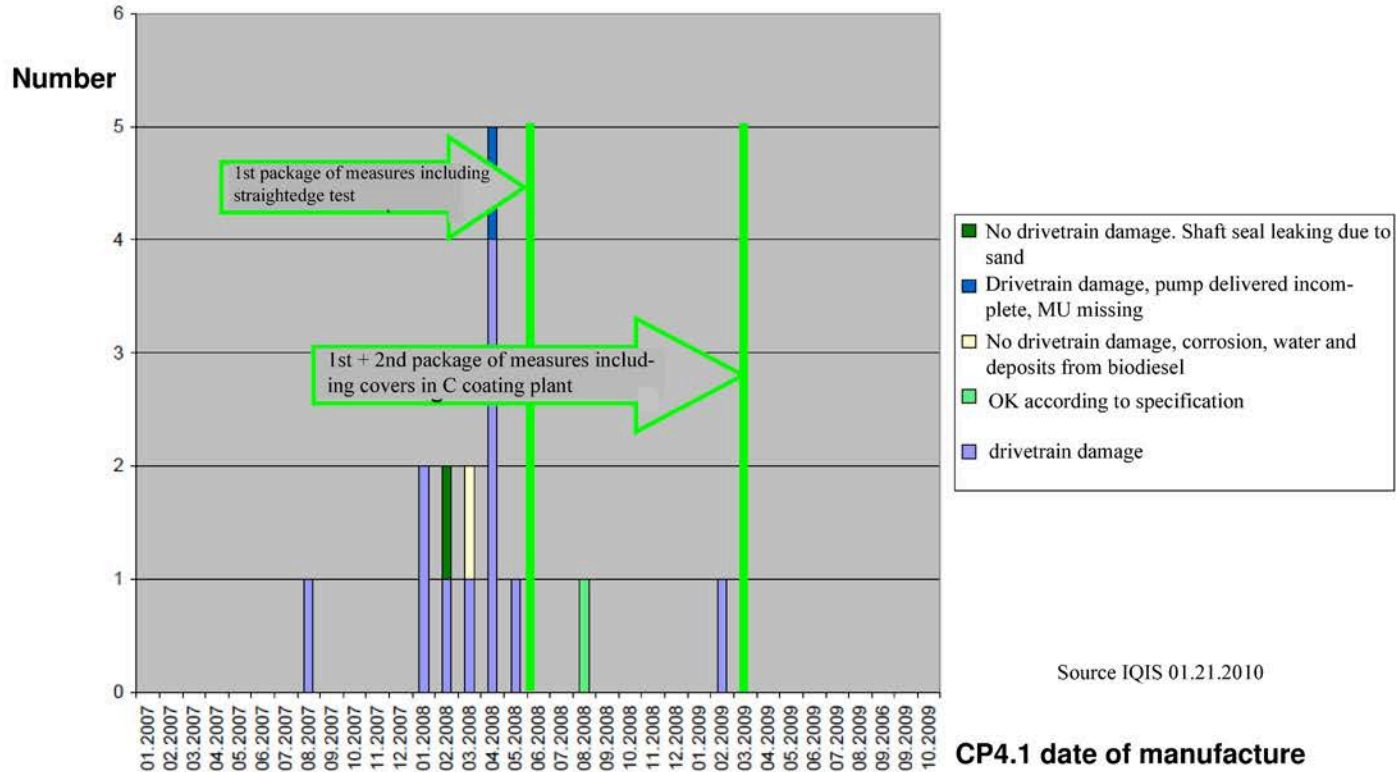
CP4.1 Field complaints from USA, status10, 21, 2010

- **Listed claims:**
  - MY 2009 = 99 vehicles
  - MY 2010 = 12 vehicles

- **Plausibility check:**
  - 12 x double bookings
  - 17 x costs < [REDACTED] (no HPP change)
  - 11 x costs [REDACTED] - [REDACTED] (no injection system change, therefore no HPP drivetrain damage)
  - 71 x costs [REDACTED] - [REDACTED] (⇒ injection system change)
  - ⇒ Large price range for system change implausible!

- ⇒ **71 potential, but not yet confirmed, cases of CP4.1 drivetrain damage**

- **Diagnosis result (return of 15 high pressure fuel pumps in total):**
  - 1 x no defect
  - 1 x radial shaft seal camshaft leaking
  - 13 x HPP drivetrain damage

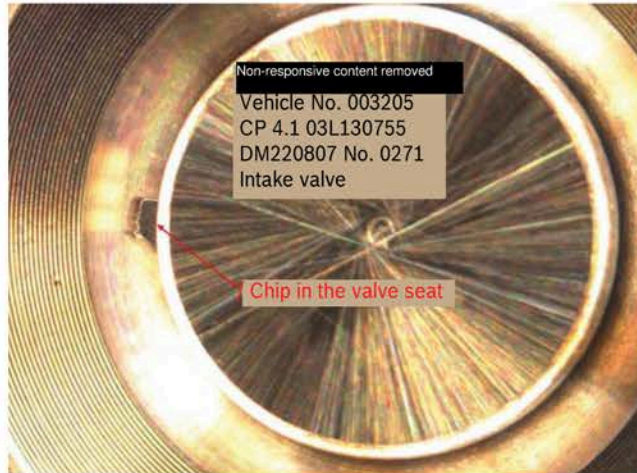
### Case 2: Non-responsive content removed

Vehicle stopped while going and would not restart, error code: P0087

Fuel rail/system pressure too low

Cause of failure: HPP cannot build up pressure due to particles in intake valve.  
Analysis by VW Development.

Notes: The component causing the problem was clearly determined using the HP case  
The VW GFF for error memory entry “Fuel rail/system pressure too low” could not be carried out because the engine operating temperature (target 50°C; actual <50°C [engine doesn't run]).

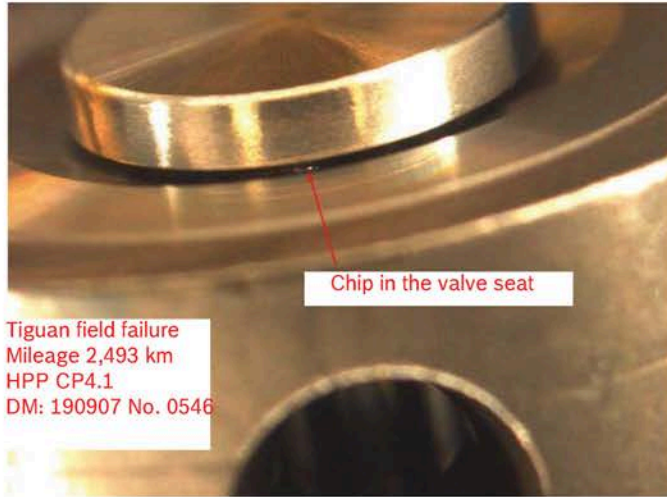
## Case 3: Non-responsive content removed

Vehicle stopped and will not start

Cause of failure: HPP cannot build up pressure due to particles in intake valve. Analysis by VW Development.

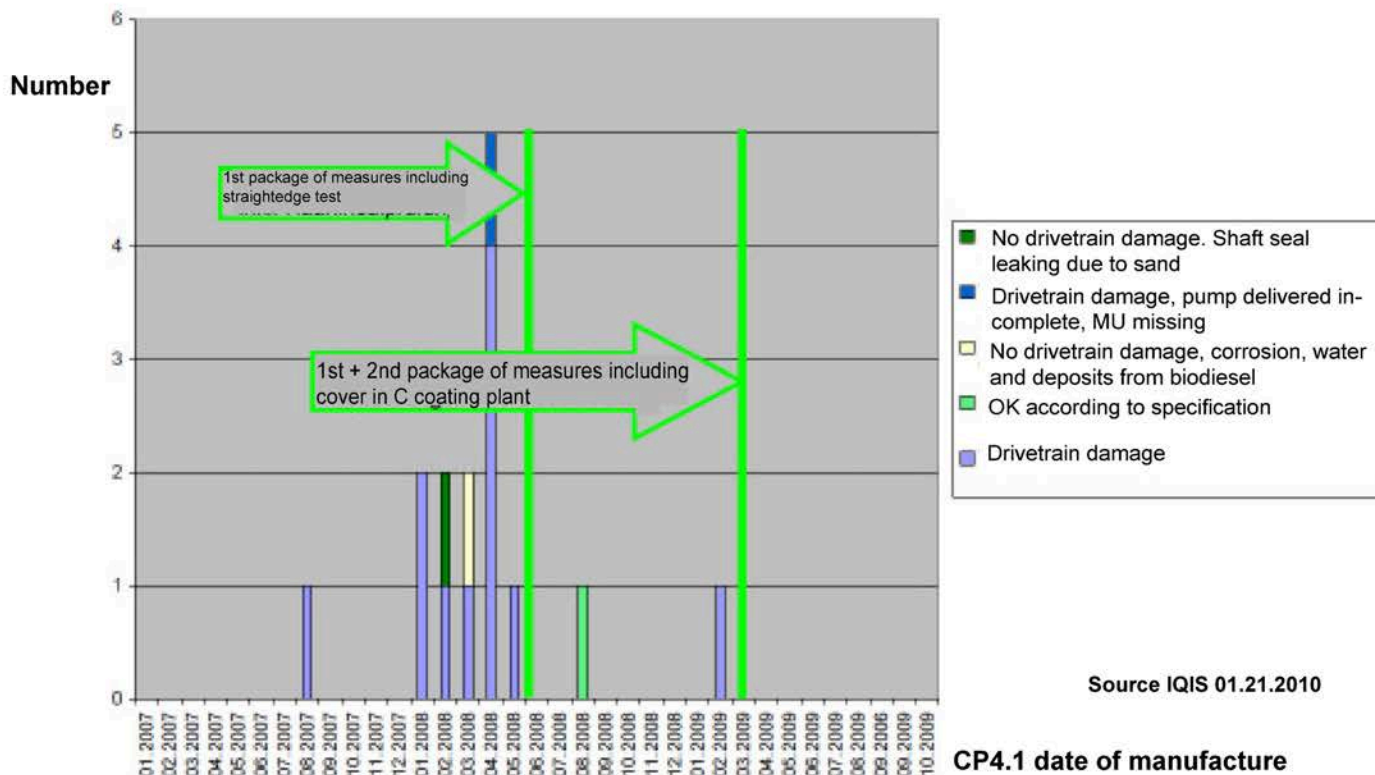
### CP4.1 Field complaints from U.S.

- **Listed claims:**
  - MY 2009 = 99 vehicles
  - MY 2010 = 12 vehicles

- **Plausibility check:**
  - 12 x double bookings
  - 17 x costs < [REDACTED] (no HPP change)
  - 11 x costs [REDACTED] - [REDACTED] (no injection system change, therefore no HPP drivetrain damage)
  - 71 x costs [REDACTED] - [REDACTED] (⇒ injection system change)

⇒ Large price range for system change implausible!

⇒ **71 potential, but not yet confirmed, cases of CP4.1 drivetrain damage**

- **Diagnosis result (return of 15 high pressure fuel pumps in total):**
  - 1 x no defect
  - 1 x radial shaft seal camshaft leaking
  - 13 x HPP drivetrain damage
