Subject: Bosch HPP drivetrain damage 2.0l R4 in [redacted]

Subject: Advanced info_Bosch-HPP-drivetrain damage

Subject: Report Q7 AWP2 Failure due to rail pressure regulation

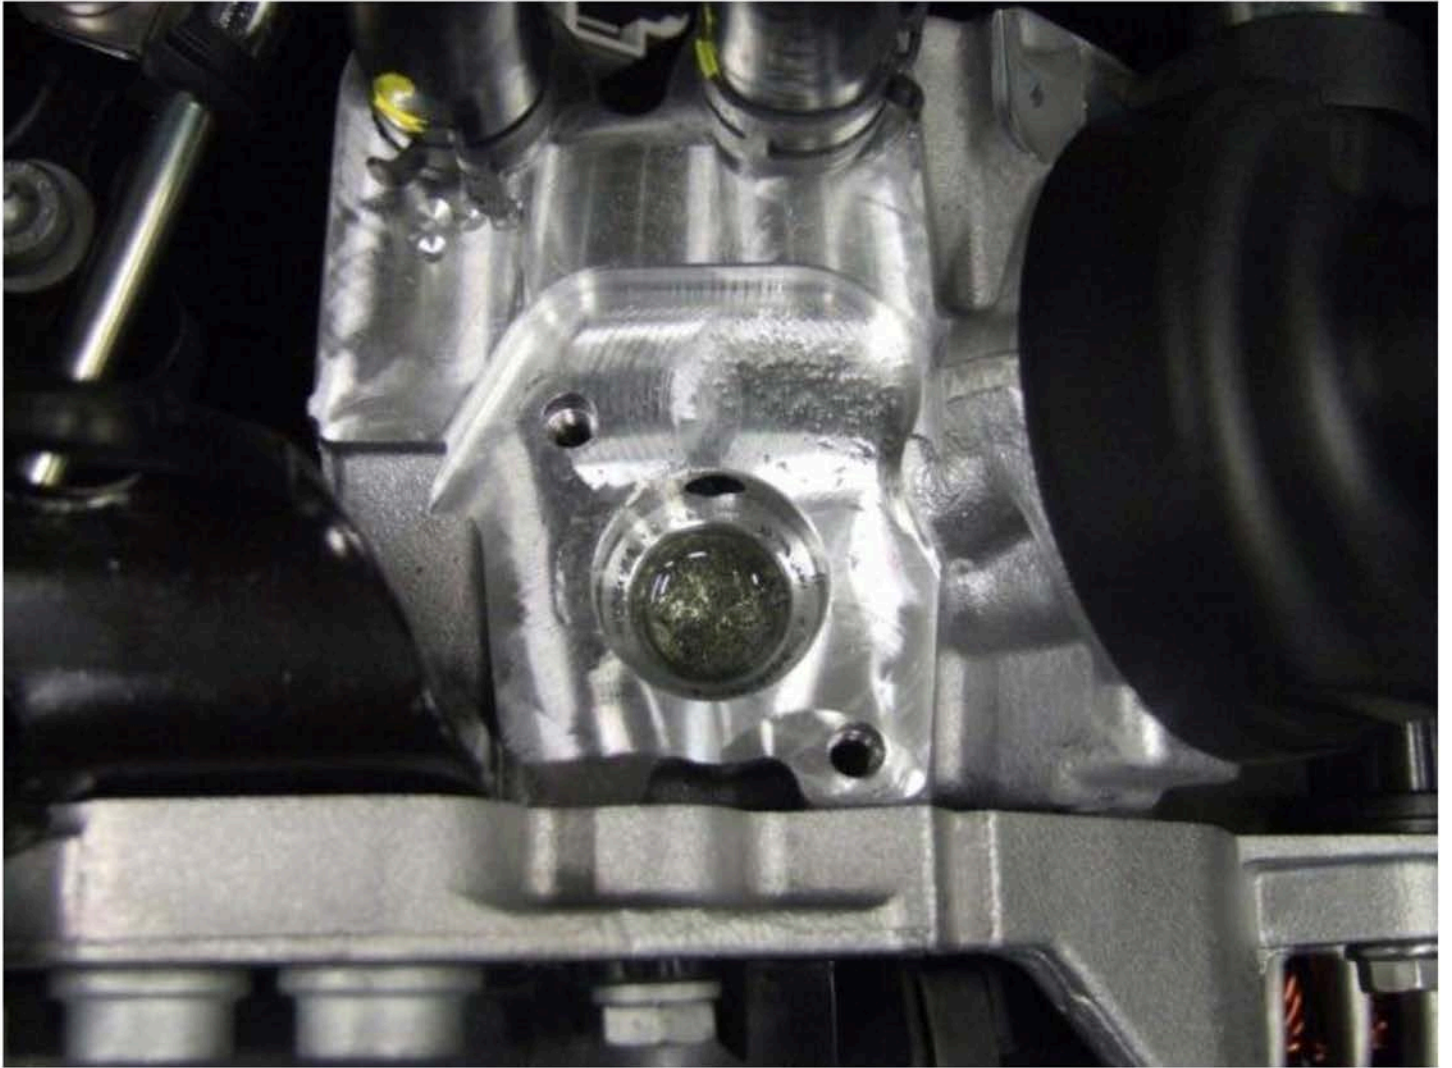
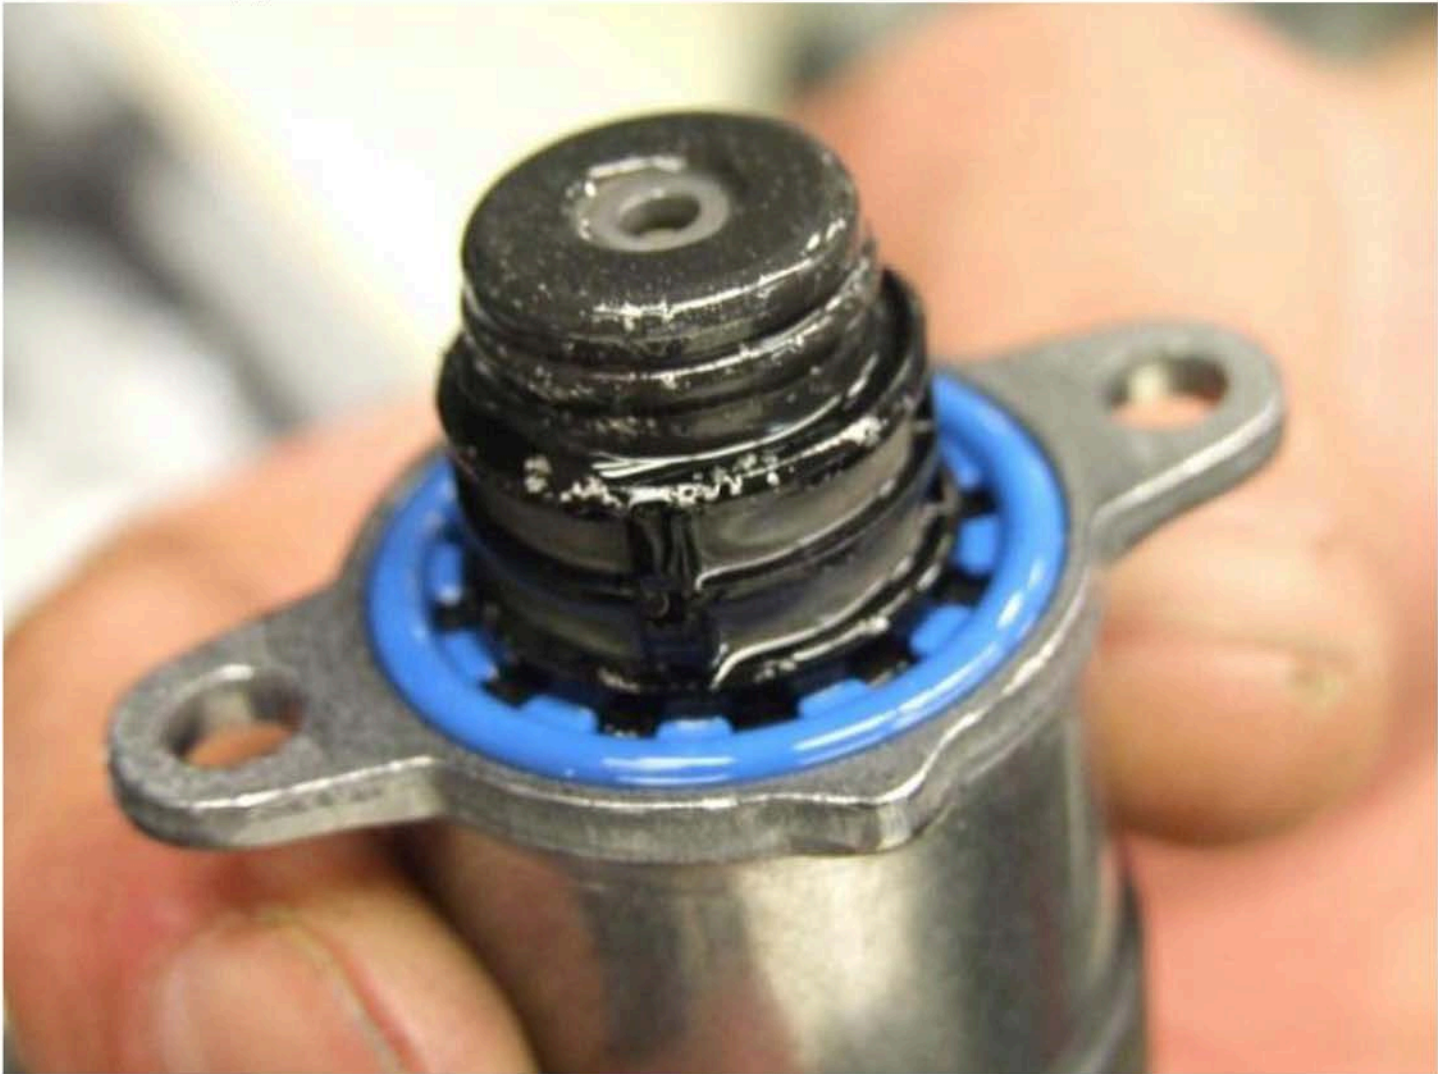
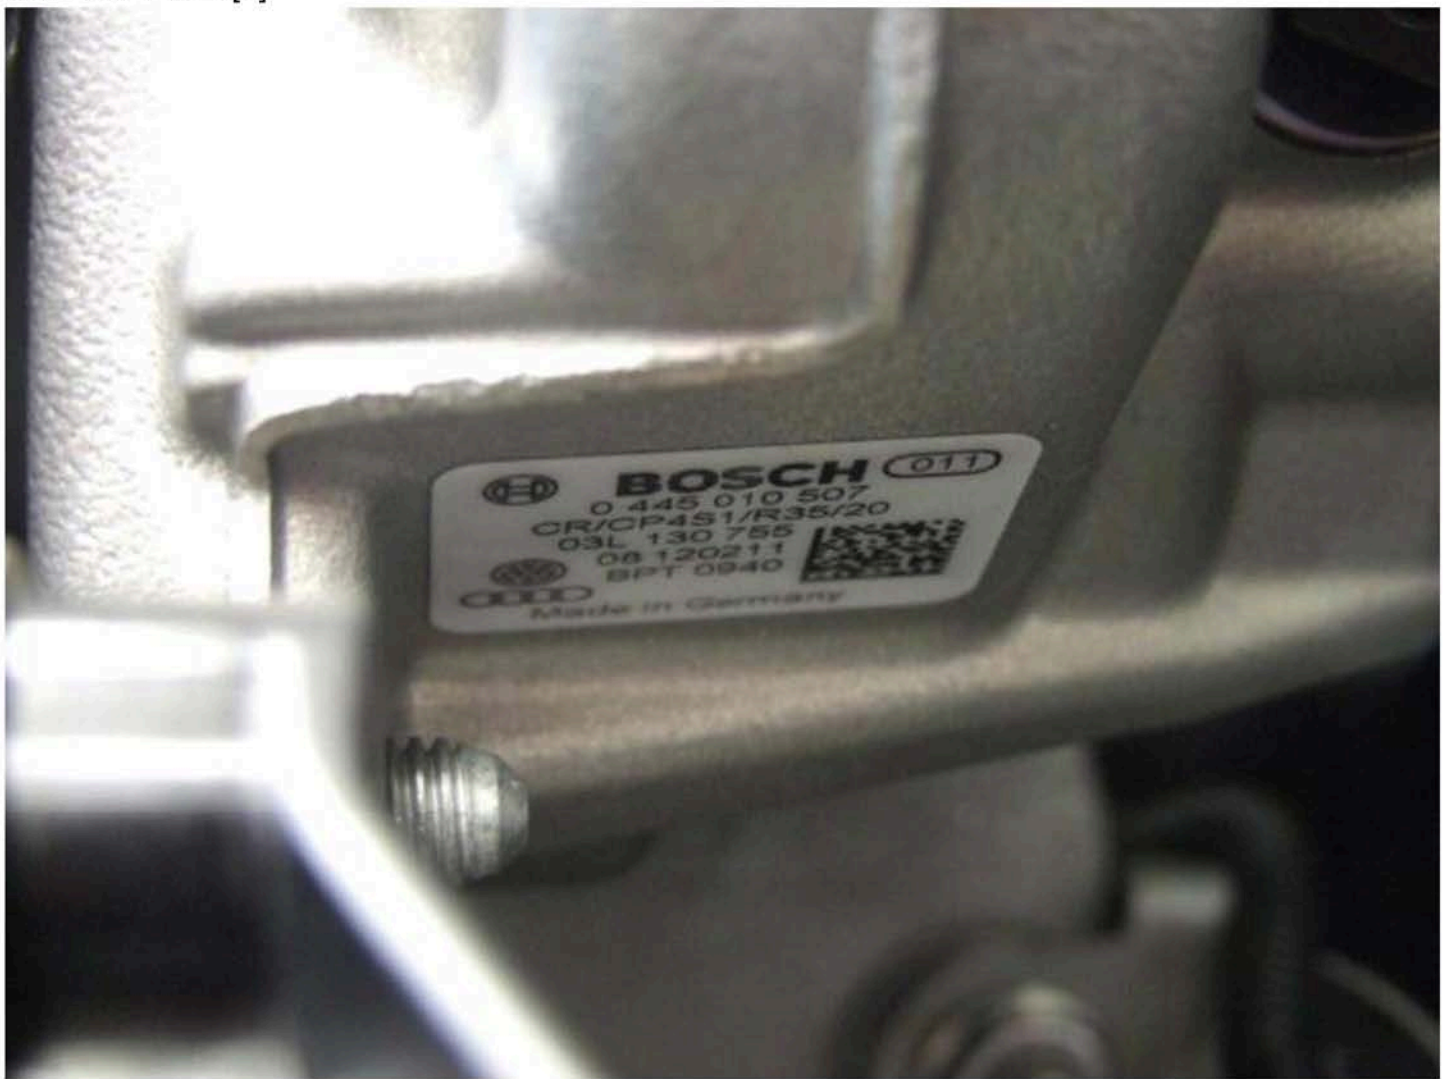
In the A4 roller test, an R4TDI 2.0l engine in an A4 failed with the following fault: "engine died, would not start again."

Engine dies during roller test and will not start again. MU full of shavings.

No error memory entry.

Please repair the drivetrain damage as normal. Looks like an AOQ of a Bosch production error. Please send the pump to Bosch, Stuttgart, as quickly as possible using the normal channels.
