<b>CR pump CP4 - Diagnosis report</b>		Report no.	[REDACTED]										
				Date	12/3/2007										
Department:	Person responsible:	Telephone:	Use	internal											
Non-responsive content removed				external	x										
To:	Non-responsive content removed														
For information:	[REDACTED]														
<b>Pump type:</b> CP4.1S_348_2x5,25_REC_3,3_1,95_MT4,2		<b>Customer:</b> VW	<b>Project:</b> R4 2.0 BIN5	<b>Project / design pattern type</b> C / C2											
<b>Part number (TTNo.):</b> 0445B21060_10		<b>Date of manufacture:</b> 690	<b>Serial number:</b> 4422	<b>Manufacturing plant - line</b> 011M FeP(Feuerbach plant) – M -											
<b>SAP-No.:</b> DS – 154947		<b>Samos no.:</b> 568938	<b>Customer order no.:</b>	<b>Engine/Vehicle number</b> 03LD/17486											
<b>Customer part number</b>		<b>Endurance run type [customer]:</b> Engine trial	<b>Endurance run conditions:</b> Oil dilution + LP full load	<b>DSBFD no.:</b> 18589

<b>Mileage</b> 995 h		<b>Parts receipt at dept. DS-PC/EDI:</b> 12/03/2007	<b>Process no.</b> 2007-CP4 / 0043	<b>Confidentiality note</b> Confidential											
<b>1 Subject</b> CP4 customer return Oil dilution program + LP full load															
<b

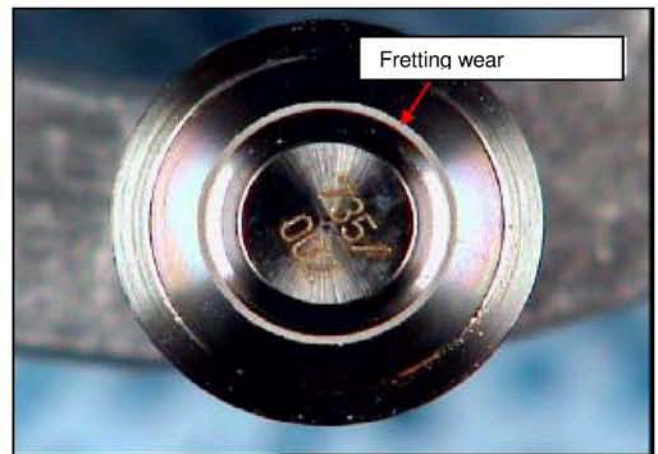
X															
X															
<b>3.3 High pressure</b> The onset of cavitation erosion on the piston base visible (Fig. 1). Fretting wear on the sealing surface of the intake valve / stationary seal ring visible (Fig. 2)					<table border="1"> <tr><td></td><td>X</td><td></td></tr> </table>			X							
	X														
<b>3.4 Bearing</b> Slight wear marks visible					<table border="1"> <tr><td>X</td><td></td><td></td></tr> </table>		X								
X															
<b>3.5 Shaft seal</b> Shaft seal slipped off the camshaft					<table border="1"> <tr><td>X</td><td></td><td></td></tr> </table>		X								
X															
<b>3.6 Holes</b> The onset of cavitation erosion in tappet hole recognizable					<table border="1"> <tr><td>X</td><td></td><td></td></tr> </table>		X								
X															
<b>3.7 Attached components (Metering Unit, Overflow Valve, Counting Point)</b> Overflow valve screw plug slightly rusted					<table border="1"> <tr><td>X</td><td></td><td></td></tr> </table>		X

Fig. 1 High-pressure piston base

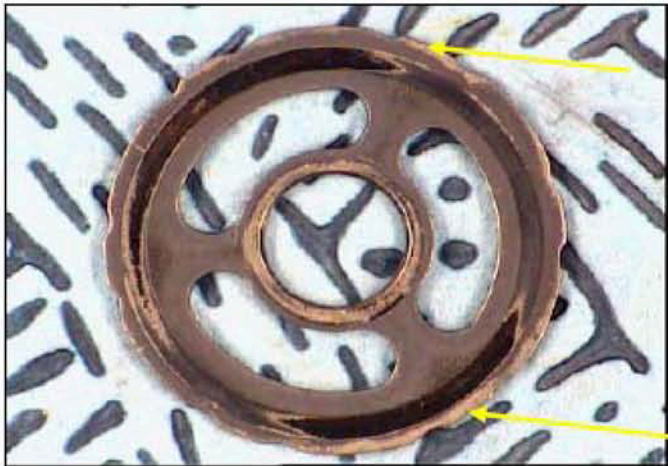
**3.2 Drivetrain**  
Spring plate with isolated anti-friction paint spalling (Figs. 1 and 2)

Fig. 1: Spring plate, tappet side

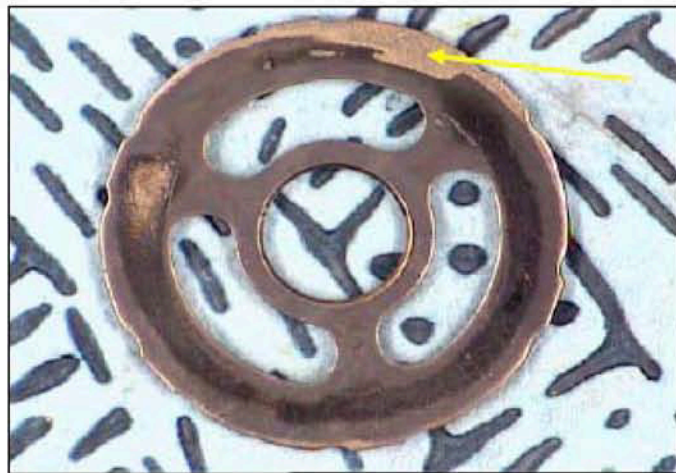
Fig. 2: Spring plate, spring side

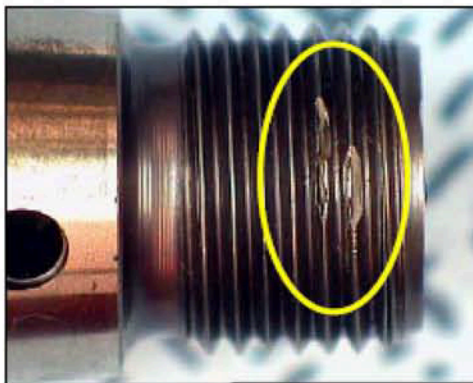
- There are abnormal grooves on almost all components and the high number of metallic and non-metallic foreign bodies, especially in the areas in front of the screens or on them.
- On the screens of the metering unit and the overflow valve, copper fibers mixed with predominantly organic particles with proportions of copper, calcium, silicon, magnesium, sulfur and oxygen were detected using EDX / EDS analysis.
- The thread of the camshaft shows damage, caused most likely due to the transport.

Thread flanks damaged (see Figure 1)

Fig. 1 Camshaft, thread (damage)

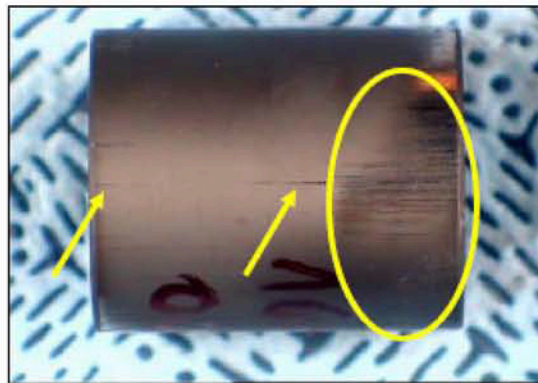
Fig. 2 Tappet body, lateral surface (grooves)

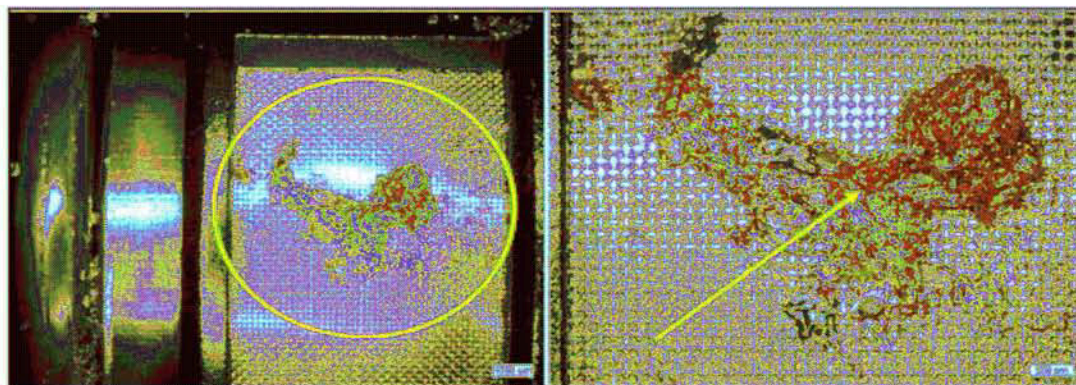
Fig. 11 Metering unit screen top view and magnification (copper fibers)

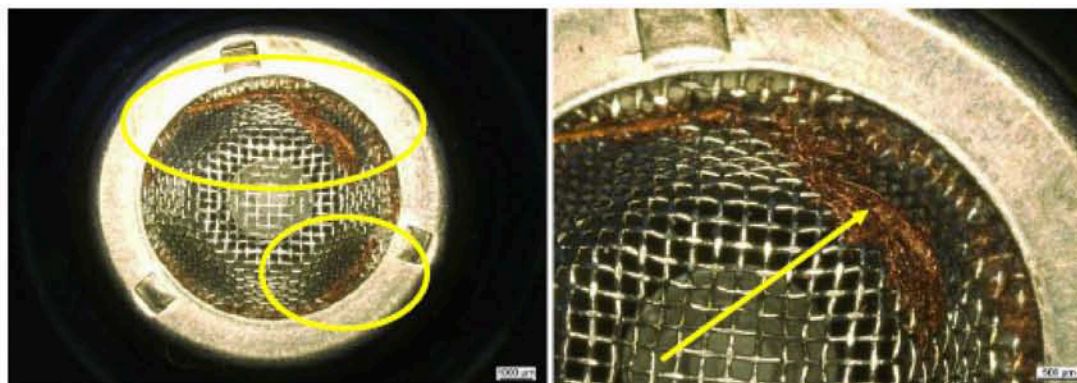
Fig. 12 Overflow valve screen top view and magnification (copper fibers)

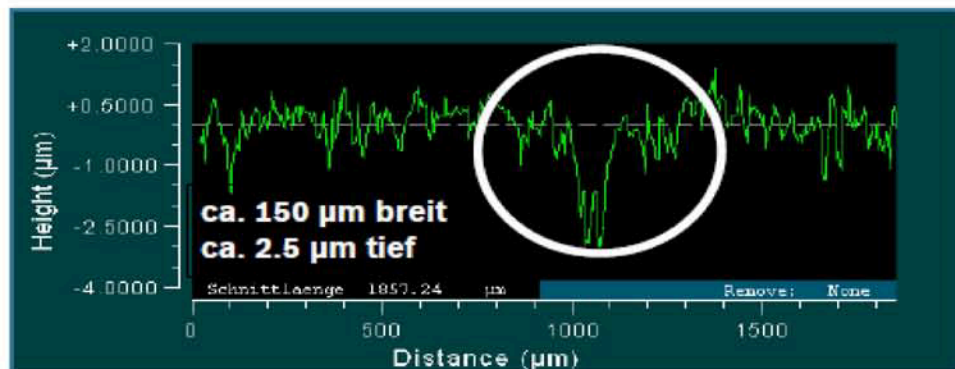
about 150 µm wide  
about 2.5 µm deep  
Cutting length

Fig. 5: WLI (white-light interferometry) measurement result, camshaft

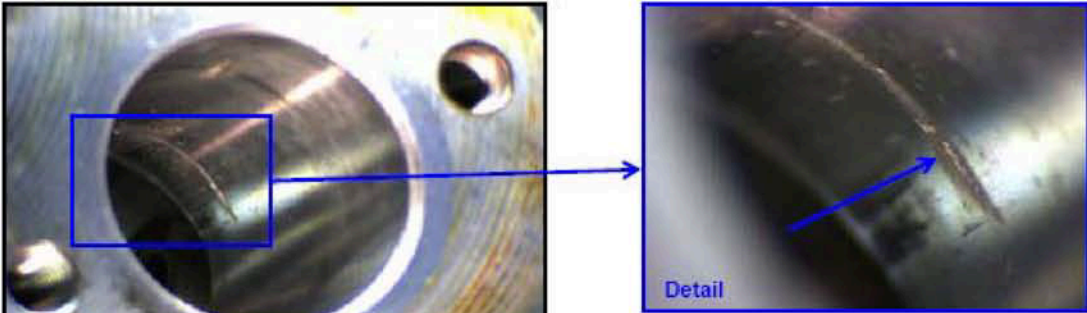
**Fig. 5:** Tappet hole to the right: Cavitation erosion

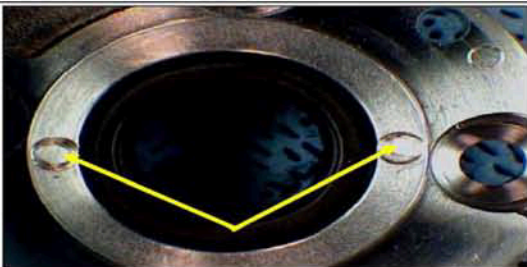
Fig. 3 Flange front surface (damage)

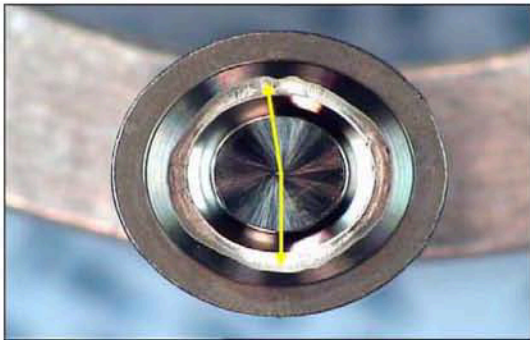
Fig. 1 Intake valve, sealing area (wear)

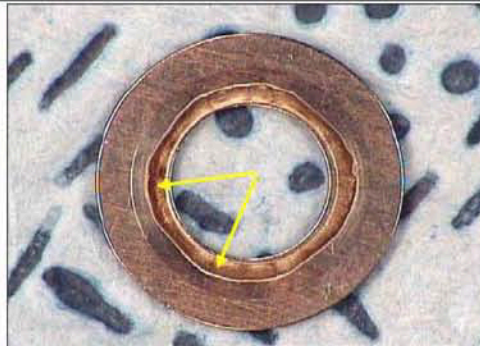
Fig. 2 Intake valve stationary seal ring, sealing area (wear)

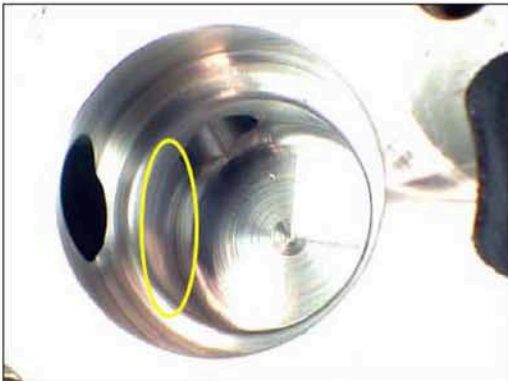
Fig. 3 Housing, metering unit hole (scrape marks)

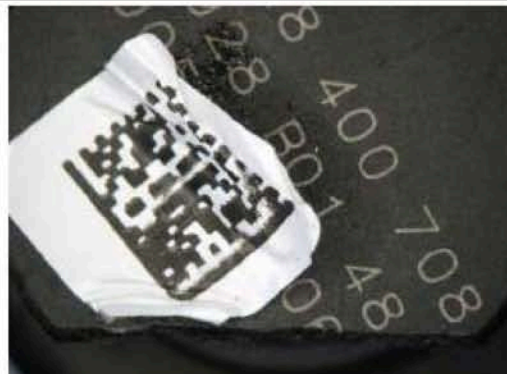
Metering unit housing

Piece of housing broken without impairment of function

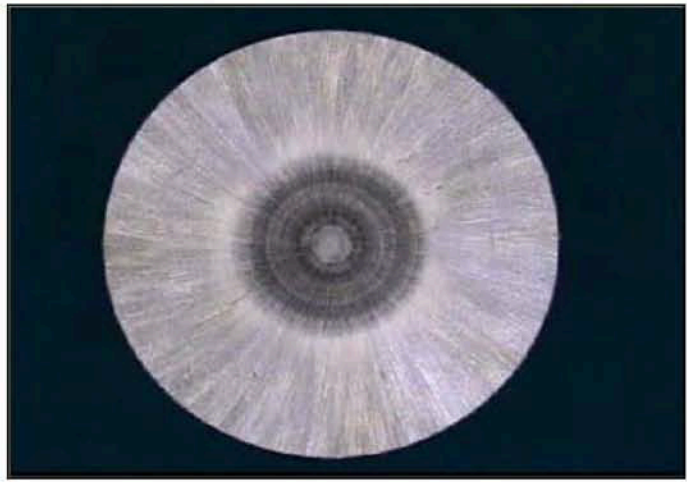
Fig. 1 Roller support, HP piston contact (cavitation)				Fig. 2 HP piston, piston base (very low cavitation)

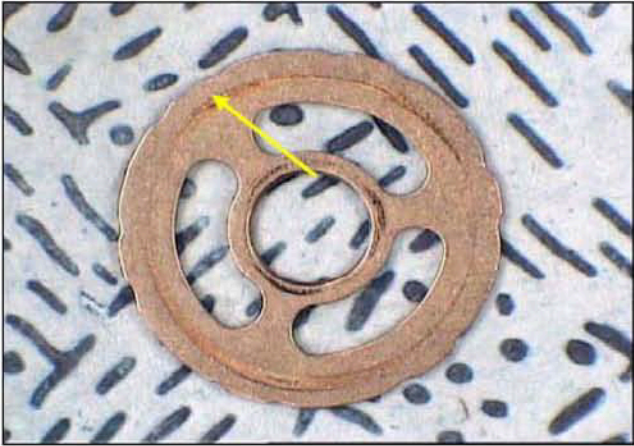
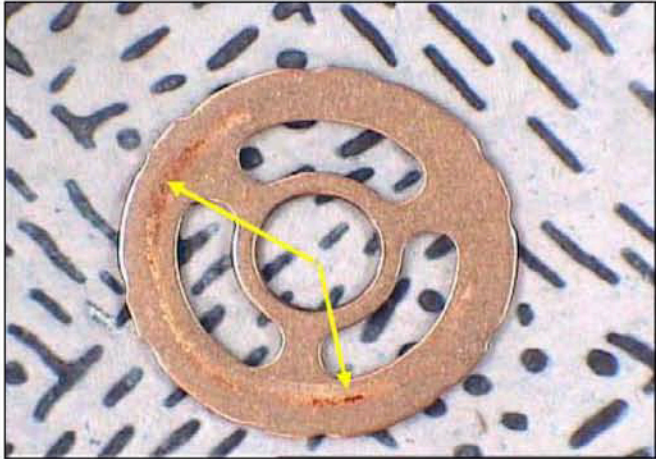
<p>Fig. 1 Spring plate, tappet-side (traces of corrosion)</p>		<p>Fig. 2 Spring plate, spring-side (traces of corrosion)</p>

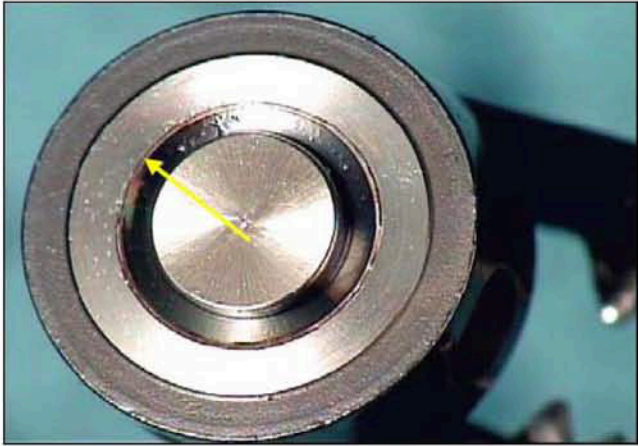
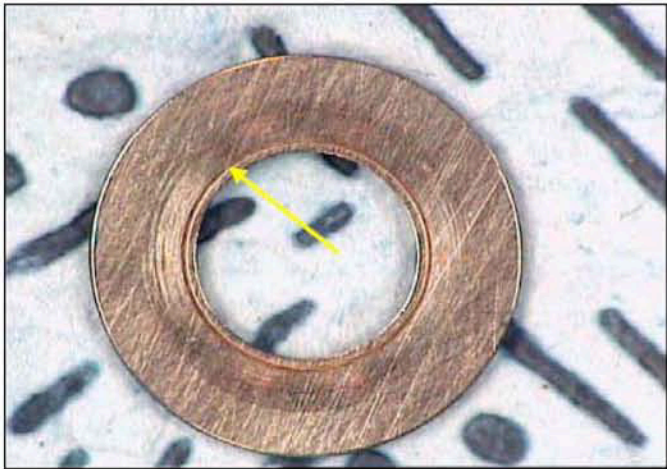
<p>Fig. 3 Intake valve, sealing area (wear)</p>		<p>Fig. 4 Stationery seal ring, SV direction (traces of corrosion)</p>

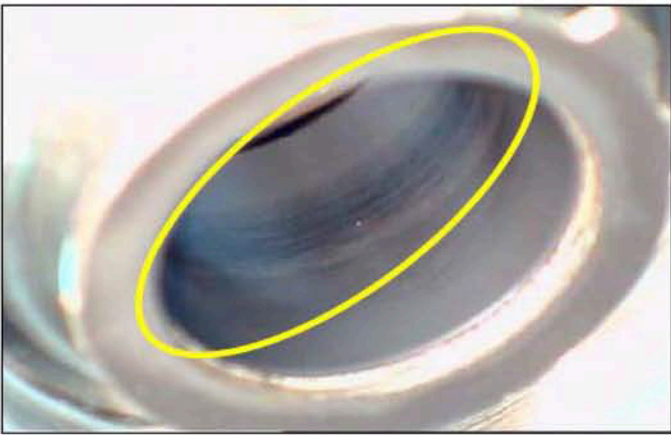
<p>Fig. 4 Flange bearing, radial (grooves, discoloration)</p>

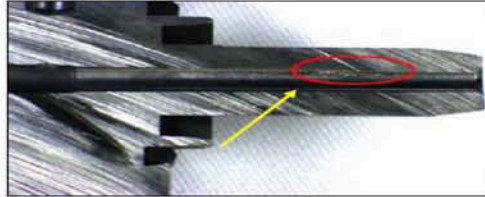
**Fig. 3 Cylinder head, piston hole (wear)**

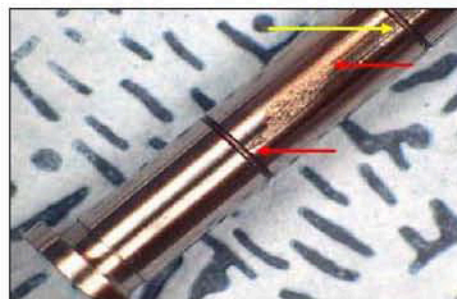
Fig. 6 HP piston, LP-side (wear)

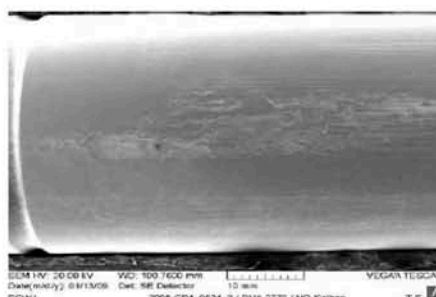
Fig. 8 HP piston, SEM (scanning electron microscopy image (wear))

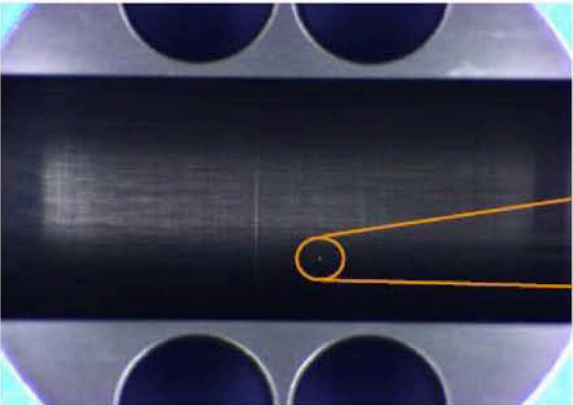
<p>Fig. 1: Roller support to the right C coating ruptures ruptures</p> </div> <div style="text-align: center;">

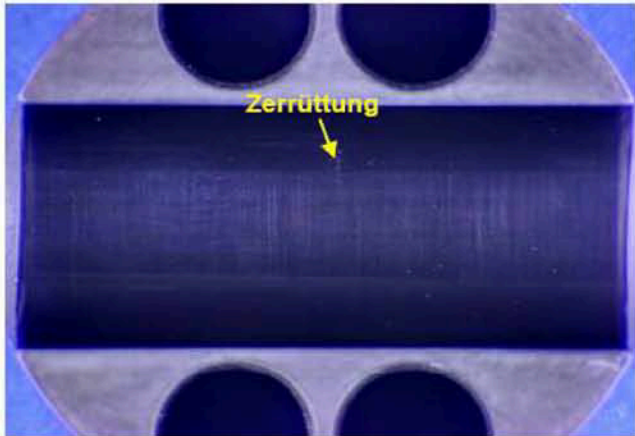
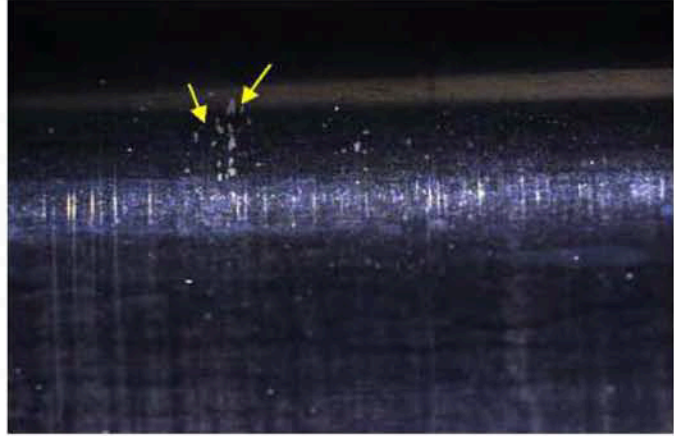
Fig. 1: Roller support			Fig. 2: Roller support, detailed rupture								
<b>4. Hydraulic function</b>											
				Delivery rate [l/h] of new part	Delivery rate [l/h] after testing						
	n[rpm]	p_rail [bar]	I_MU [A]	11/18/2008	9/23/2010						
ST	200	200	0.4	4.4	4.5						
LG	1000	1800	0.4	19.9	20.4						
				<input checked="" type="checkbox"/> <input type="checkbox"/> <input type="checkbox"/>							
No significant volumetric efficiency change compared to delivery measurement. Back measurement is within the TCD for new parts.											
<b>5. Destiny of the parts</b>											
The pump is stored at RB until 06/2011 and then scrapped.											
<b>6. Attachments</b>											
Appendix 1: WLI (white-light interferometry) measurement of roller support											
<b>Tested:</b>	Non-responsive content removed	<b>Telephone:</b>	Non-responsive content removed	<b>Date:</b>	12/16/2010						
<b>Signature:</b>	Non-responsive content removed	<b>Date:</b>	12/17/2010	<b>Signature:</b>	Non-responsive content removed						
<b>Department:</b>	Non-responsive content removed	<b>Telephone:</b>	Non-responsive content removed	<b>Date:</b>	12/17/2010						
<b>Signature:</b>	Non-responsive content removed	<b>Date:</b>	12/17/2010	<b>Signature:</b>	Non-responsive content removed

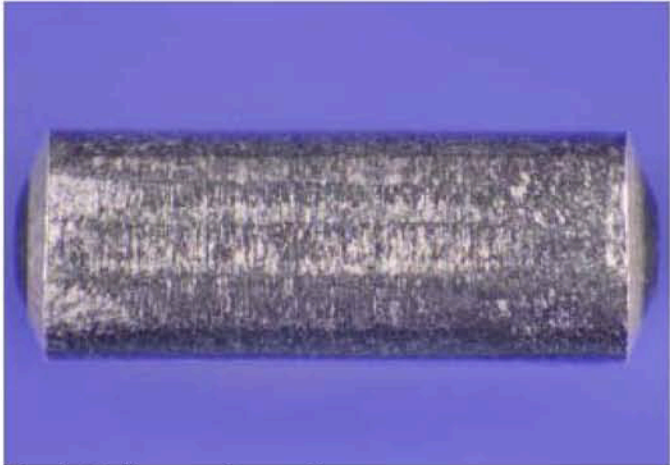
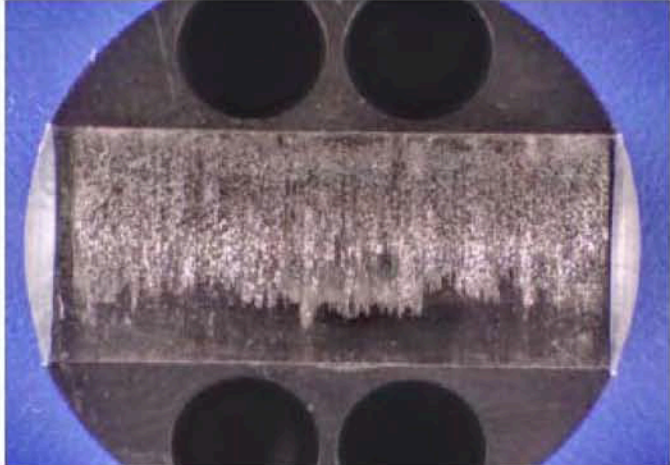
<b>3.6 Holes</b> As a result of drivetrain damage, particle marks and particles are in the metering hole.			<input type="checkbox"/> <input checked="" type="checkbox"/> <input type="checkbox"/>			
<b>3.7 Attached components (metering unit, overflow valve, counting point)</b> As a result of drivetrain damage, there are particles on the MU (metering unit).			<input checked="" type="checkbox"/> <input type="checkbox"/> <input type="checkbox"/>			
<b>3.8 O-rings</b> No striking feature			<input checked="" type="checkbox"/> <input type="checkbox"/> <input type="checkbox"/>			
<b>3.9 Other</b> No striking feature			<input checked="" type="checkbox"/> <input type="checkbox"/> <input type="checkbox"/>			
<b>3.10 Images</b>

<b>Fig. 1: Roller, running surface</b>			<b>Fig. 2: Roller support, running surface</b>

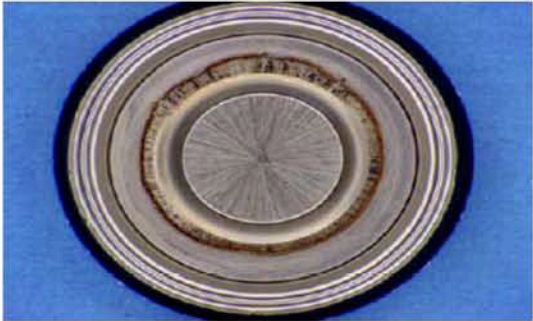
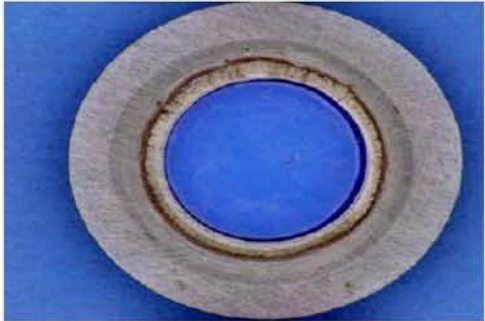
Fig. 1: Intake valve of fretting wear (Rating 4)		Fig. 2: Fretting wear at stationery seal ring (Rating 4)						
<b>4. Hydraulic function</b>								
The pump function in the specified testing point meets the requirements. In comparison to the delivery measurement, no significant fuel-quantity drift is detectable.								
			Delivery rate [l/h] New part	Delivery rate [l/h] After testing				
	n[rpm]	p_rail [bar]	I_MU [A]					
			9/17/2009	11/8/2010				
ST	200	200	0.4	4.4				
LG	1000	1800	0.4	20.4				
				4.5				
				20.5				
				<input checked="" type="checkbox"/>				
				<input checked="" type="checkbox"/>				
<b>5. Destiny of the parts</b> The pump parts remain with Robert Bosch GmbH at the request of the customer								
<b>6. Attachments</b> None								
Tested:	<span style="background-color: black; color: black;">Non-responsive content removed</span>	Telephone:	<span style="background-color: black; color: black;">Non-responsive content removed</span>	Date: 3/10/2011				
Signature:	<span style="background-color: black; color: black;">Non-responsive content removed</span>	Date: 3/10/2011	Signature:	<span style="background-color: black; color: black;">Non-responsive content removed</span>

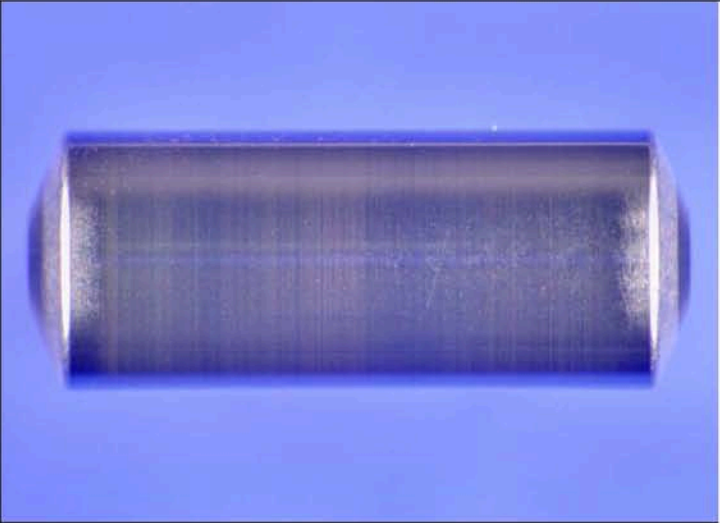
**Fig. 3: Roller to the left**  
Faint brown discoloration R3

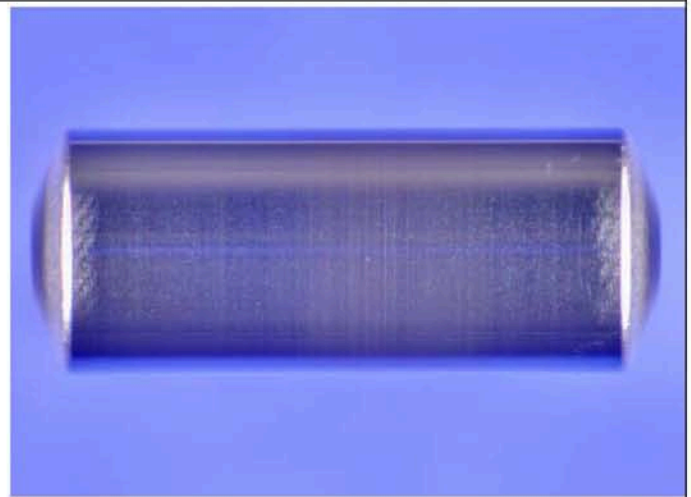
**Fig. 4: Roller to the right**  
Faint brown discoloration R3
