**Weekly report Service Technology WK 13/09**

**Audi A4, A5, Q7, Q5 V6 TDI EU 5 – cases of high-pressure fuel pump damage after installation**

**Drivetrain damage, high pressure diesel fuel pump CP4.2**

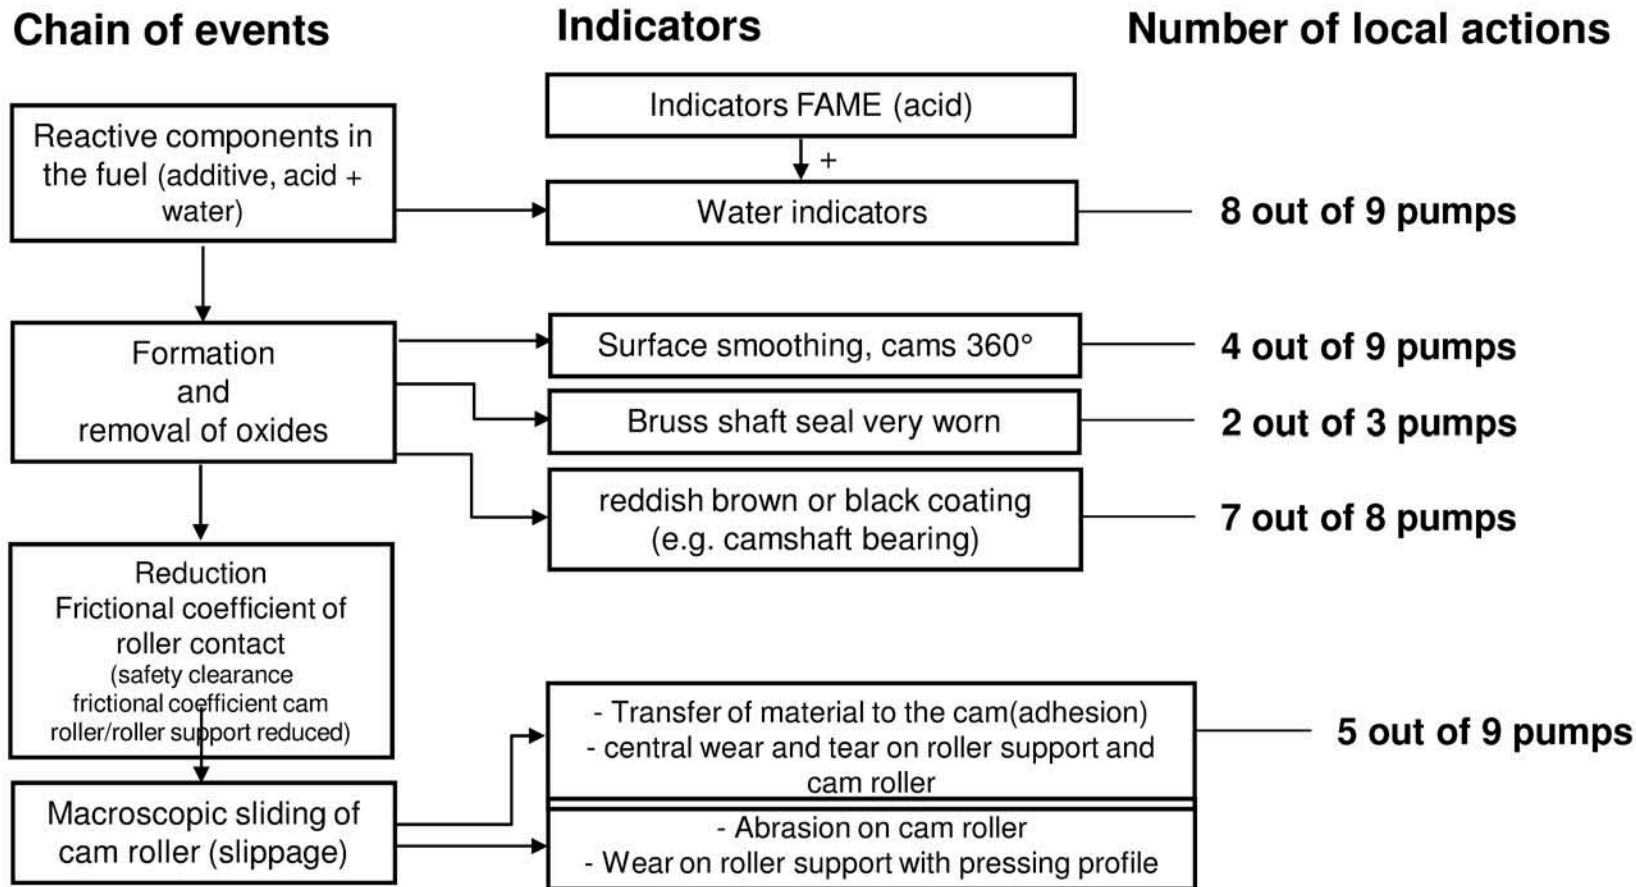
# Failure hypothesis 4: Fuel additives -> Tribochemicals

8/9 signs of corrosion, 8/9 black coating,  
4 polished camshafts, 9/9 feature 90° turned tappet.  
Most likely damage hypothesis (see slide 6) is  
therefore tribochemical wear and tear.

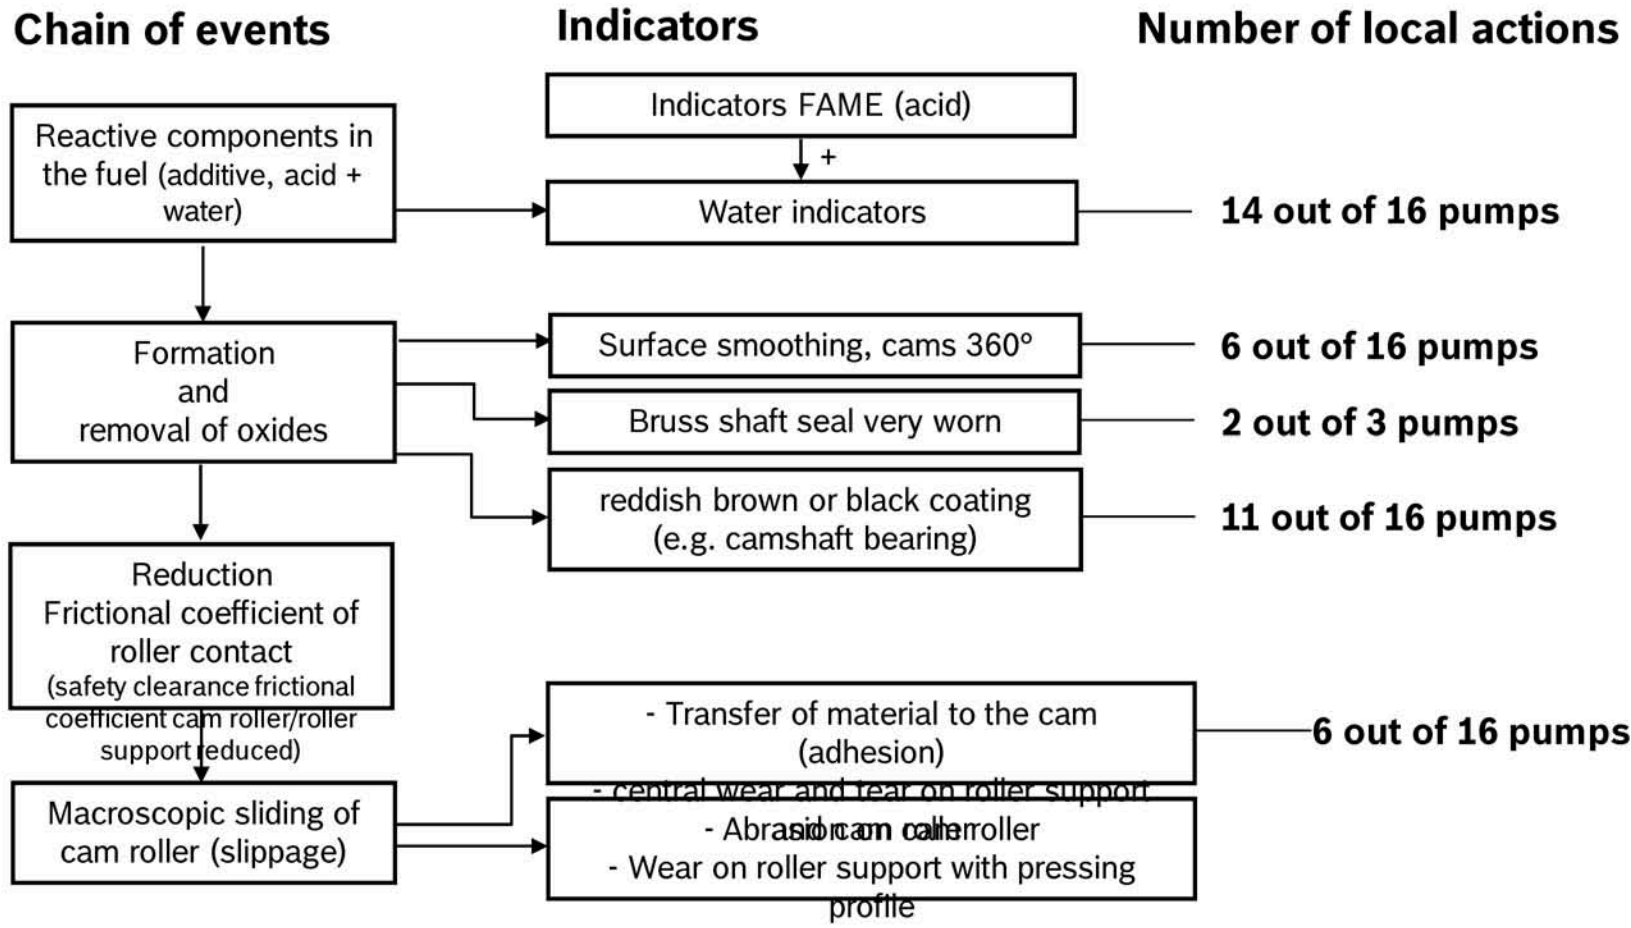
# Failure hypothesis: Fuel additives -> Tribochemicals

- 14/16 signs of corrosion
- 11/16 black coating on cams and bearings (under analysis)
- 6 camshafts smoothed (polished)
- 16/16 feature two tappets turned by 90°
- 2/3 Bruss shaft seals very worn

Most probable damage hypothesis is therefore tribochemical wear and jammed roller due to residue (such as soaps) -> anti-algal products.

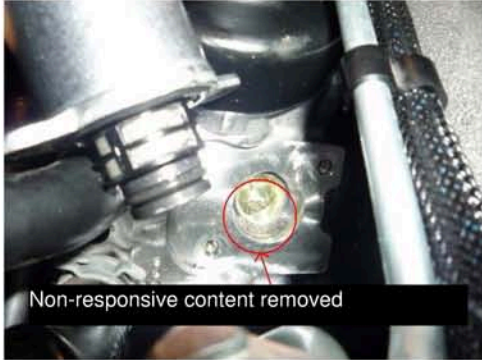
High-pressure pump with removable Fuel dosing valve

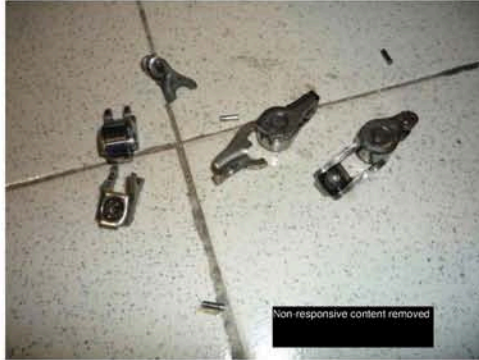
broken roller cam follower.
