CP4 rating catalog for visual findings

2 x CP4.2 drivetrain damage cases in US vehicle endurance runs

CP4 drivetrain damage: Damage mechanism:

Drivetrain damage, high-pressure diesel fuel pump CP4.2 TOP meeting between Bosch and Audi on 02/12/2010 in Non-responsive content removed

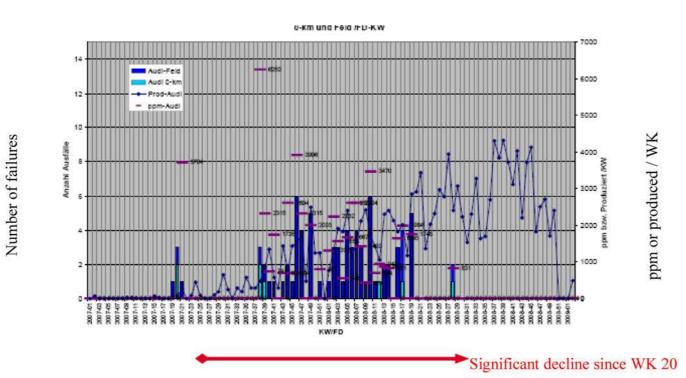
Quality situation CP4.2 @ VW & Audi

Drivetrain damage VW/Audi CP4.2 (-611/613 and/or 059 130 755 AB / AG) 0 km and on-field / date of manufacture WK

Significant decline in CP4 drivetrain damage - especially on-field since WK 20 2008 Adopt measures to prevent or detect faults in the plant. Other measures are being implemented.

This explains the difference in failure rate between CP4.1 and CP4.2, as CP4.1 are equipped exclusively with Güntert rollers.

Since WK 20 2008 primarily RB internal failures and ZP7 failures (0-km). Causes of these failures are being analyzed.

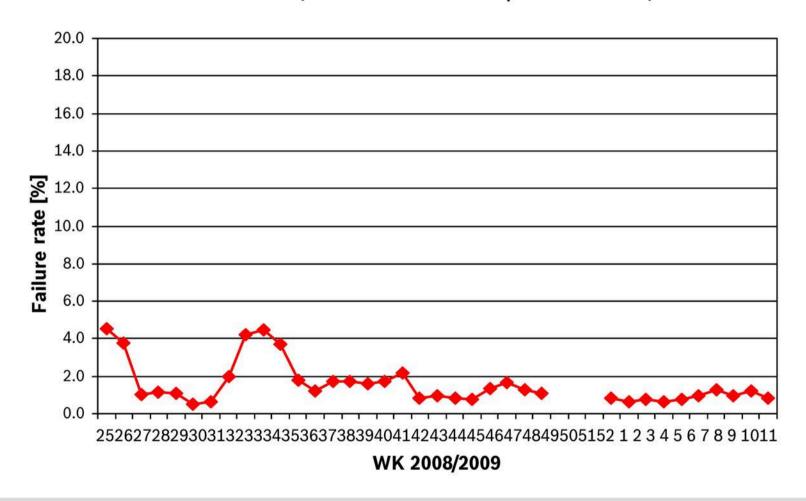
FeP: Visual check of MU4 (Failure rate due to particles in %)

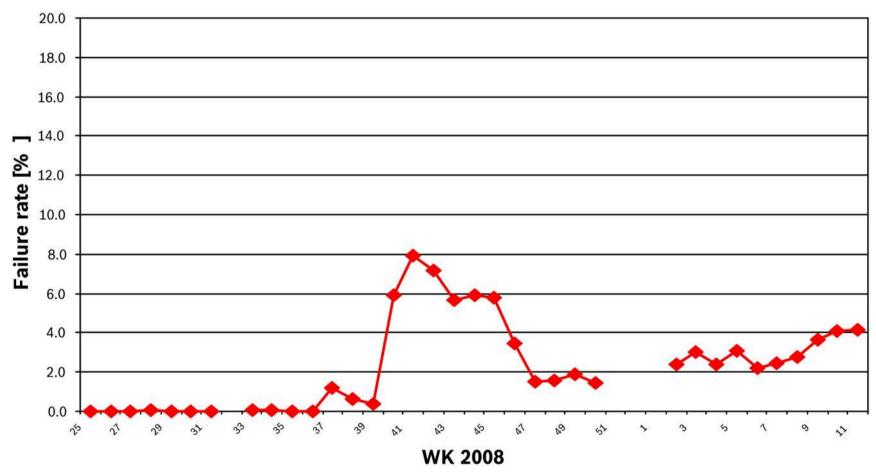
JhP: Visual check of MU4 (Failure rate due to particles in %)

Note: Due to holiday shutdown, there is no data available for WK 32-33.

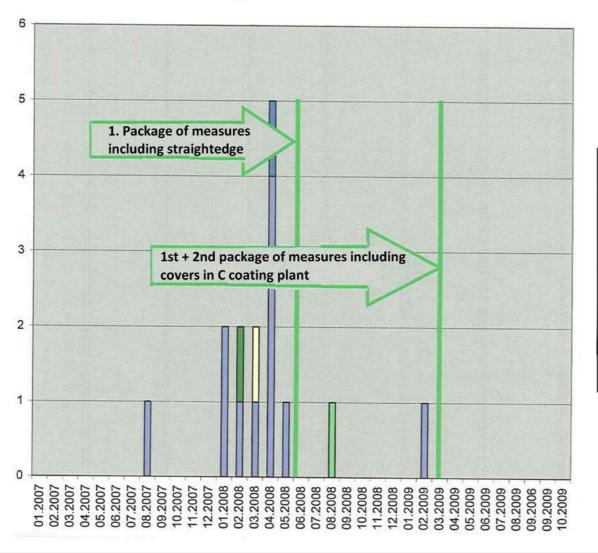
CP4.1 Field complaints from the USA, Status as on 10.21.2010

- No drivetrain damage, shaft seal leaking due to sand
- Drivetrain damage, pump delivered incomplete, metering unit missing
- No drivetrain damage, corrosion, water and deposits from biodiesel
- OK according to specification
- Drivetrain damage

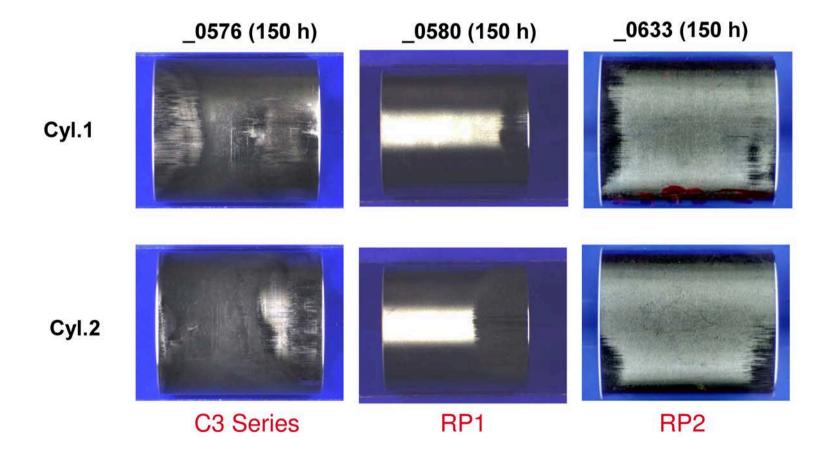
TM: Audi overload tests

Summary of visual findings

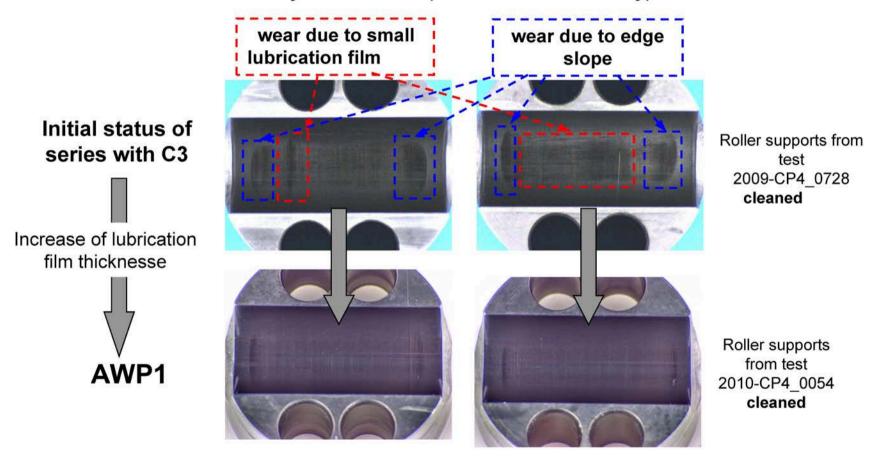
Task Force – Anti-wear packages @ CP4

Anti-wear package AWP1

Verification of effectiveness by overload test (150 h with low viscosity)

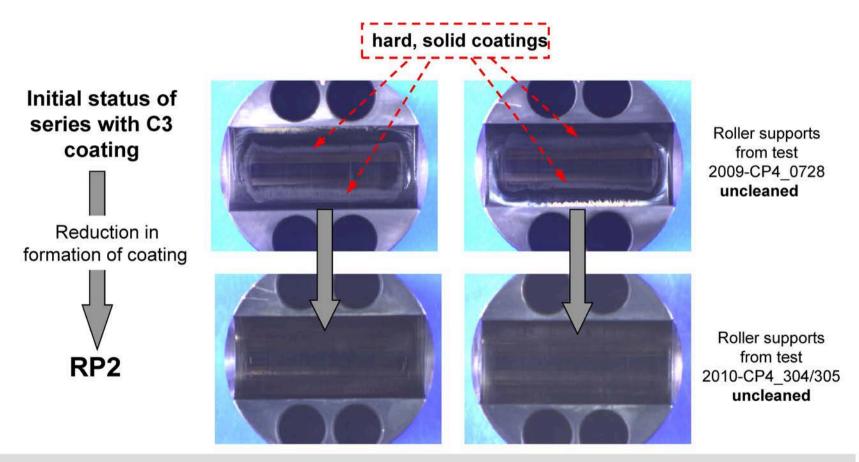
Task Force – Anti-wear packages @ CP4

Anti-wear package RP2

Verification of effectiveness by overload test (150 h with low viscosity)

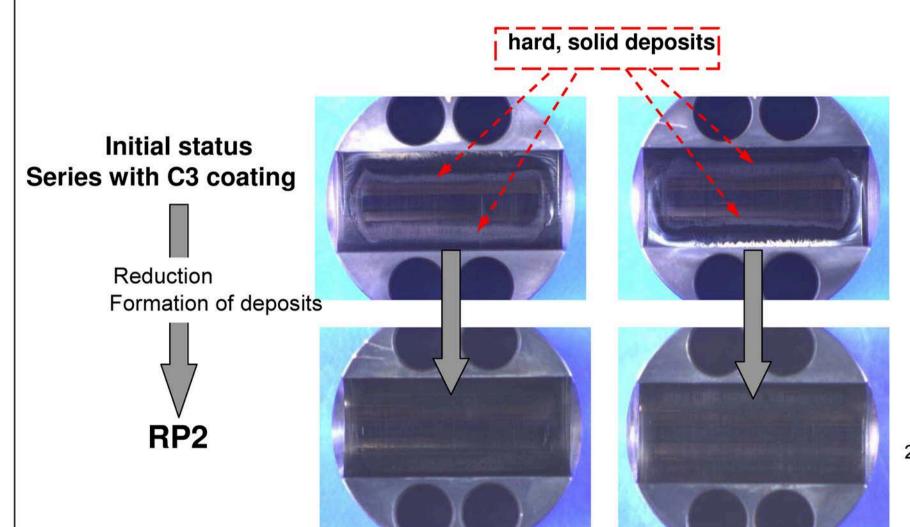
Anti-wear package RP2

Proof of effectiveness by overload test (150 h with low viscosity)

Roller supports from test 2009-CP4_0728 uncleaned

Roller supports from test 2010-CP4_304/305 uncleaned
