Drivetrain damage VW/Audi CP4.1(-507/508) 0 km and field /FD-KW

Drivetrain damage VW/Audi CP4.2 (-611/613) 0 km and field /FD-KW

Task force activities to reduce power train failures

Drivetrain Damage Diesel High-Pressure Fuel Pump CP4.2

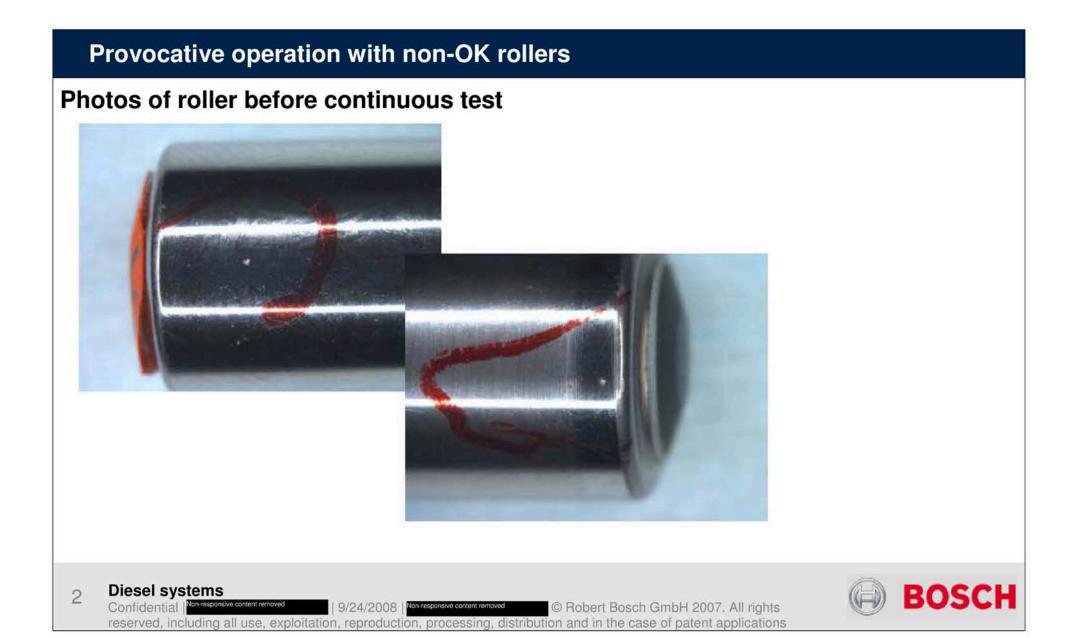
Drivetrain damage after 35 hours of operation

The **drivetrain** task force carried out several similar tests with EN590, although only one case of drivetrain damage occurred.

Result confirms the **failure hypothesis**. Pumps manufactured prior to the introduction of the straight-edge test (7.04.2008) can--in combination with poor lubricity--experience failures.

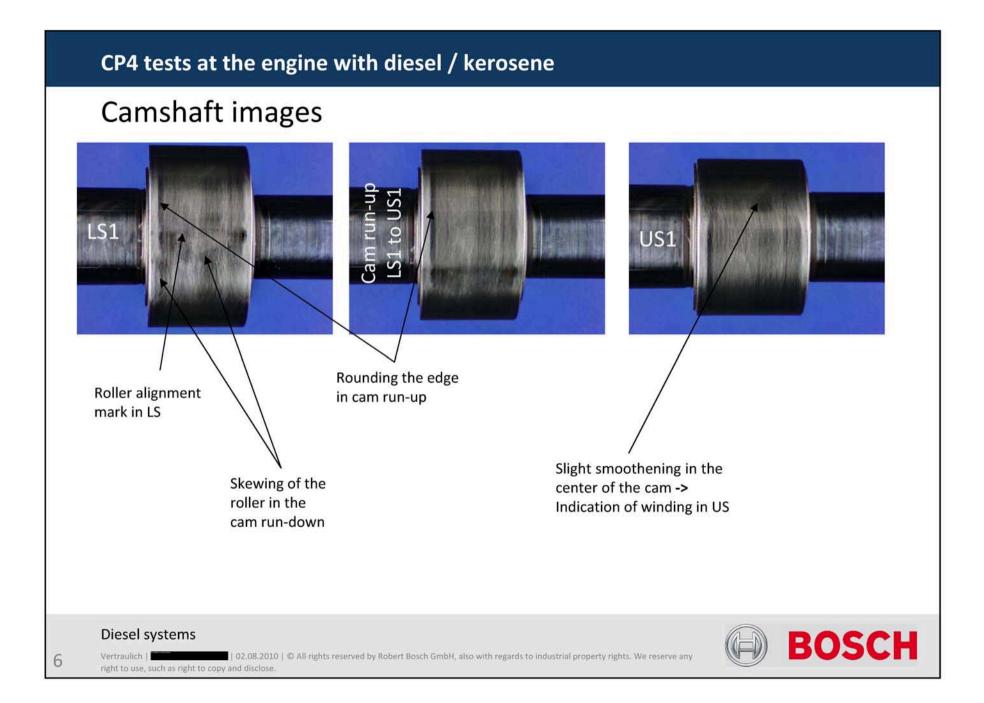
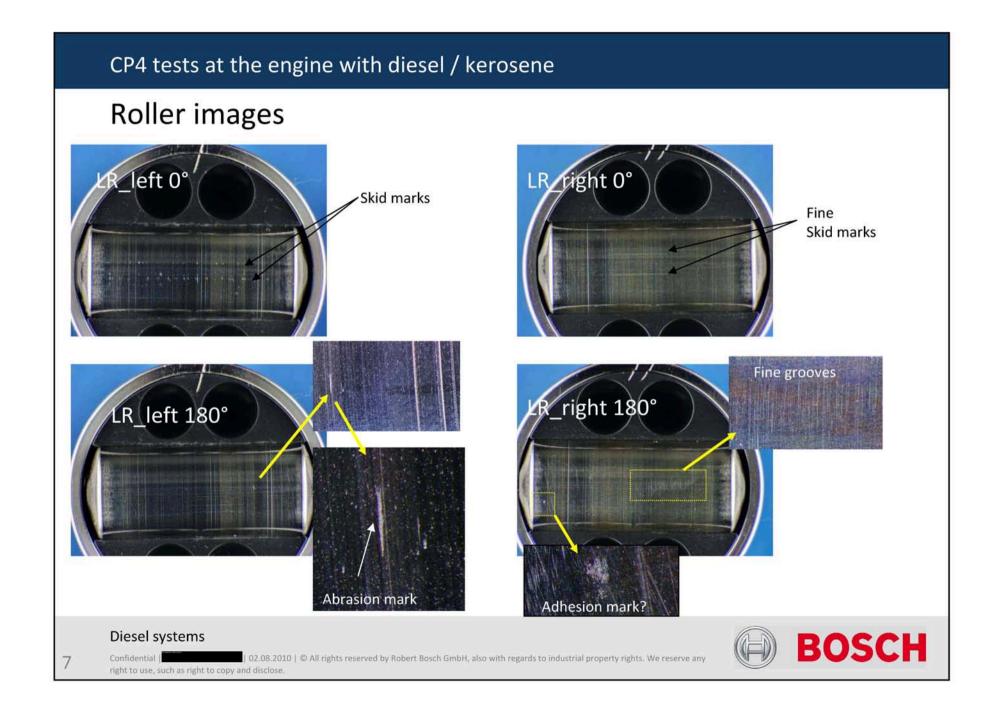
- -> Light edge support on the cam in cam run-up
- -> Alignment mark in LS
- -> Skewing of the roller in the cam profile recognizable
- -> 2 skid marks on the roller, left roller as well as 2 very fine skid marks on the running surface of the right roller

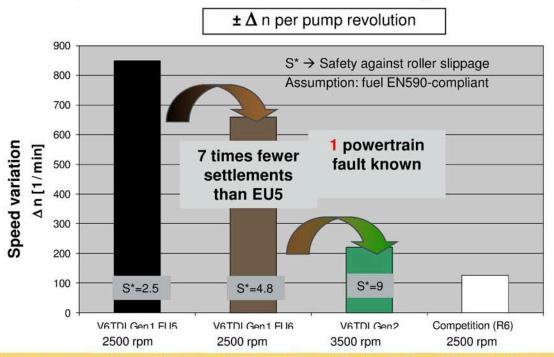
- High speed fluctuations when starting up the high-pressure fuel pump result in high rotations of the roller in operation.
- Major speed changes in operation of the roller have an impact on the hydrodynamic lubricant layer between roller and roller contact. → Torsional vibrations are an amplification factor for powertrain damage.

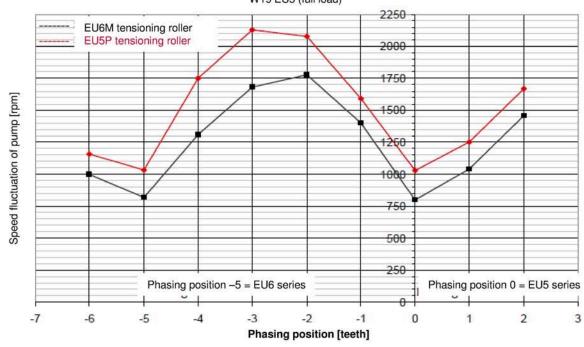
Results: Speed fluctuation (p-p) pump =f (phasing position), @ 2440 rpm (3250 rpm engine)

Summary:

- . EU 6 tensioning roller in the center leads to approx. 250 rpm less rotation speed oscillations on the pump
- . Setup position 0 or minus 5 teeth found to be best variant
- . Misorientation of the pump at pump change leads to a stronger increase of torsional vibrations under certain conditions.
