CR pump CP4 - Diagnosis report		Report no.	19420
				Date	12/4/2007
Department:	Person responsible:	Telephone:	Use	internal	
Non-responsive content removed			external		x
Pump type:	Customer:	Project:	Project/ design sample version		
CP4.1XX_298_2x5,25_REC_3,3_1,95_MT4,2	VW	R4 2.0 EU5	D / C2		
Item number (Part no.) :	Date of manufacture:	Serial number:	Plant - line		
0445B21058	010207	0045	0110 FeP - 1		
SAP-No.:	Samos no.:	Customer order no.:	Engine/Vehicle number		
DS-164763	578256		AU 481-8-8008		
Customer part number	ER type [customer]:	Endurance run conditions:	DSBFD no.:		
	Q endurance run		19420		
Mileage:	Received by DS-PC/EDI on:	Process no.	Confidentiality note		
80000 km	10/22/2007	2007 - CP4 / 0006	Confidential		
Complaint:	None. Endurance run end.

CP4 customer return
Q-ER; CAG 0000 067; AU 481-8-8008

Subject: Teleconference 9/18/2008, Production measures to reduce drivetrain damage

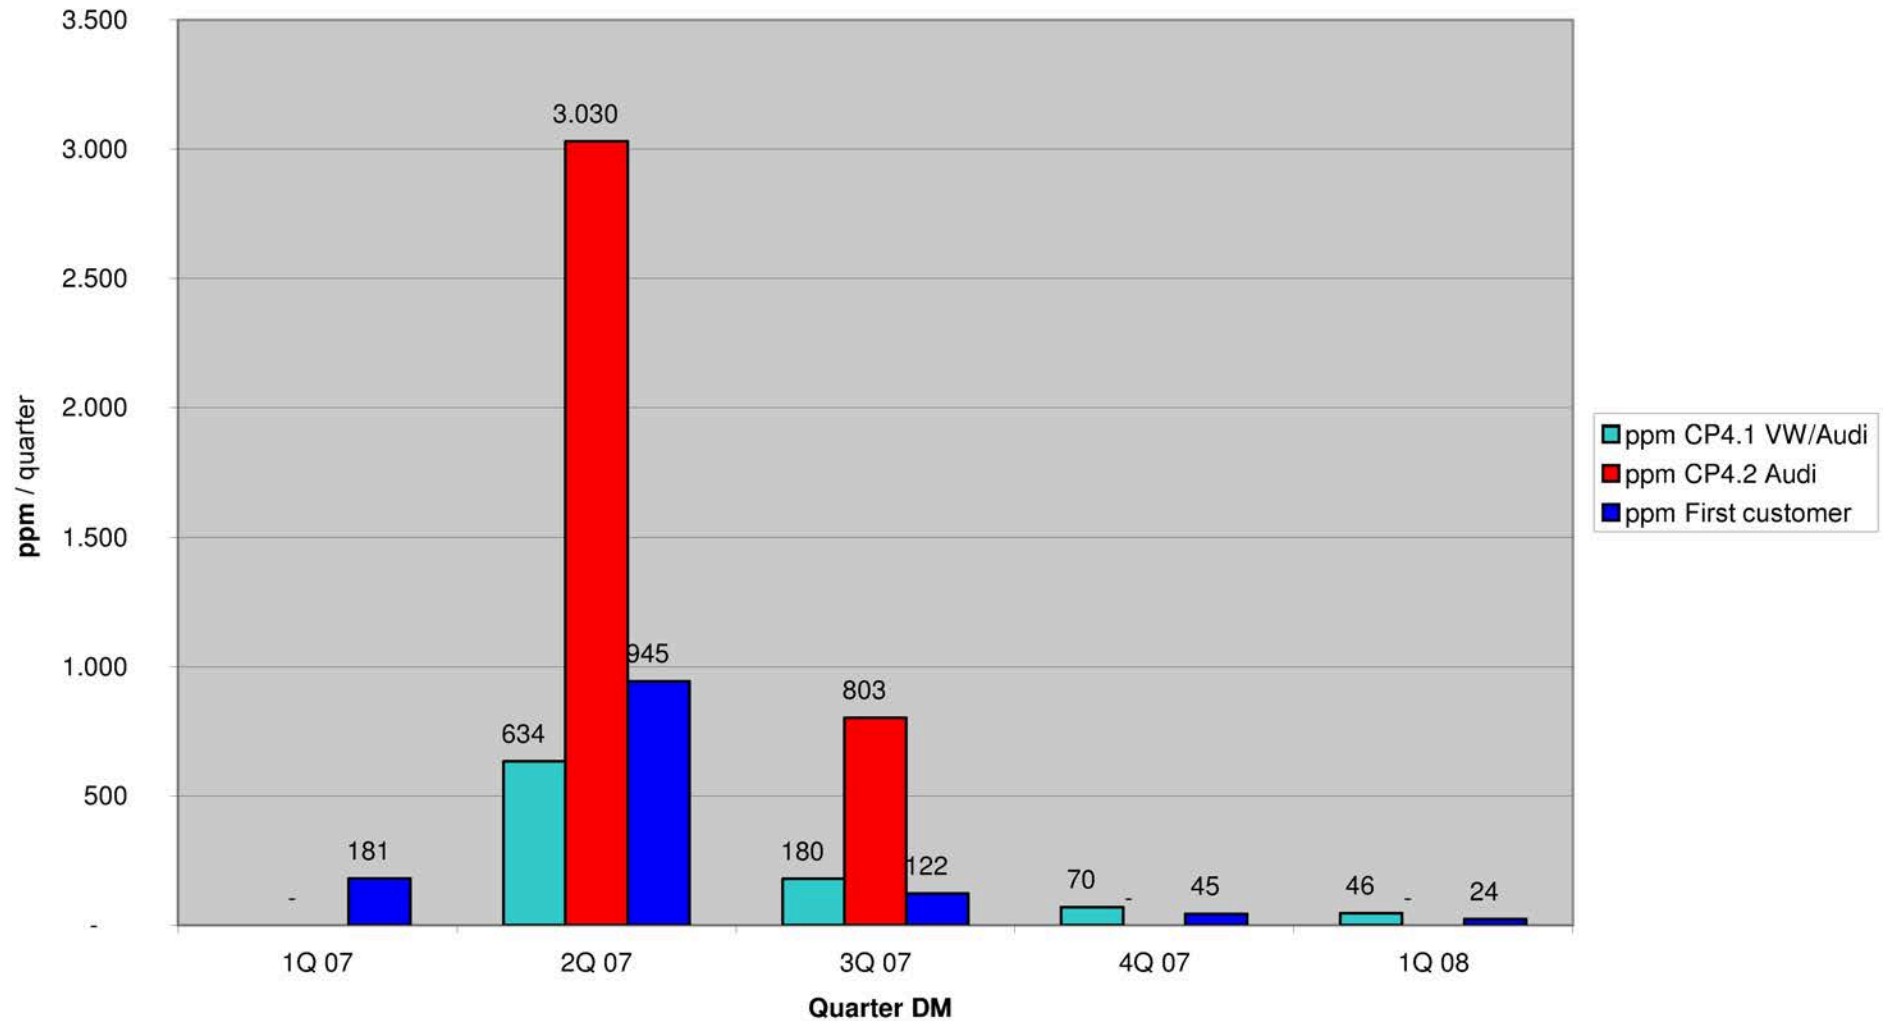
Drivetrain damage CP4 0 km and field

Failure statistics 0 km / Field All customers

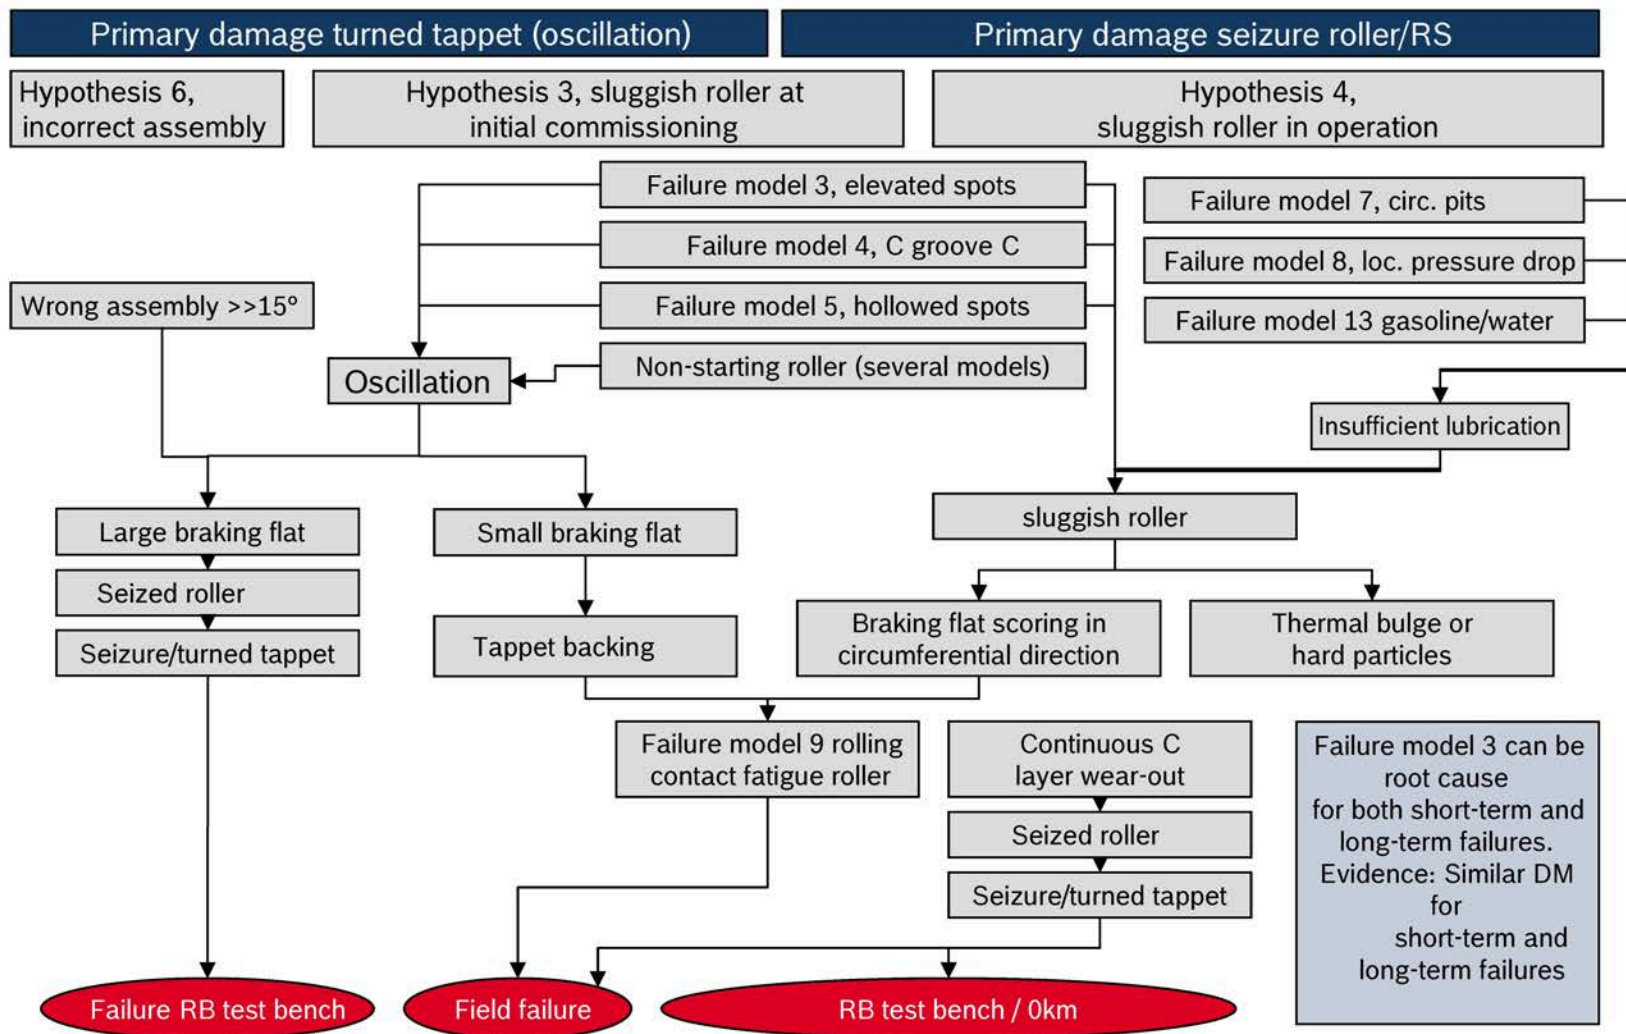
Status drivetrain damage SC 3/19/2008

Circumferential roller wear, no 90° turning evident

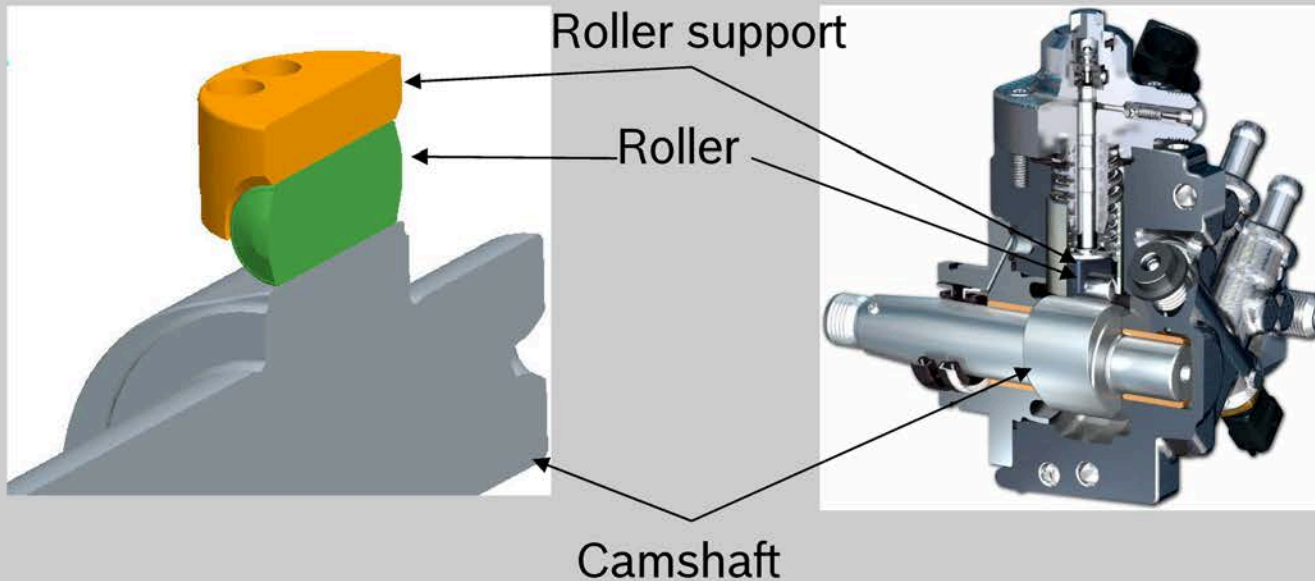
Robustness of Common Rail System for Rest of the World Interactions of CP4 drivetrain damages

The cause of drivetrain damage is operation with impermissible fuel qualities and/or high component function sensitivity

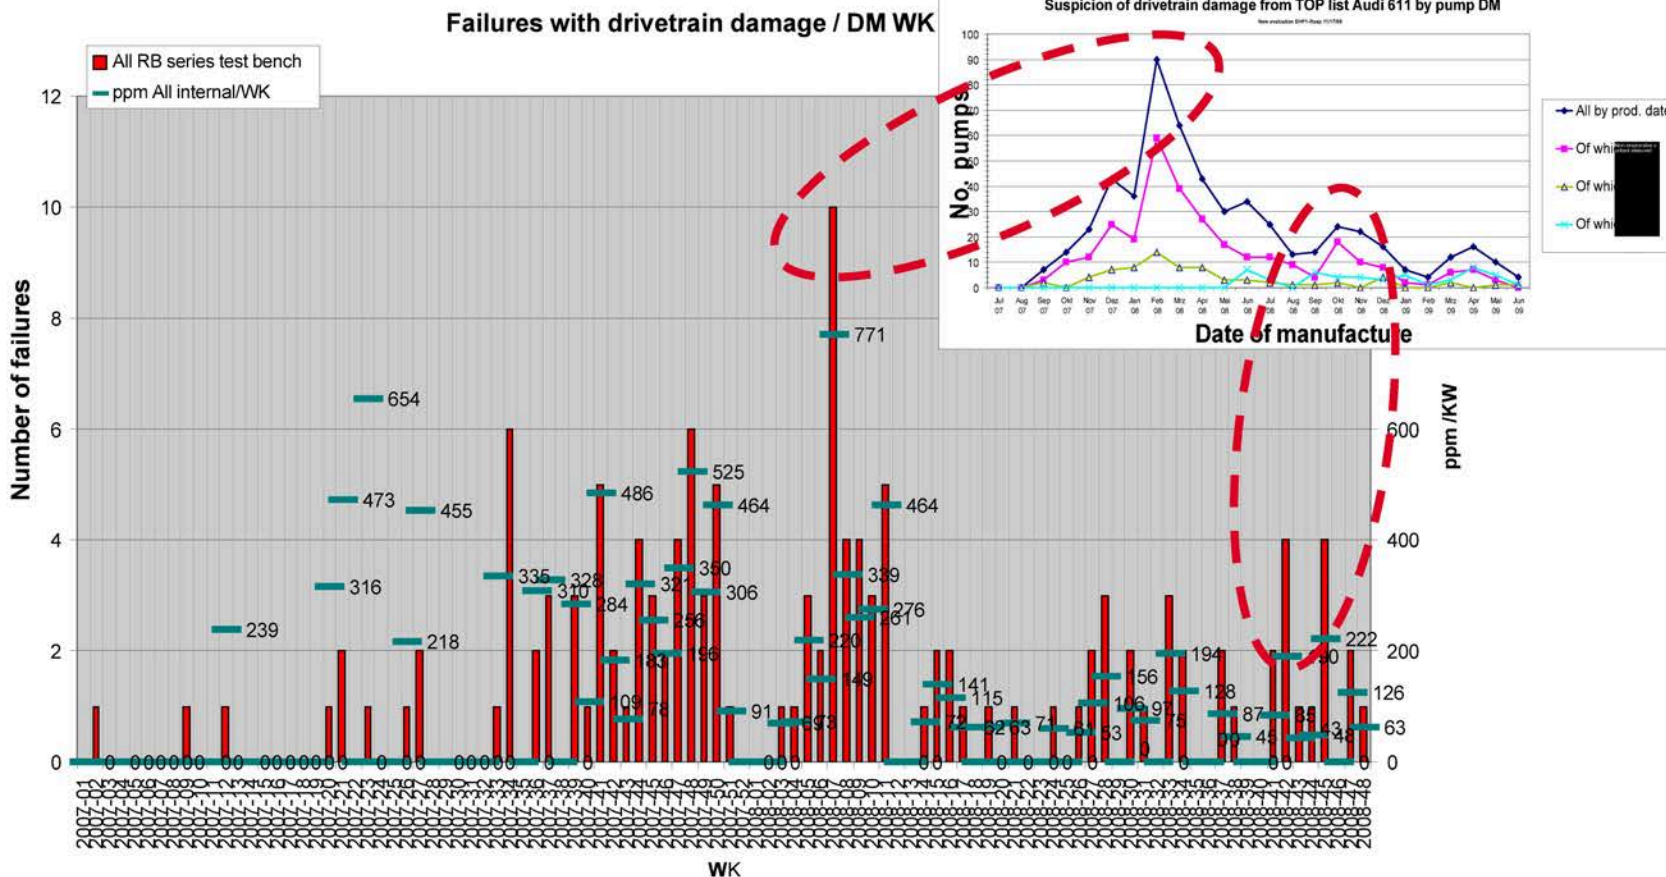
Overview of failures, internal test bench & Field (failure peaks)

-> Increased internal test bench failures correlate with increased field failures

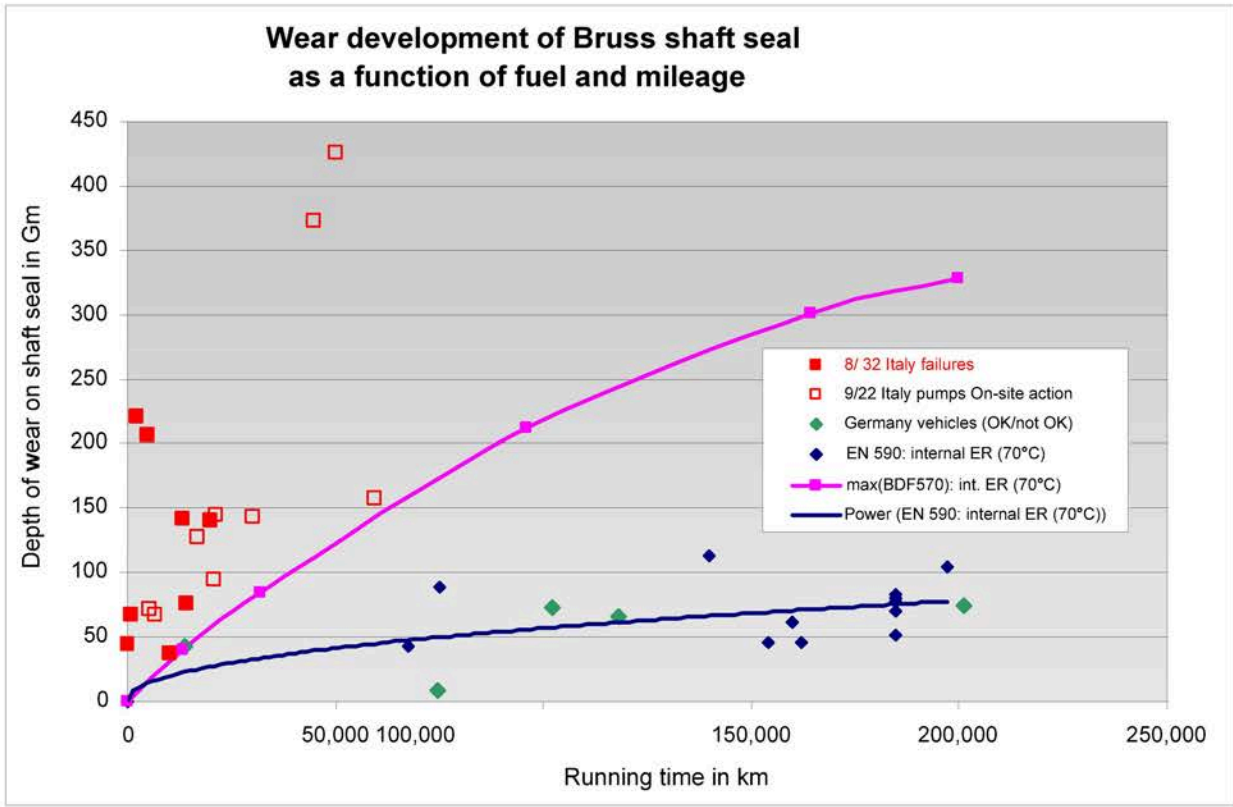
Result of shaft seal wear measurement, Non-responsive content removed

- => Bruss shaft seal Non-responsive content removed (17x) worn more than with EN590 (= fuel influence)
- => No functional leakage of described shaft seal
- => No dependency on manufacturing or failure date

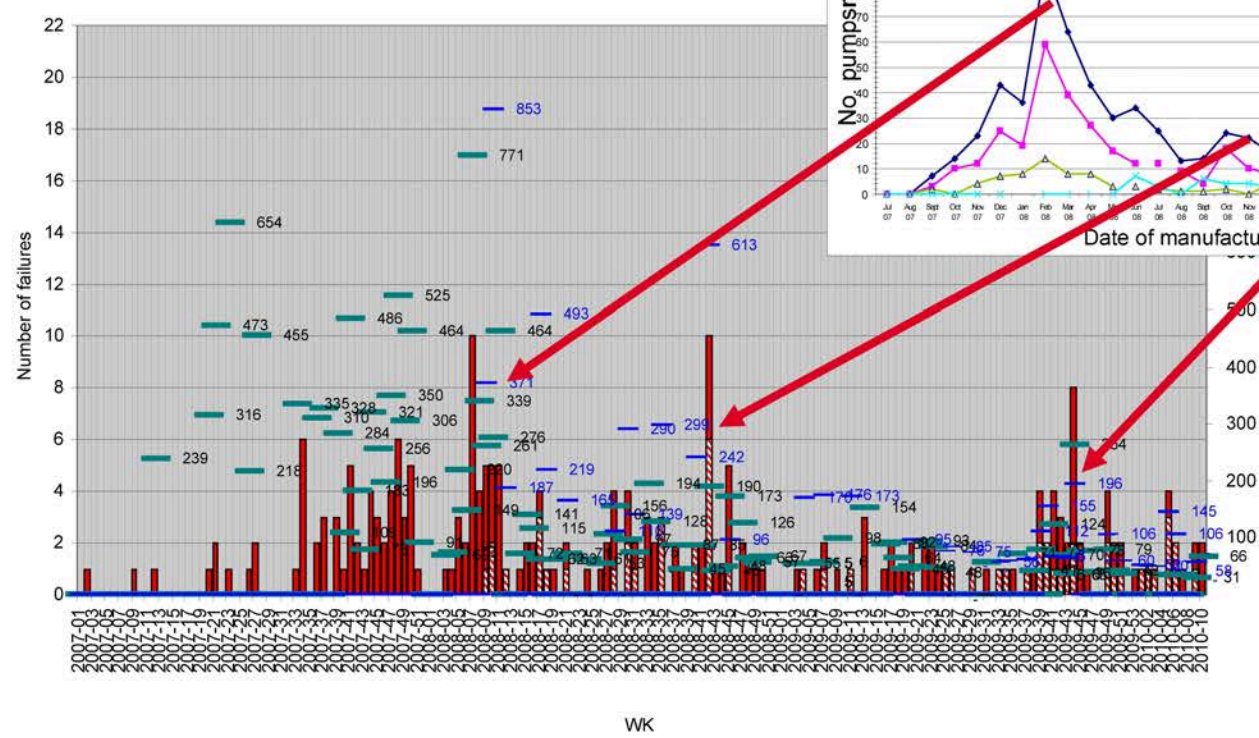
failures drivetrain damage DM WK CP4.1/C P4. 2 Internal

-> Increased internal test bench failures correlate with increased field failures

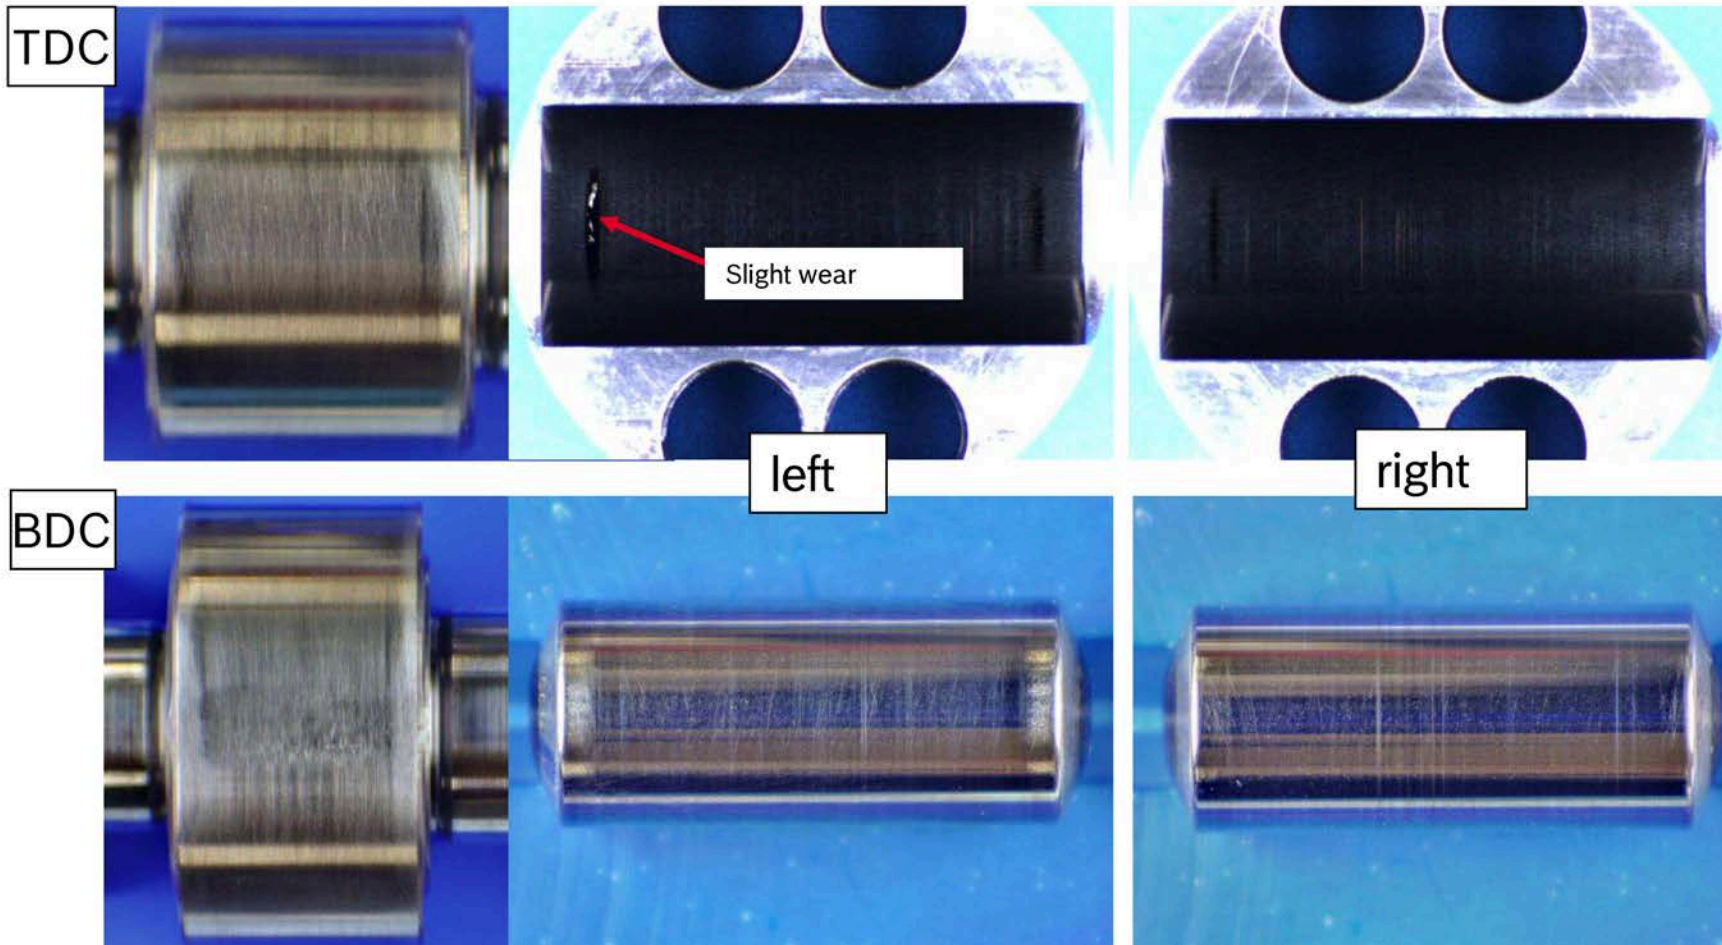
Pictures C2.1 good 18 μm (2010-CP4_0053)

Slight wear

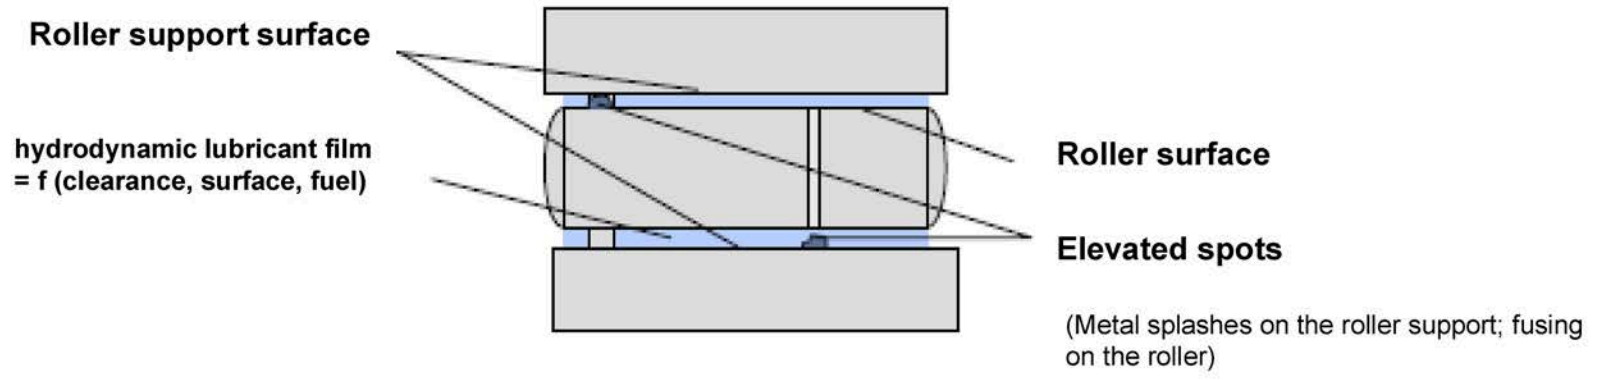
Intensification factors: Fuel with low viscosity; elevated spots on roller (e.g. fusing) and in the roller support (e.g. metal splashes); surface of roller/roller support
