Bosch CP4.1 Drivetrain Damage

EAD Quality Offensive 2,01 TDI BIN5

Draft for possible damage pattern for drivetrain wear on CP4.2 and the influential factors

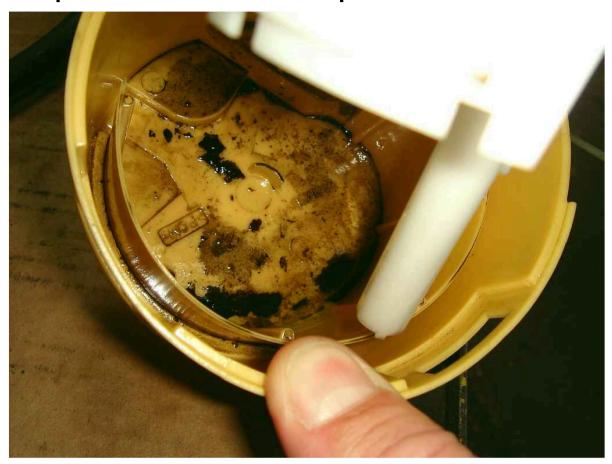
Deposits in the swirl pot

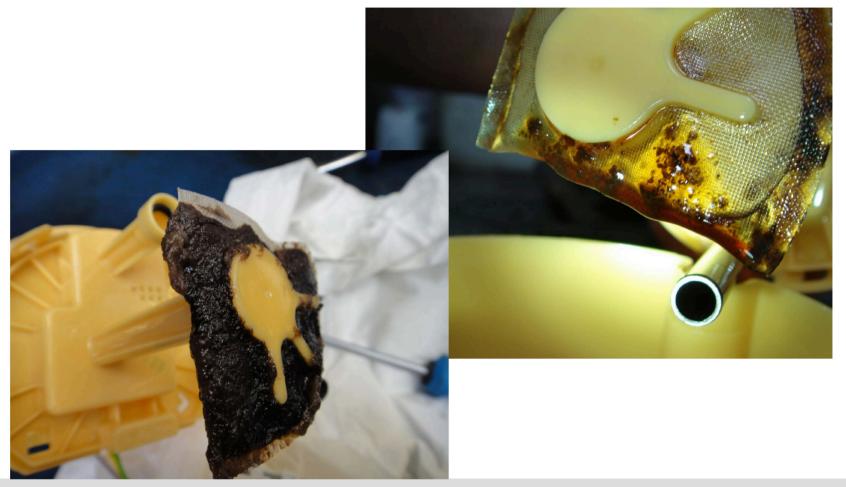
Deposits on the screen in the swirl pot

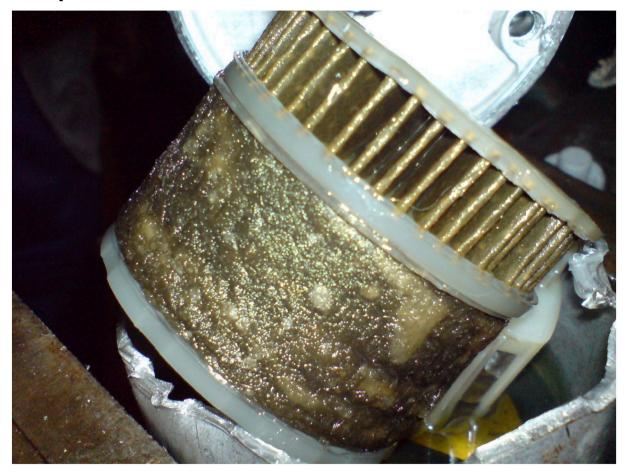
Deposits in the fuel filter

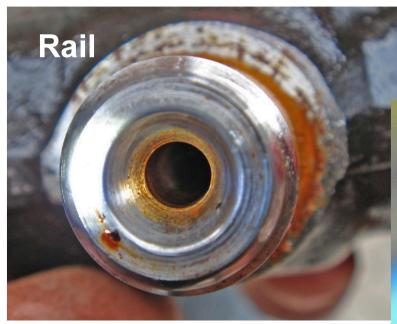
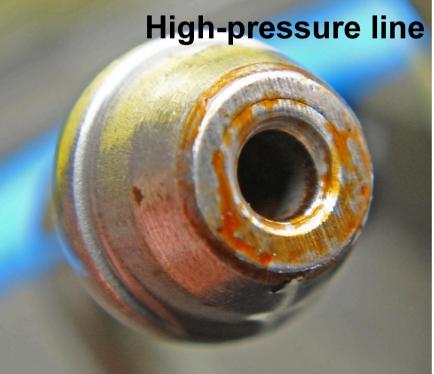
Deposits on connections

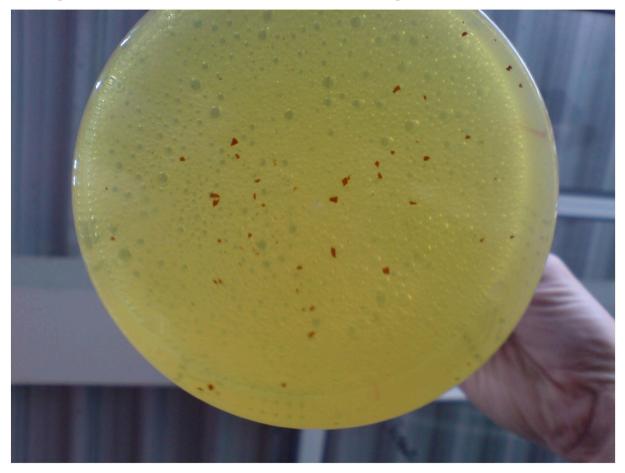
Deposits in the fuel samples

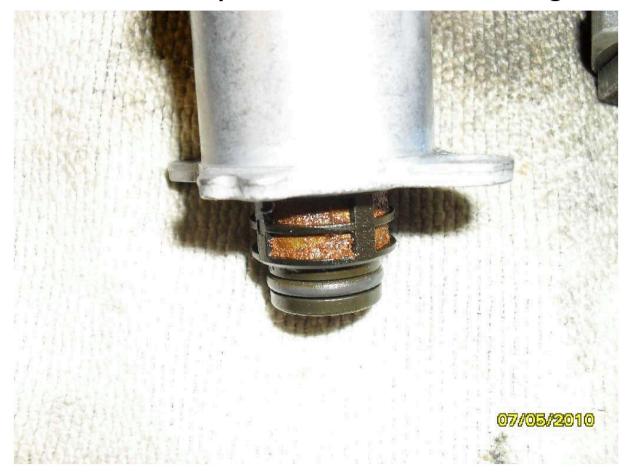
Corrosive deposits on the metering unit filter

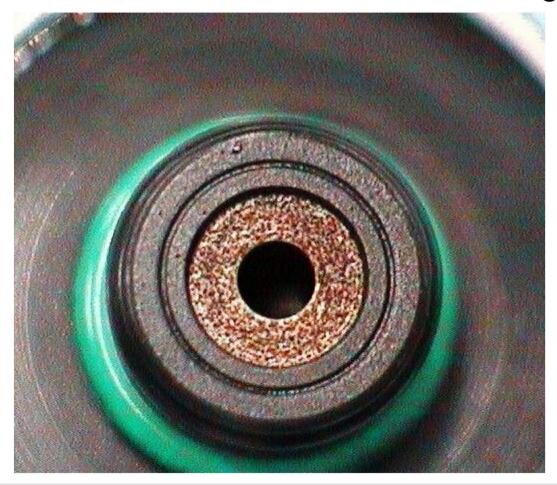
Traces of corrosion on the metering unit
