TF: Audi overload tests

CP4 diagnosis: VW R4 2.0i EU5 - first findings

CP4 - Drive Train Failures - Analysis

Cause-effect relationship CP4 drivetrain damage

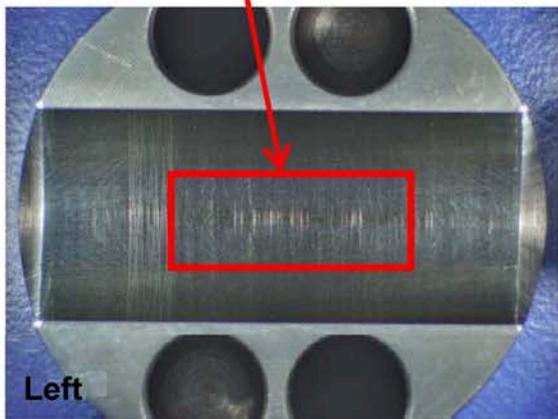
Signs of wear on the roller

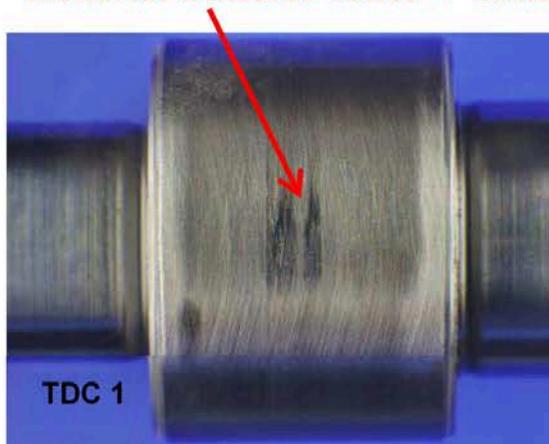
Material transfer roller -> cam

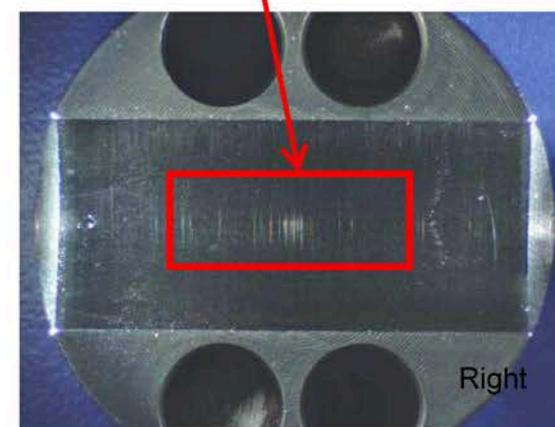
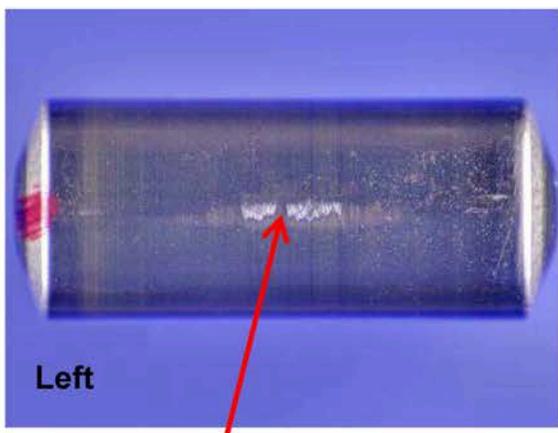
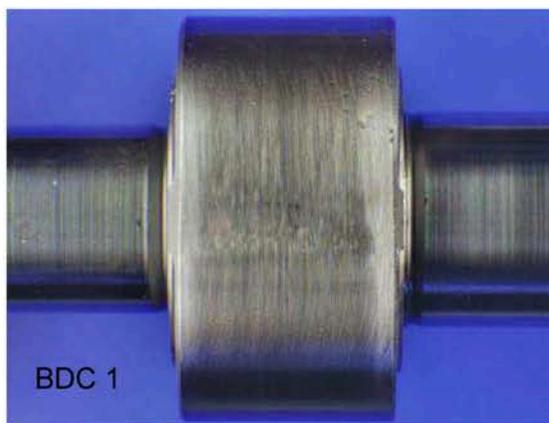
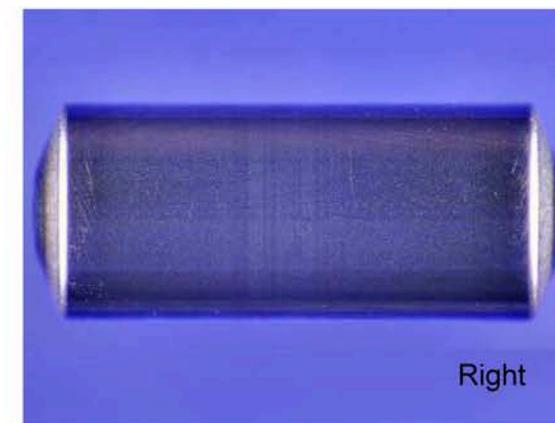
Signs of wear on the roller

Braking flat (R8) Material transfer roller -> cam

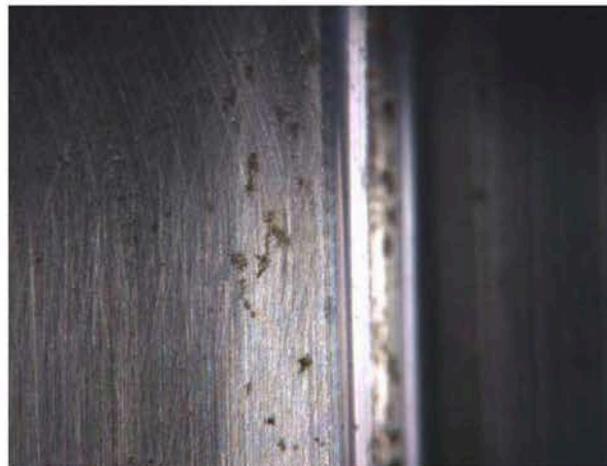
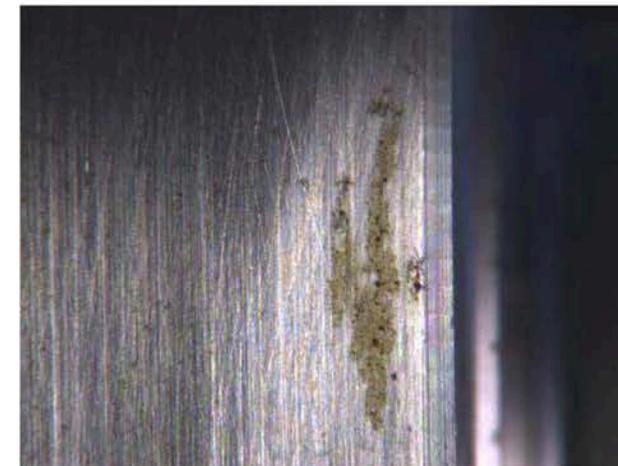
Corrosion on the cam track

- Material transfer from roller to cam
- Signs of wear on the roller on the roller support running face (⇒ fuel viscosity ↓)
- Corrosion on various components, among others MU pistons (⇒ water)
MU pistons sluggish → quantity deviation → engine running irregularly)
- Fuel smells of petrol
(Petrol quantity proven with gas chromatograph, flash point <40°)

- Cause of complaint: Corrosion on the MU pistons due to water
- Cause for material transfer from the roller and signs of wear on the roller support: probably petrol + water

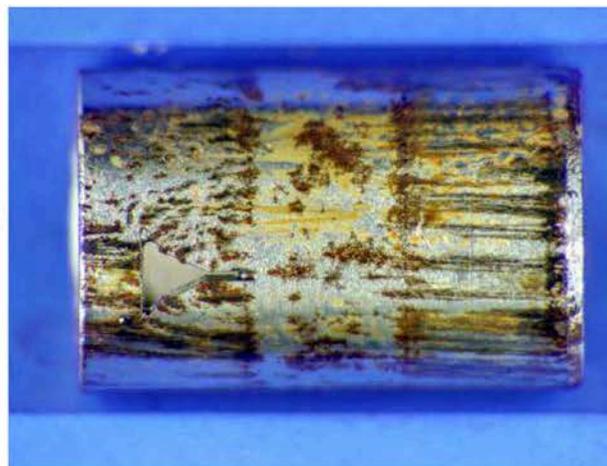
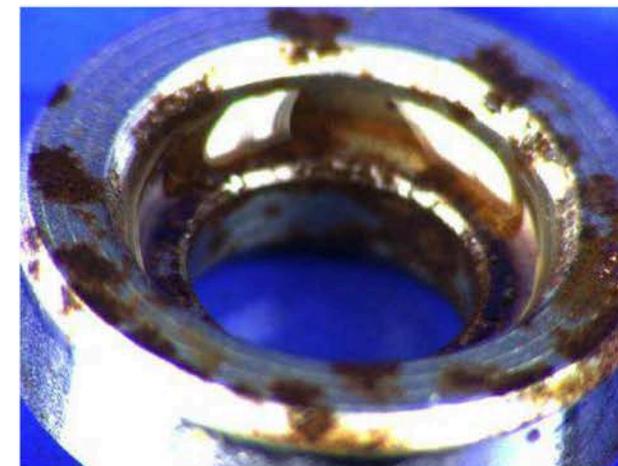
MU corrosion (Pistons, safety element, etc.)

The corrosion has caused the pistons to cake and therefore the MU function is not OK.

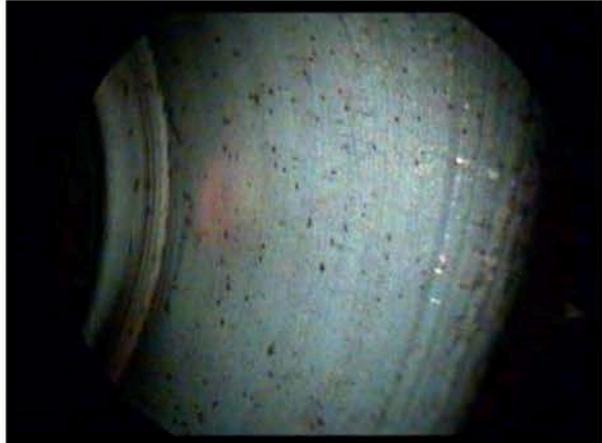
Fig. 4 Housing corrosion

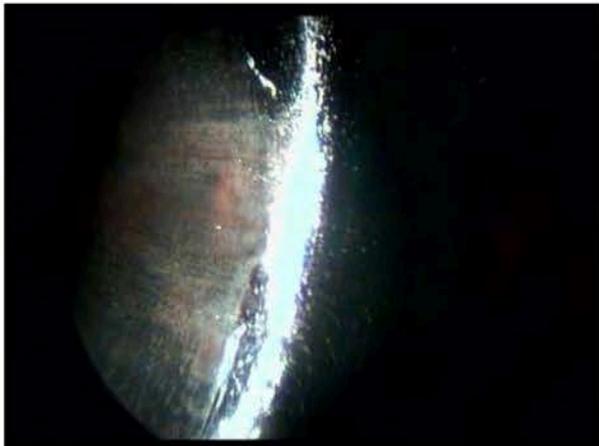
Fig. 5 Magnet core bearing

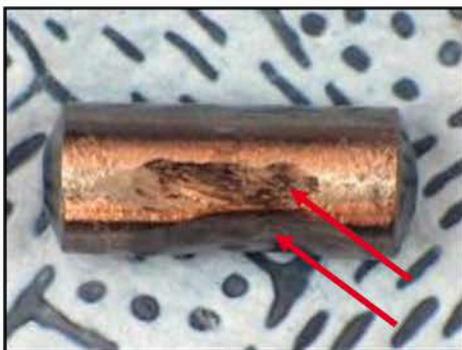
Roller with two pronounced 90° run marks on a completely abrasive worn surface

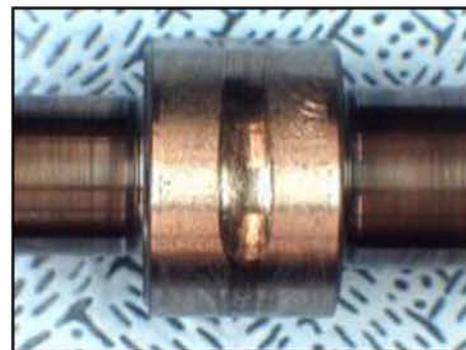
Camshaft with a completely abrasive, worn surface and a pronounced 90° wear zone

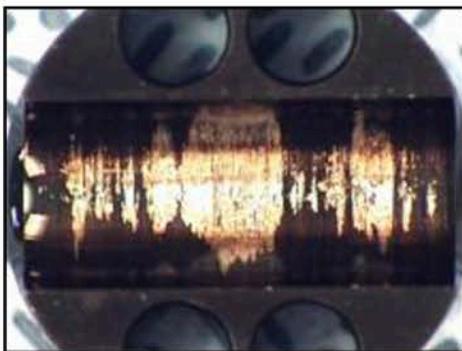
C coating wear similar to pressure profile

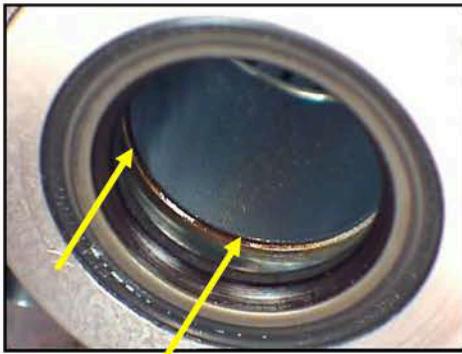
Local, brown deposits in the area between the flange bearing bushing (front surface) and shaft seal

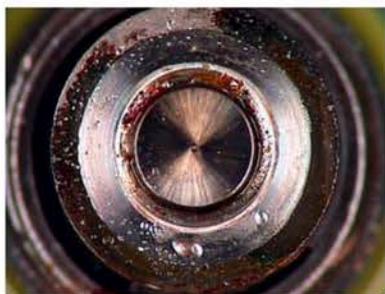
Intake valve

Brownish deposits (corrosion?)

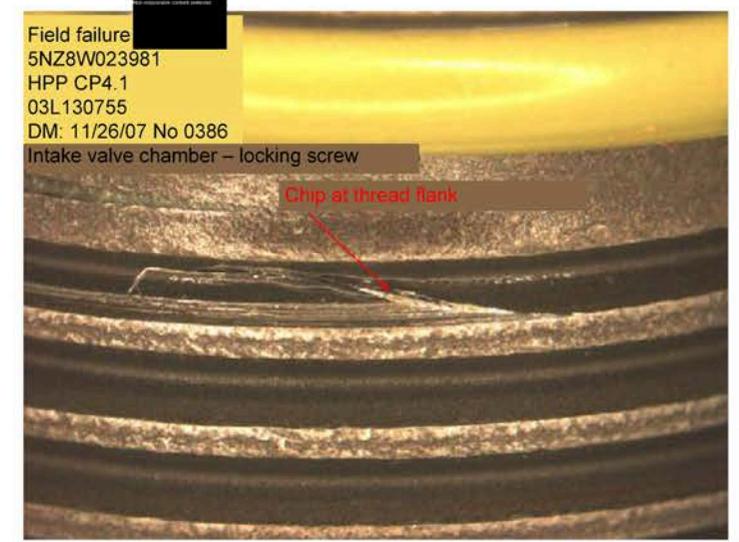
- Failed pump disassembled and examined by VW.
- Result:
- 1.) Chips in the intake valve (IV) area
 - 2.) Chip at the locking screw (see figure)

- Striking feature known and countermeasures initiated
- The screw connection may cause chips to form.
Cause: Thread geometry of the cylinder head (limited by its construction)
- A series of tests was conducted on cylinder heads (CH) with different thread geometries. Result:
A variant that can be used to prevent the formation of chips on the locking screw was identified. This variant is within the valid specification.

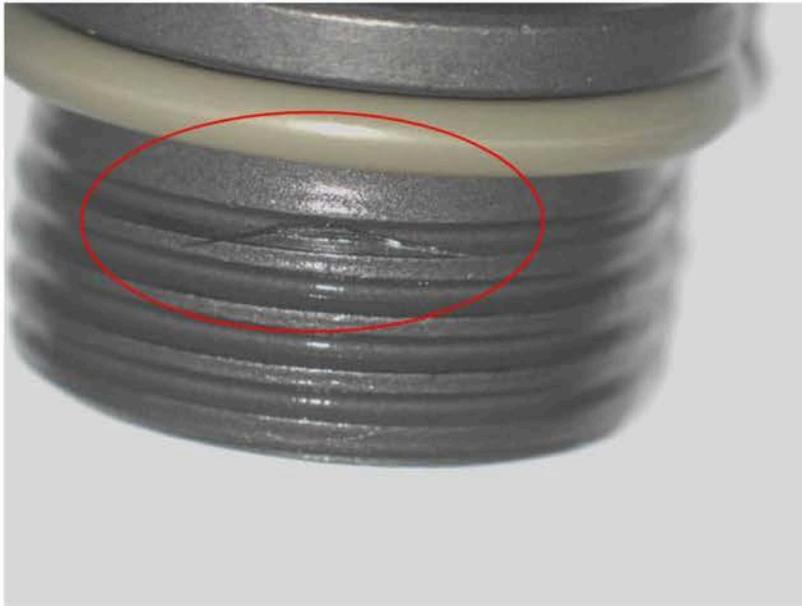
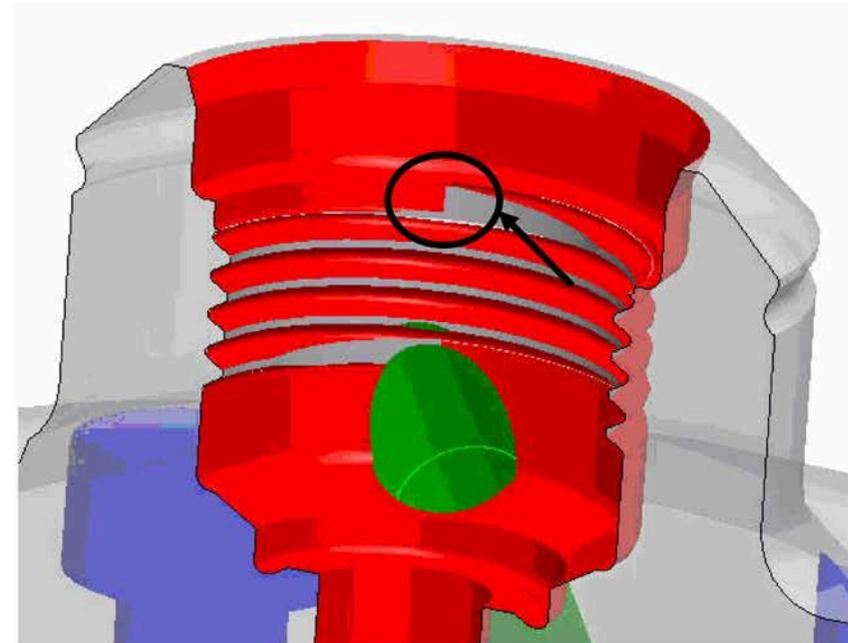
- When assembling the locking screw, an indentation/chip forms in the thread of the locking screw. This is produced by the thread end of the inner thread at the cylinder head.
- The chip always forms at the locking screw because this is the softer material.

- The chip can only be formed if the axial force is sufficient (i.e. at the end of the bolting procedure). In the assembled state, the chip always remains above the intake valve thread.
- In order to access the intake valve, it would have to migrate downwards through the thread pitch (approx. 4 rotations at $75\mu\text{m}$, which is the greatest possible thread clearance) against the fuel flow. Since this can be ruled out, disassembly is the only risk that remains.
- During disassembly, the chip may be loosen from the locking screw, drop into the cylinder head or intake valve and become entangled there, where it remains and causes damage during reassembly.

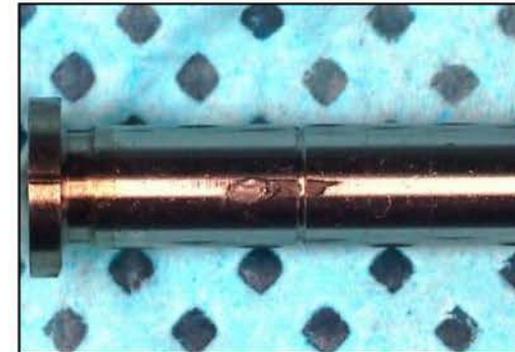
Image 3: disassembled seized piston

They were due to external cylindrical grinding of the pump pistons in the form of roundness defects

Nom.: $0.7 \mu\text{m}$ Actual-failure parts to $3.38 \mu\text{m}$

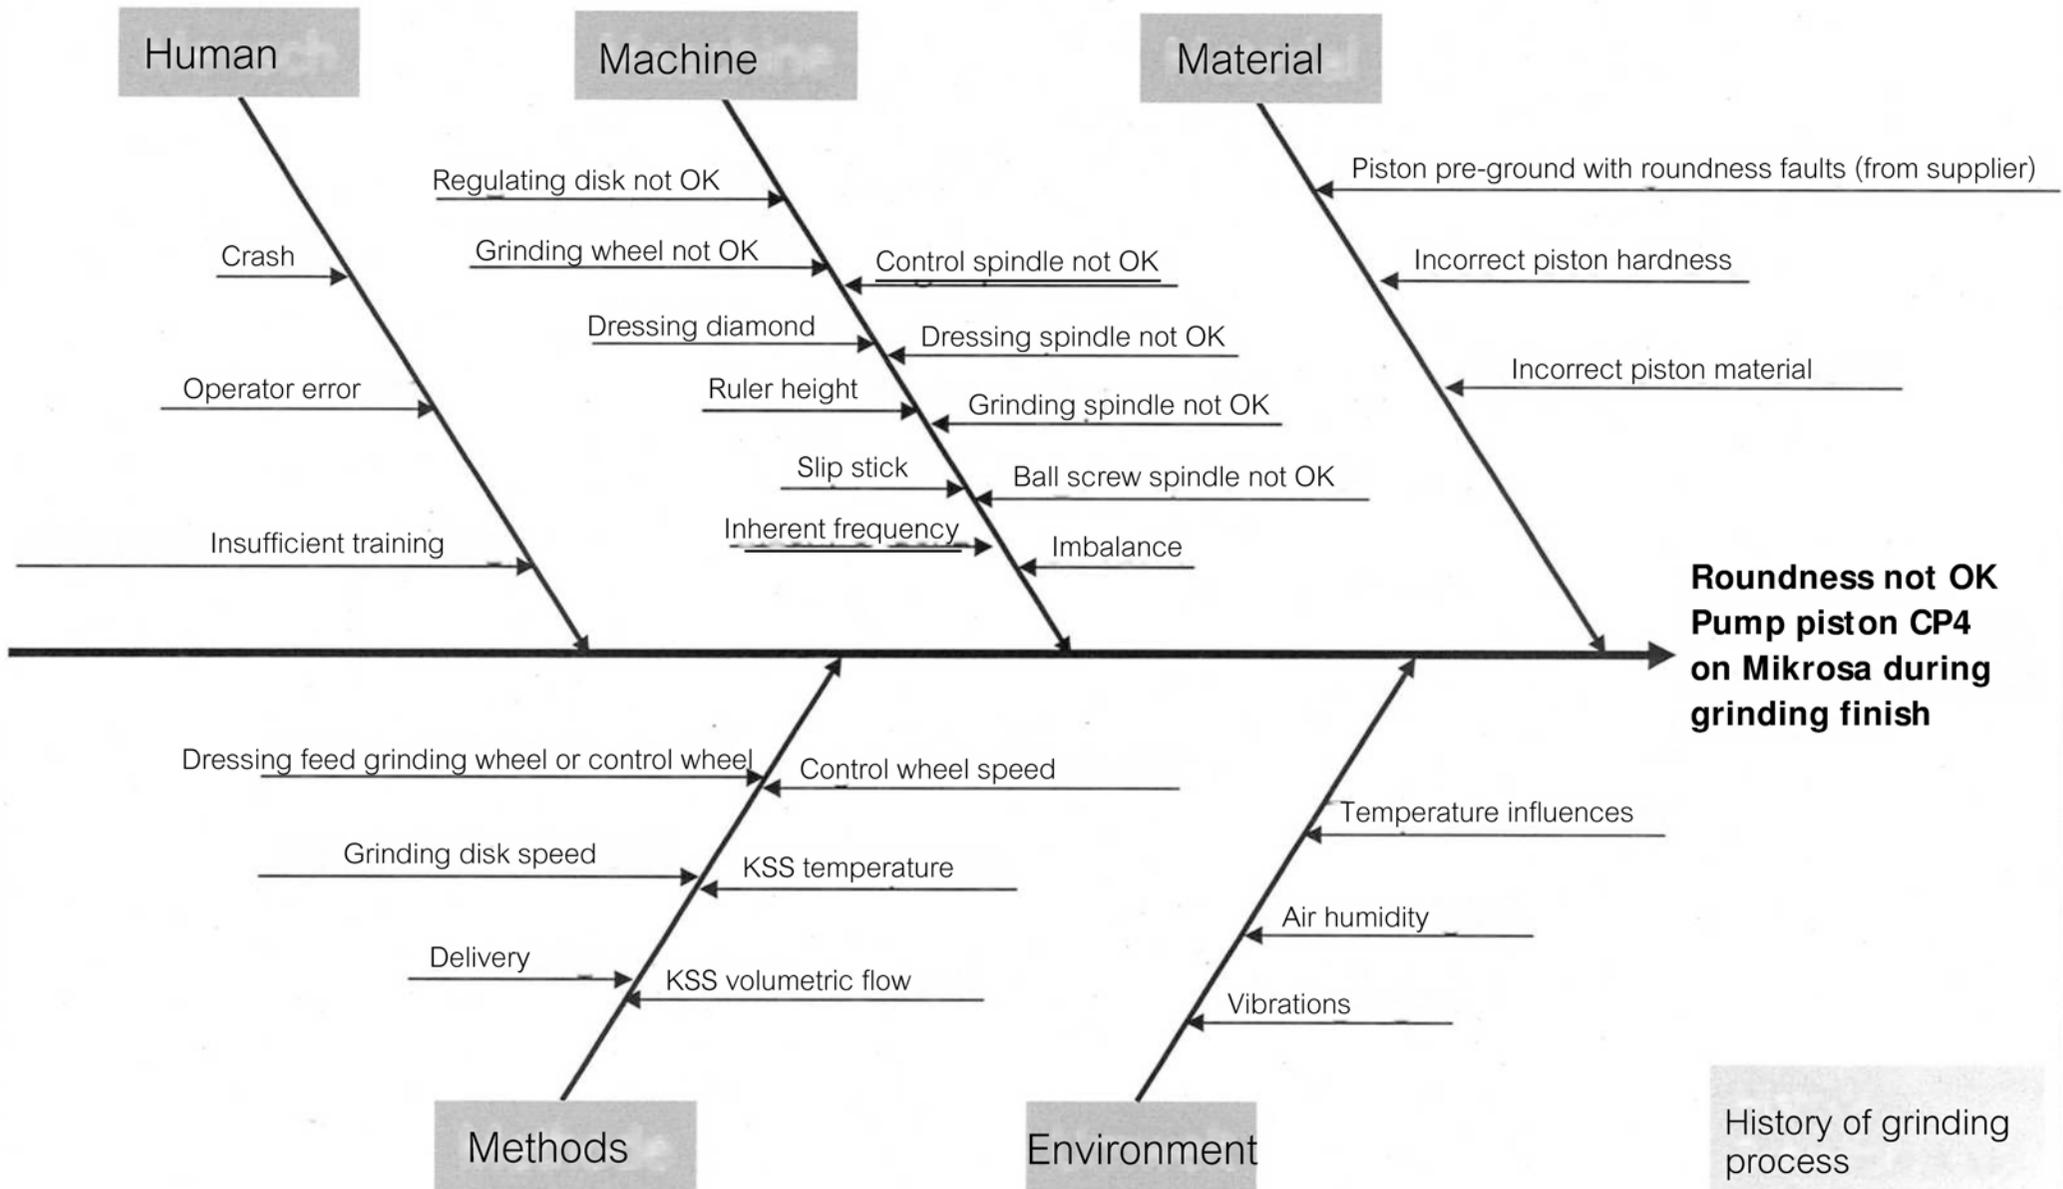
Grinding of CP4 pump piston

Further procedure		
100% check for pump piston roundness	R	D
1. adjustment to existing measurement equipment	Non-responsive content removed	}
2. Introduction of tactile measurement		
3. 100% gauge insertion testing since 05/14/09:		
3.1 with measurement rings instead of cylinder head		
3.2 with one measurement ring for each CH class		
Investigate variances in coolant pressure		06/20
Representation of batch releases since 2008		06/19
Process capability examination before/after		
Quality loss		06/19

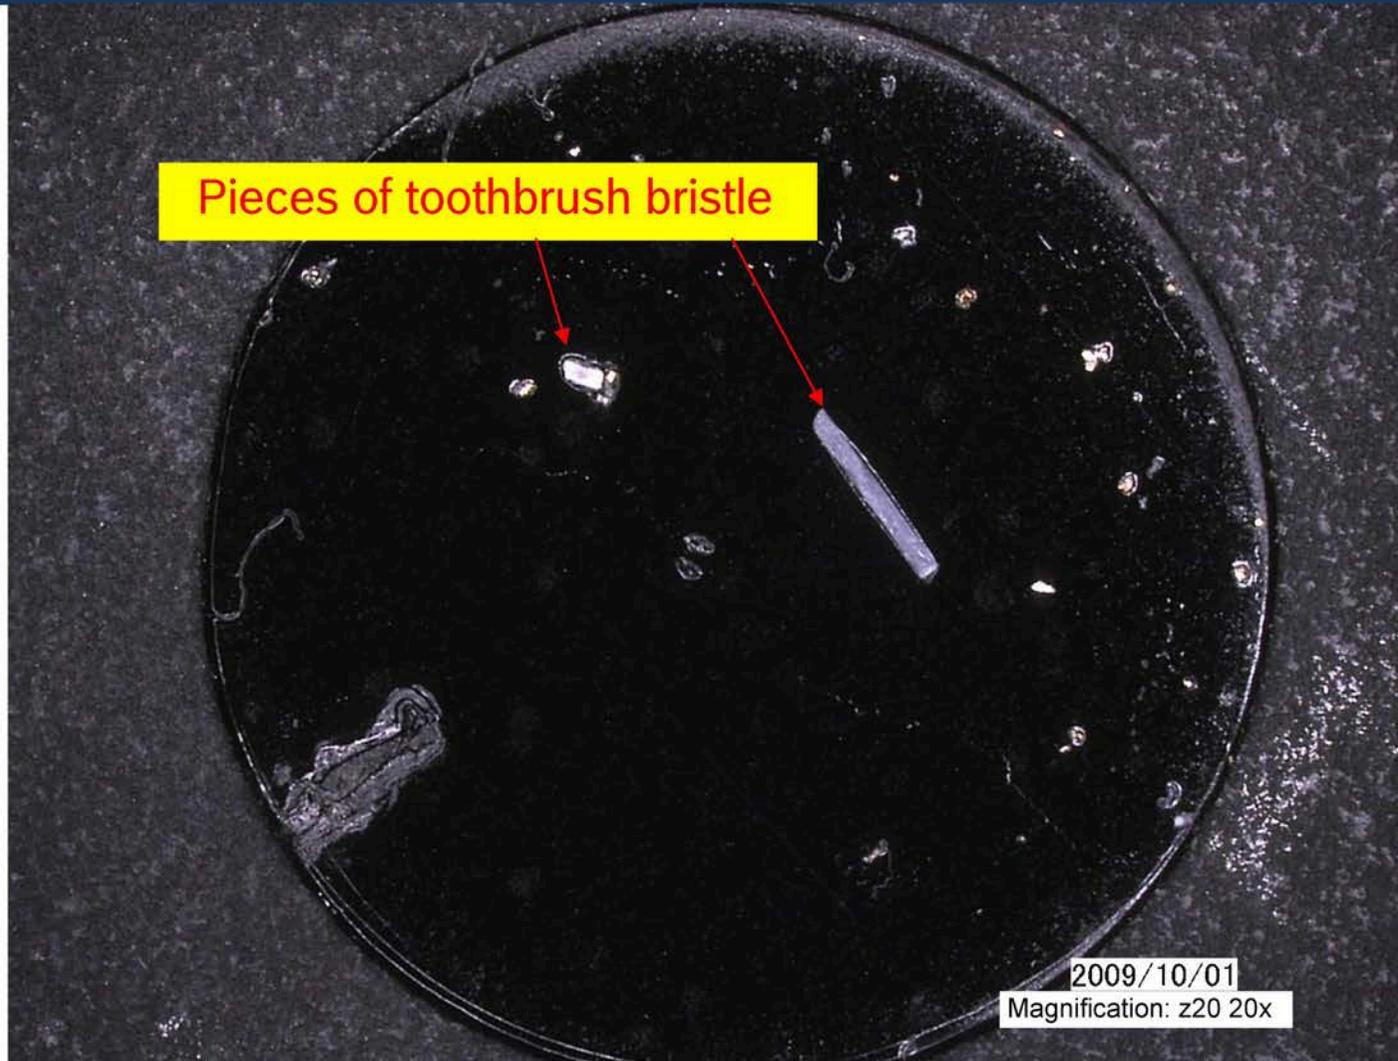
Particles from shim between sliding bearing and flange

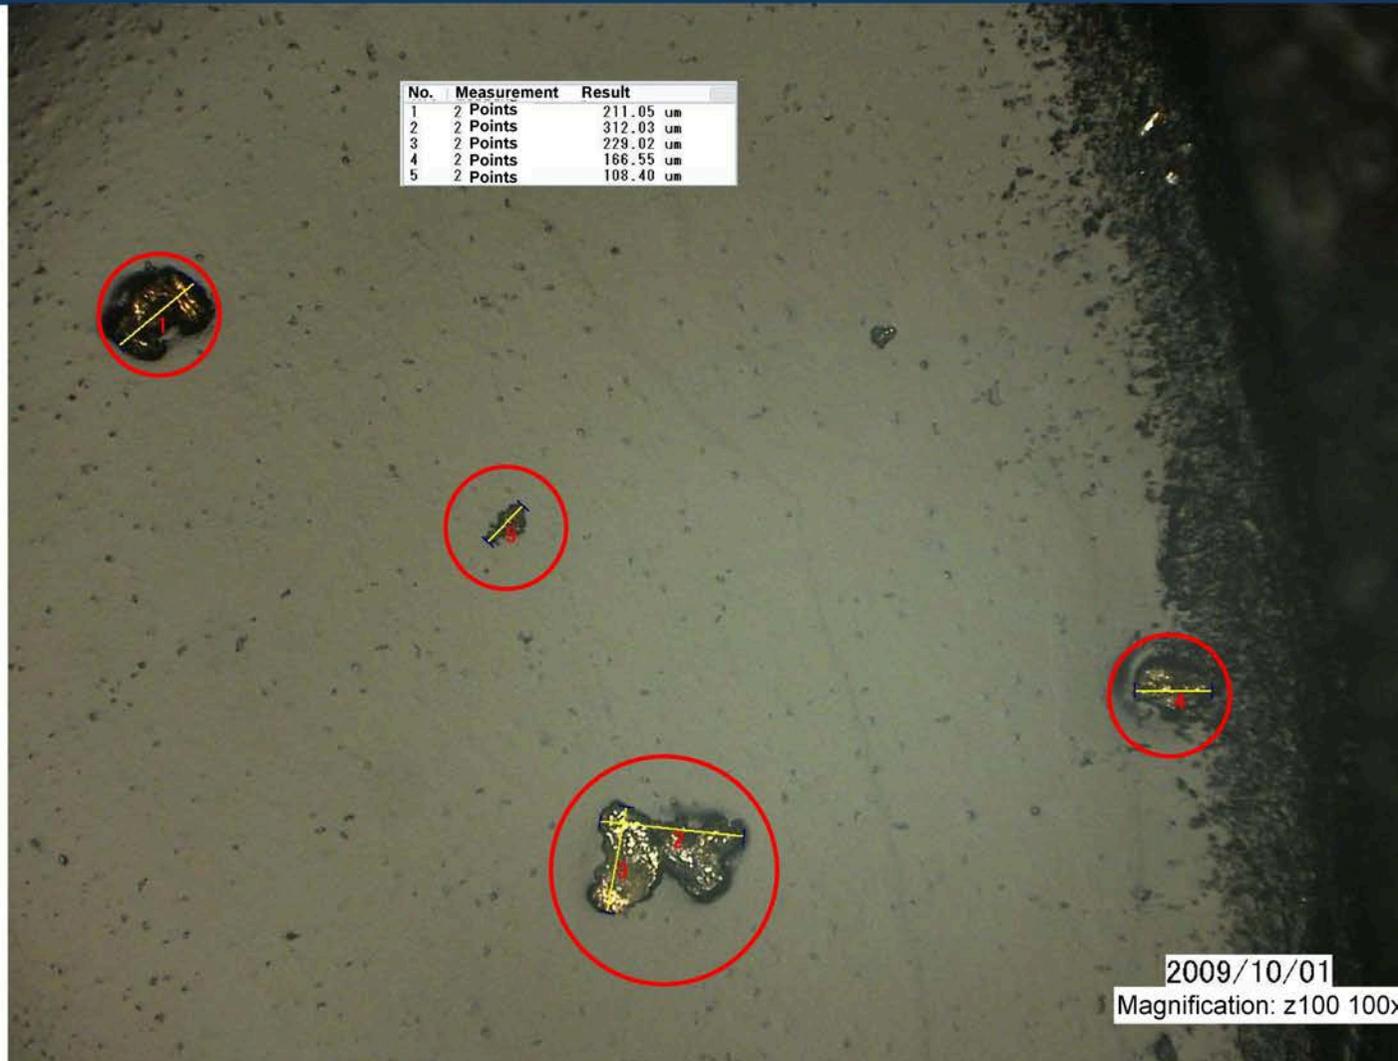
Particles from shim between sliding bearing and flange

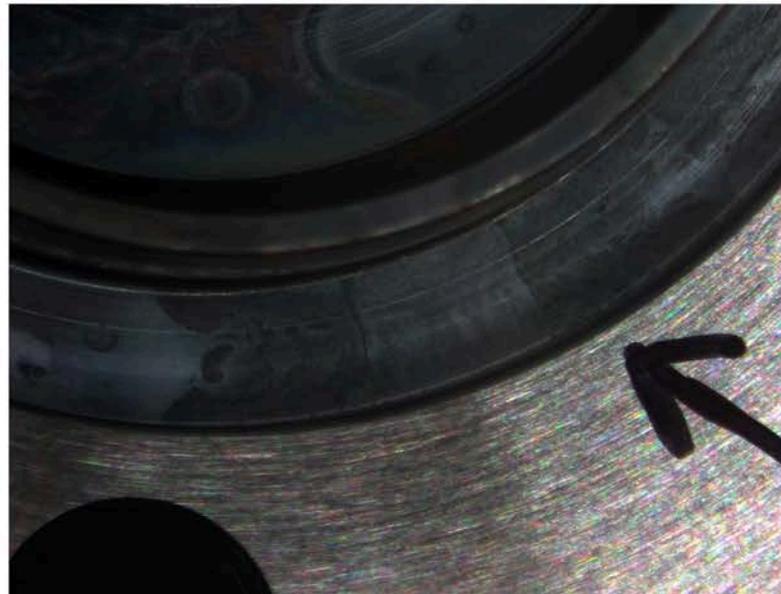
No rust traces detectable, neither during test with demineralized water nor with other concentrations (1%, 3%, 5%). Merely water residues were found.

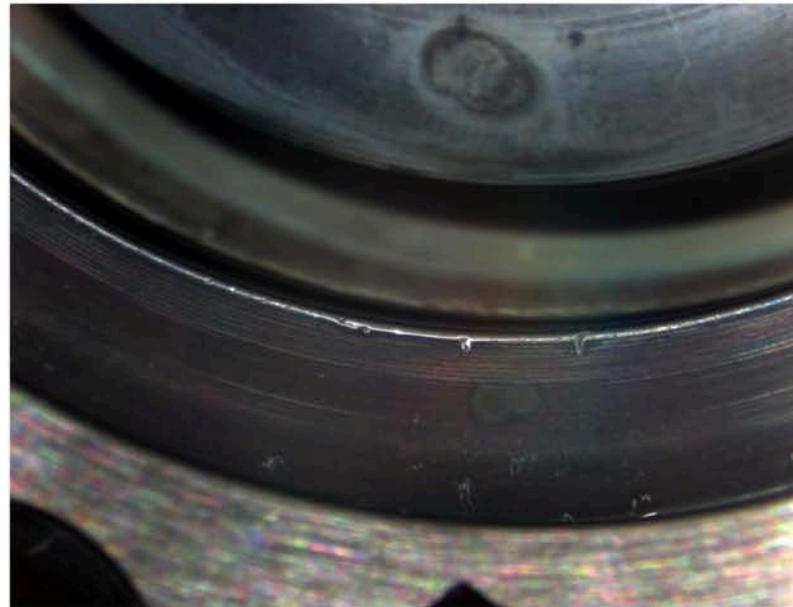
No rust traces detectable, neither during test with demineralized water nor with other concentrations (1%, 3%, 5%). Here, as well, only water residues were found.

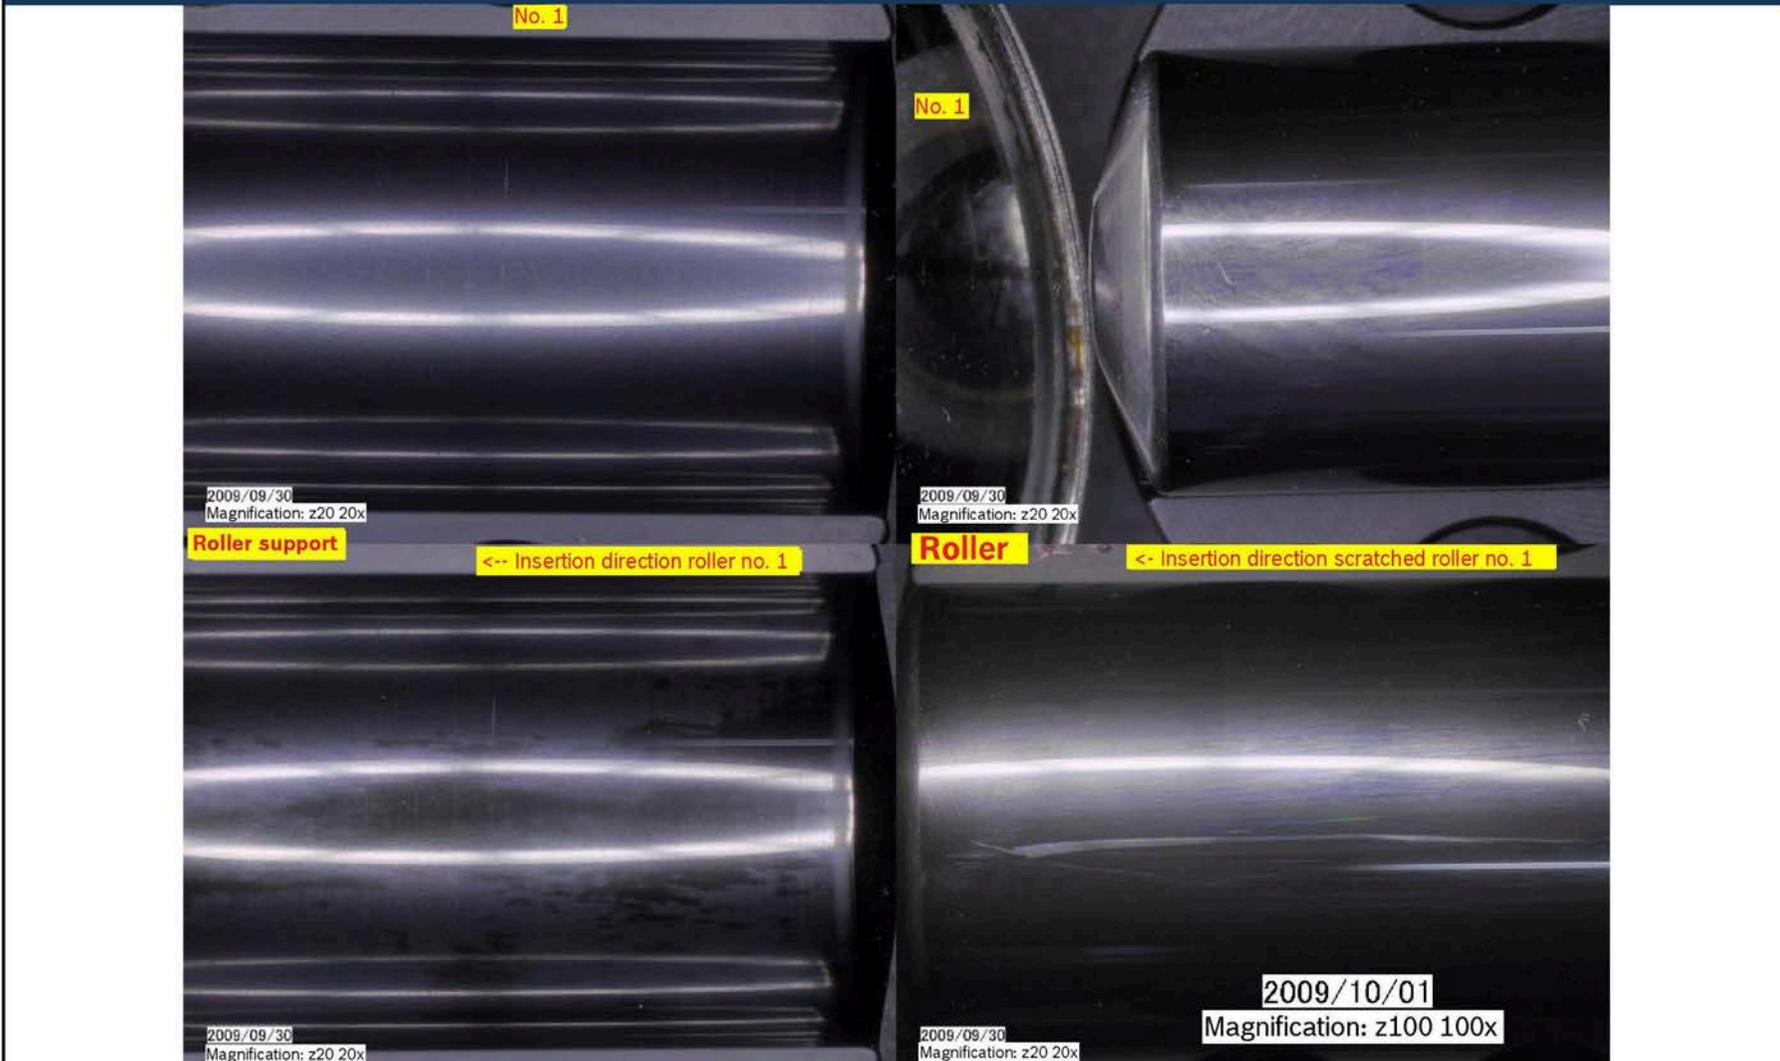
Tilted insertion of roller into RS: **Roller 1 + RS 1**

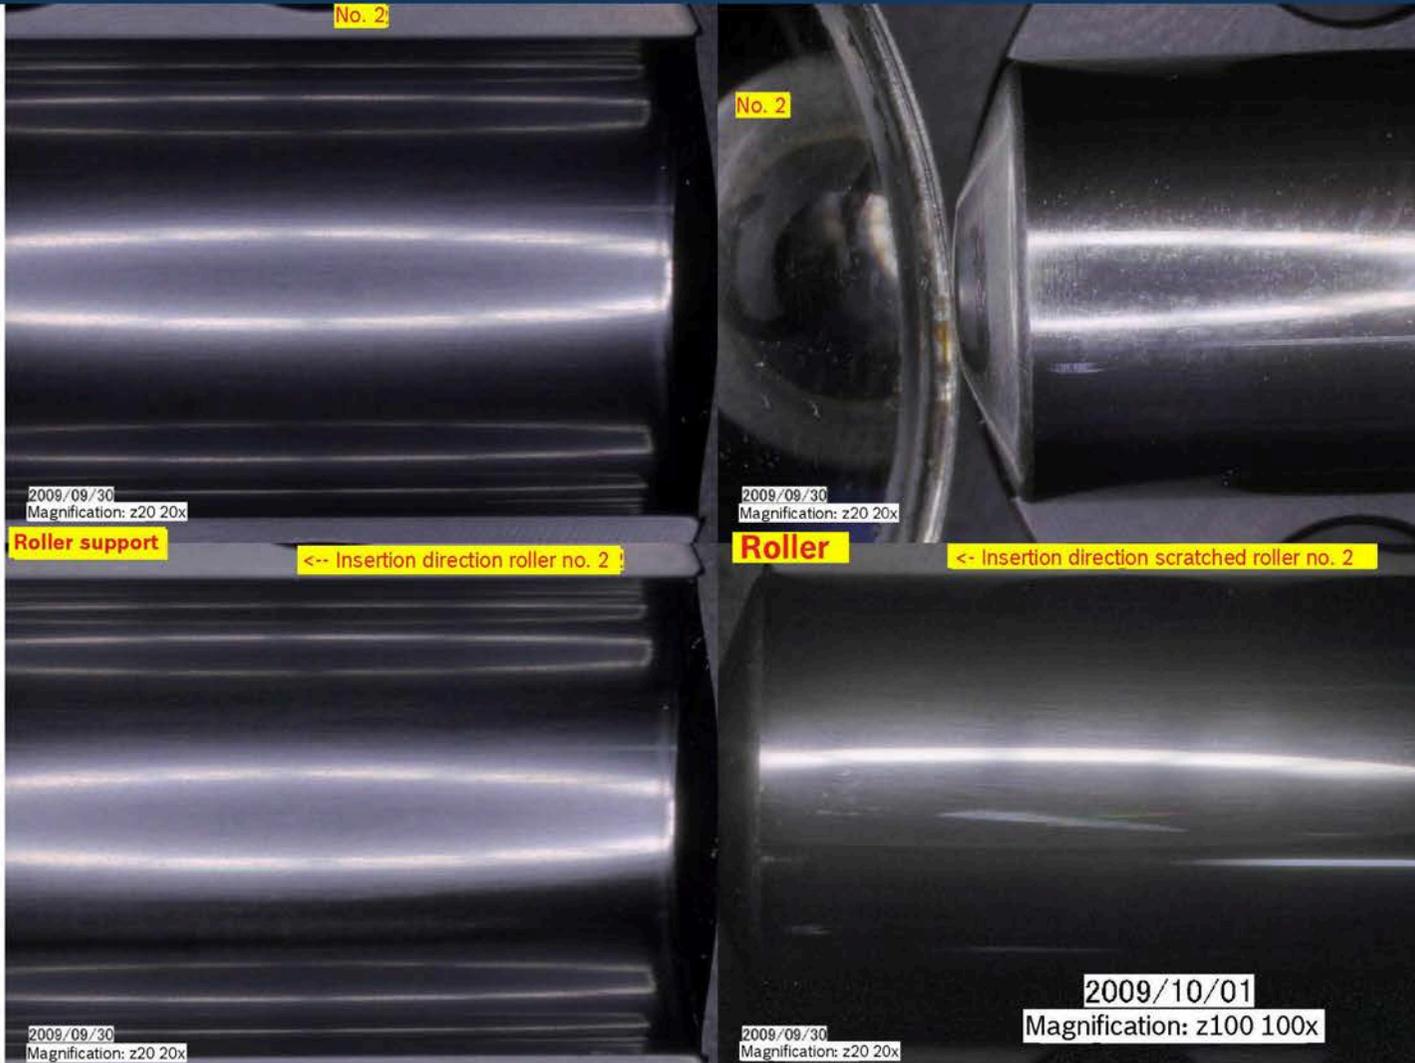
Tilted insertion of roller into RS: **Roller 2 + RS 2**

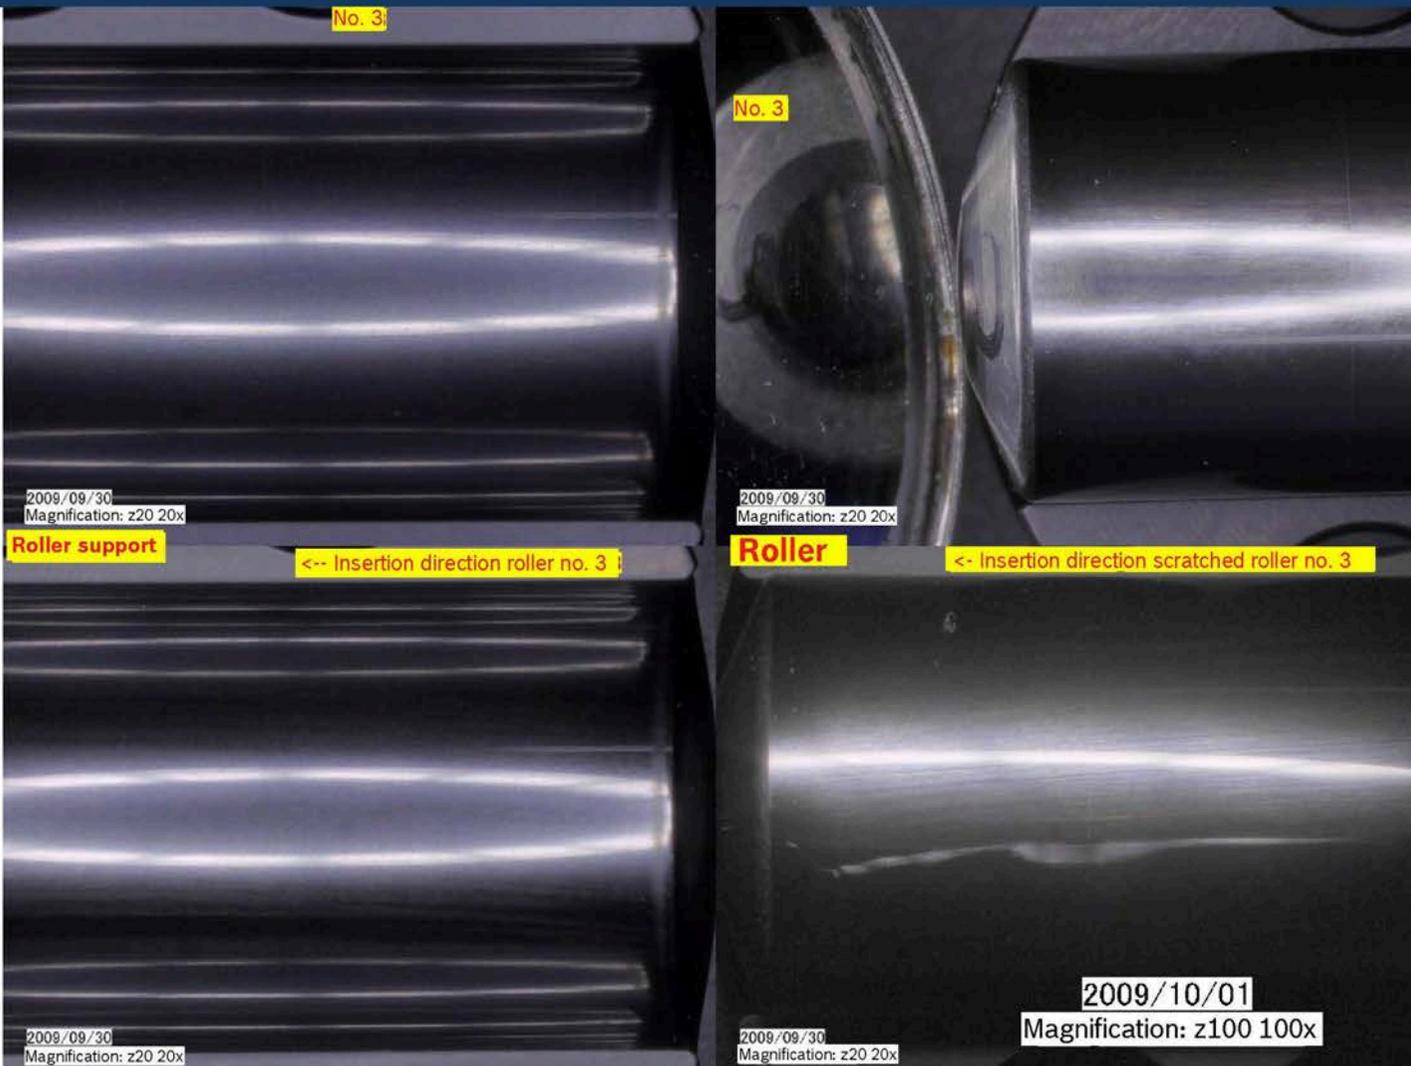
Tilted insertion of roller into RS: **Roller 3 + RS 3**

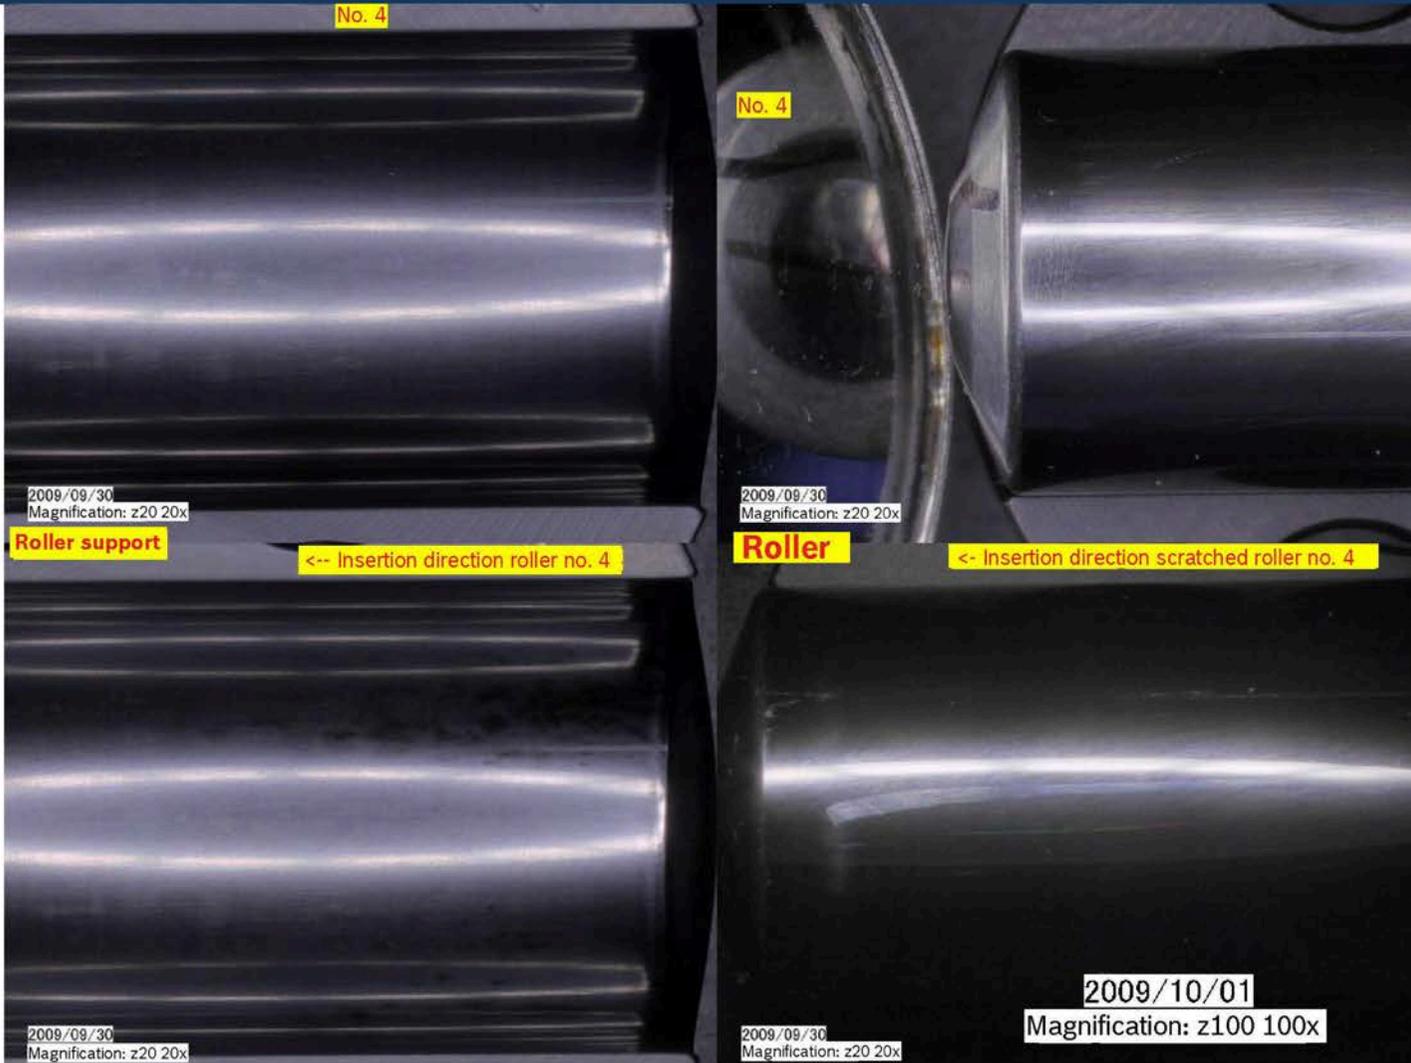
Tilted insertion of roller into RS: **Roller 4 + RS 4**

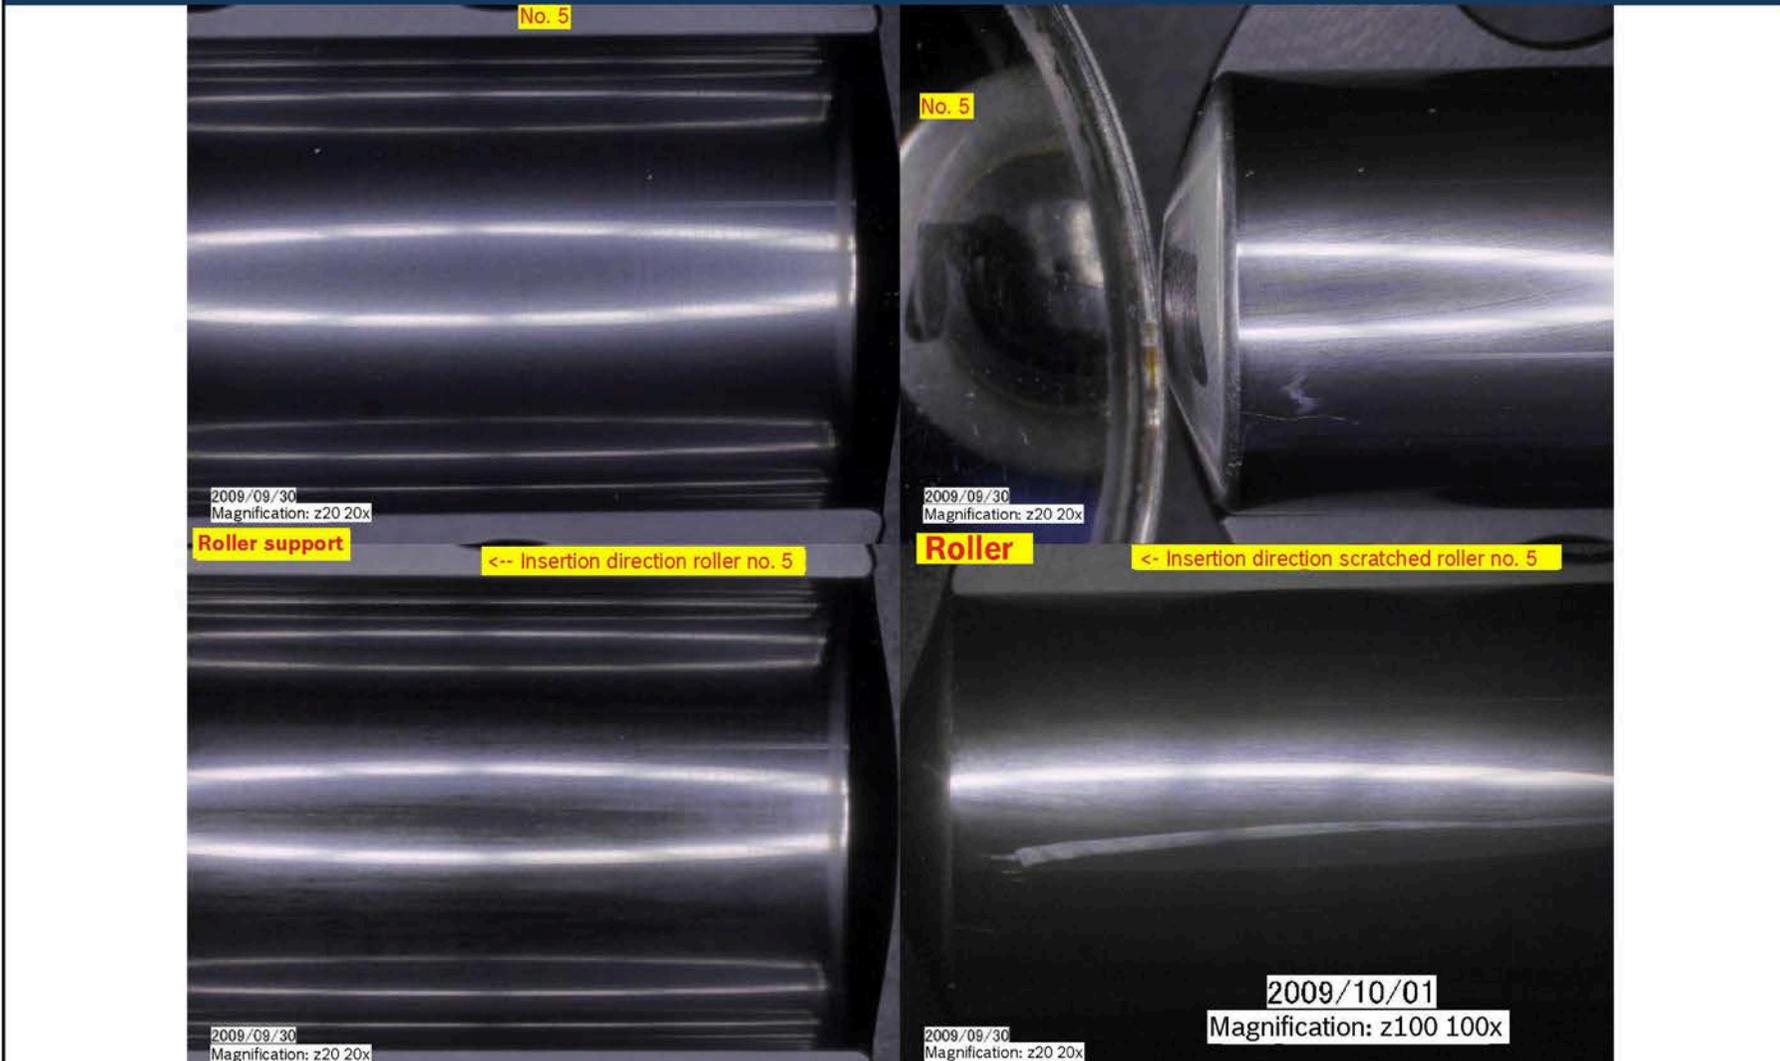
Tilted insertion of roller into RS: **Roller 5 + RS 5**

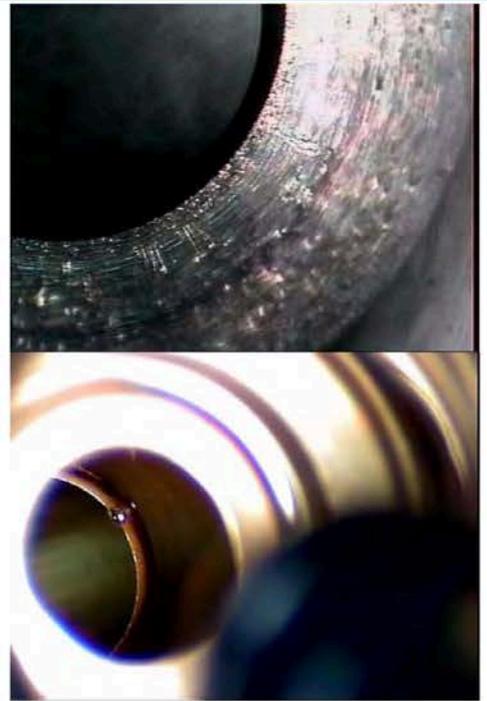
- Non-return valve leaking during pressure test
- Impressions on cylinder head seat of the RSV. Suspect particles, but could not clearly confirm this.

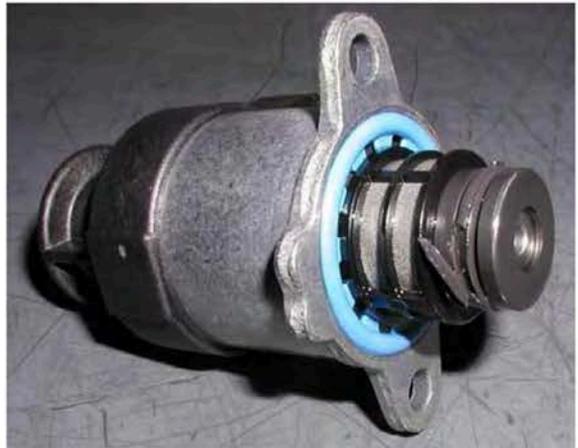
Fracture structures of the failure parts and of the O-ring damaged in the FeP test are similar, O-rings have been twisted

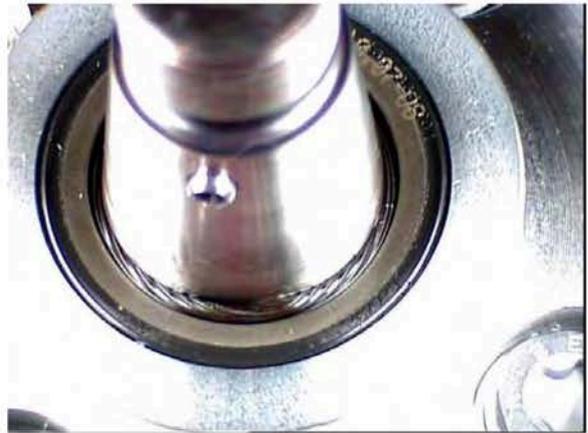
- Assembly of 7 pumps with folded BSS and subsequent He leak test -> all pumps very leaky D: 11/29/2007 compl.
- Test BSS in the SEM for run marks D: 12/11/2007 compl.
 - > Rotation marks on the camshaft in the folded area
- Try to reproduce fault pattern on the test bench D: 12/11/2007 compl.
 - > Partial folding of the BSS could be relatively reproduced with an inlet pressure of 6.8 bar
