EA11003EN-01864[0]

Subject: Re: Results of samples from [Redacted] with defined specifications

Status of the CP4.2 high-pressure fuel pump

Initial results of Non-responsive content removed field analysis

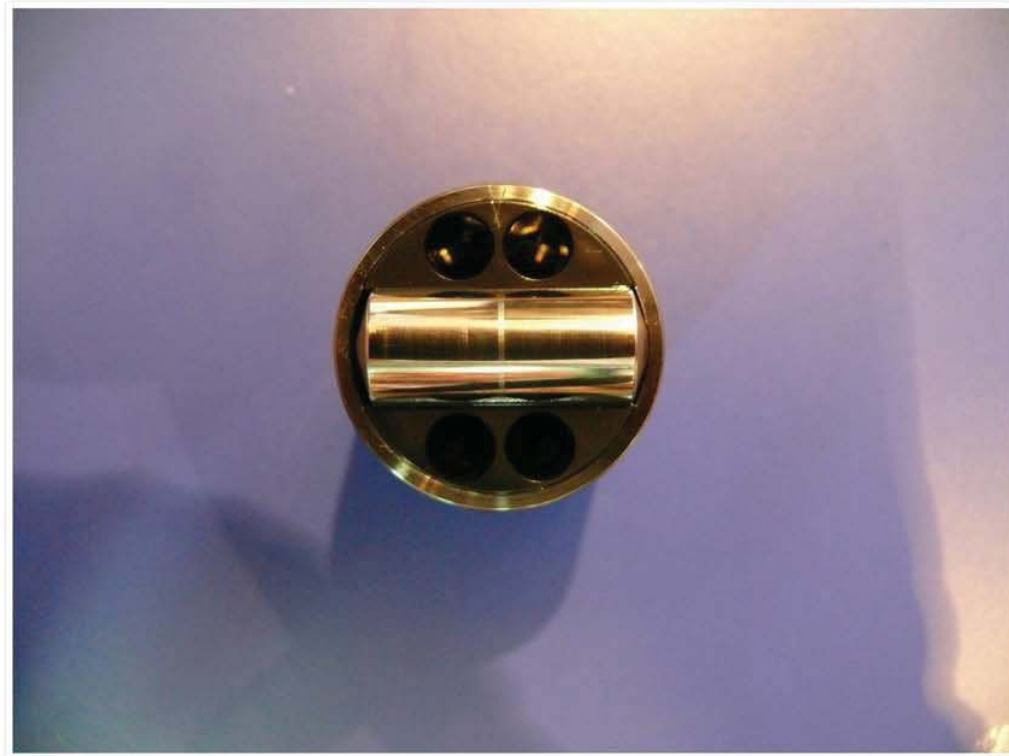
- ▶ High-pressure system
 - ▶ Only one of the examined vehicles had anything of note on the high-pressure fuel pump: slippage and stop flattening

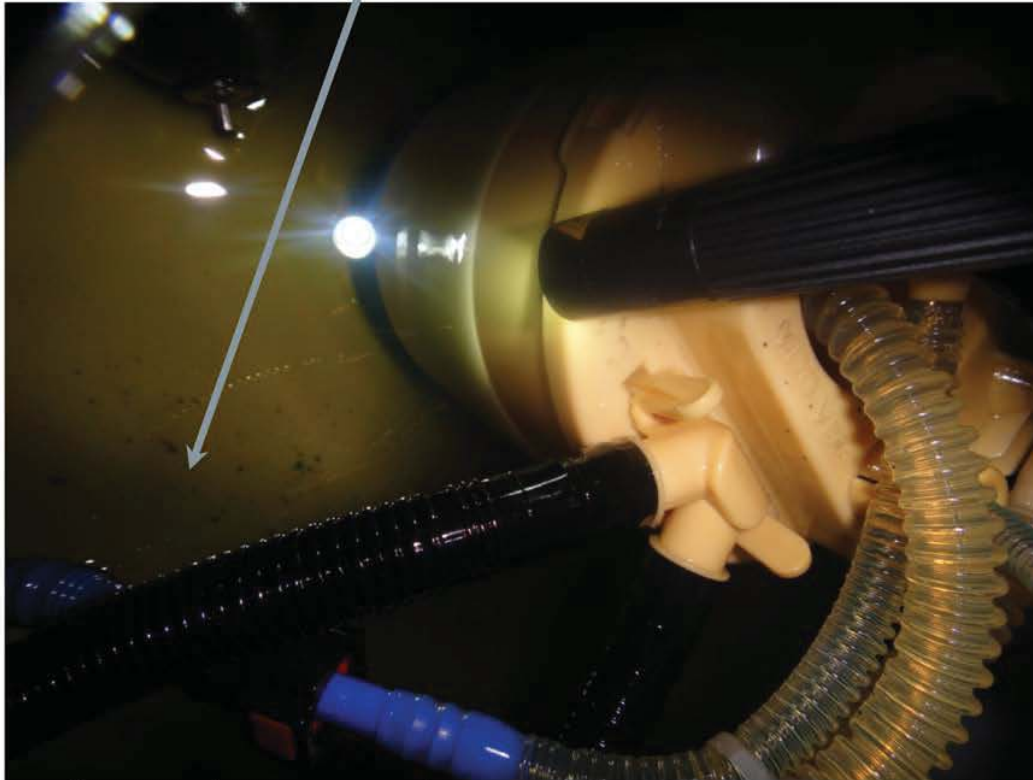
- ▶ The tank modules are sometimes exposed to extreme dust/dirt loads.
- ▶ A vacuum measurement of the Q5 tank system should be carried out in [REDACTED] to determine the opening pressure of the tank venting valve.
- ▶ Particles of different sizes and properties observed on the tank floor in several cases, including those with metallic origin.
No particles found behind the fuel filter to date.

Particles in tank

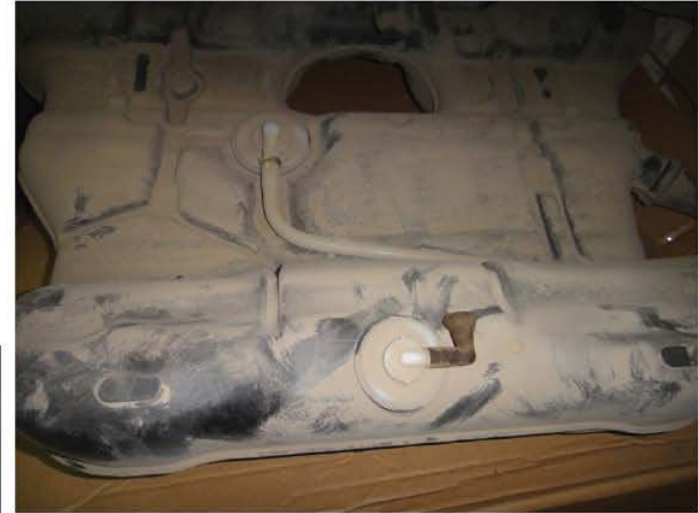
Dust load on dismantled tank

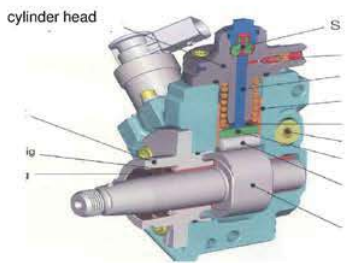
Analysis of 2 parts at [REDACTED] (5/21/2010)

- 1x** Particles in the non-return valve
- 1x** drivetrain damage possibly due to poor fuel

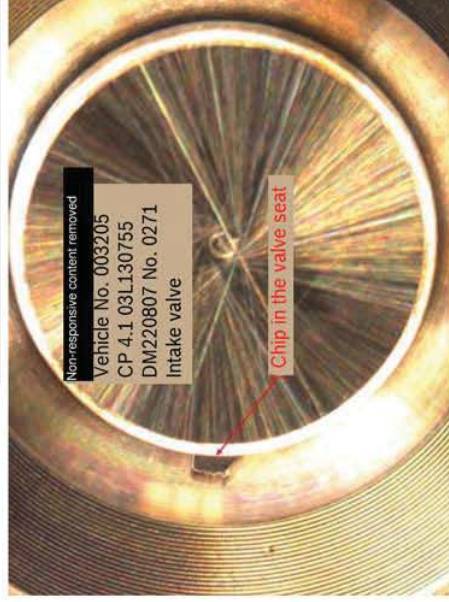
Case 2:

Cause of failure: HPP cannot build up pressure due to particles in intake valve.
Analysis by VW Development.
Notes: The component causing the problem was clearly determined using the HP case
The VW GFF for error memory entry “Fuel rail/system pressure too low” could not be carried out because the engine operating temperature (target 50°C; actual <50°C [engine doesn’t run]).

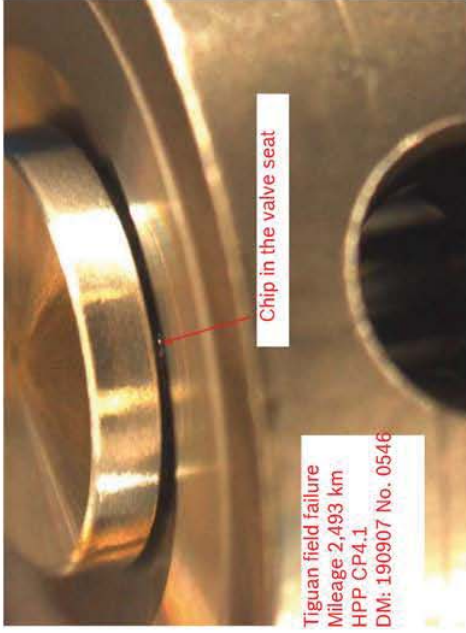
Case 3: Non-responsive content removed

Cause of failure: HPP cannot build up pressure due to particles in intake valve. Analysis by VW Development.
