EA11-004

HONDA

4/27/2012

DRIVERS MASTER SWITCH BURNED UP AND DOOR
HARNESS WAS MELTED

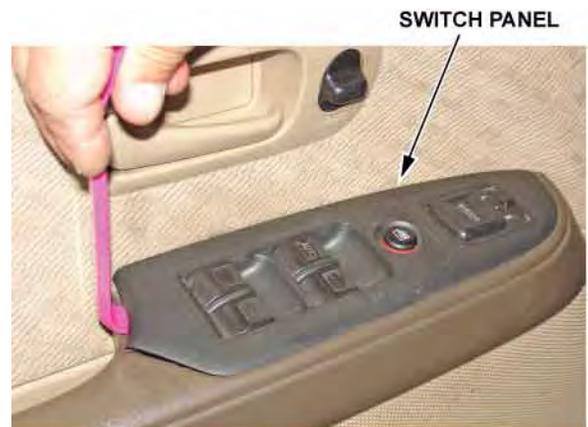
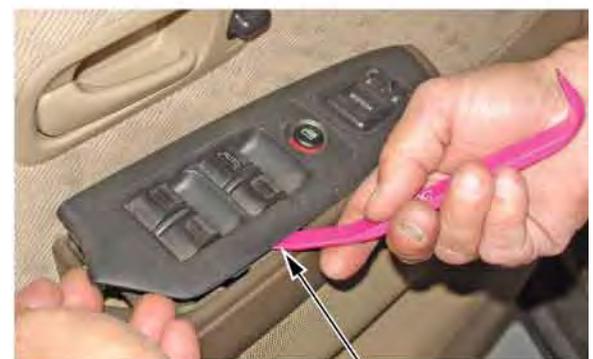
Start prying at the rear and work forward.

1. Using the appropriate trim tool, start prying at the rear of the driver's switch panel and move forward to release the hooks.

- Disconnect the two connectors from the driver's power window master switch.

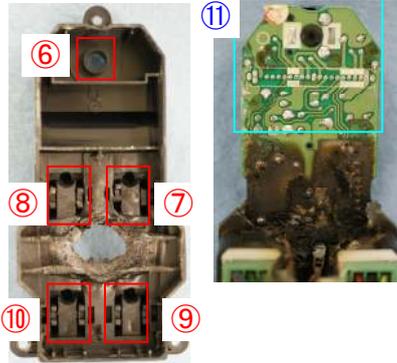
Defective Power Window Master Switch

- Wipe surfaces of through of the PCB SW, of the case, and with a 1x1cm cloth soaked in 90% methanol. and extract by 2mL 90% methanol, then filter.
- Extract through of inner case and of the PCB by pouring 2ml 90% methanol, then filter the extracted liquid.
- Concentrate each extracted liquid for one night (15hrs) and let methanol evaporate .
- Measure this liquid with LC/MS and check a peak of Sucrose compound (m/z 365).

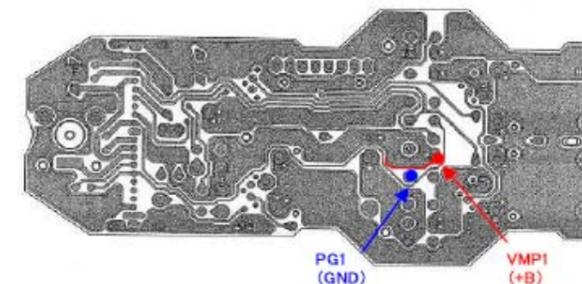
- As a verification results of damaged parts, it was confirmed that heat generated from the PCB around the VMP1 terminal and stopped its progress when the VMP1 terminal which supplies power to the SW came off (melt).
- Heat cause is considered to be liquid which contains sucrose/glucose and electrolyte from the evidence on the PCB and the analysis results.
- It appeared to be that the liquid was attached around the pattern which connects to VMP1 terminal on the PCB, and leaked to adjacent GND terminal.

PG1 terminal (GND) was set near the pattern which is connected to the VMP terminal.
 Pattern Gap: Approx. 0.5 mm

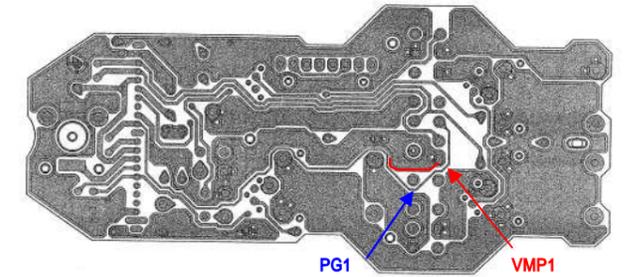
- 損傷状態の確認結果より、VMP1端子周辺の基板上より発熱し、VMP1端子が脱落(溶断)して電源供給がされなくなり、溶損の進行が終了したものと考えられます。
- 発熱の要因は、基板上の痕跡・分析結果より、糖や電解質を含む液体が基板上のVMP1端子に繋がっているパターン周辺に付着して、隣接するGND端子とリークしたと考えられます。

VMP1端子に繋がっているパターン周辺にPG1端子(GND)が存在
パターンGap: 約0.5mm

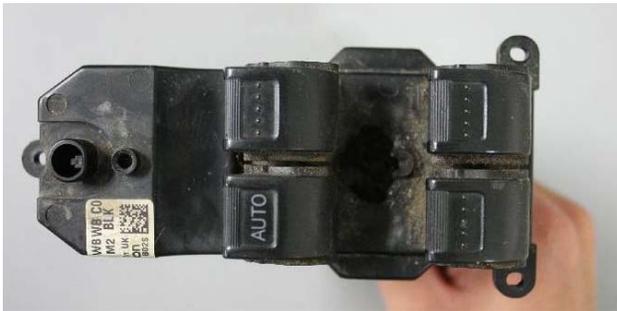
Full view of PCB_01

- A great amount of dust was attached to the PWS case.
- Discoloration and white abnormal substances were confirmed as a result of PCB check.
- Discoloration and white abnormal substances were confirmed when the connector base was removed to check the PCB condition.

• A great amount of dust was attached to the PWS case.

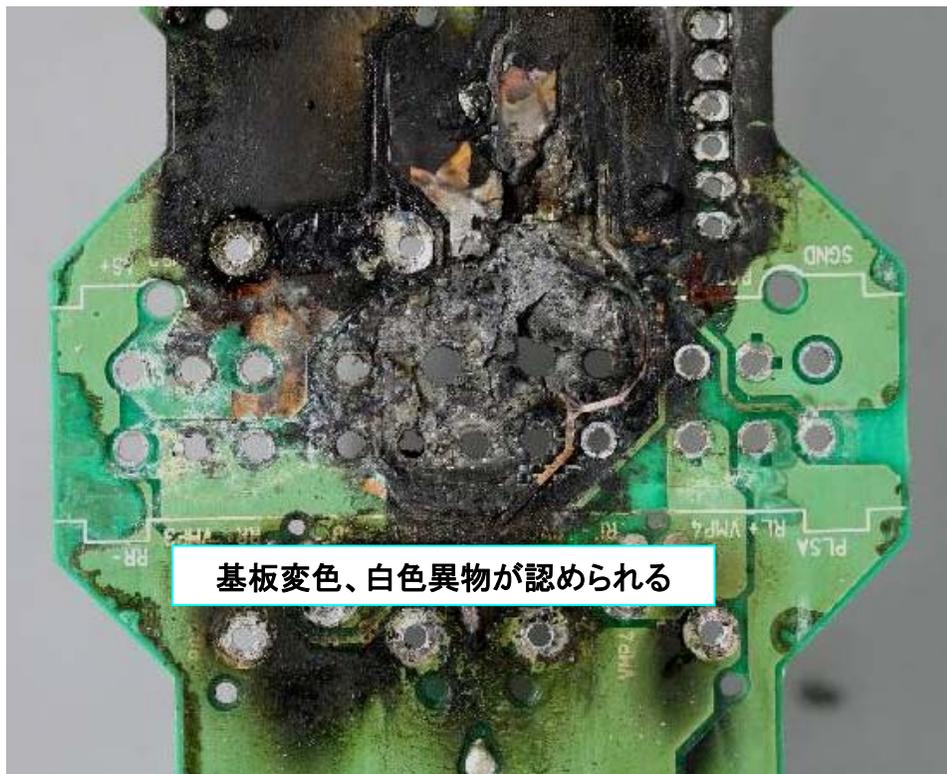
基板はんだ面 コネクタ部(コネクタベース取り外し)

基板変色、白色異物が認められる

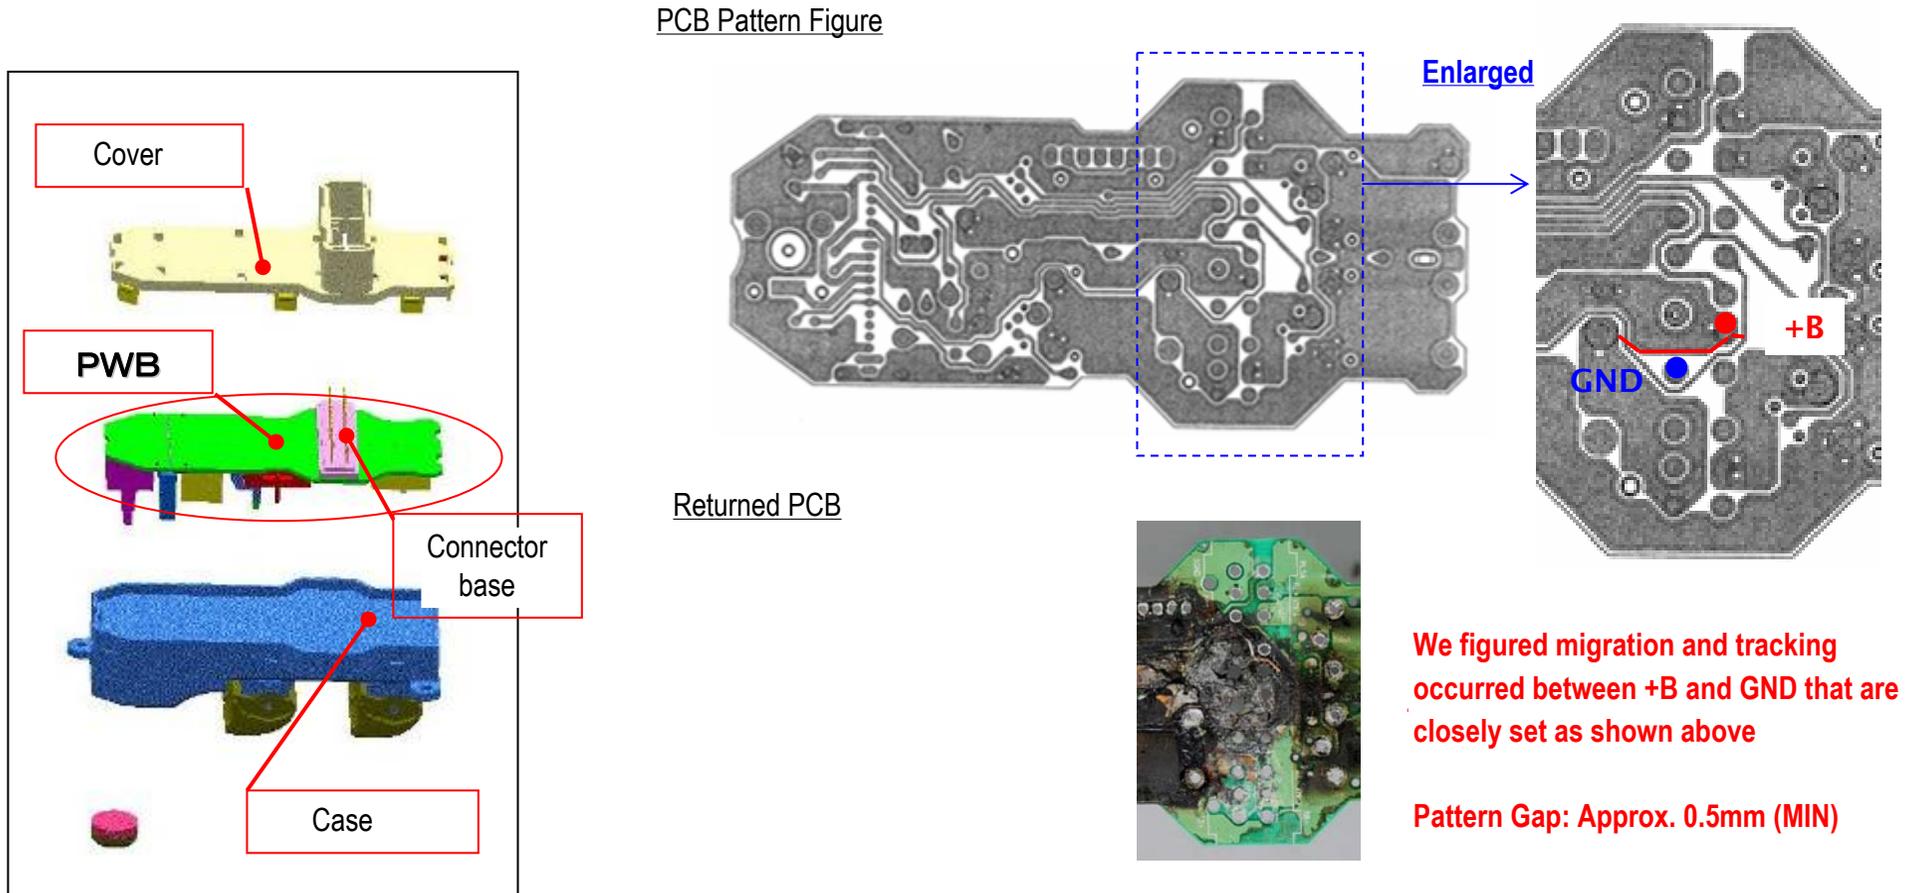
From the evidence of liquid confirmed on the returned part, it was considered that the short was occurred because of tracking (local heating) caused by the circuit with materials educed from the migration (metal transfer).

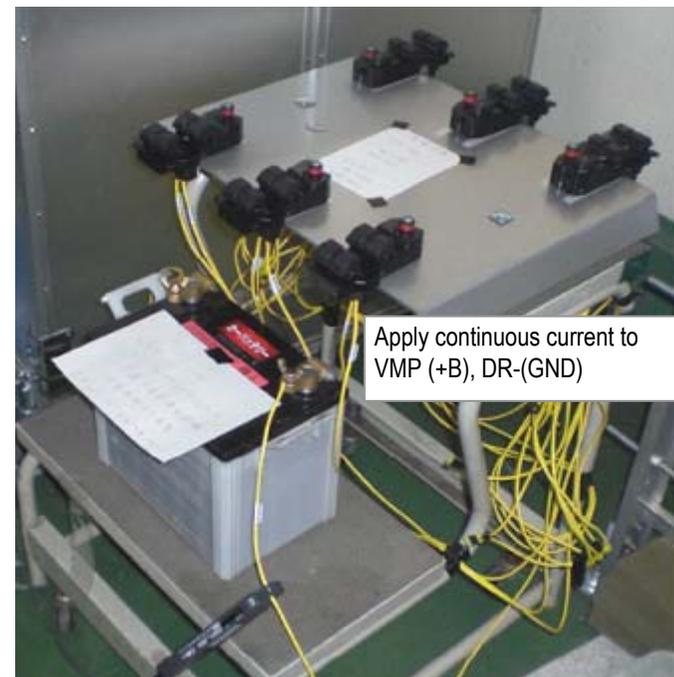
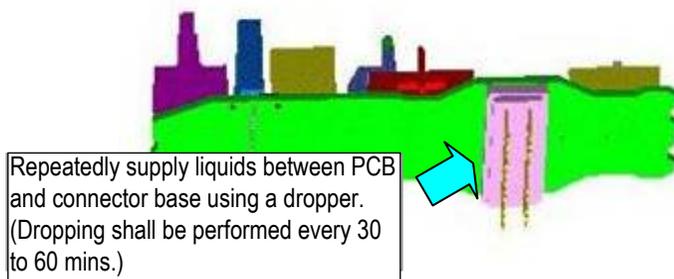
No	Liquid	Test Result	Reproducibility
1	Tap water	Tested for 100hrs. Heat damage could not be reproduced.	×
2	Tap water	Tested for 100hrs. Heat damage could not be reproduced.	×
3	Tap water	Tested for 100hrs. Heat damage could not be reproduced.	×
4	Salt water (5%)	Heat damage very similar to returned part was reproduced after 34hrs	○
5	Salt water (5%)	Tested for 100hrs. Heat damage could not be reproduced.	×
6	Salt water (5%)	Tested for 100hrs. Heat damage could not be reproduced.	×

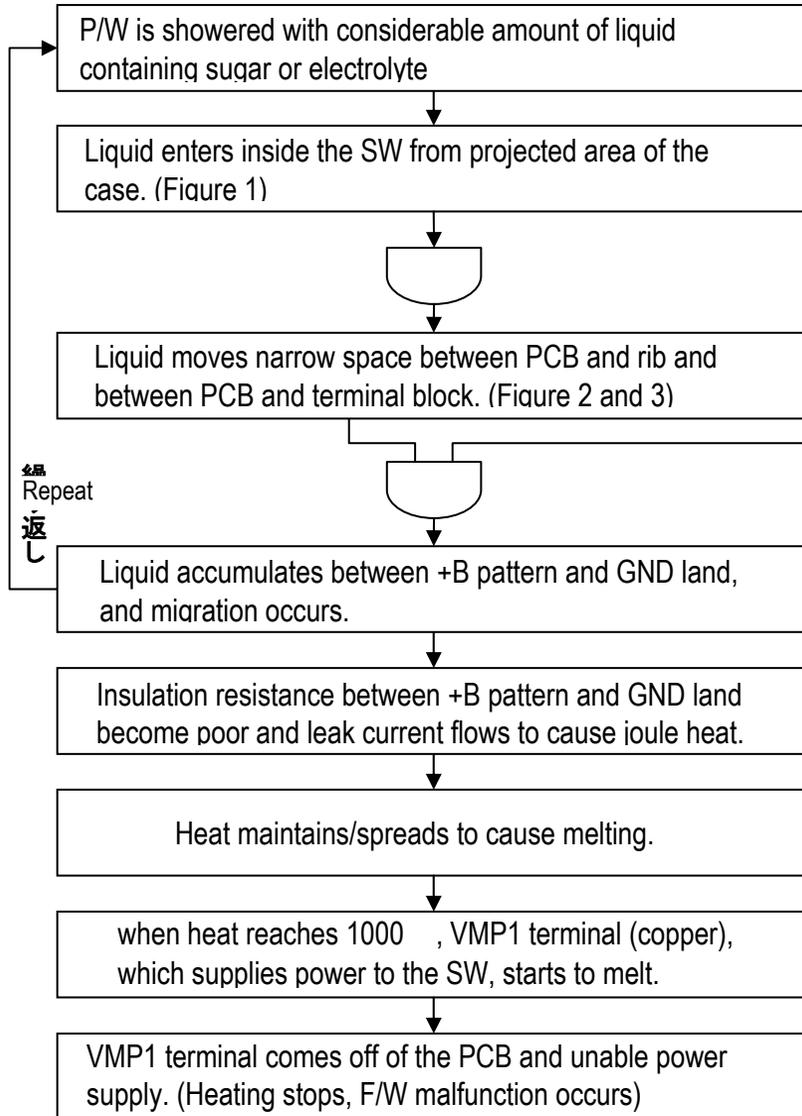
Liquid accumulates to where +B pattern and GND land are closely set with gap below 1.5mm

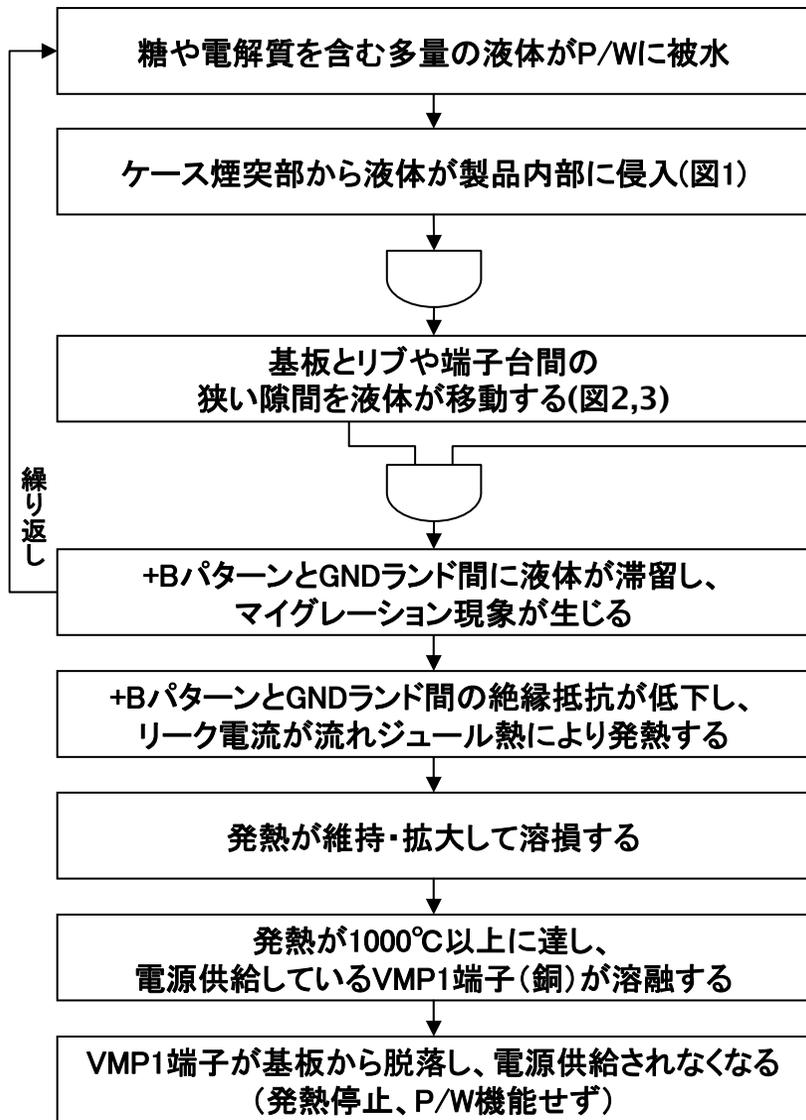
液体が滞留する部位に+BパターンとGNDランドが1.5mm以内に隣接している

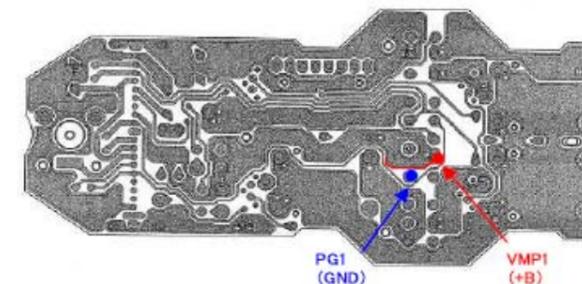
- As a verification results of damaged parts, it was confirmed that heat generated from the PCB around the VMP1 terminal and stopped its progress when the VMP1 terminal which supplies power to the SW came off (melt).
 - Heat cause is considered to be liquid which contains sucrose/glucose and electrolyte from the evidence on the PCB and the analysis results.
- It appeared to be that the liquid was attached around the pattern which connects to VMP1 terminal on the PCB, and leaked to adjacent GND terminal.

PG1 terminal (GND) was set near the pattern which is connected to the VMP terminal.
 Pattern Gap: Approx. 0.5 mm

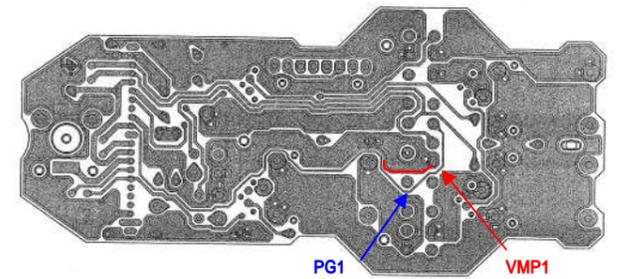
- 損傷状態の確認結果より、VMP1端子周辺の基板上より発熱し、VMP1端子が脱落(溶断)して電源供給がされなくなり、溶損の進行が終了したものと考えられます。
- 発熱の要因は、基板上の痕跡・分析結果より、糖や電解質を含む液体が基板上のVMP1端子に繋がっているパターン周辺に付着して、隣接するGND端子とリークしたと考えられます。

VMP1端子に繋がっているパターン周辺にPG1端子(GND)が存在
パターンGap: 約0.5mm

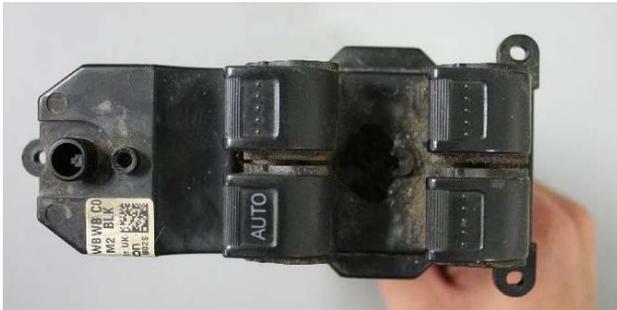
Full view of PCB_01

- A great amount of dust was attached to the PWS case.
- Discoloration and white abnormal substances were confirmed as a result of PCB check.
- Discoloration and white abnormal substances were confirmed when the connector base was removed to check the PCB condition.

• A great amount of dust was attached to the PWS case.

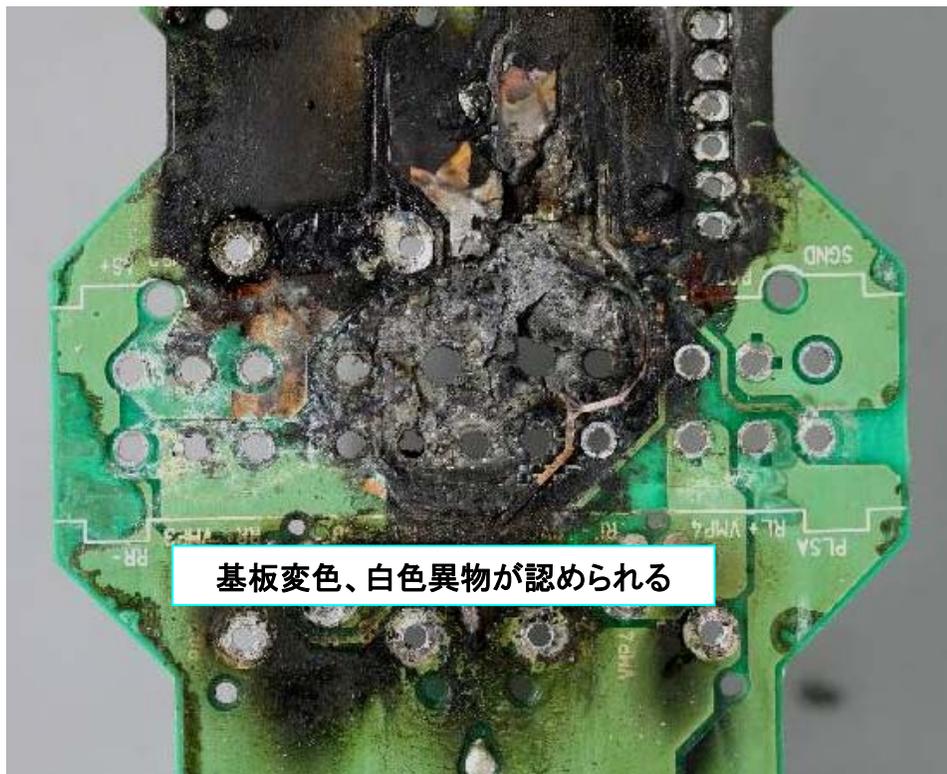
基板はんだ面 コネクタ部(コネクタベース取り外し)

基板変色、白色異物が認められる

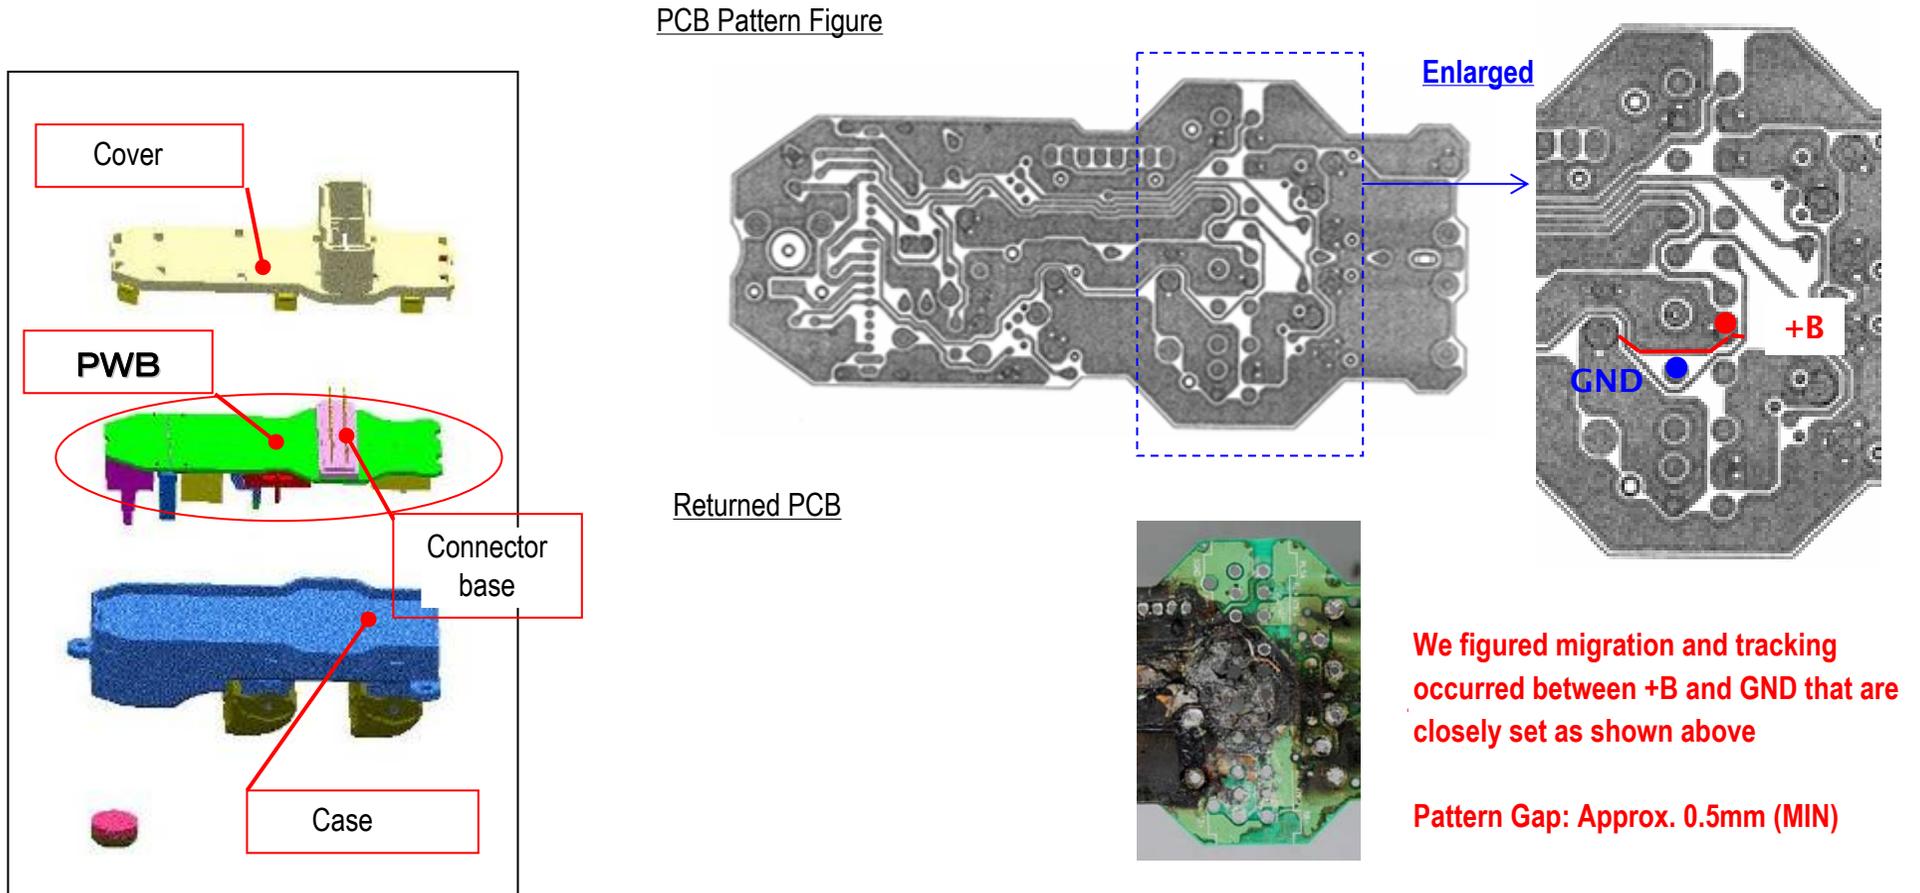
From the evidence of liquid confirmed on the returned part, it was considered that the short was occurred because of tracking (local heating) caused by the circuit with materials educed from the migration (metal transfer).

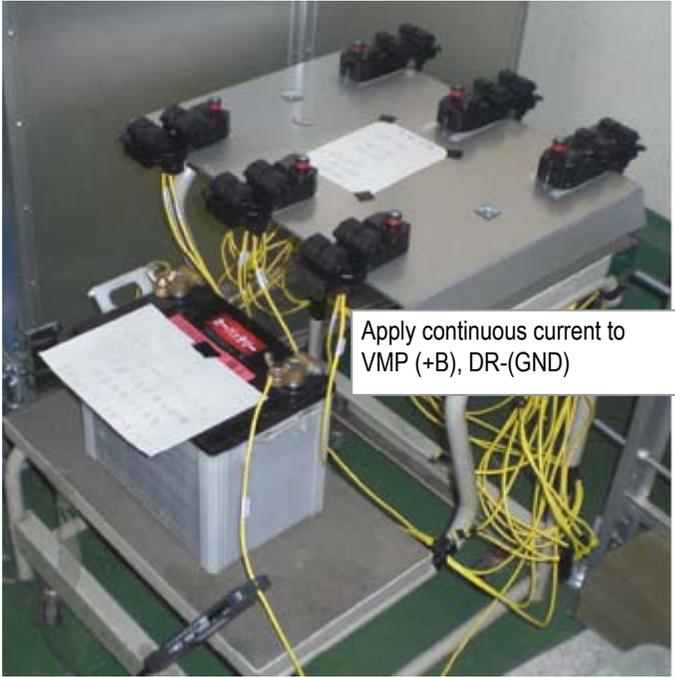
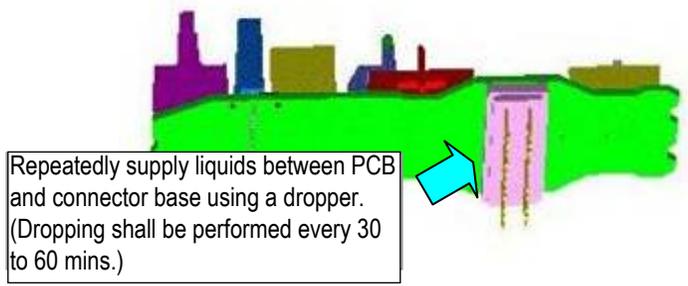
- Position similar to the ones installed on the actual vehicle (on the level)
- Test temperature: 15%, humidity: 40%
- Drop liquids on VMP1, VBU, PLSB, and DR - terminals between PCB and base and apply current.
- Use 5% salt water(pure water) and tap water for liquids.
 - *For tests using salt water, drop salt water only once, followed by pure water.
- Connect harness to +B:VMP1 and GND:DR- to apply current.
- Use the battery for power source (Make sure it is above 12V before/after the tests)

No	Liquid	Test Result	Reproducibility
1	Tap water	Tested for 100hrs. Heat damage could not be reproduced.	×
2	Tap water	Tested for 100hrs. Heat damage could not be reproduced.	×
3	Tap water	Tested for 100hrs. Heat damage could not be reproduced.	×
4	Salt water (5%)	Heat damage very similar to returned part was reproduced after 34hrs	○
5	Salt water (5%)	Tested for 100hrs. Heat damage could not be reproduced.	×
6	Salt water (5%)	Tested for 100hrs. Heat damage could not be reproduced.	×

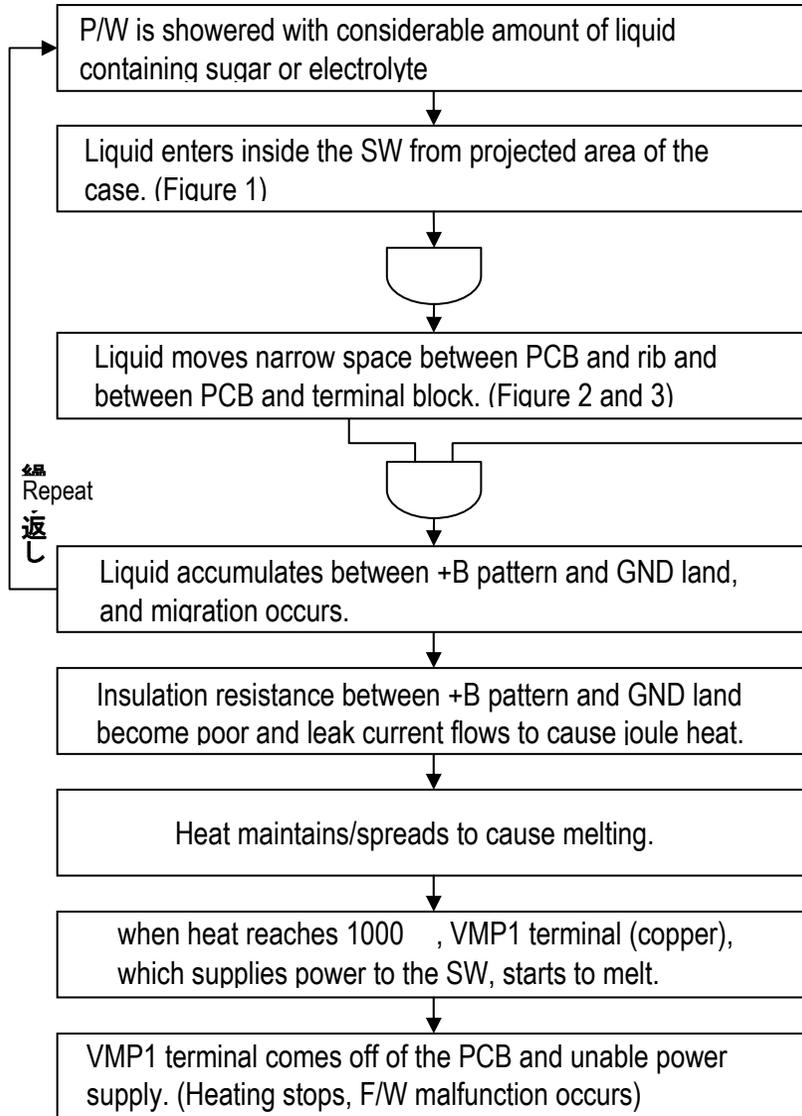
Liquid accumulates to where +B pattern and GND land are closely set with gap below 1.5mm

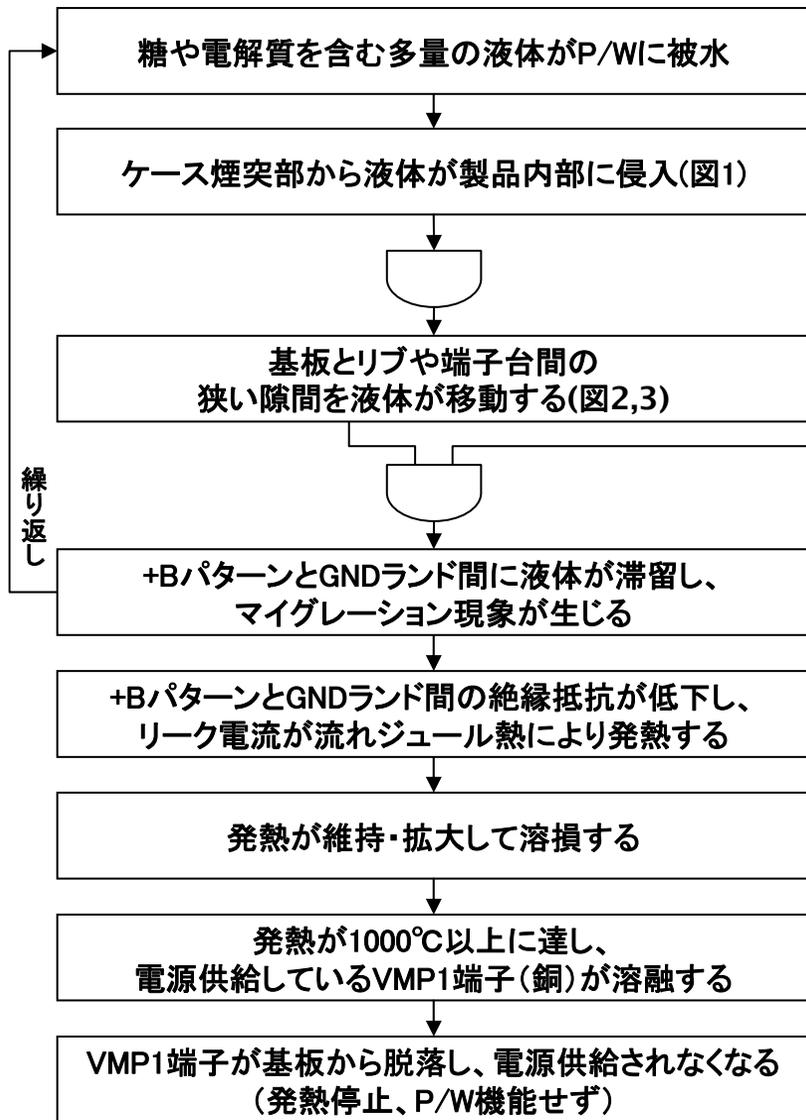
液体が滞留する部位に+BパターンとGNDランドが1.5mm以内に隣接している
