EA11-015

Service Bulletin

SUBJECT: Special Coverage Adjustment - Shift Lever May Not Display Correct Gear

**MODELS: 2007-2008 Saturn AURA
Equipped with 4-Speed Automatic Transmission (ME7/MN5)**

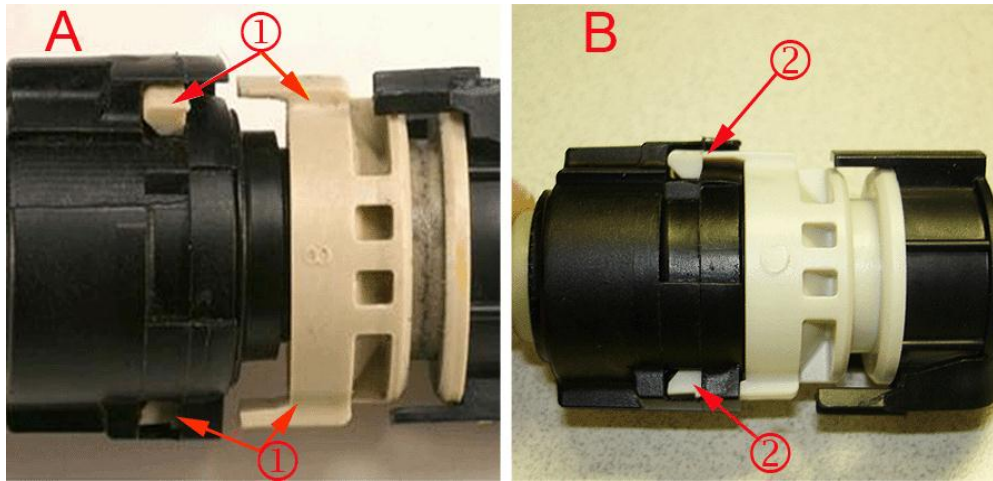
2269486

1. Open the hood and locate the transmission shift cable.
2. Determine if the transmission shift cable locking tabs are fractured and separated.

- If the transmission shift cable locking tabs (1) are fractured and separated (A), remove the transmission shift cable and replace it with a new one. Refer to *Floor Shift Control Cable Replacement or Range Selector Lever Cable Replacement* in SI. **Also install a transmission shift cable kit with the new shift cable.**
- If the transmission shift cable locking tabs (2) are NOT fractured and separated (B), install the transmission shift cable kit. Proceed to Step 3.
