PE11-017

HONDA

ATTACHMENT Q2

Summary Description

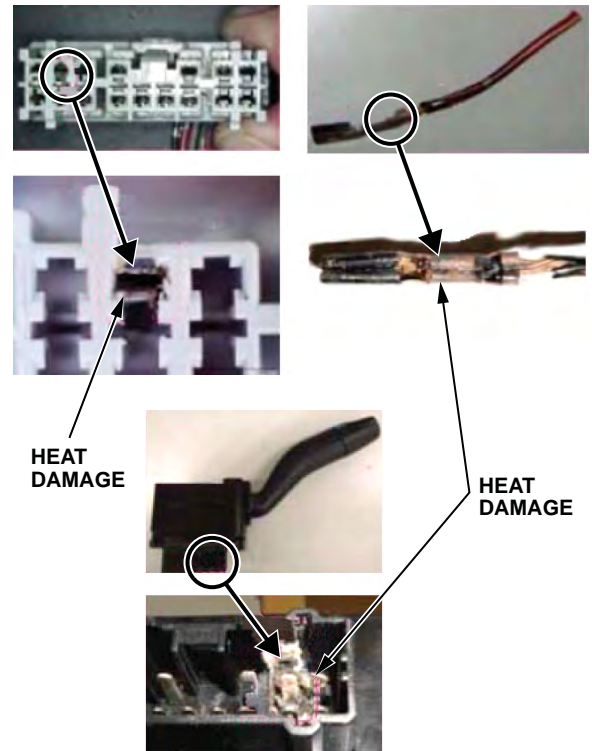
- Using the photos below, check for signs of heat damage on the 16P connector, the terminal end of the RED/WHT wire, and the 16P terminals of the combination light switch.

- If you don't find any signs of heat damage, *retain the combination light switch* because you'll only be installing a Combination Light Switch Wire Kit. Go to step 14.
- If you do find signs of heat damage, *discard the combination light switch* because you'll be installing a Combination Light Switch Repair Kit. Go to step 12.

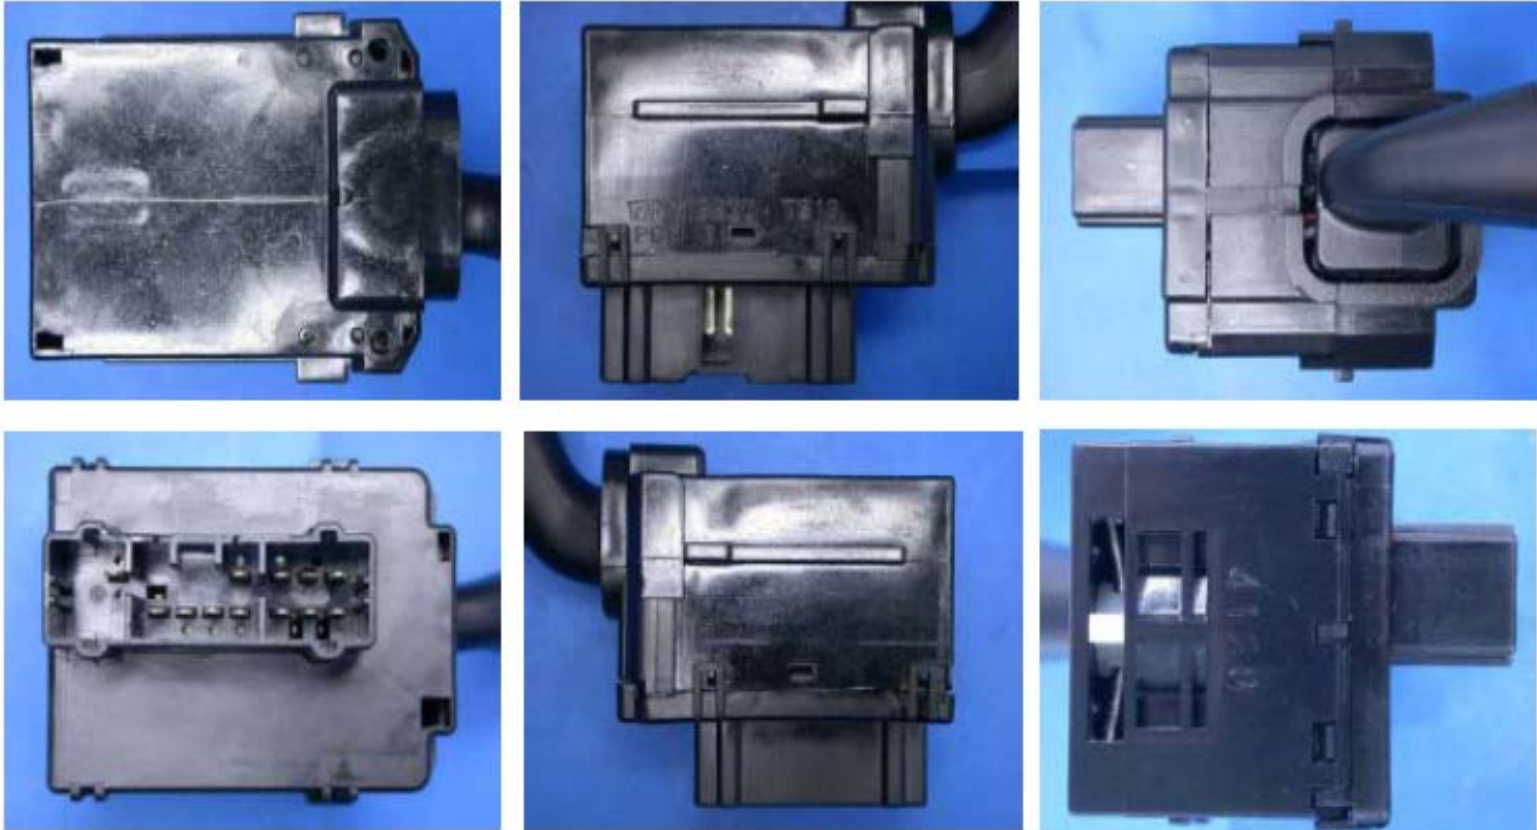
## 1-1). Visual confirmation

No damage or dents etc confirmed visually, no particular abnormality evident.

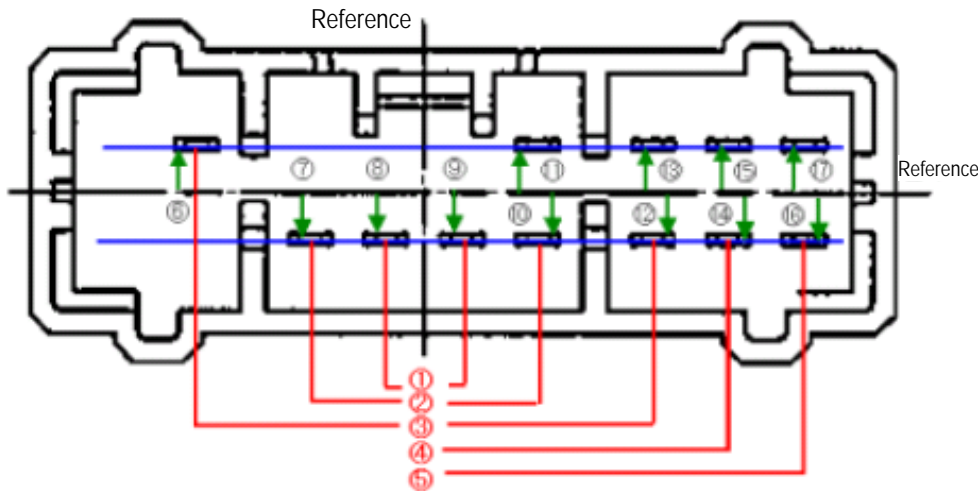
## 1-2). Alignment measurement results

All alignments meet the SPEC, and each terminal clearance is determined to be no problem.

Unit [mm]			
Location	SPEC	Measurement	Judge
①	$4 \pm 0.1$	4.004	OK
②	$12 \pm 0.1$	12.033	OK
③	$24 \pm 0.1$	23.065	OK
④	$16 \pm 0.1$	16.036	OK
⑤	$20 \pm 0.1$	20.048	OK
⑩+⑪	$5 \pm 0.1$	5.090	OK
⑫+⑬		4.885	OK
⑭+⑮		4.843	OK
⑯+⑰		4.993	OK
⑥		2.491	
⑦		2.487	
⑧		2.508	
⑨		2.389	
⑩		2.528	
⑪		2.562	
⑫		2.419	
⑬		2.466	
⑭		2.377	
⑮		2.466	
⑯		2.527	
⑰		2.466

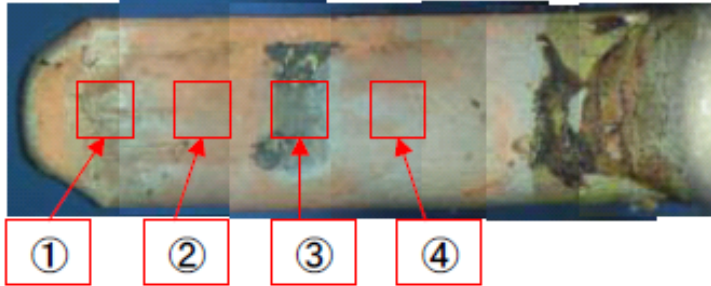
①	②	③	④
Failed part Lo terminal	180	12	2.9M	200
Failed part Hi terminal	0.01	0.01	0.01	0.01
Mass production part	0.01	0.01	0.01	0.01

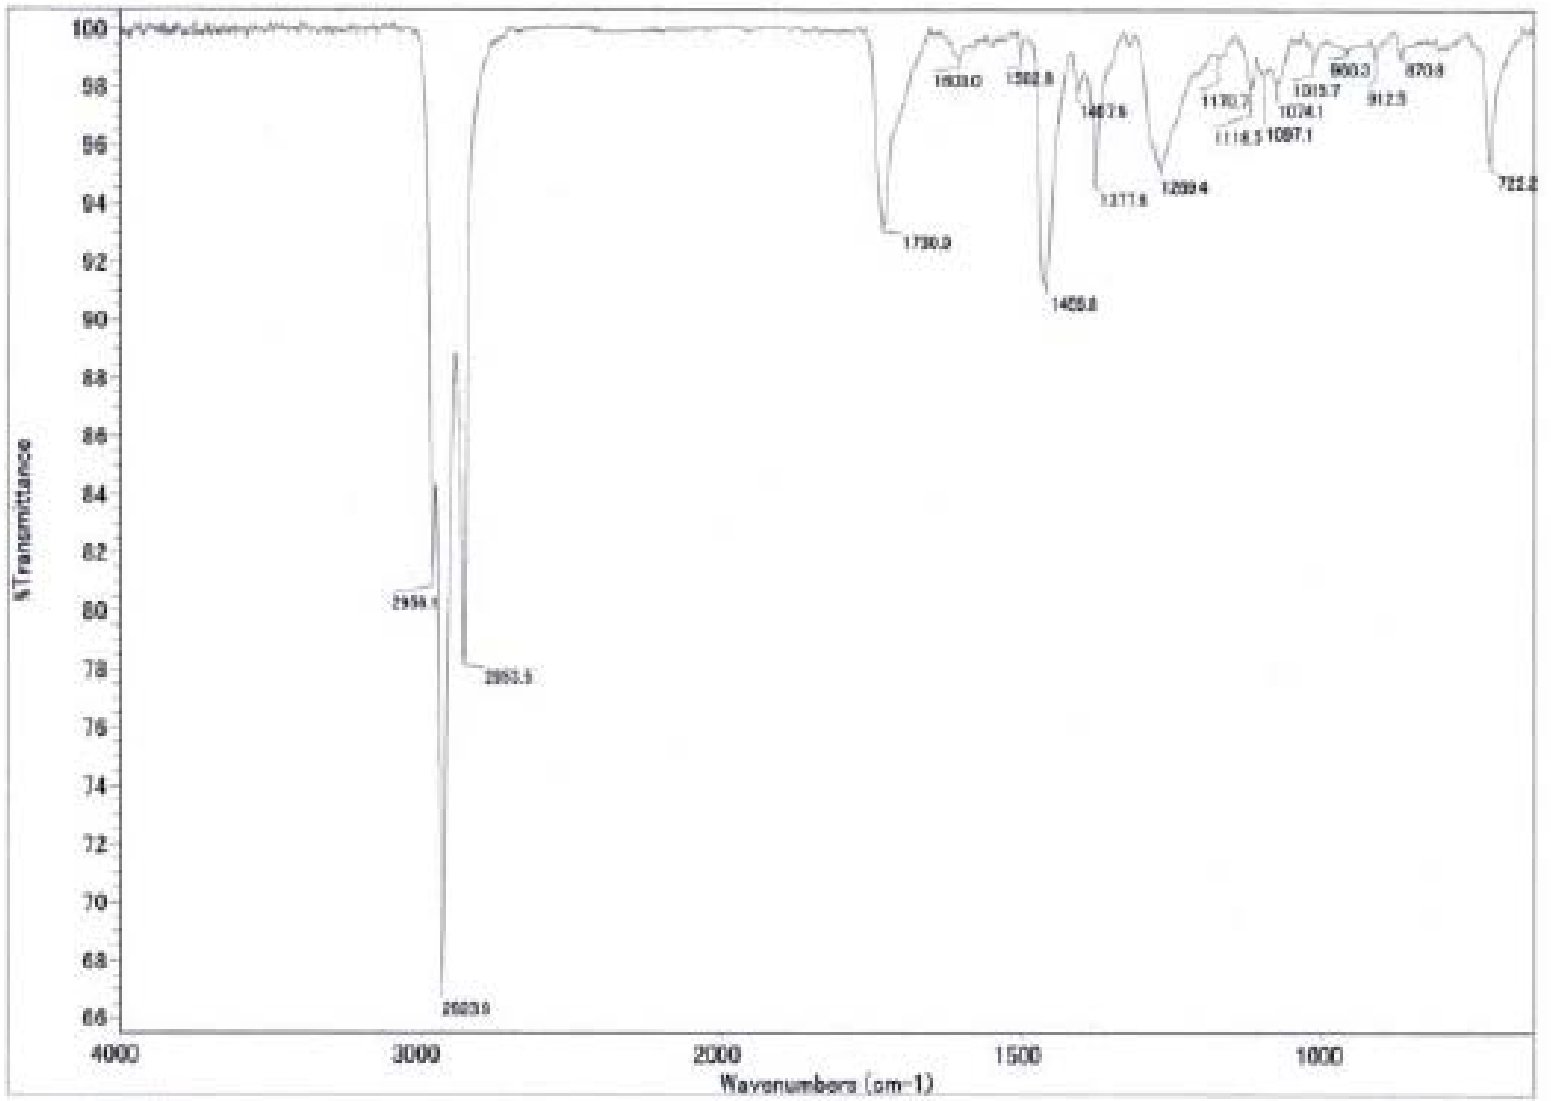
Photo. 24

Liquid adhered to connector

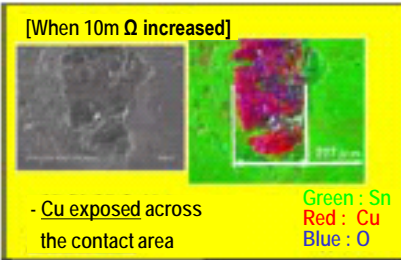
### <Surface observation>

- ◆ No abnormality found when contact pressure is within mass production control value (8N or above) .
- ◆ Since GND (Ag-Sn) SPEC has an advantage, Ag plating is a cause of increased strength in GND terminal. (Cu-Sn, Sn-Sn : 6N, Ag-Sn : 4N)
- ◆ Increase in resistance value was caused because base material copper was exposed.
- ◆ When contact load is high, resistance value is stable because "oxide film is broken" which is a known effect, also, it is confirmed by this analysis result "friction of terminal is suppressed and wear of plating is less progressed."

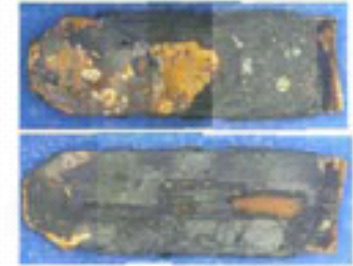
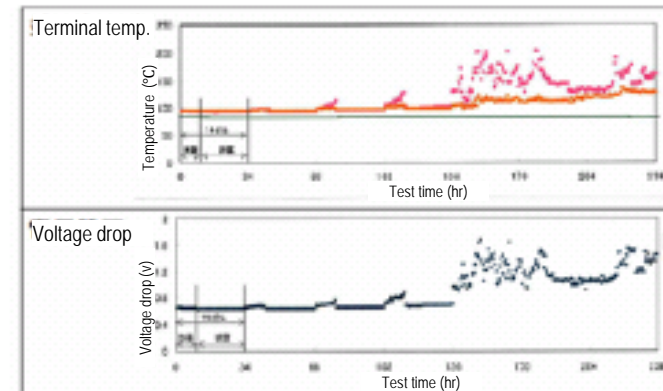
look like problem part form the market

- ◆ No abnormality found when contact pressure is within mass production control value.
- ◆ Symptom reproduced at actual use vibration level when contact pressure was reduced to 1.5N and oxidation acceleration mode was added as accelerating factor.
- ◆ When evaluated with NG contact pressure terminal used for GND terminal only, slight drop in voltage was confirmed, but not resulted in melting. (Doubled the normal test cycles).
- ◆ When evaluated a sample with altered plating material, melting reproduced in Lo terminal with Ag plating.
