PE11-034

HONDA

### QUALITY IMPROVEMENT SHEET (Q.I.S.)

# SHJ Tailgate Open Stay Design Change History (08-10M)

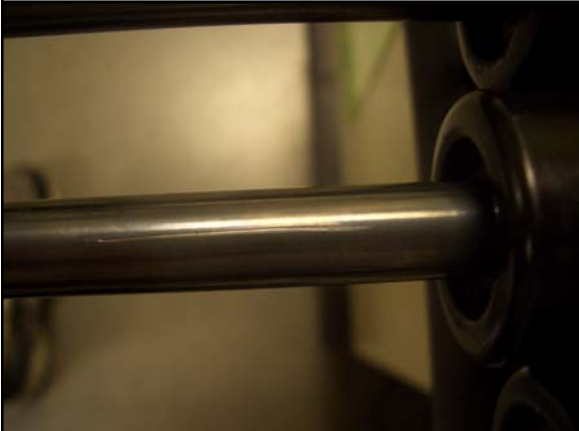
VIEW BEFORE COUNTERMEASURE	VIEW AFTER COUNTERMEASURE

Vehicles with power tailgates fail more often than those without. Also claims are much higher during warmer months and southern regions.			
<b>Investigation Cause Analysis</b>			
Analyzed four sets of returned parts. Three of four sets caused tailgate to fail on CBU (fourth set returned for oil leaking contention). Of failed parts, two sets returned with completely compressed right side parts (parts failed due to complete gas loss). On remaining failing set, 30mm groove/scratch was found on left side rod. Testing parts on this set individually showed left side part was causing tailgate to not hold open.

Rod damage due to rod contact with the rod guide. The damaged rod then damages (wears) the seal which results in gas loss.

An additional spacer was added, changing the contact angle of the rod to the guide. The seal material was changed. The oil was changed. The rod and tube length was changed slightly to compensate for the additional spacer.

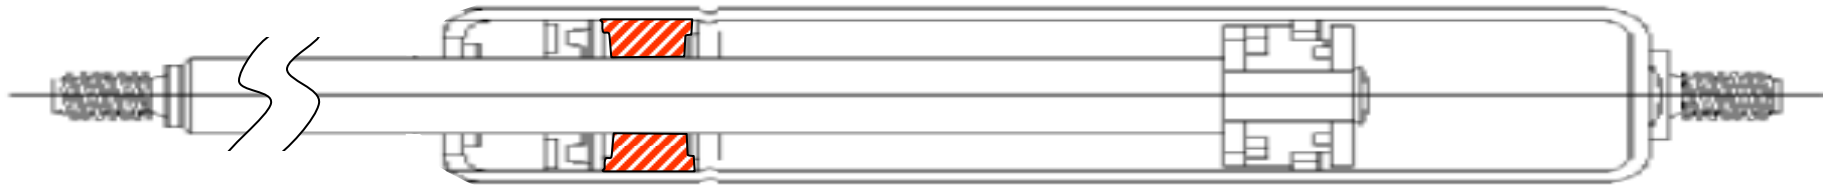
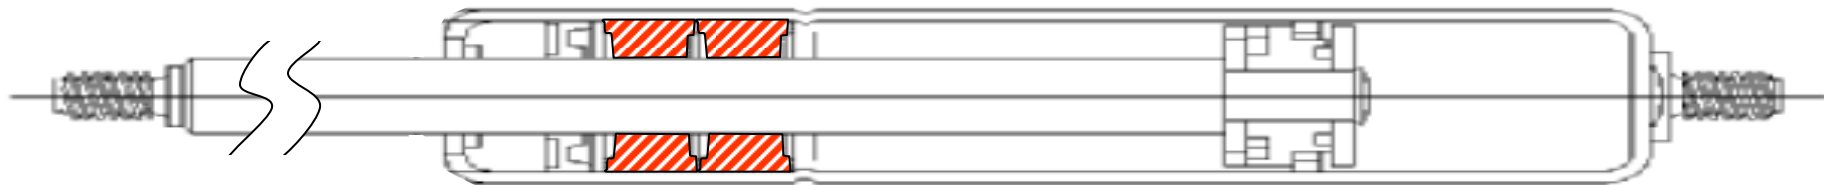
Double spacer had been applied from 10M.

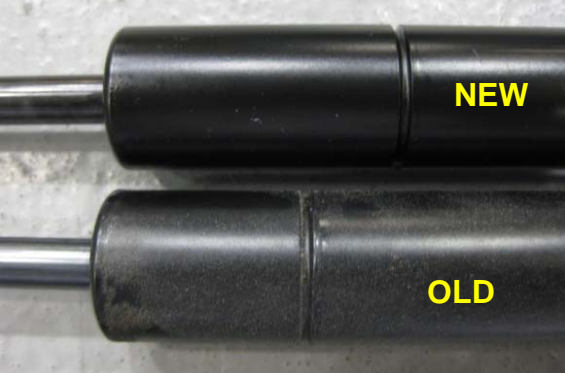
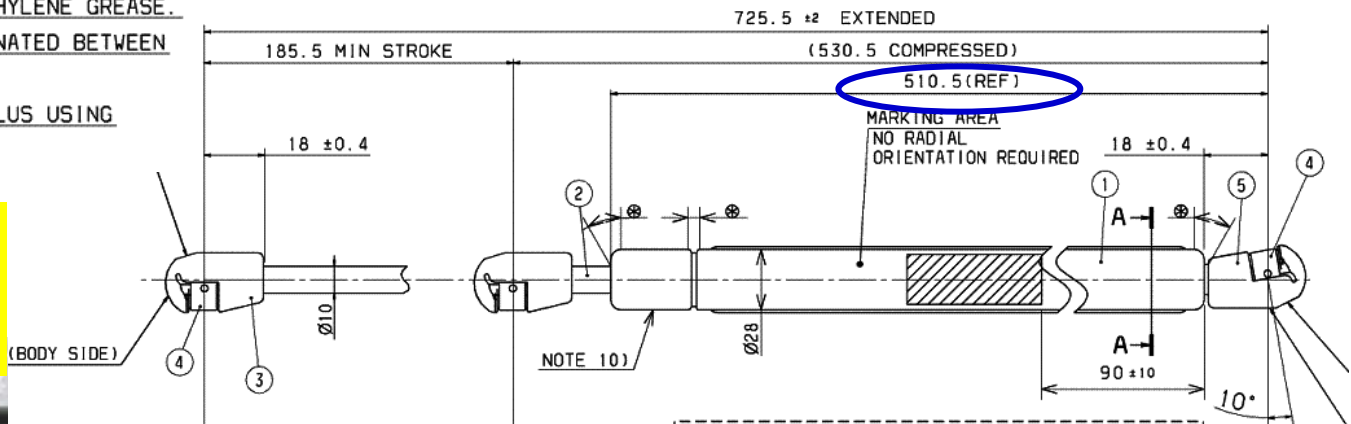
**TUBE CRIMPING LOCATION IS ONLY VISIBLE DIFFERENCE**

- ROD LENGTH INCREASED BY 18mm
- TUBE LENGTH CHANGED BY 0.5mm
- SEAL PACKAGE LENGTH CHANGE BY 18.5mm
- OIL CHANGE
