PE11-034

HONDA

#Q8 QIS HMA09070801

QUALITY IMPROVEMENT SHEET (Q.I.S.)

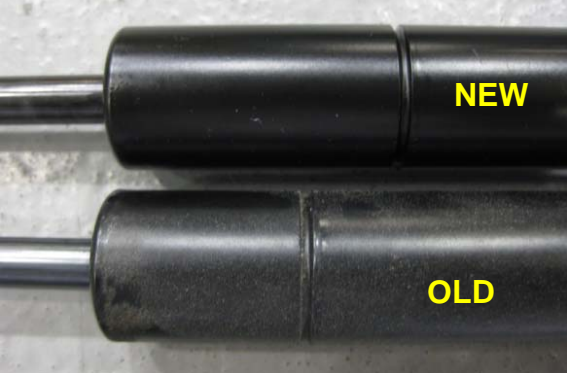
TUBE CRIMPING LOCATION IS ONLY VISIBLE DIFFERENCE

- QA RECOMMENDS APPLYING CHANGE TO SHJ
- QA ISSUED CRF Z4F081126001 TO HGT
- QA ISSUED MI TO APPLY CHANGE UNTIL DESIGN CHANGE IS RECEIVED (STABILUS SHIPPING C/M PARTS 1 MONTH AFTER RECEIVING MI, APPROX SEPT-END)
- QA TO CONTINUE TESTING COUNTERMEASURE FOR SZA
