**RESPONSE TO QUESTION
NO. 9**

Defect Investigation V2010-04	5/1/2010	12/2/2010	Investigate reports of upper bunk side window of the bottom track that attaches to the arms used to open and close the window de-bonding.	Water Bonnet, supplier of the window.

**DEFECT INVESTIGATION
NO. 03-1-1**

SUBJECT: Defect Investigation
03-1-1

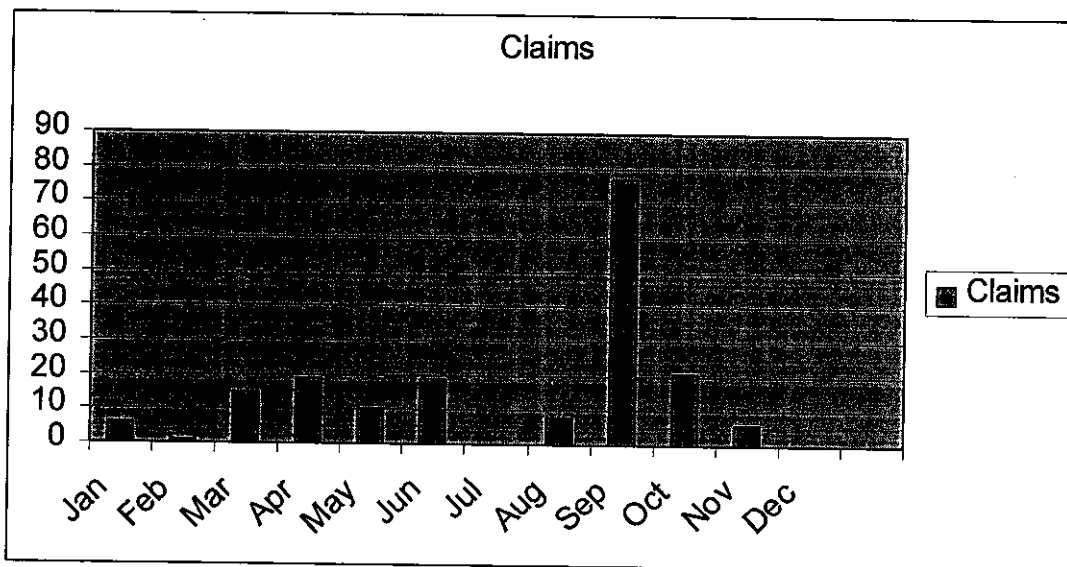
Ken Moore gave a presentation of how many warranty claims received over the last three calendar years were actually related to the window track. He found there were only 16 in 2000 and 9 in 2001. He found 182 in 2002, with a peak of 77 in September. They have established the build dates for the suspect trucks to be August 22, 2002 though November 8, 2002. We have established the Julian dates of the suspect windows to be August 6, 2002 through October 30, 2002. The following diagram illustrates that our findings support each other.

Ken's chart of warranty claims in 2002 also confirms our dates, as shown below.
