Re: EA11-005

**BMW Response
to
NHTSA EA11-005
(Questions 1 – 6)
2 Sep 2011**

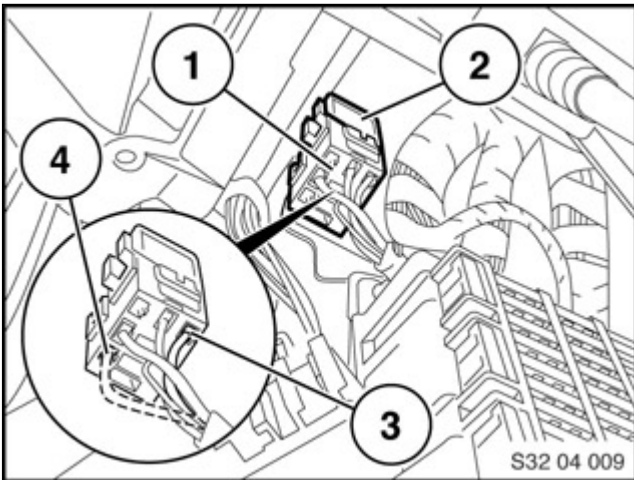
The relay for the power steering cooling fan is located above the fuse box in the driver's foot-well area.

2. Remove the relay (2).
3. Disconnect the relay base (1) from its mounting.
4. Disassemble the relay base by removing the upper white portion of the housing.
5. Use special tool 61 1 136 to remove the green/violet wire with connector from pin location 1 (4) of the relay housing.
6. Insert the green/violet wire with connector into location 9 (3) of the relay housing.
7. Reinstall the upper white portion of the relay housing.
8. Reinstall the relay and clip the relay base into its mounting position above the fuse box.
