Reference: NVS-212am; EA11-010

Attached is Chrysler Group LLC's ("Chrysler") response for Questions 16, 17, 19, 21, 23, and 24 of the referenced inquiry. Also attached are supplemental responses to Questions 18 and 20. By providing the information contained herein, Chrysler is not waiving its claim to attorney work product and attorney-client privileged communications.

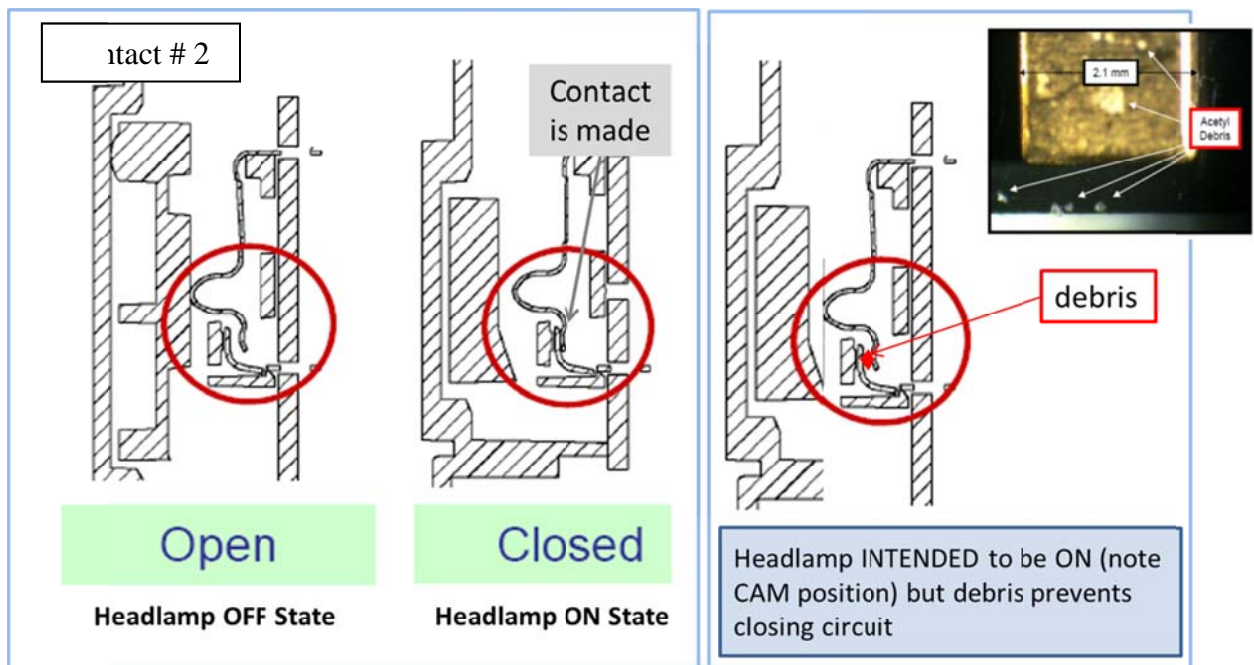
Chrysler notes that there are a number of conditions that must all occur in order for acetyl debris in the switch cell to result in a loss of headlamps:

- The conditions required to form acetyl cam debris must be present;
- The acetyl debris must be sufficient in size to prevent the switch contact from closing;
- The acetyl debris would have to land at precisely the same location as the place where the point contact of the fulcrum lands to generate the closed circuit; and
- The debris would have to remain in that position during actuation of the headlamp switch.

Contact switch # 2 is normally in OPEN state (Headlamps OFF). Actuation of CAM to turn headlamps ON will CLOSE switch # 2

Headlamp INTENDED to be ON (note CAM position) but debris prevents closing circuit

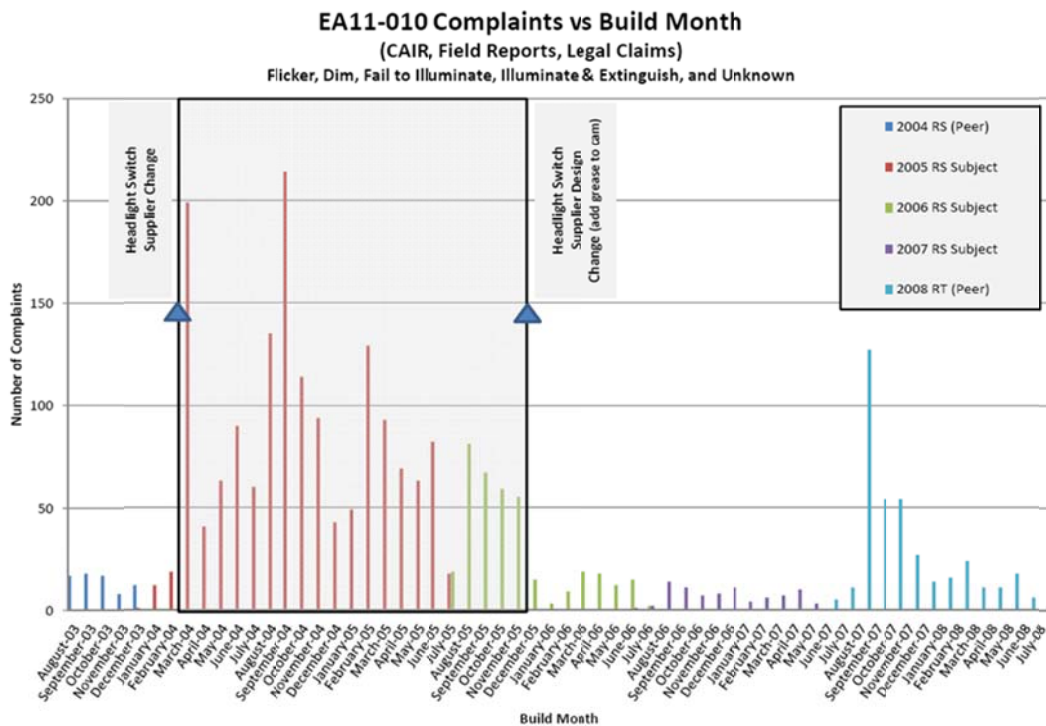
Part II – Distribution of Complaints by Build Date: Enclosure 11 – Assessment 1, Figure C provides an analysis of the complaints received for the Alleged Defect, as defined by NHTSA, by vehicle build date. The vast majority (93%) of complaints occur in vehicles built between March of 2004 (early 2005 MY) and November of 2005 (early 2006 MY). For reasons discussed more thoroughly in Assessment 7 – Headlamp Root Cause Analysis, this 21 months of production has been identified as vital in this investigation. In short, the beginning and end of the 21 months of elevated complaint data shown in Enclosure 11 – Assessment 1, Figure C, also aligns precisely with a change in suppliers for the headlamp switch assembly in March of 2004 and a supplier design change made in November of 2005.

Figure C reveals that most of the 2005 MY vehicles and a portion of the 2006 MY vehicles were responsible for the vast majority (93%) of the Alleged Defect complaints. Chrysler has now learned that this trend is defined by: 1) the launch of the new TRW switch (March of 2004); and 2) TRW's introduction of grease to the mechanical cam surface in the headlamp switch assembly (November of 2005) to prevent acetyl debris from interfering with the headlamp switch contacts.

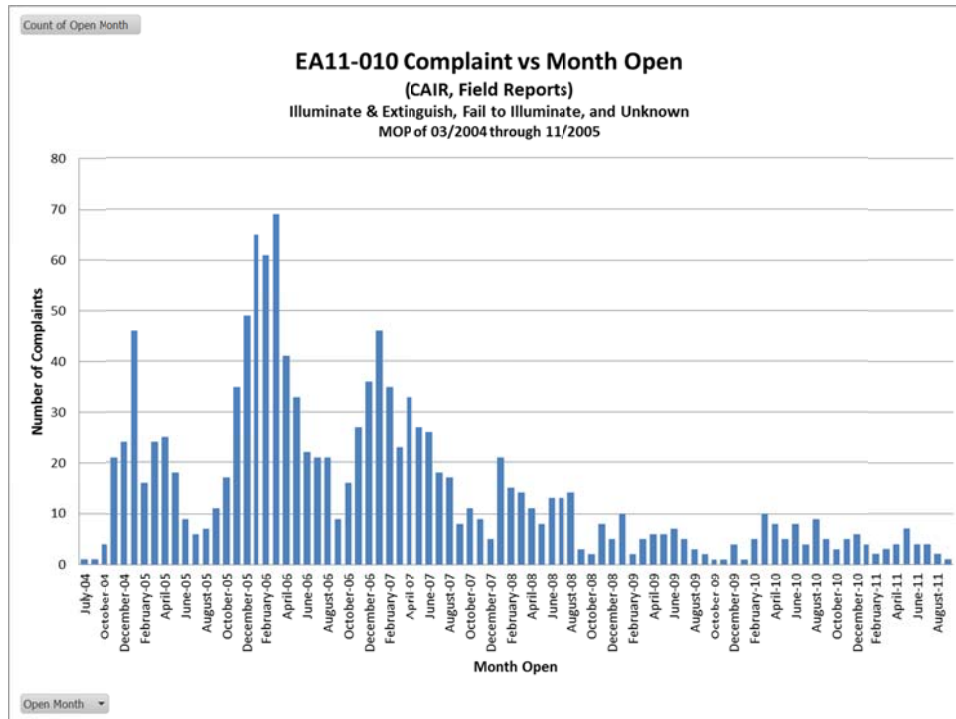
Enclosure 17 – Final Assessment, Figure D

As shown in Figure D, below, the field data demonstrates that the loss of forward headlamp lighting relating to a faulty TRW switch occurred early in the life of the Suspect Population and there is a significant downward trend.
