May 20, 2011

Attachment-Response 8-1\_E

## Field Technical Report

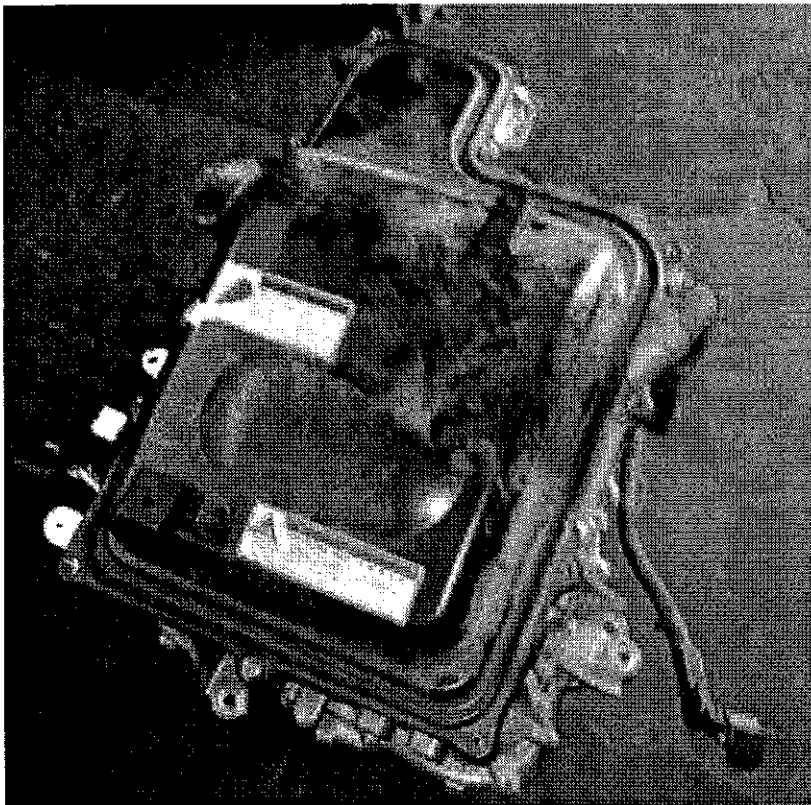
Inverter Assy W Converter  
G9200-48011  
0F27YA032

Customer states vehicle will not start and master warning light is ON.

Internal malfunction in inverter assembly.

Above: Inverter assembly removed from vehicle.

Replace inverter assembly, recheck for any DTC's, and test drive to confirm repair effectiveness.
