**Re: PE11 – 015**

Based upon the review of your letter to Daniel Del Rio received on June 10, 2011 regarding Preliminary Evaluation PE11-015 the following information is provided per your request. The information provided herein was gathered by our staff after review of the ODI Resume Summary and Vehicle Owner's Questionnaire provided to us.

## WORK INSTRUCTION FOR INSTALLATION OF CABLE FROM BATTERY TO ANL 400 Amps FUSE

Document # : W - 278  
Issue Date : 07.12.2011  
Revision # : 1  
Revision Date : 07-12-2011  
Written by : Field Srv. Eng.  
Page : 1 of 2

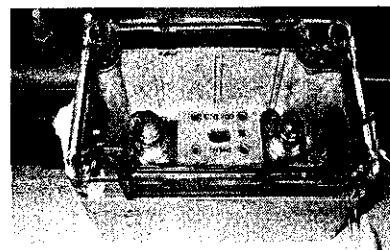
The finished product  
should resemble this  
picture  
Picture 3.
