November 10, 2011

Mazda's response: NHTSA Inquiry NVS-13cni, PE11-026

Brake fluid Leak from the Master cylinder

Reproduction test result for master cylinder's brake fluid external leakage

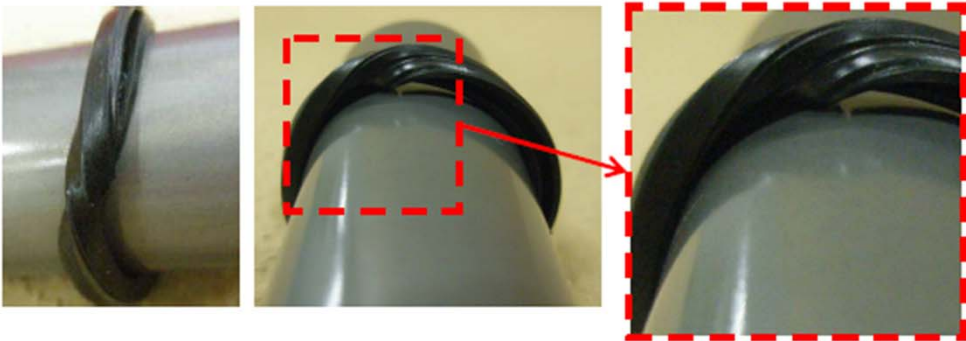
他社案件	TRW 不具合
状況写真

<p>(注:写真は、シールめくれのイメージであり、極端な状態)</p>	 
発生内容	<p>シールめくれ時、<u>プランジャーとシールの間に隙間発生</u> (シールしない状態)</p> <p>→ブレーキ液漏れの“液路が形成”される →不具合部位は負圧室とのシールのため負圧による漏れ助長</p>	<p>ストローク時にブレーキ液掻き出し (ブレーキ操作ない場合は掻き出さない)</p>
推定	<p>シールめくれ状態発生後 →「ブレーキ液漏れ、エア噛みに至るのは早い」と推定</p>	<p>ブレーキ液掻き出し量は微小 →掻き出しによりエア噛みに至る時間はかかる</p> <p>(掻き出し量推定は、提出済み資料 MAZDA_J50_Mcyl_BrakeFluid_Leakage_2010_12_09 _ver01.pdf 参照)</p>

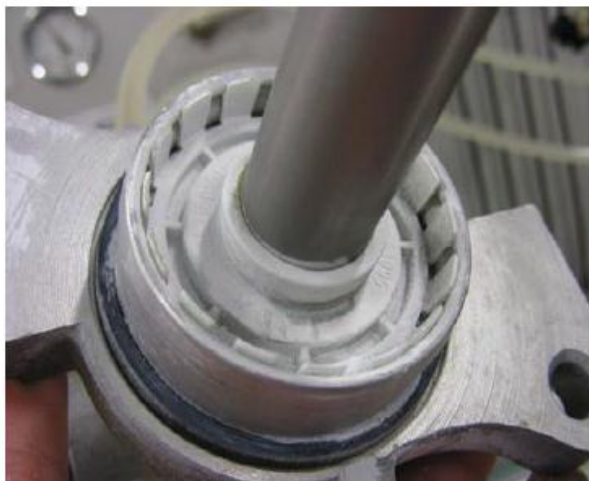
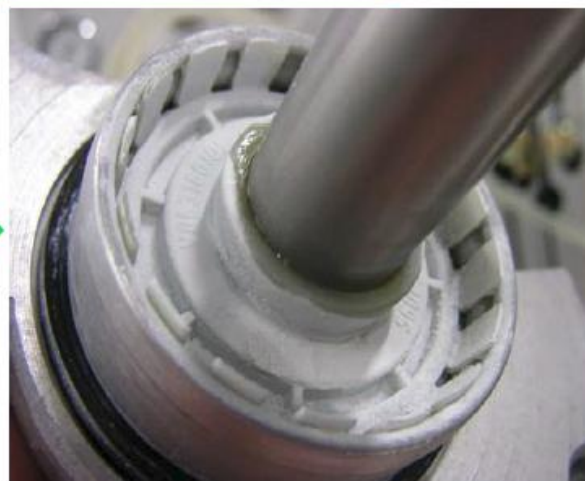
試験開始 (負圧: -667mbar)

20分後: にじみ確認

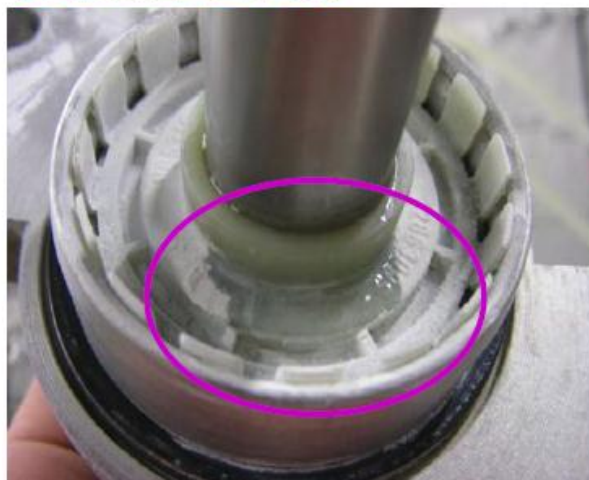
40分後: にじみ拡大 明らかな液漏れを確認

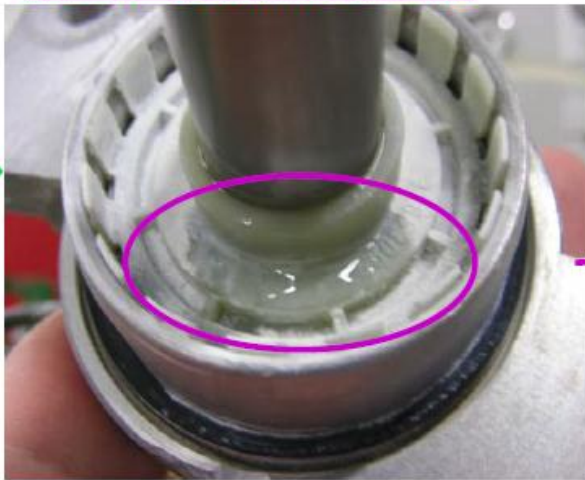
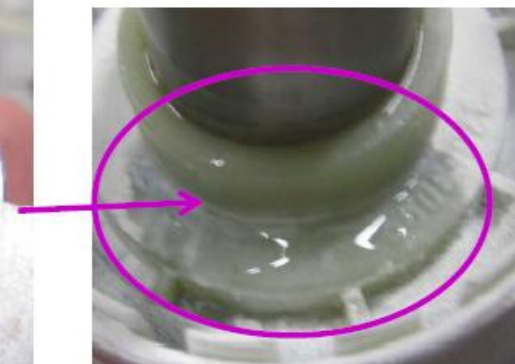
60分後: にじみ更に拡大 明らかな液漏れを確認

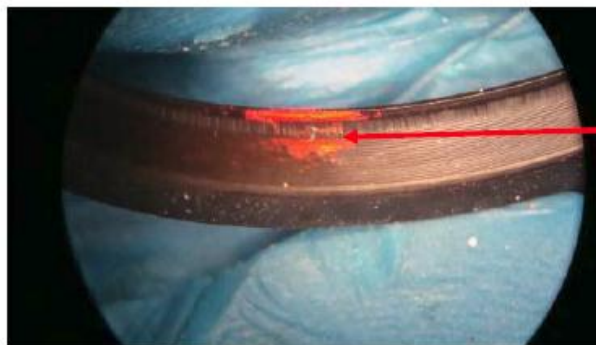
- Contamination found in vacuum seal of the primary circuit is creating a leak path of brake fluid from the master cylinder. The composition of the metallic particles found show to be the same as the aluminum in the master cylinder primary plunger. This confirms that the plunger is a possible place of origin and not the master cylinder body.

アルミニウム製コンタミ確認:プライマリープランジャー傷から出たと思われる異物を確認(異物の分析結果アルミニウムでありプライマリープランジャーと同等成分)

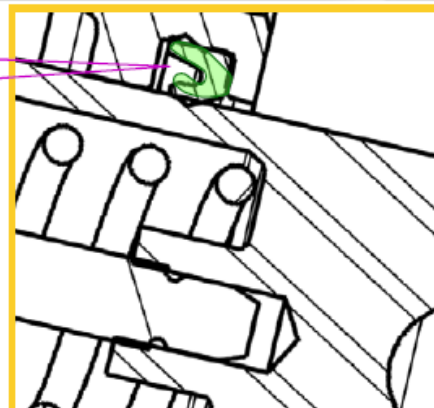
- Vacuum seal damage due metallic particle

コンタミ混入により、プランジャー作動からシールに磨耗を確認

コンタミ混入によるフルードリーク現象

コンタミがある事でプランジャーストローク毎にシールが擦れて磨耗する。(傷が出る)

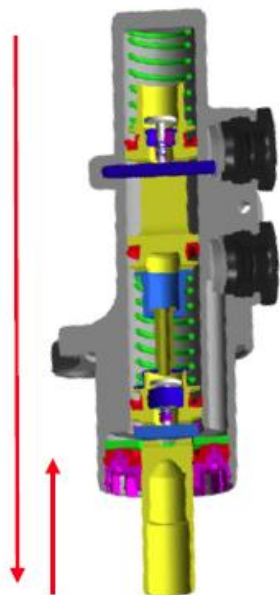
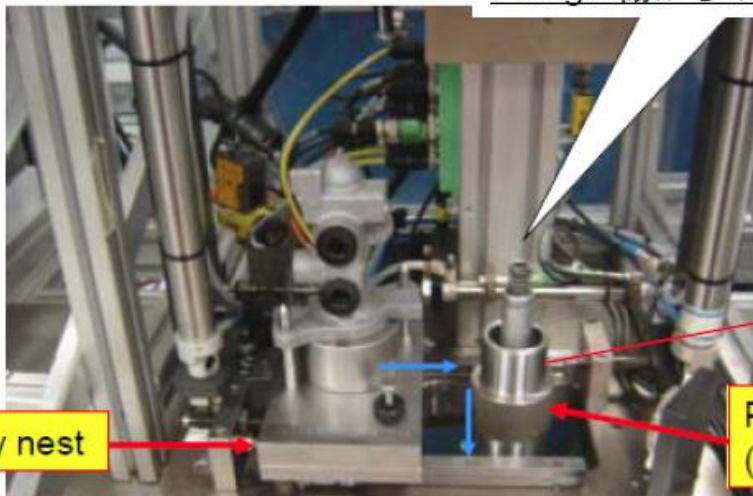
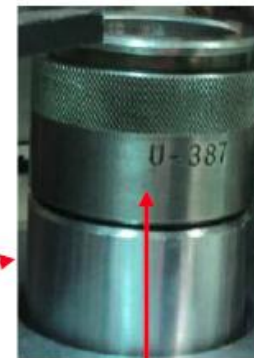
Op 60: Primary piston insertion

Primary Plunger にM/Cy bodyを挿入する際に、アライメントを行うツールの位置ズレで干渉してPrimary Plunger傷からの異物発生の可能性

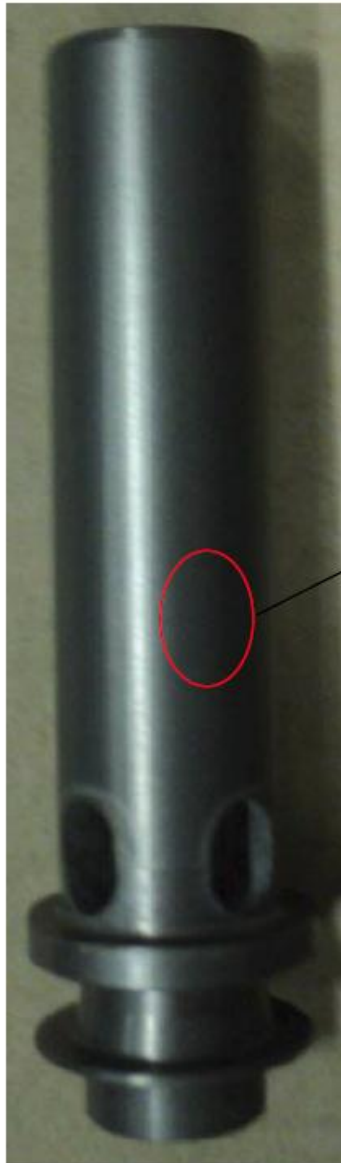
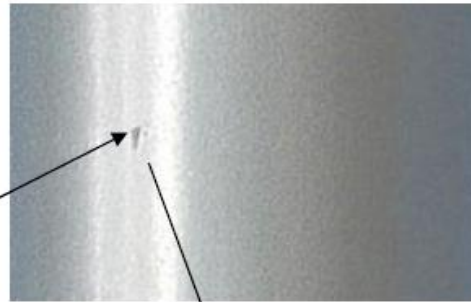
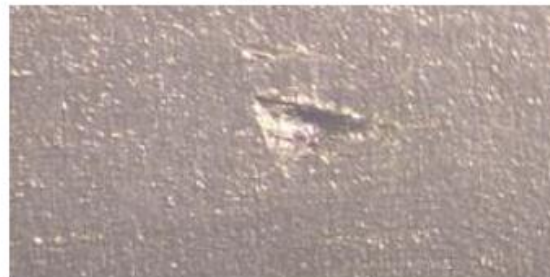
再現試験結果

Op 60 での再現試験の結果、ツールの位置ズレにより、プランジャーとマスターシリンダーボディが干渉して、プランジャーに傷が出来た事を確認。傷から出た、アルミ製破片が混入したまま組み立てられた可能性がある。

Due the nature of the nick. The damage was done after anodizing process

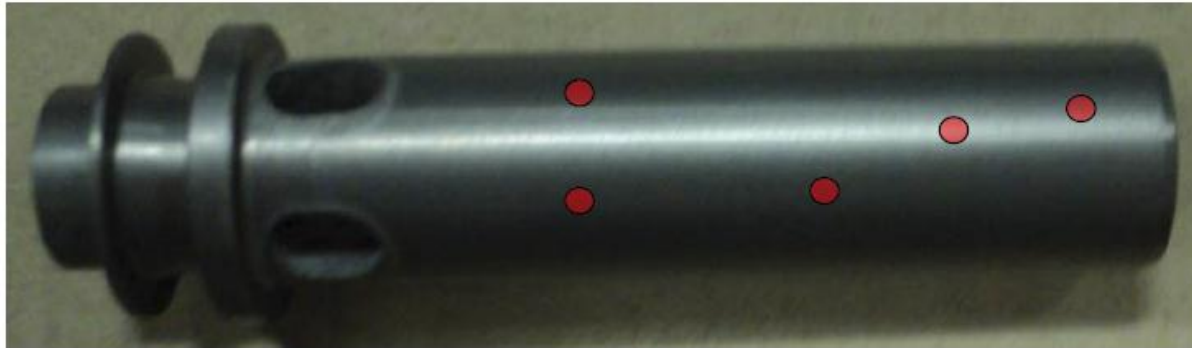
プランジャーに異物が付着したまま工程へ流動した可能性

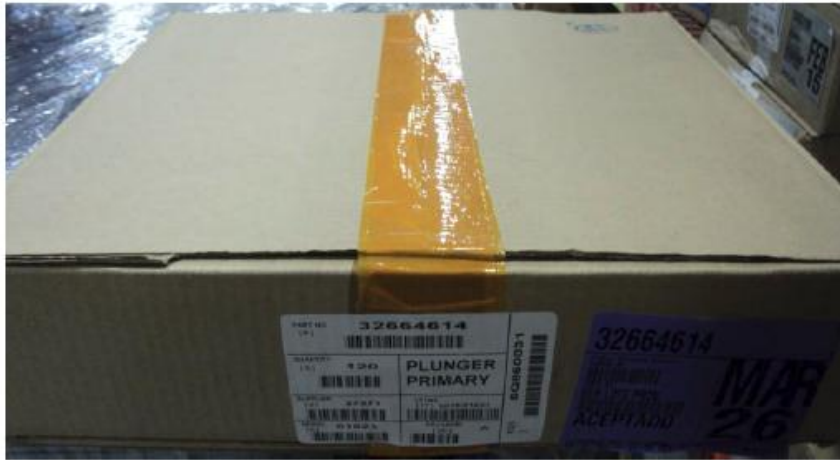
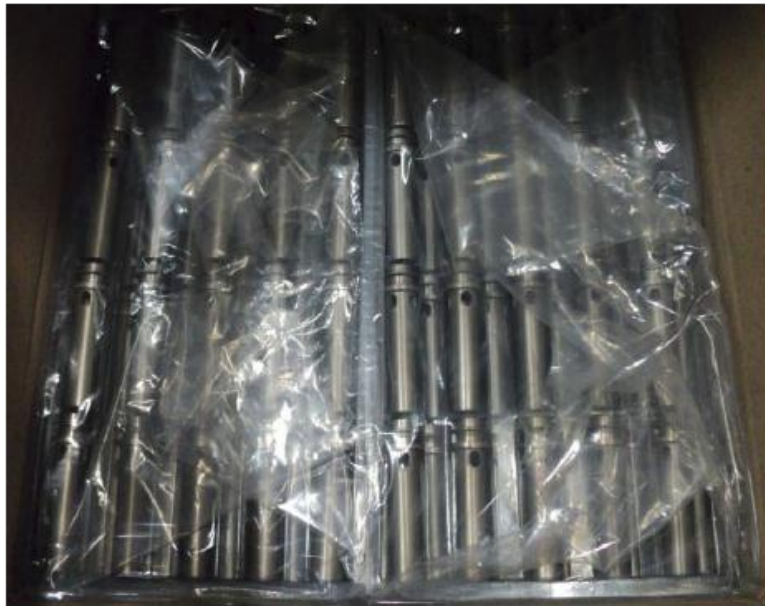
Incoming condition of Plunger

The packaging is perfectly sealed and inside are the pistons in a tray where it enters each in place preventing this from hitting

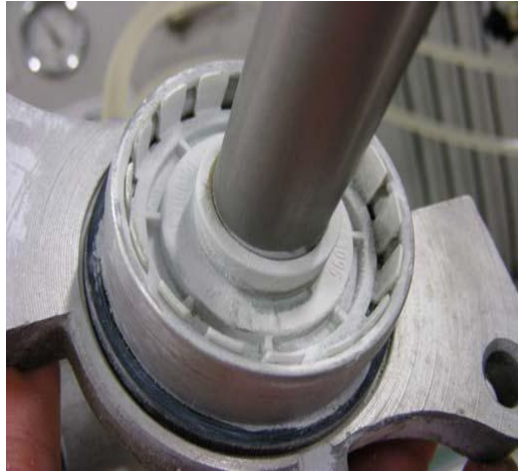
Test start (vacuum: - 667mbar)

Reproduction condition
* Vacuum maintained
(Test vacuum: - 667mbar)
* Booster, master cylinder
not operated.

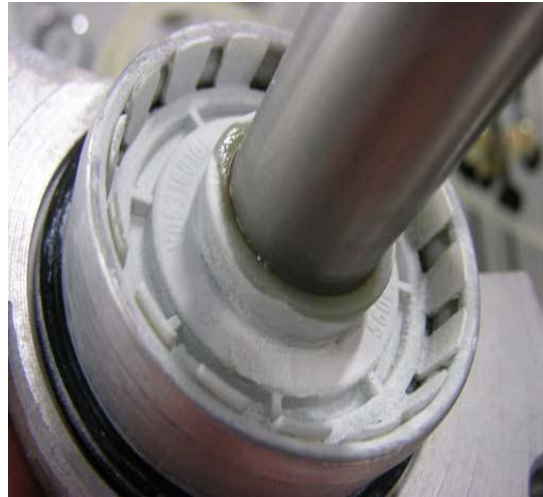
20 min later: fluid began to leak

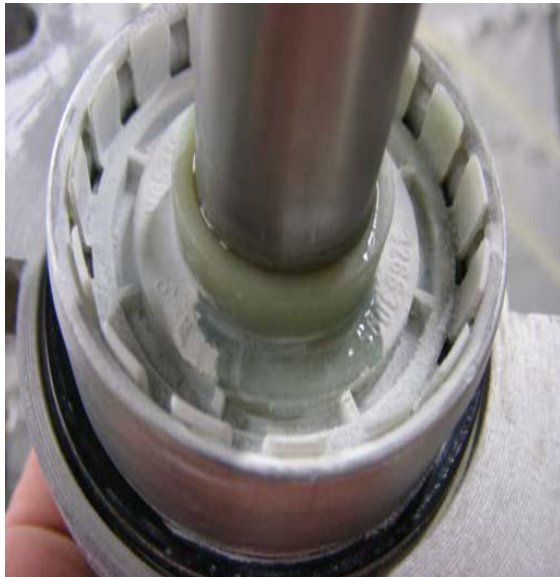
40 min later: Leak spread
and became obvious.

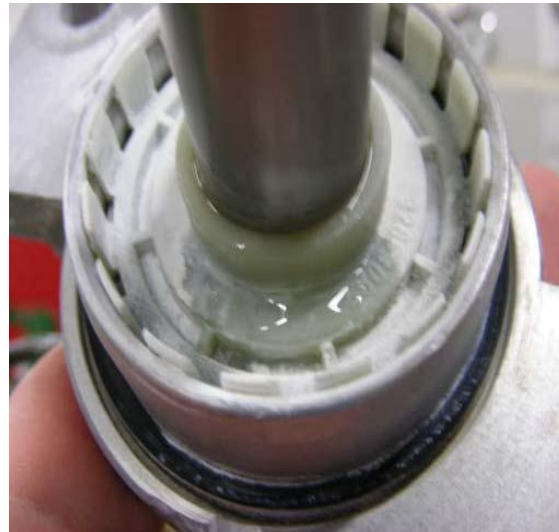
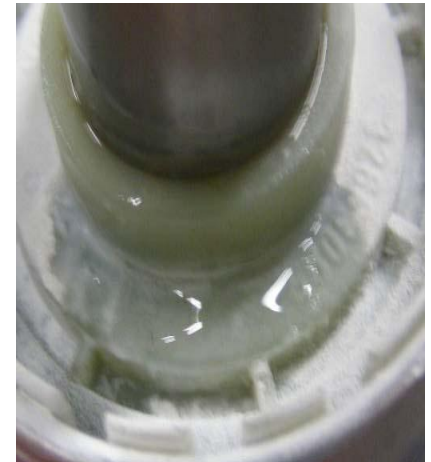
60 min later: Leak spread further
and became more obvious.

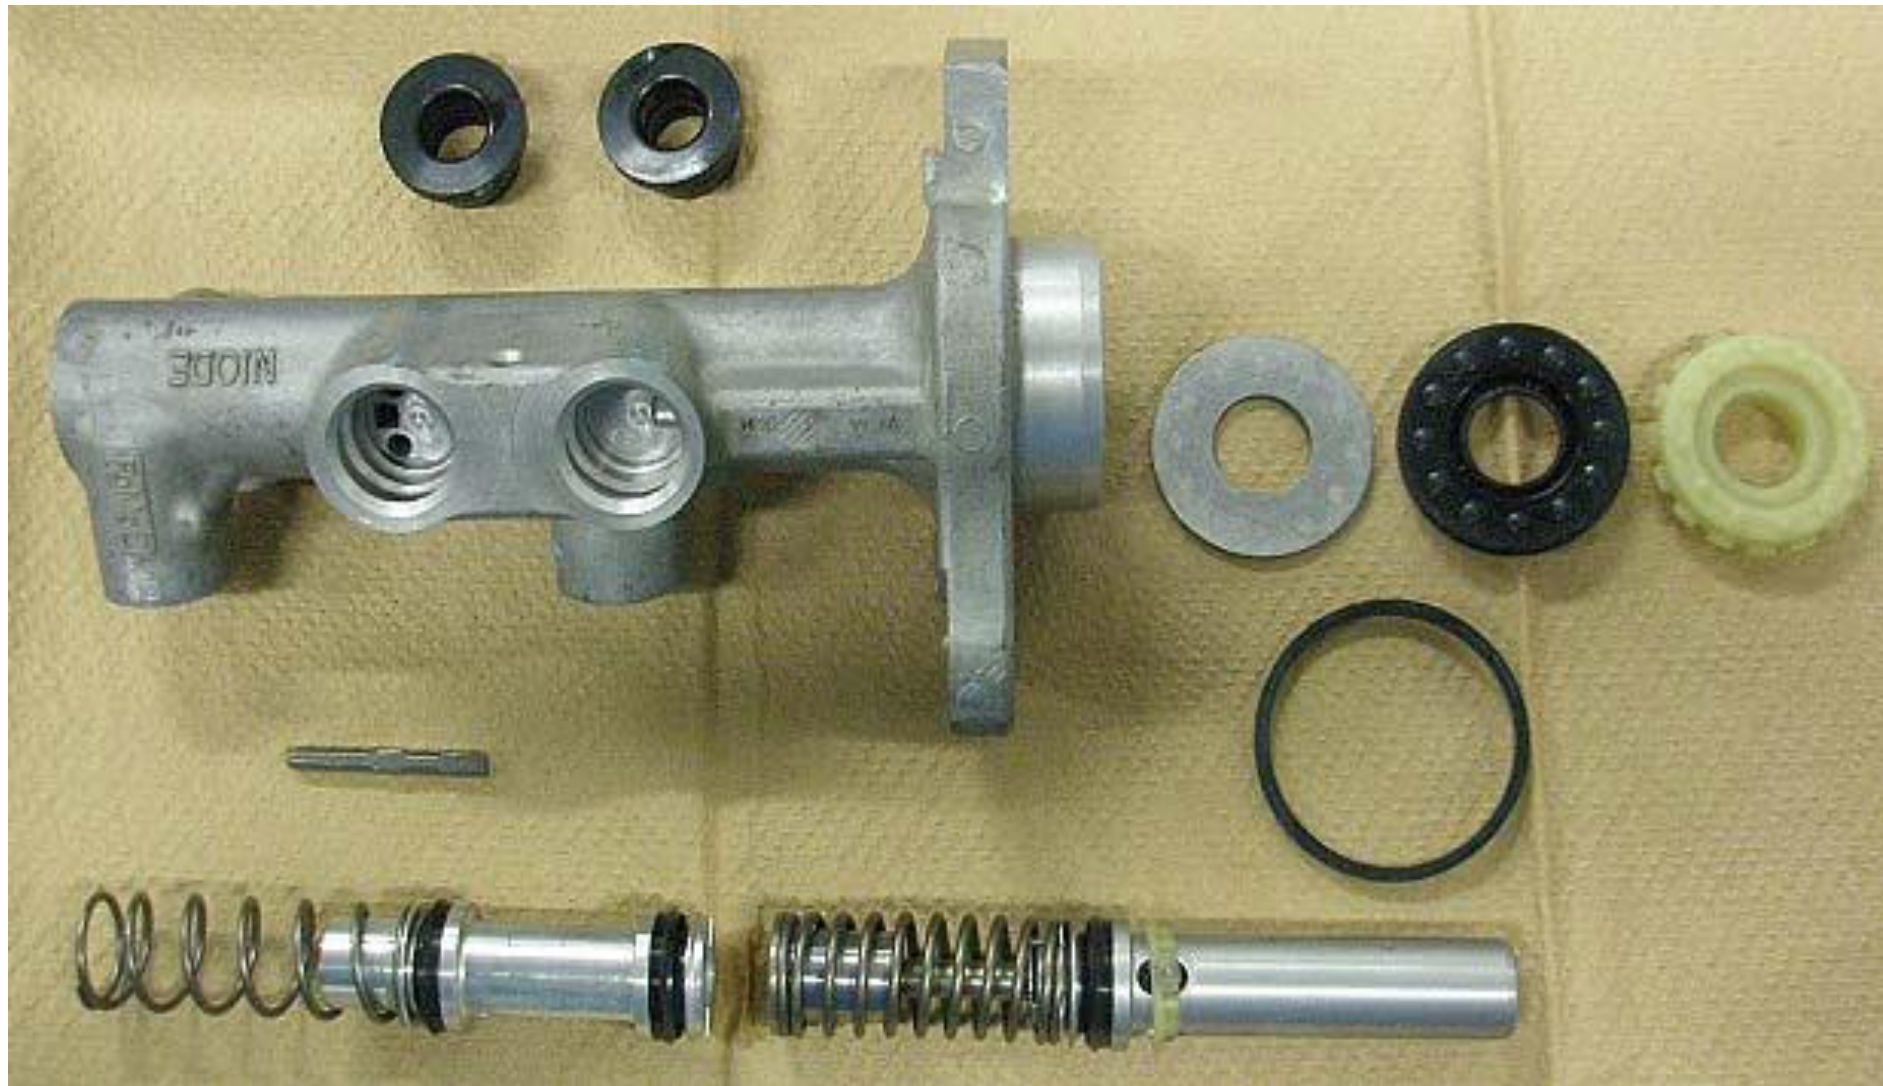
Master cylinder disassembly result-1

A scratch on the primary plunger and a small piece of aluminum (contamination) were found. Also, the vacuum seal was damaged. Fluid leak at the test with vacuum pressure -667bar, was observed. Mazda assumed that contaminated piece of aluminum caused the vacuum seal

damage while vehicle usage, resulting in a fluid leakage. This corresponds with the Factor(3) described in Answer8.

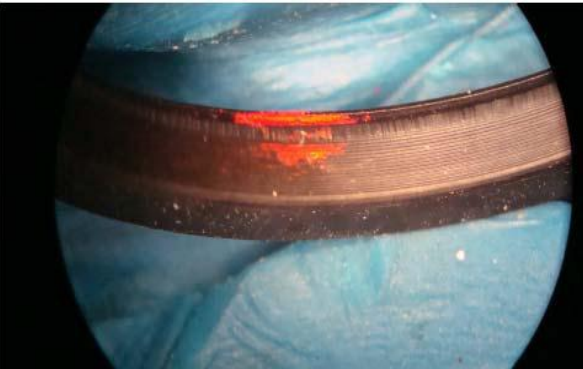
- Vacuum seal damage due metallic particle

Wear of seal due to contamination was confirmed through plunger operation.

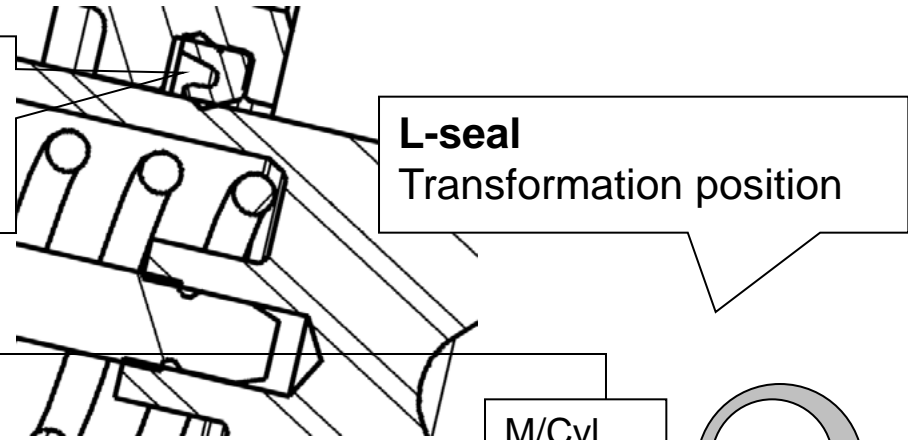
Fluid leak phenomenon due to contamination

Due to contamination, seal is rubbed at every plunger stroke, causing seal wear (with scratches formed)

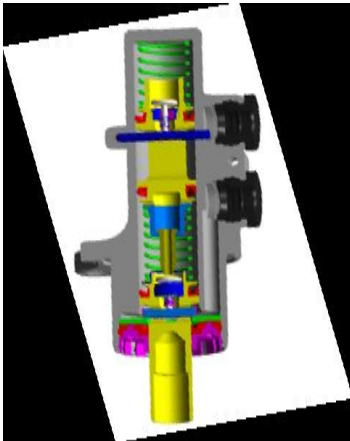
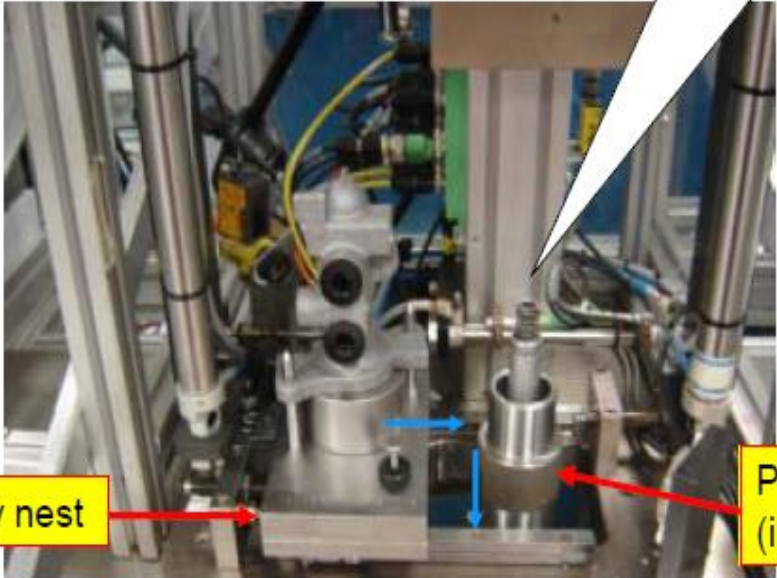
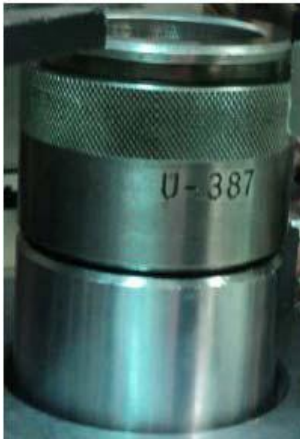
Op 60: Primary piston insertion

When master cylinder body is inserted into the primary plunger, both parts may interfere each other due to misplacement of alignment tool, which may cause foreign material generated from the primary plunger scratch.

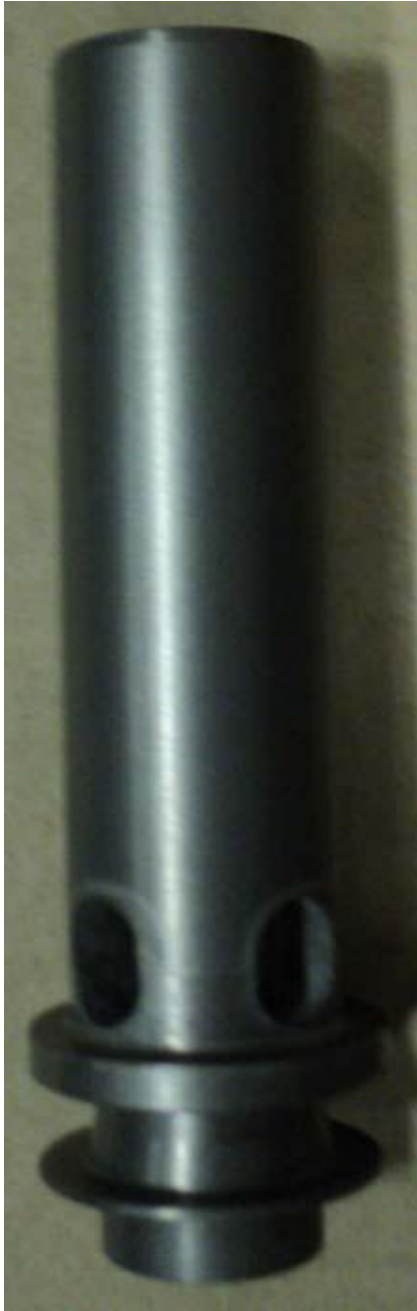
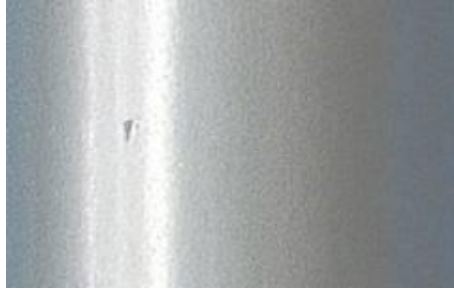
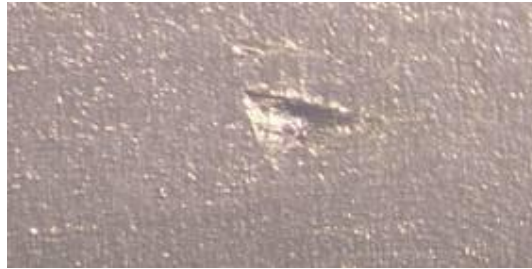
Reproduction test result

As a result of reproduction test with **Op 60**, we verified a scratch was created after the plunger and the master cylinder body interfered each other due to the tool misplacement. There's a possibility that it may have been assembled with aluminum piece coming from the scratch included.

Due the nature of the nick. The damage was done after anodizing process

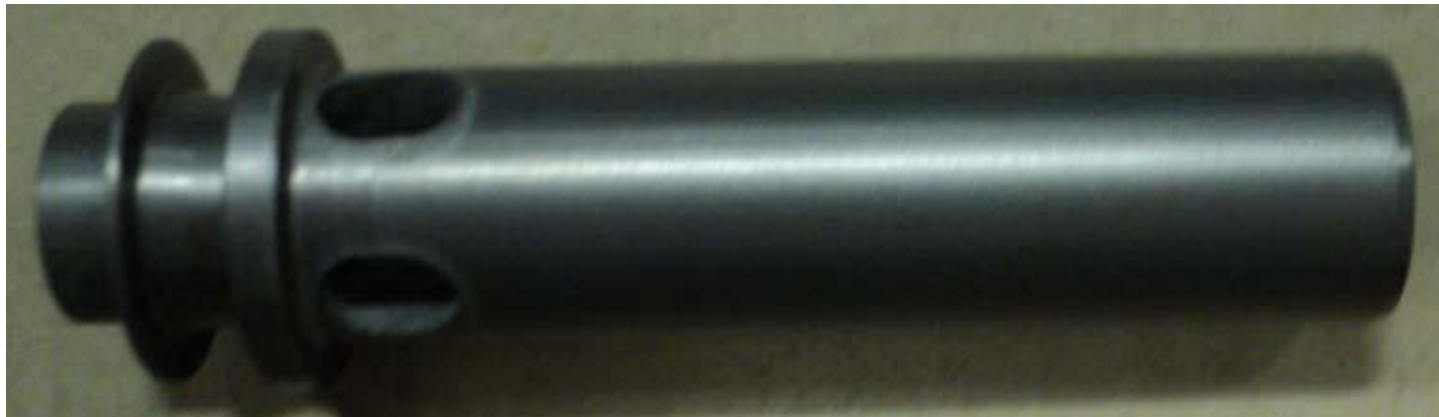
Estimated root cause of contamination-2

Possibility that the plunger with foreign material (contamination) attached may have been delivered to the process.

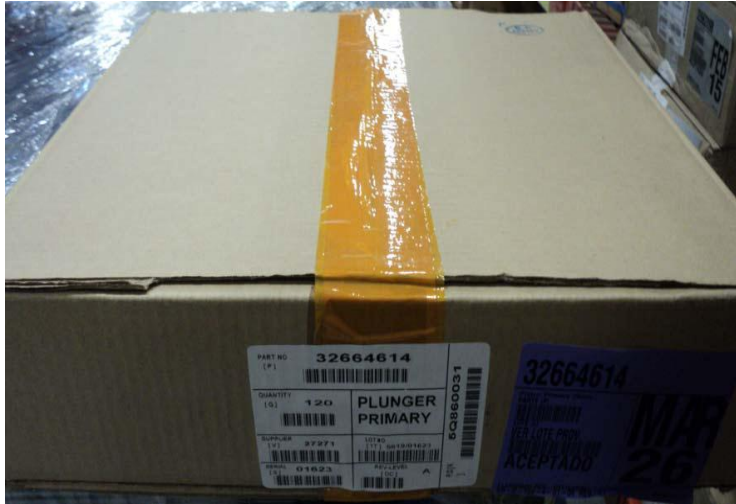
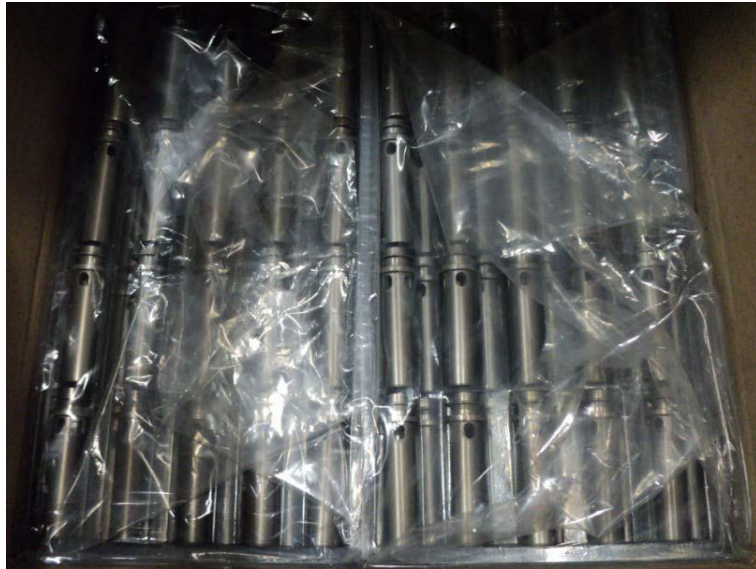
Incoming condition of Plunger

The packaging is perfectly sealed and inside are the plungers in a tray where it enters each in place preventing this from hitting
