**Re: Request for Confidential Treatment/PE11-029**

## **Re: PE11-029, CNG Tanks and Caged Mounting System**

**Subject: Saf-T-Liner HDX CNG Tank Clearance Inspection**

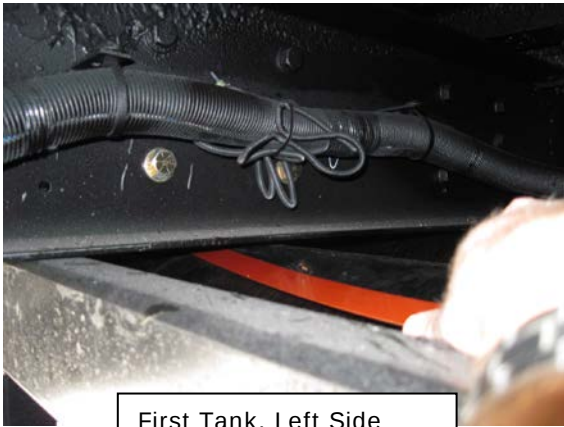
First Tank, Left Side  
(Inside Frame Rails)

4. From between the chassis frame rails, sweep the test gauge over each CNG tank and under the frame rail / tank cage. The gauge should move between the frame rail / tank cage and the CNG tank easily.

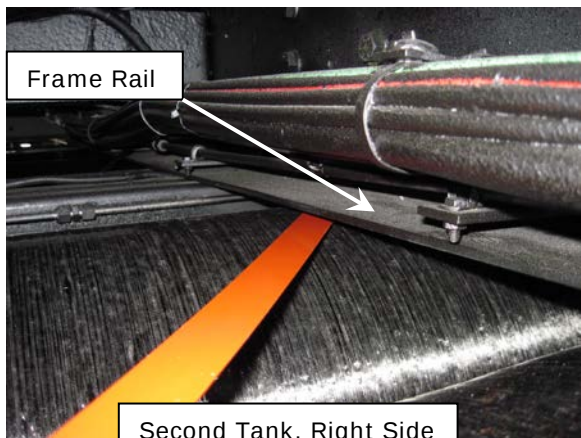
Second Tank, Right Side  
(Inside Frame Rails)

5. While performing each sweep of the gauge, be sure the test gauge is extended past the CNG tank cage on the outside of the frame rail. This allows one sweep per tank end to confirm clearance of both frame rail and tank cage.

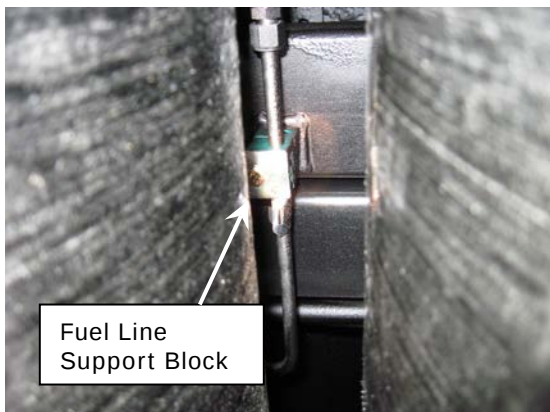
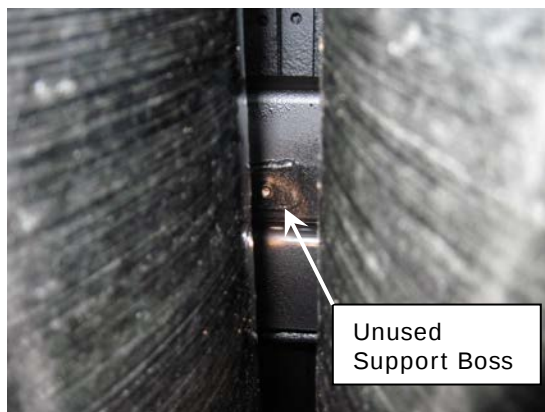
Note: There are fuel line supports blocks and unused fuel line support boss on the under-side of the tank cage member shown above. If the test gauge strikes an object, confirm first that it is not a fuel line support block or unused boss in that location. These are located between CNG tanks, but may be an obstacle for the test gauge when sweeping from one tank to the next.

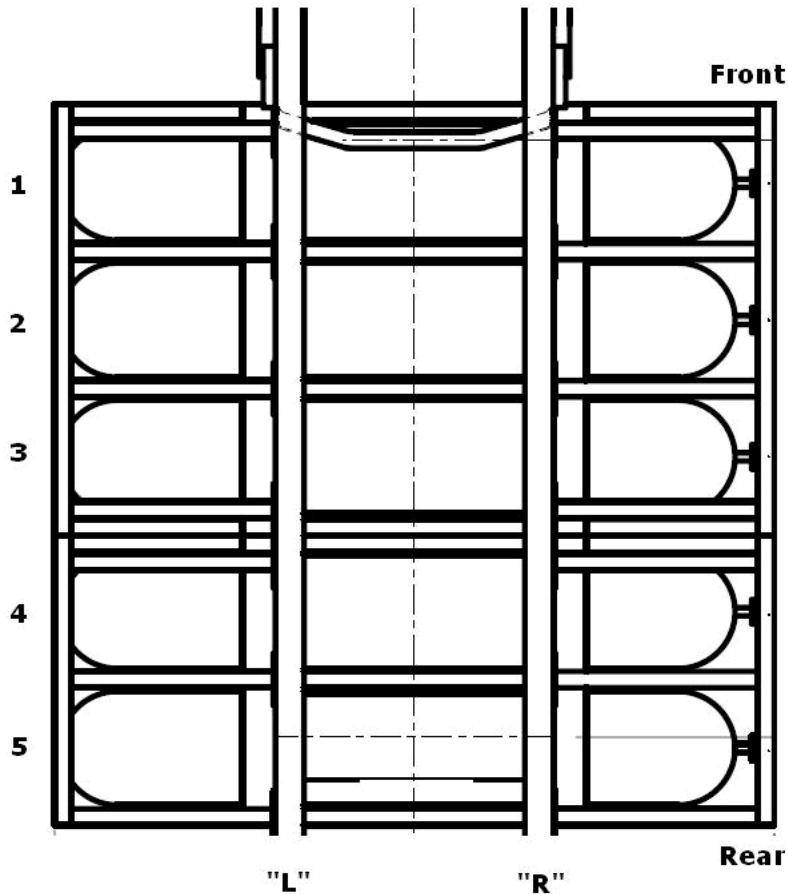
Examples: "1L" First Tank, Left Side; "3R" Third Tank, Right Side

6. Proceed to test the clearance on each side of each CNG tank. If the test gauge fails to pass between the CNG Tank and the Frame Rail / Tank Cage (confirm gauge did not strike a surrounding object), record its location on the form provided. Use the diagram below to describe the location where a sweep of the test gauge fails to pass. Tanks, depending on sales option, can number from one (1) to eight (8). A five (5) tank option is shown.

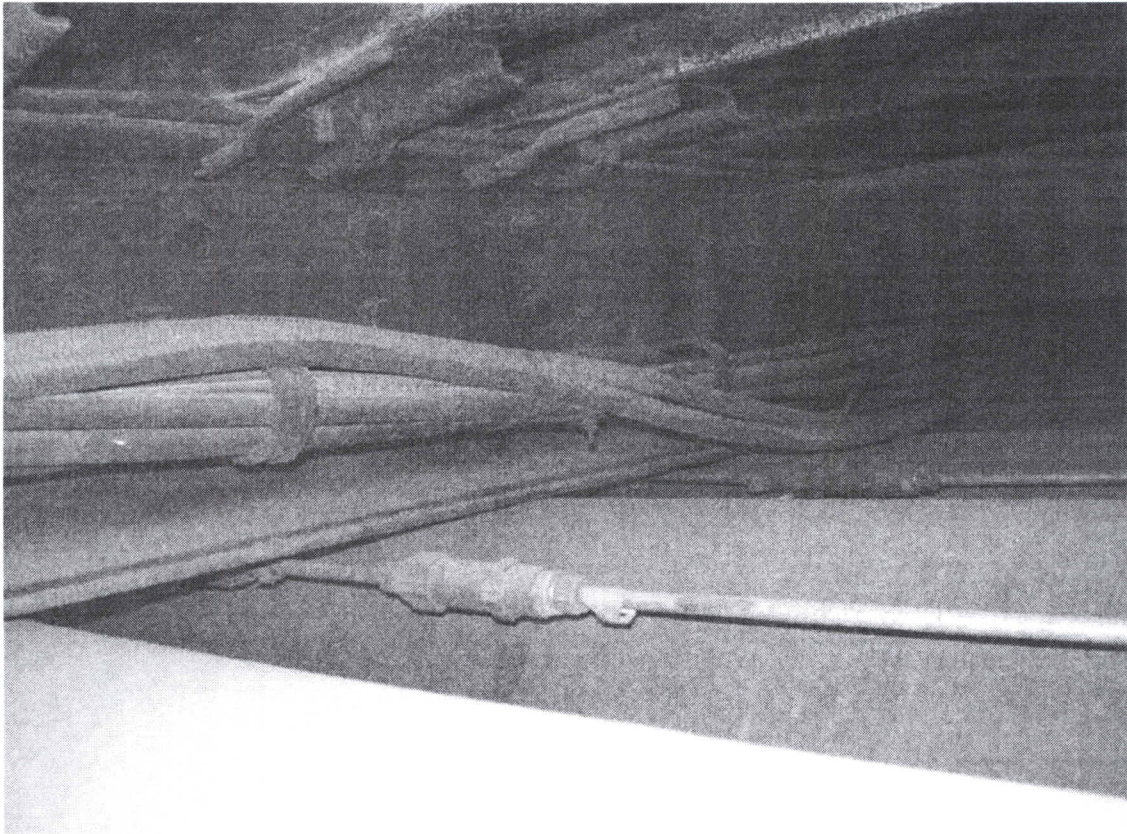
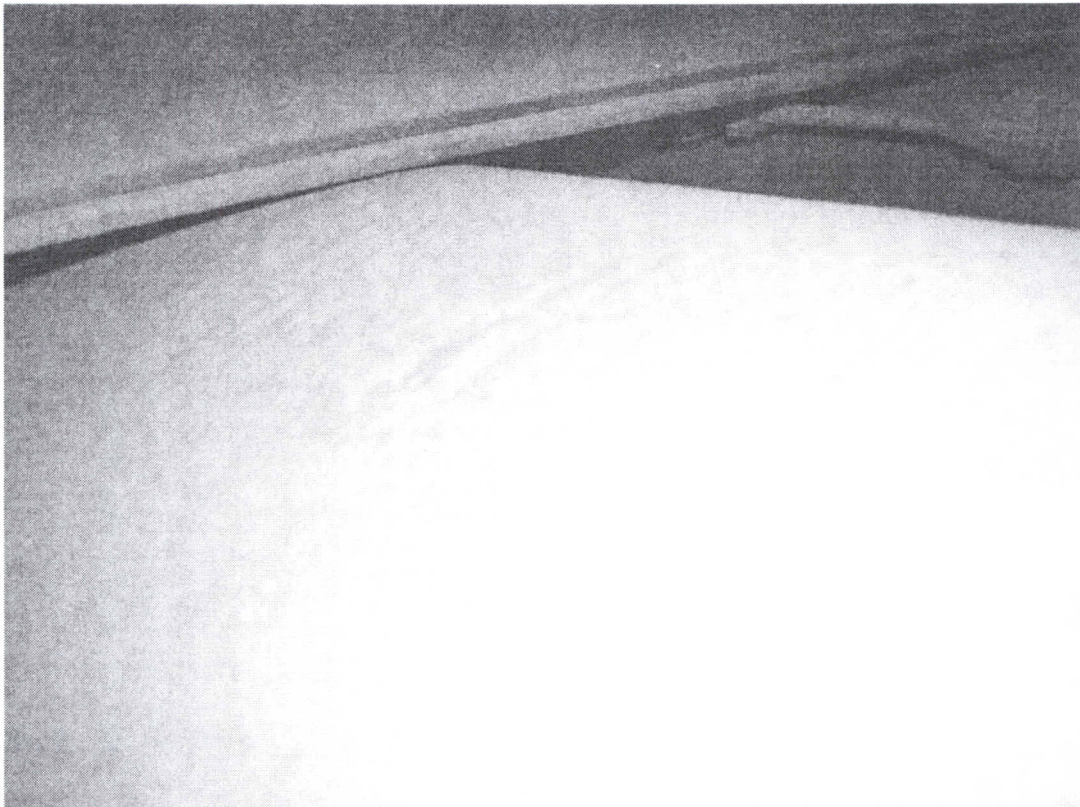
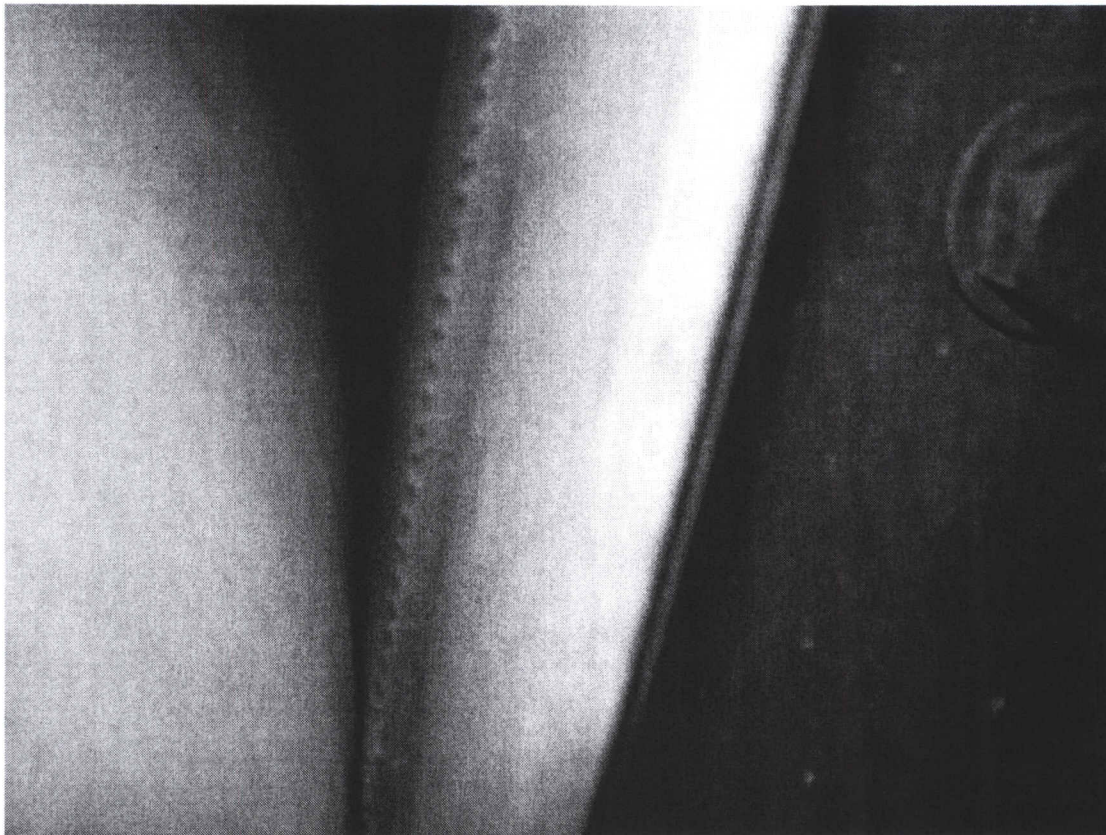
Joint inspection conducted on September 20, 2011, to review CNG tank damage and evaluate tank mounting system and clearances. Inspection included representatives from LA Unified Schools, Buswest, Dynetek, The National Highway Traffic Safety Administration, Freightliner Custom Chassis, Thomas Built Buses, and Daimler Trucks North America. The CNG tank was observed to have non structural damage in the form of a series of small indentations with a maximum depth of 0.52mm caused by contact with a gusset on the mounting cage.

There has been a single field report for insufficient clearance which lead to unintended contact and non-structural damage to the CNG fuel tank covering. This was caused by a mounting bracket that was attached to the fuel tank cage in a way that it encroached on the area intended for the CNG tank. Non-structural damage to the CNG tank covering does not pose a risk to motor vehicle safety. As an established practice, a thorough inspection of the CNG tanks and mounting system performed by a trained CNG system inspector is required at a minimum of every three years. Any potential settling or movement of the CNG fuel tank resulting in reduced clearance and potential damage to the tank or mounting system would be detectable during those inspections.

Take a look at the included photo. This was found on the tank inspection. The tank is rubbing the frame rail.  
Can Thomas do something with this?

We have a 2003 Thomas bus that has a chassis frame rail actually contacting a CNG tank. This bus has not been in an accident or altered in any way. Would Thomas still have some responsibility in this situation?
