Reference: NVS-212pco; PE11-035

PE11-035

Enclosure 9 – Assessments

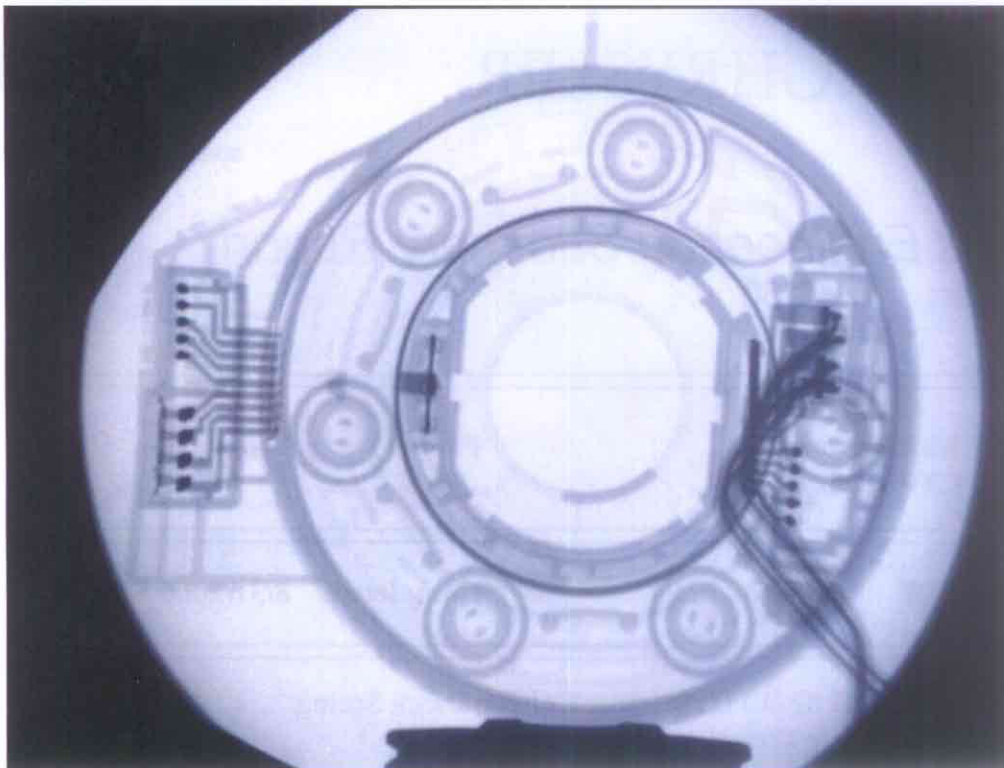
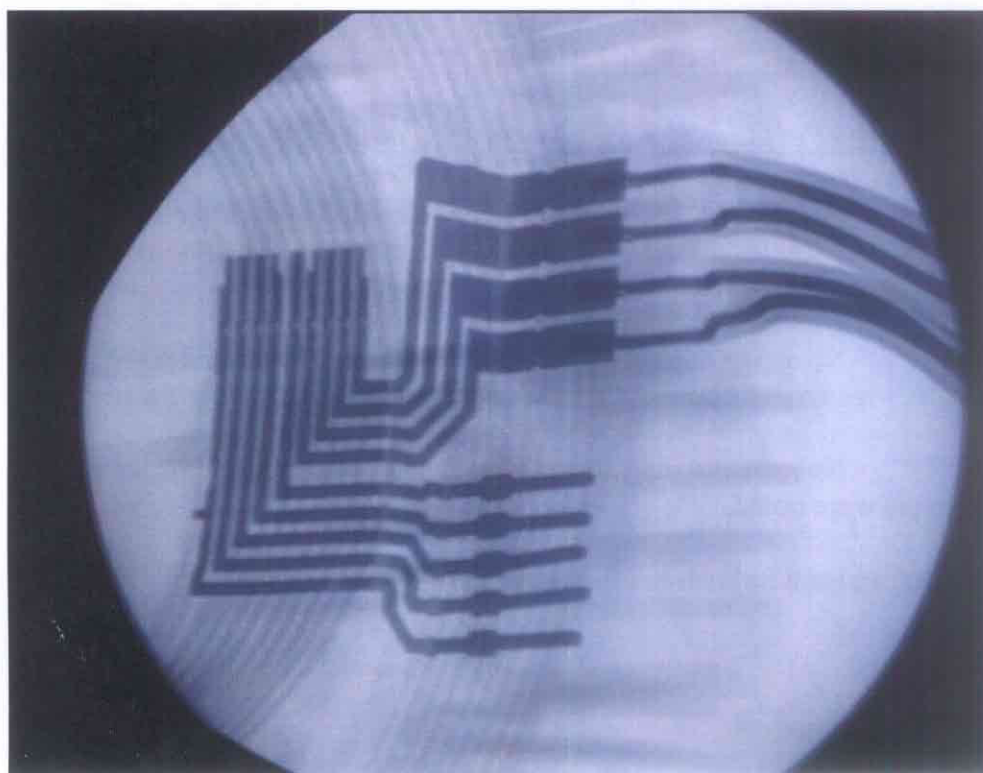
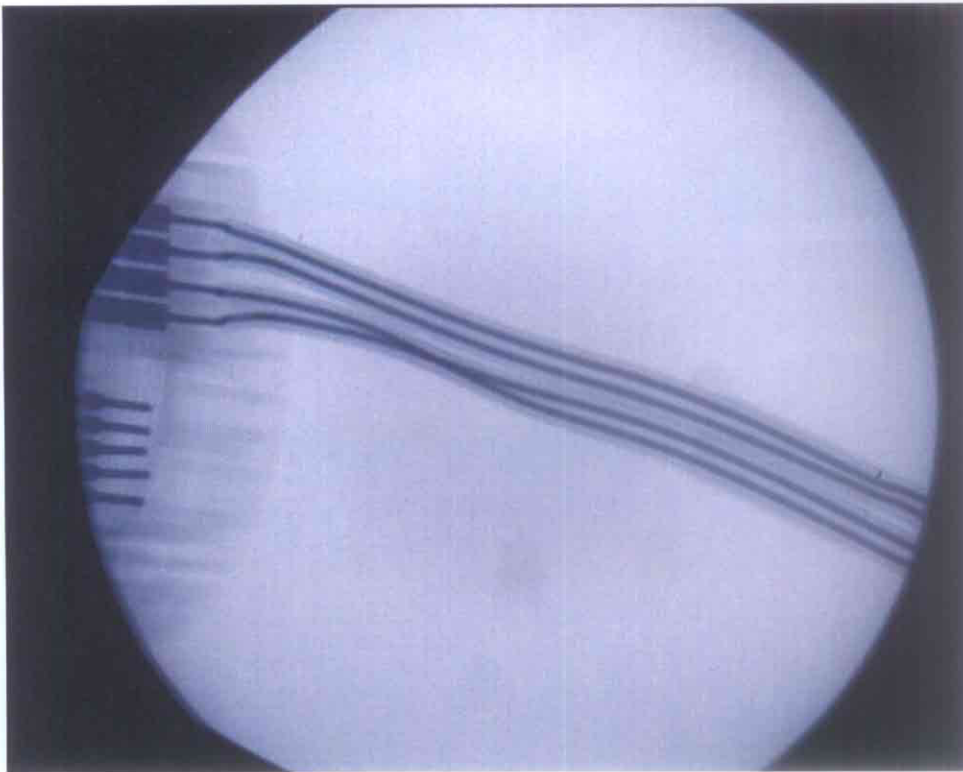
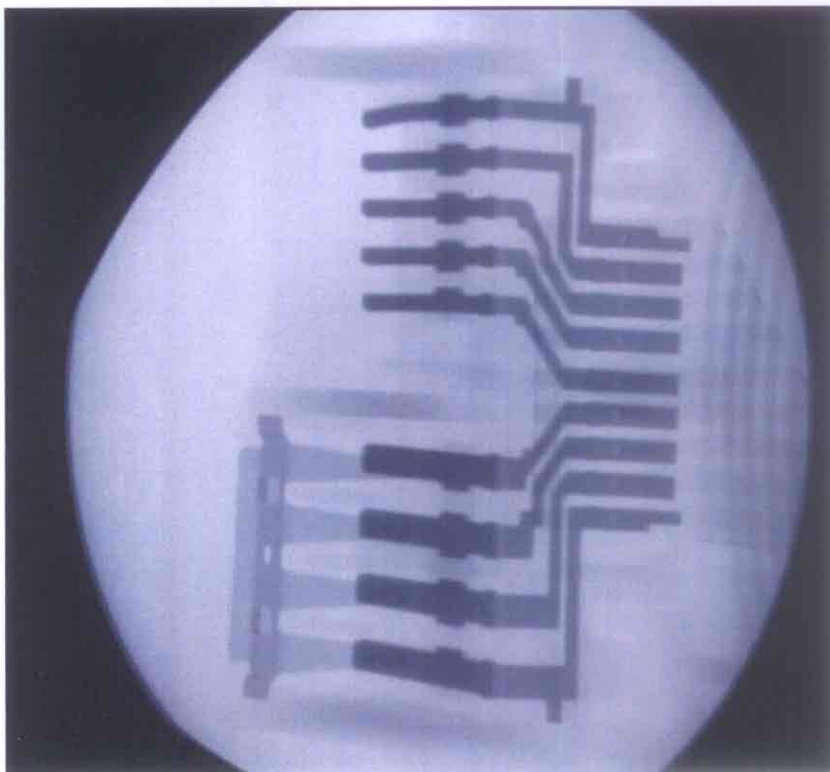
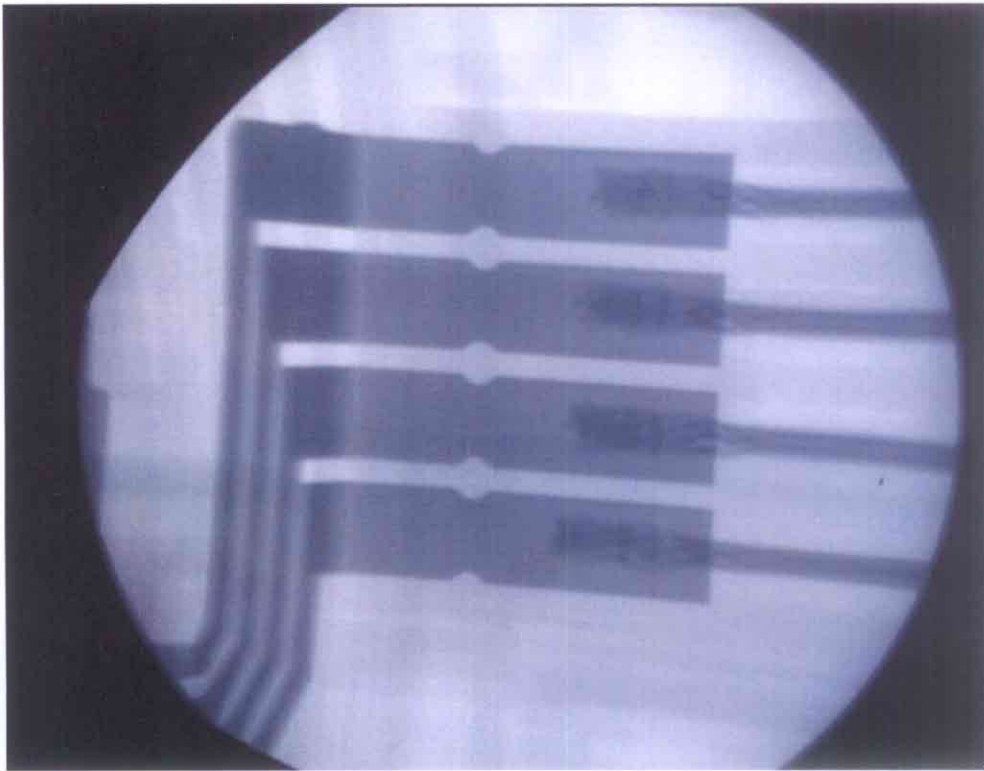
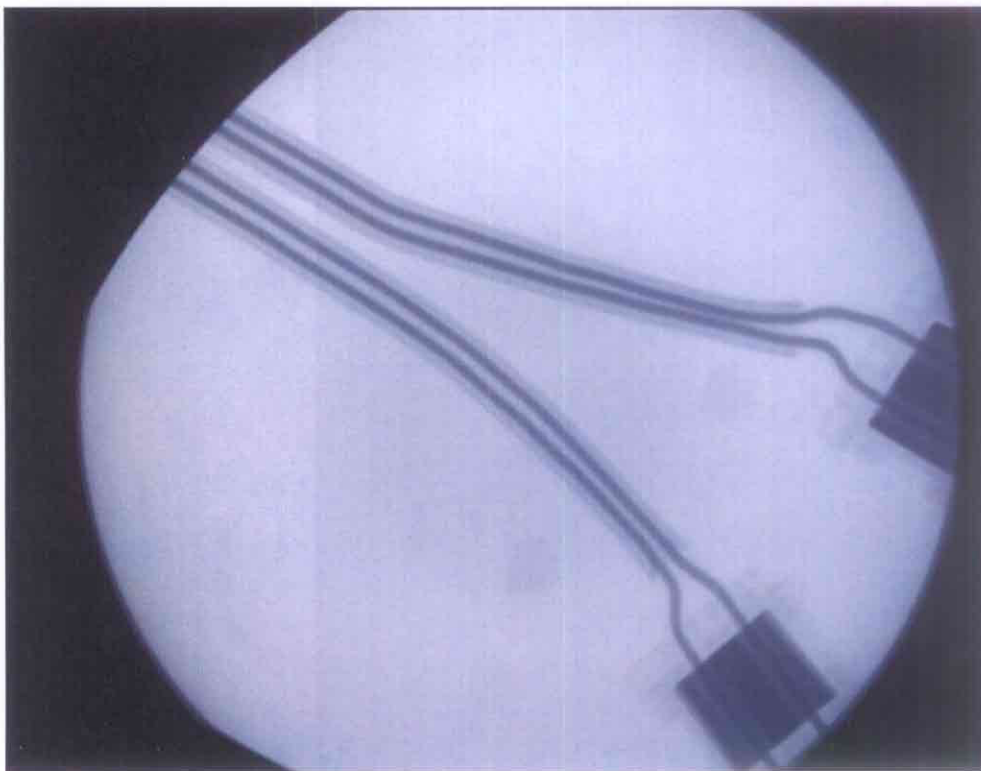
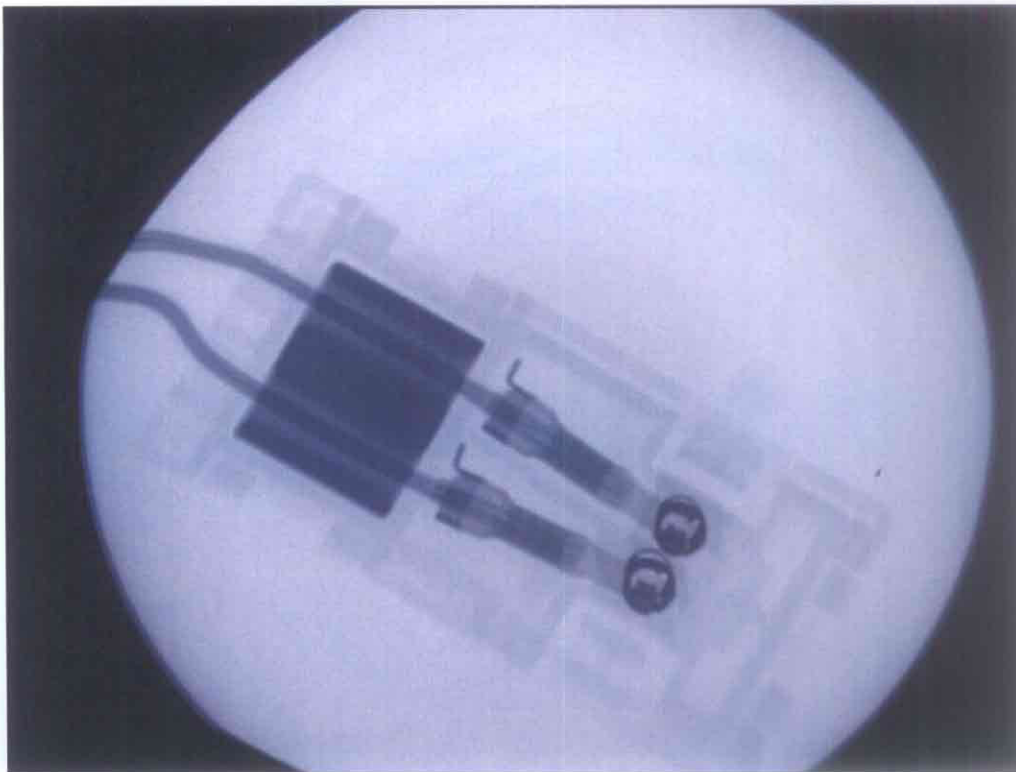
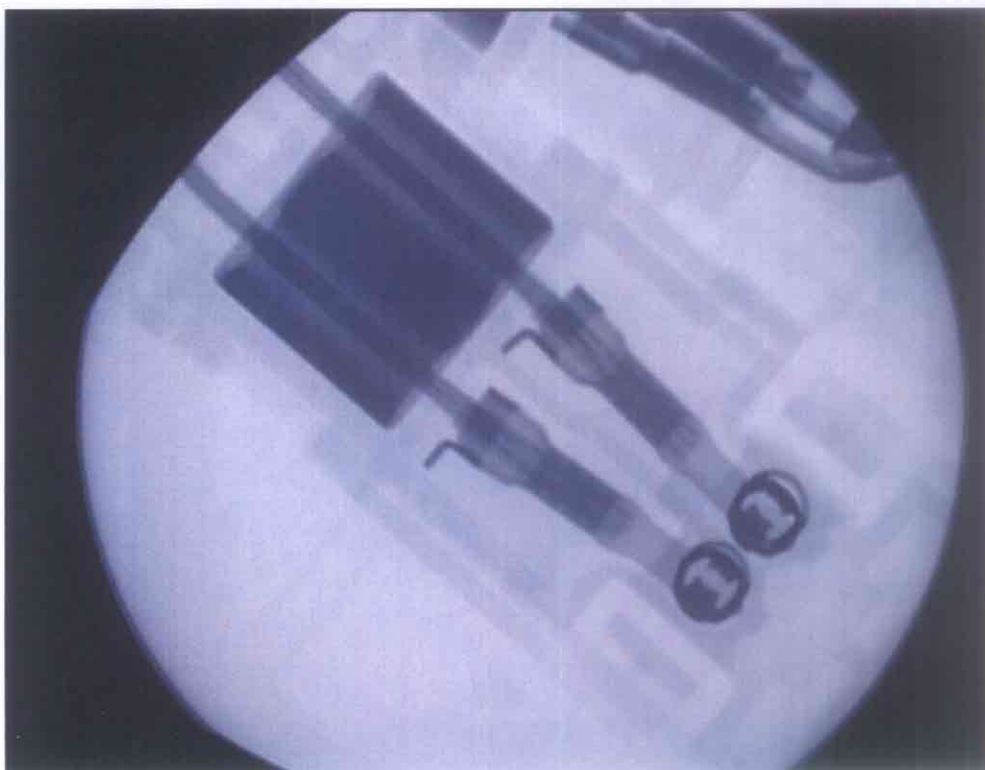
VIN 2W [REDACTED] - No apparent indications of back-winding, kinks in the wire tape or broken connectors were noted. are included below for review.

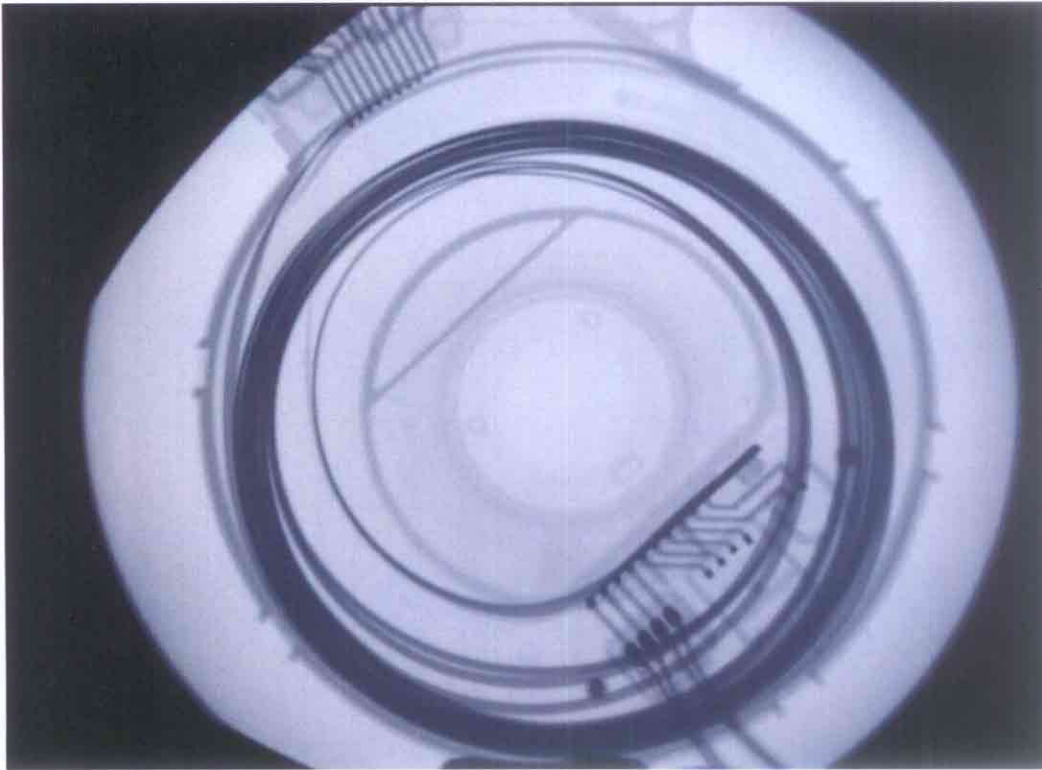
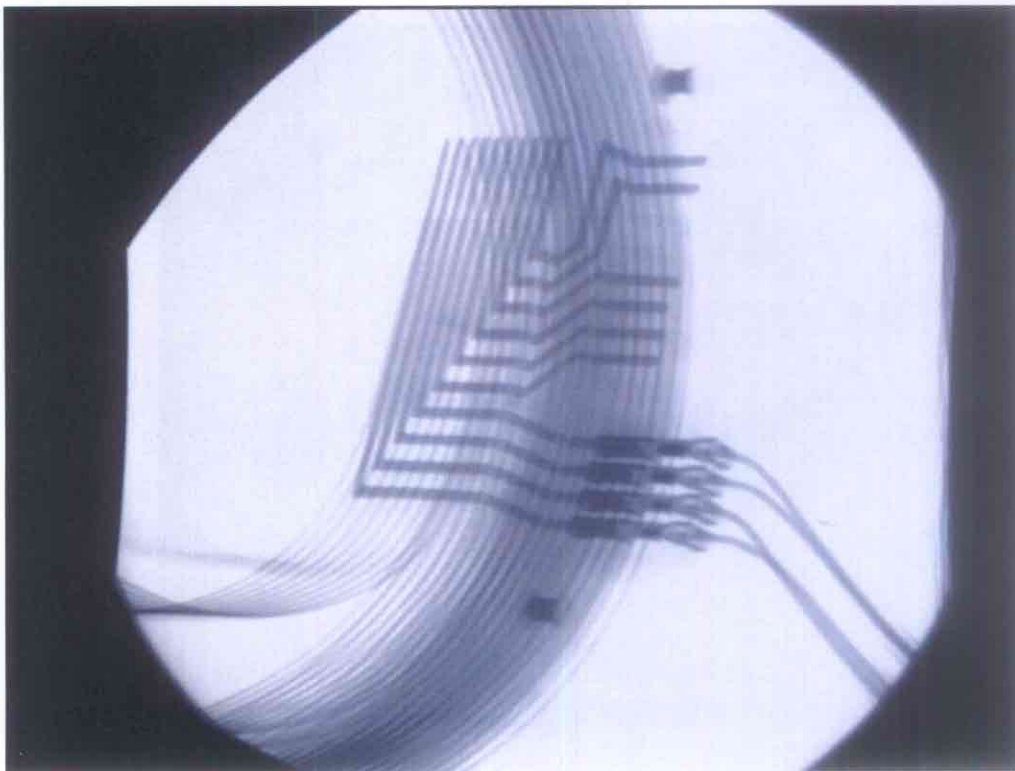
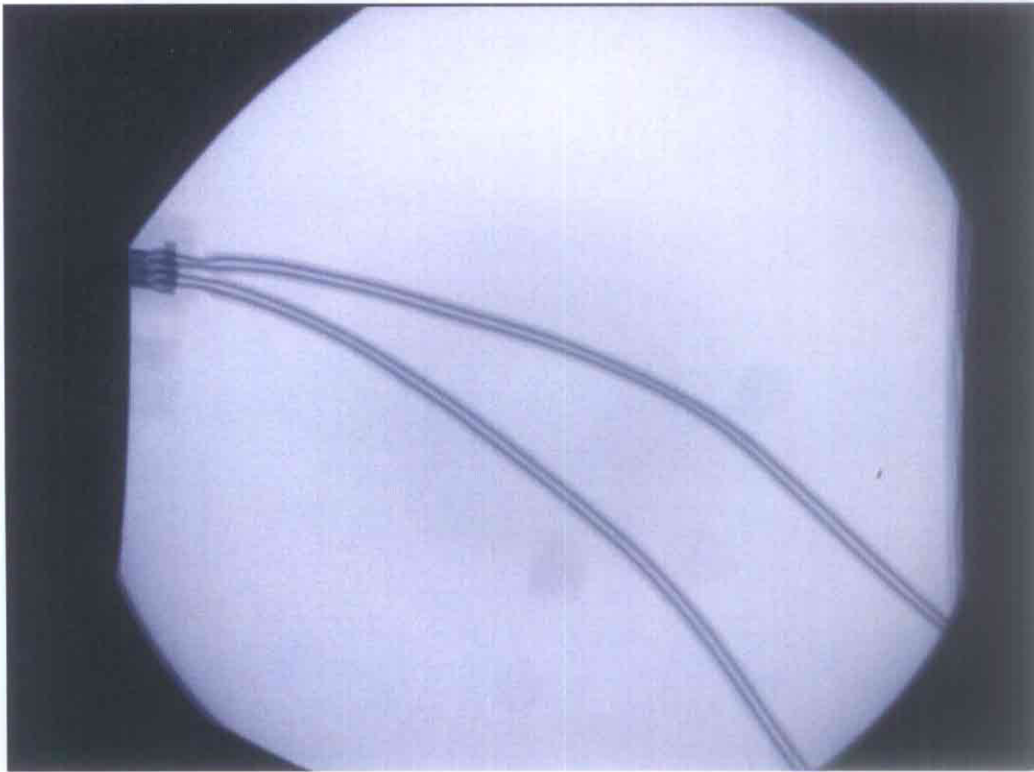
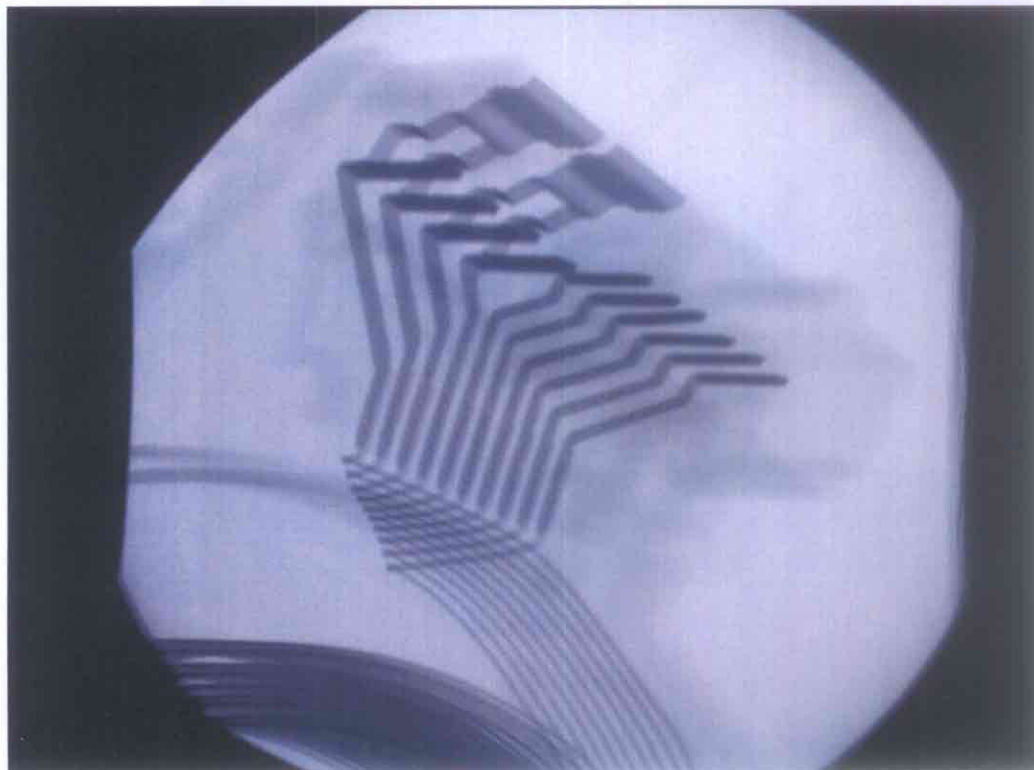
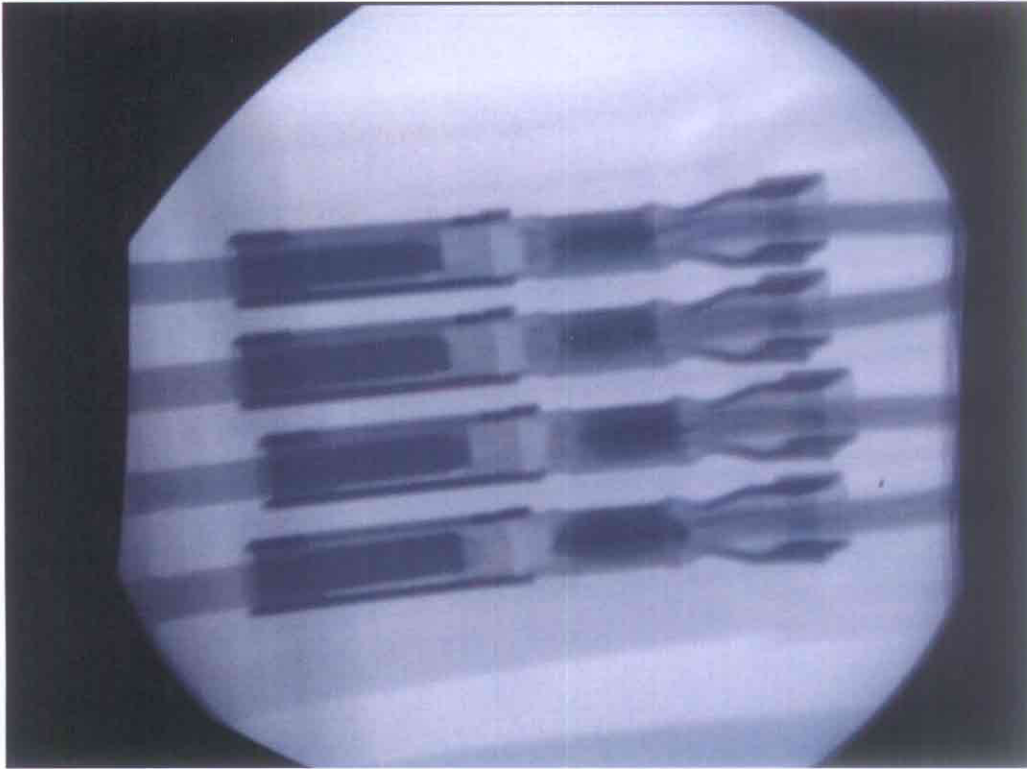
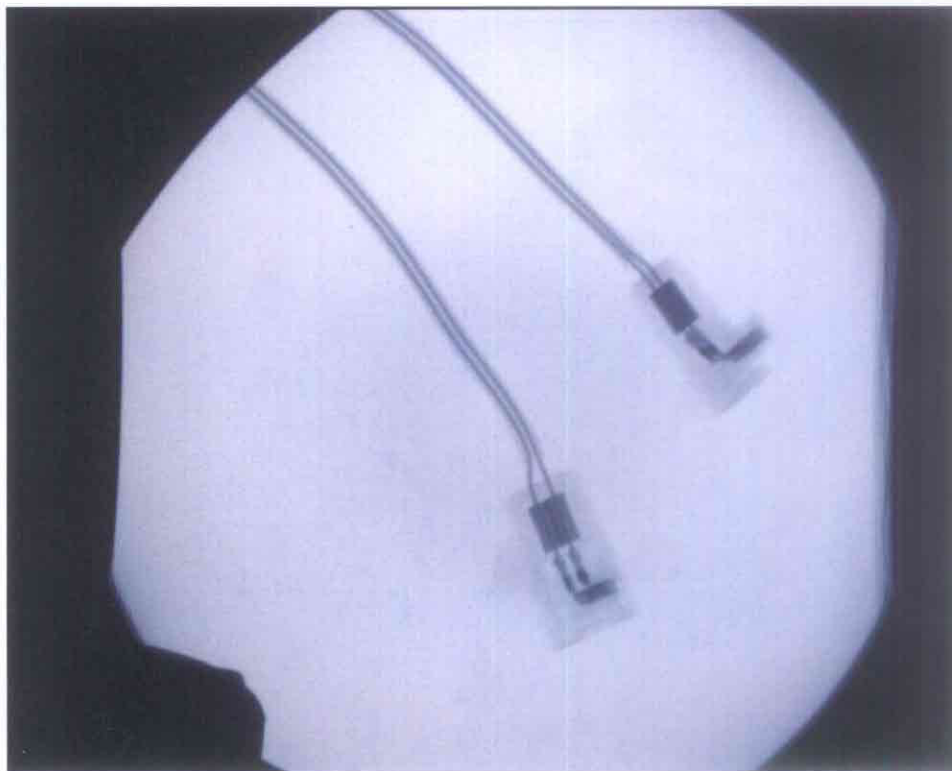
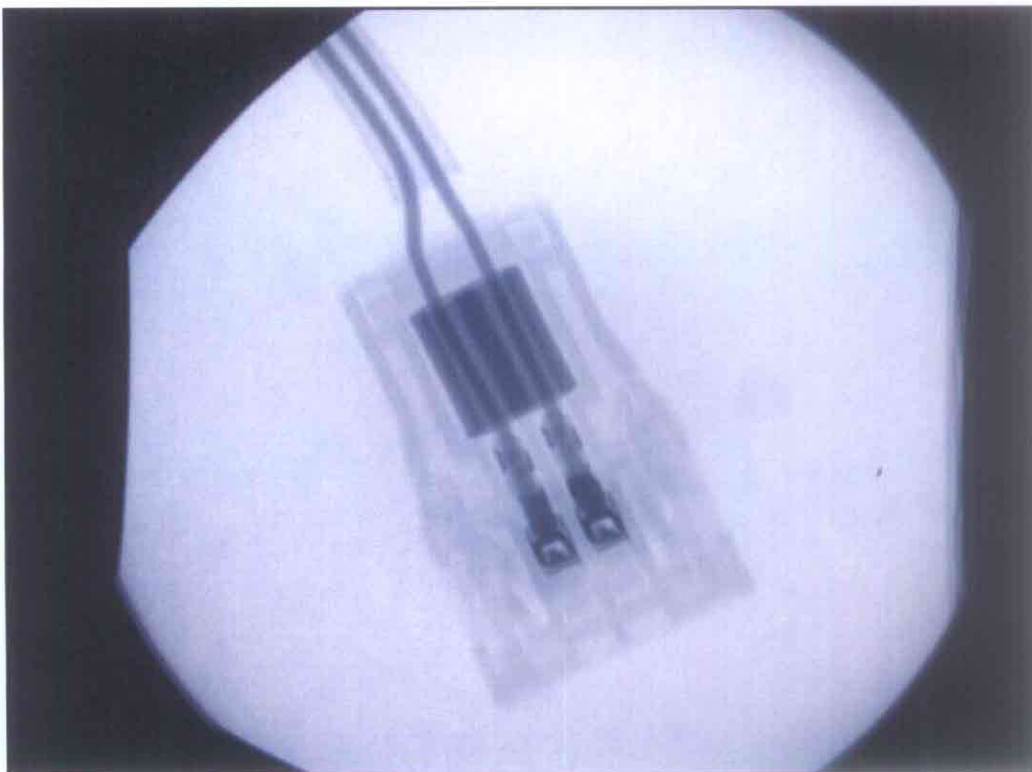
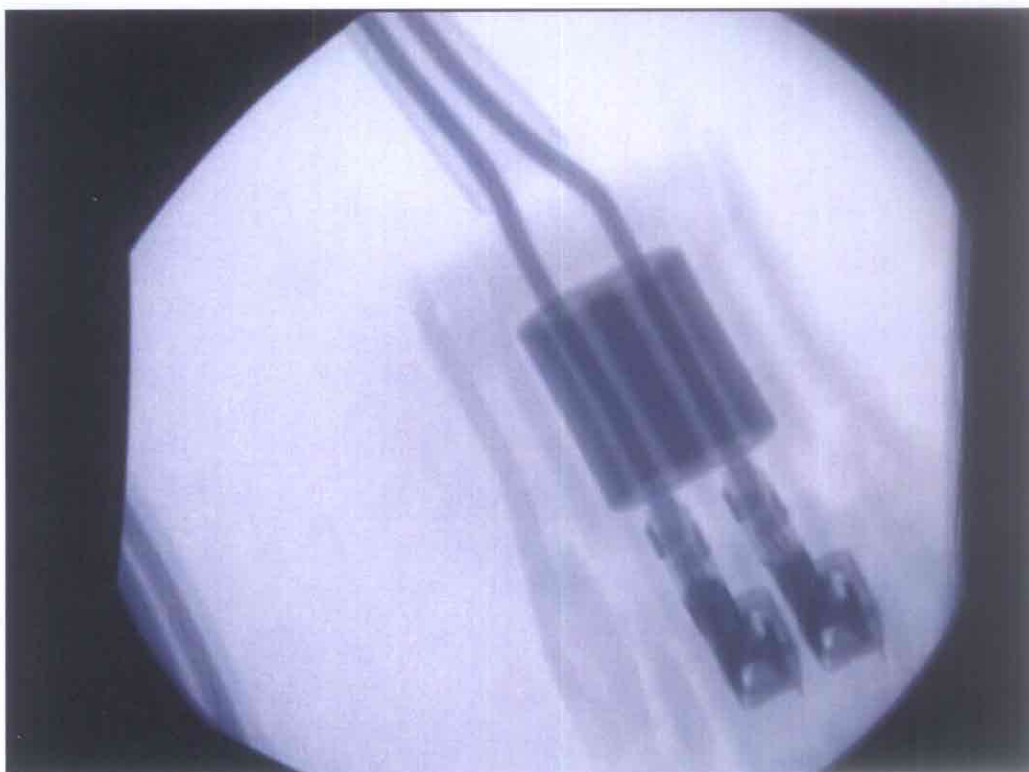
VIN 2C [REDACTED] - No apparent indications of back-winding, kinks in the wire tape or broken connectors were noted.
