GENERAL MOTORS LLC  
Global Interior and Safety Center

NVS-212eer  
PE11-040

This letter is General Motors (GM) response to your preliminary evaluation (PE11-040), dated December 28, 2011, to investigate allegations of failure of the fuel filler pipe on model year (MY) 2003 Chevrolet Express vehicles with a left side passenger door manufactured by General Motors Company, and to request certain information.

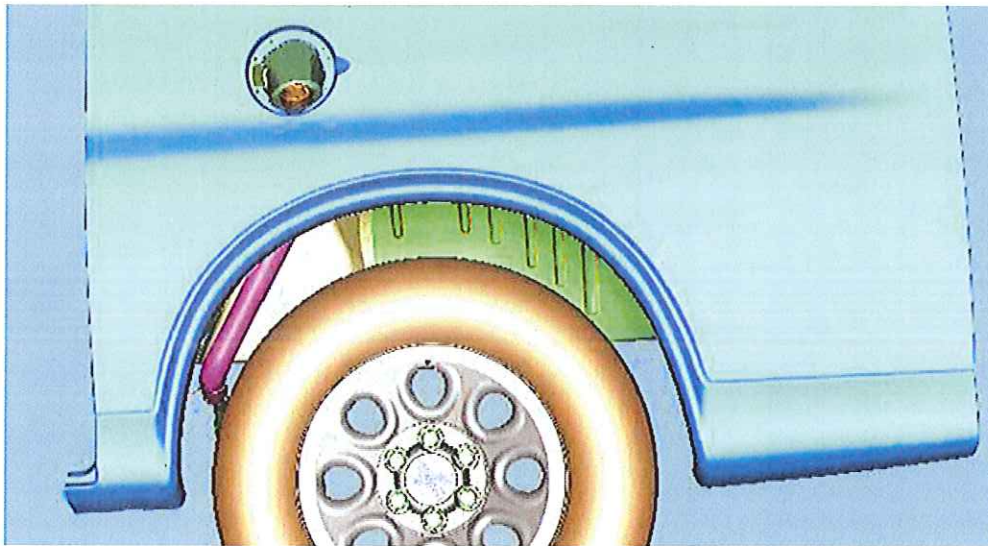
On vehicles equipped with the left side cargo door option, the fuel filler is located above the left rear wheel and routed through the inner wheel well opening to the fuel tank. The filler pipe, and a ground strap that runs the length of the filler pipe assembly, are covered by a protective corrugated plastic conduit that shields the fuel filler pipe assembly from exposure to stones and road debris in the inner wheel well environment.

Figure 12-1: Fuel Filler Pipe Assembly as it appears in the inner wheel well opening

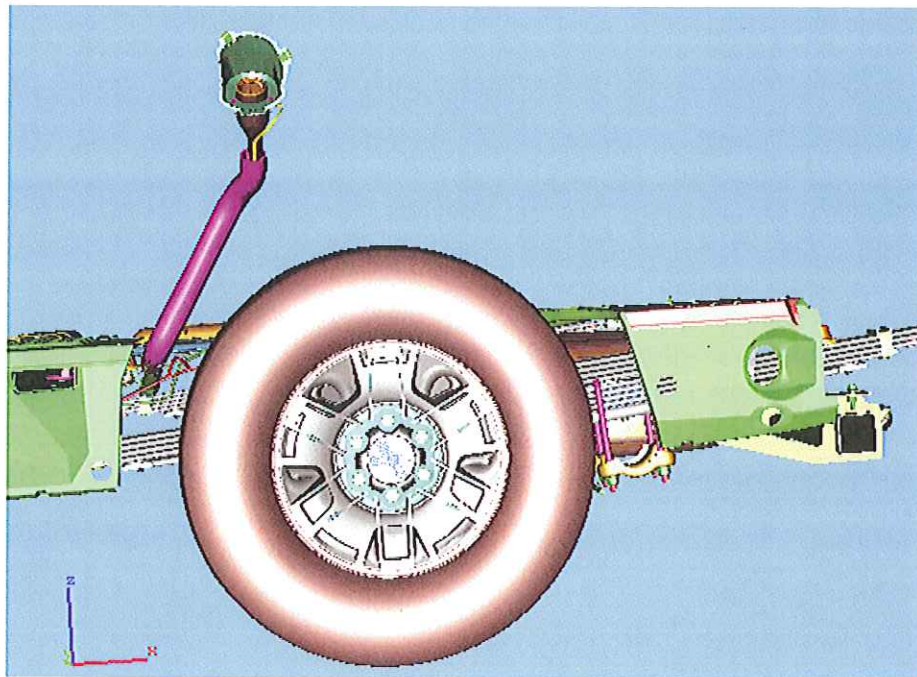
Figure 12-2: Cutaway view of the Fuel Filler Pipe Assembly

Localized corrosion of the steel fuel filler pipe may occur in isolated areas along the length of the filler pipe where the copper ground strap is closely tethered to the filler pipe. The localized corrosion is the result of a galvanic reaction between the copper ground strap and the steel filler pipe, and tends to occur in areas where the strap may be closely wrapped on the filler pipe by the corrugated conduit, tape, or band ties. The condition may be aggravated by relative movement and abrasion of the conduit and ground strap on the pipe, along with water and road contaminants that become entrapped in the conduit. This configuration may result in premature localized corrosion of the steel fill pipe in corrosive environments or certain geographical locations.

Eventually, this corrosion may create a small perforation in the steel fuel filler pipe, through which fuel vapors could pass. At this time, the vehicle operator may notice a fuel odor.
