U.S. Department
of Transportation
**National Highway
Traffic Safety
Administration**

DOT HS 811 573

January 2012

Chevrolet Volt Battery Incident Overview Report

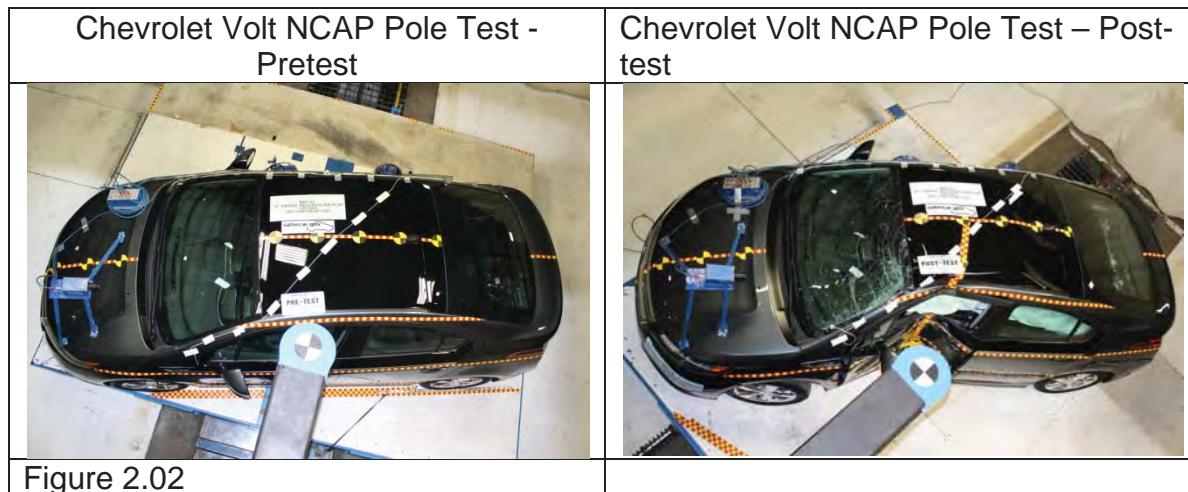
During the NCAP pole test conducted with the 5th percentile female dummy on May 12, 2011 at the MGA test facility (Figure 2.02), the battery was physically damaged by part of the vehicle structure that intruded into the side of the battery. This intrusion, not easily detected by visual inspection, went unnoticed at the time of the test. This intrusion is believed to have produced damage within the battery that eventually led to a vehicle fire three weeks after the test was conducted. See Figure 2.03.

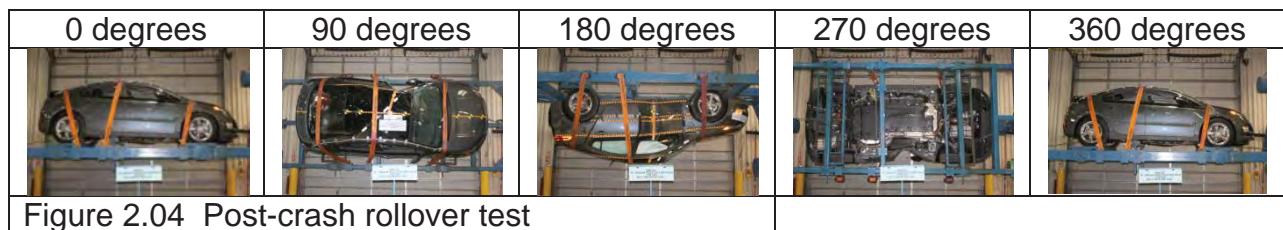
Figure 2.04 Post-crash rollover test

As part of the May 12, 2011 test, FMVSS 301 and 305 test protocols specify a rollover of the vehicle about the longitudinal axis with a 5 minute hold period and each of the 90 degree positions. (0, 90, 180, 270, 360) The purpose of this test is to check for leakage of either liquid fuels or battery electrolyte. Figure 2.04 shows the NCAP pole test vehicle in the rollover positions for this test.

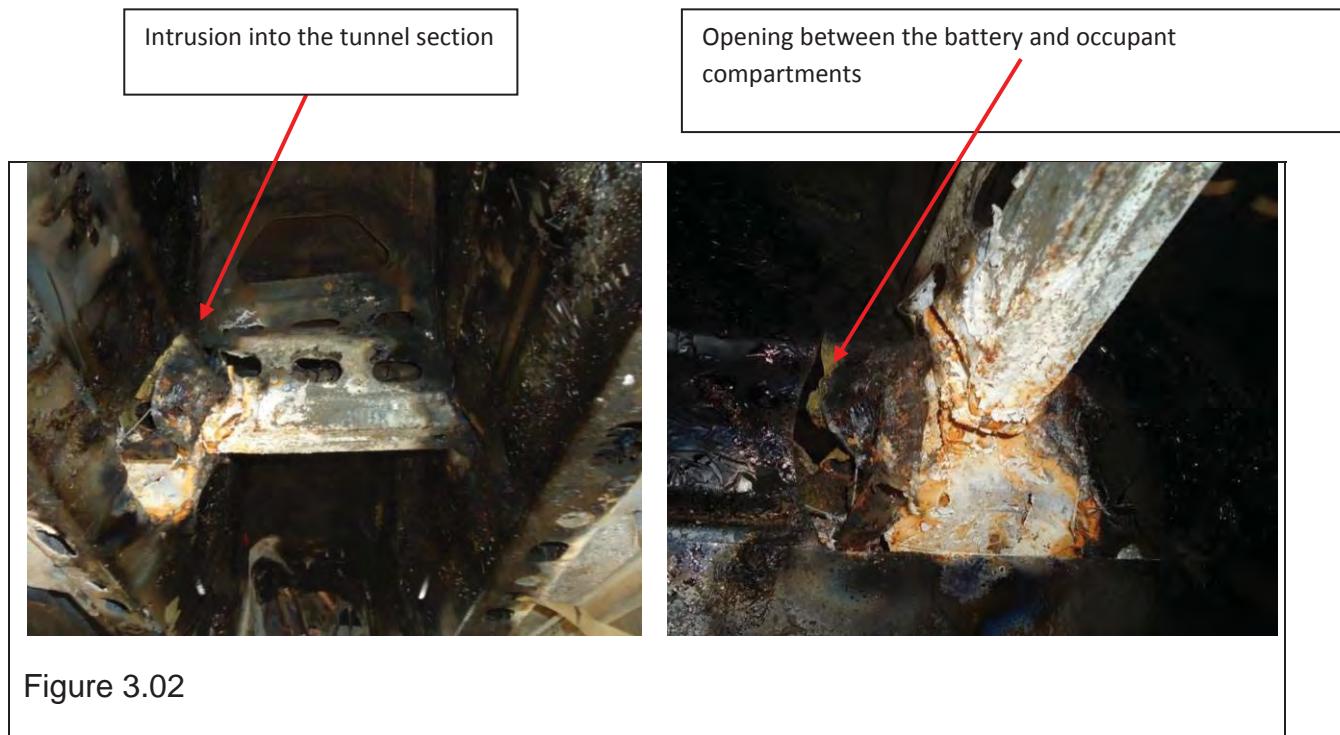
stiffener located under the driver's seat penetrated the tunnel section of the battery compartment (see Figure 3.02), damaged the lithium-ion battery, and ruptured the battery's liquid cooling system. Review of the crash test photographs and video confirmed that battery coolant leaked from the battery compartment. See Figure 3.03. The results of the forensic inspections at VRTC are included in the MGA Incident report.

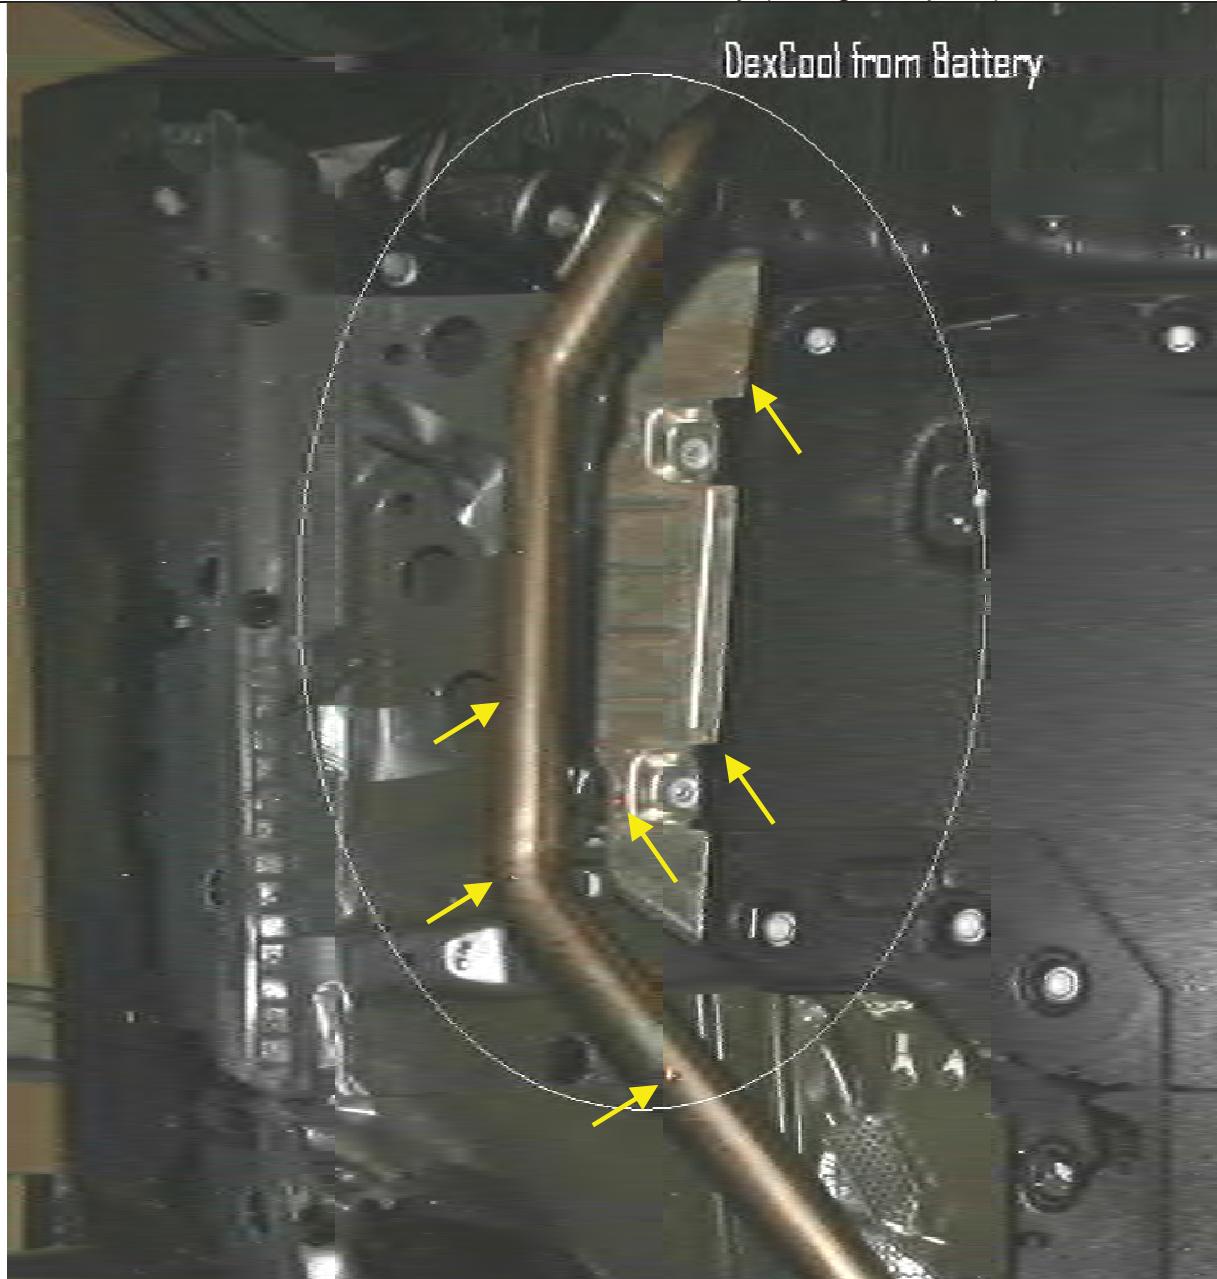
Figure 3.03

Leaked DexCool Coolant from Chevrolet Volt Battery (orange droplets)

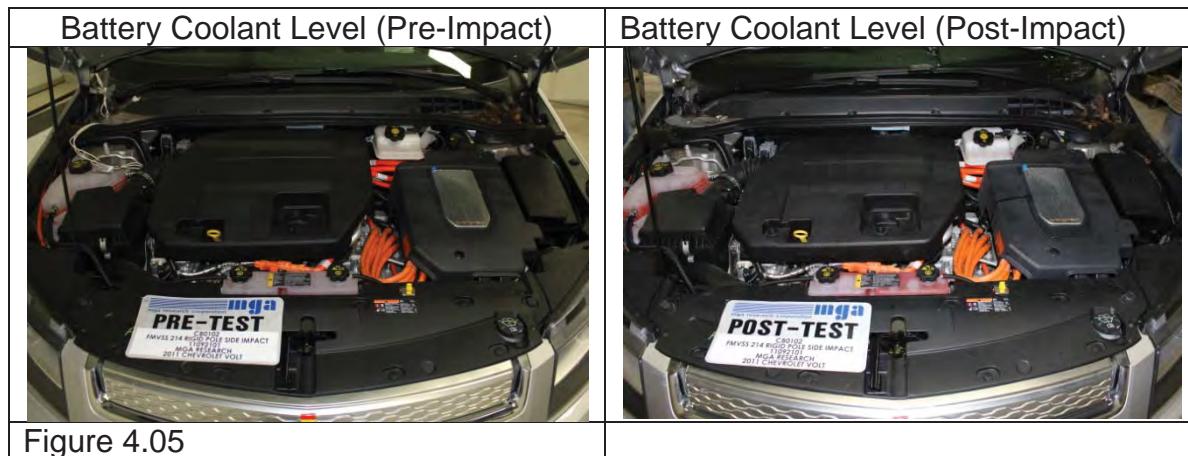
No significant battery deformation or intrusion was observed for the September 21, 2011 crash test. There were no signs of coolant leakage during the crash test or the subsequent rollover test as evidenced by the coolant reservoir level post-test. See Figure 4.05. No thermal or electrical activity was observed in the vehicle or the battery immediately after impact or during the three week monitoring period following the test.

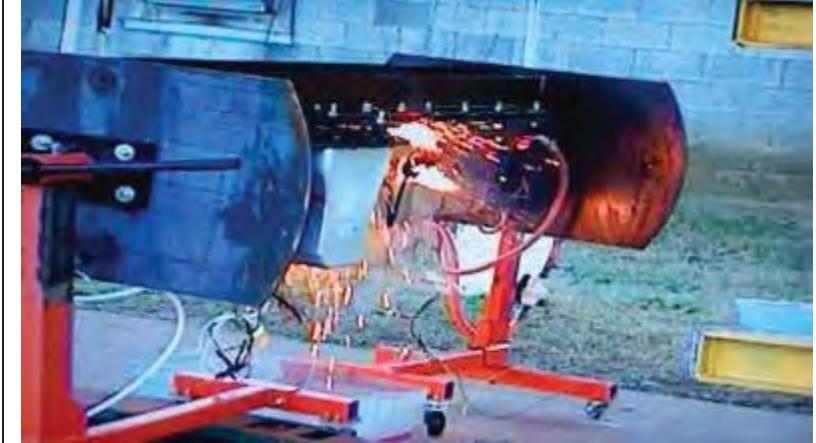
Figure 5.04 Battery 3 Arcing Event

During Test 3, while the battery was inverted, an event occurred resulting in smoke, and finally an arcing event that jetted sparks and flames from the battery housing for about a second. See Figure 5.04.

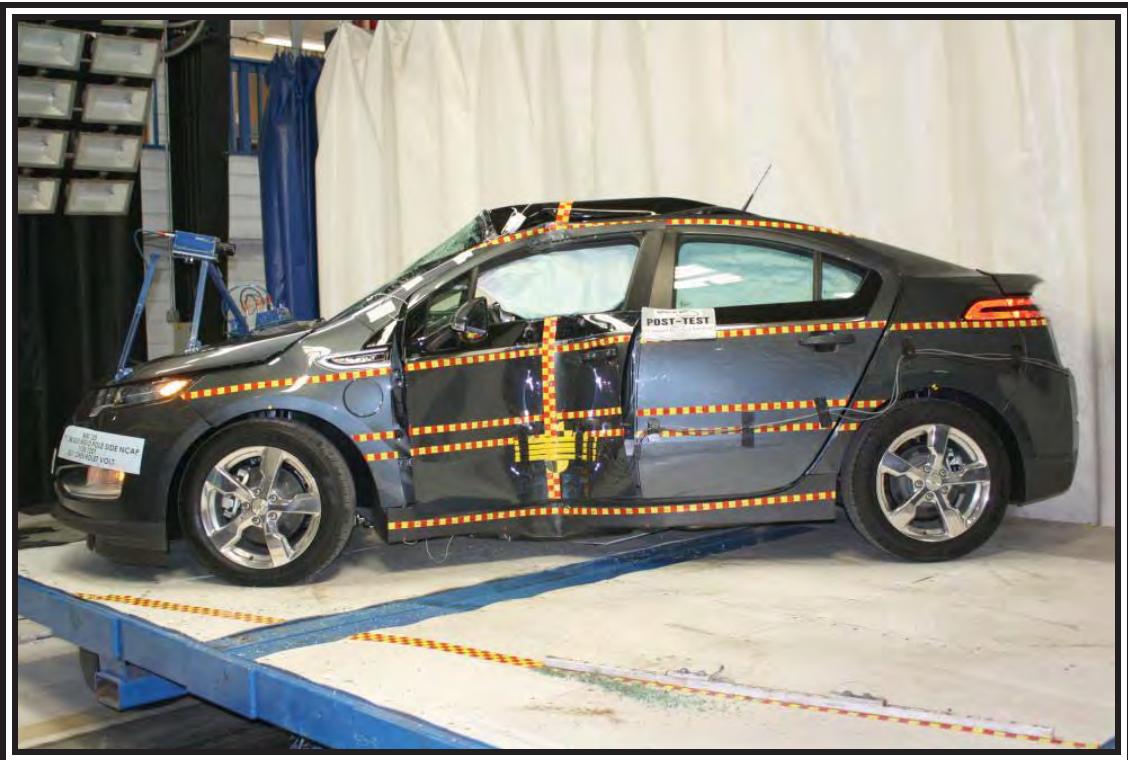
2011 Chevrolet Volt, post-impact, view from the driver's side

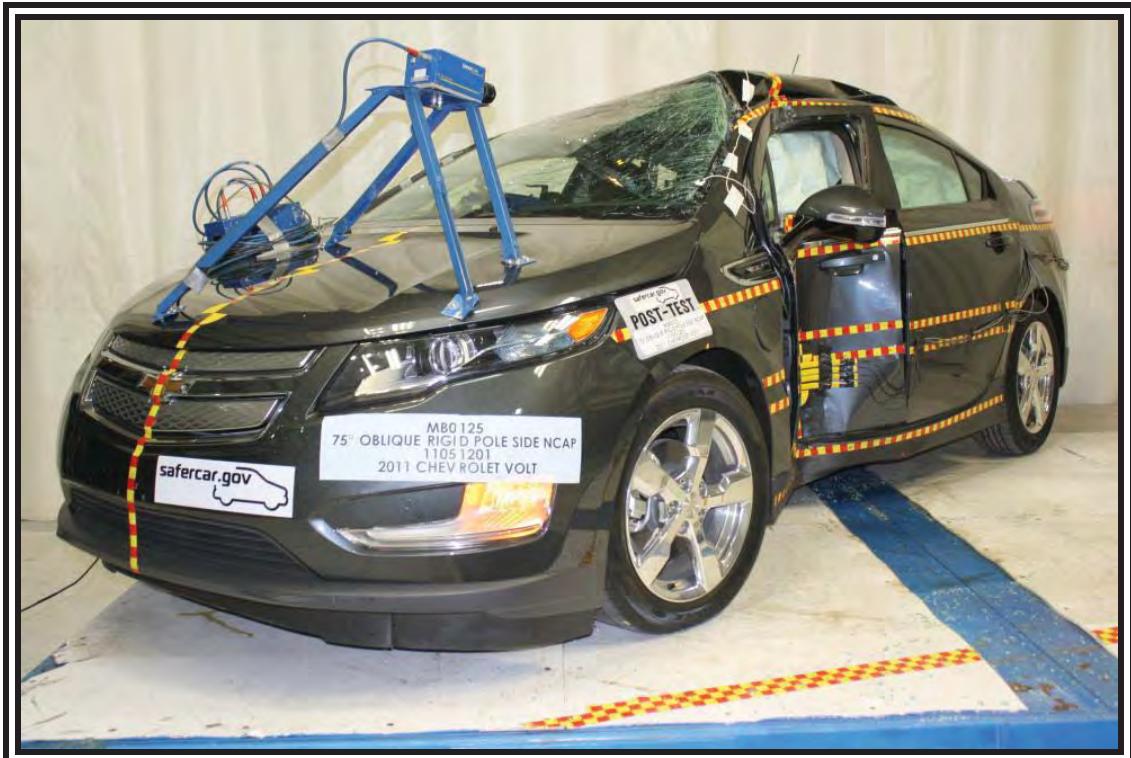
2011 Chevrolet Volt, post-impact, view from the driver's side front

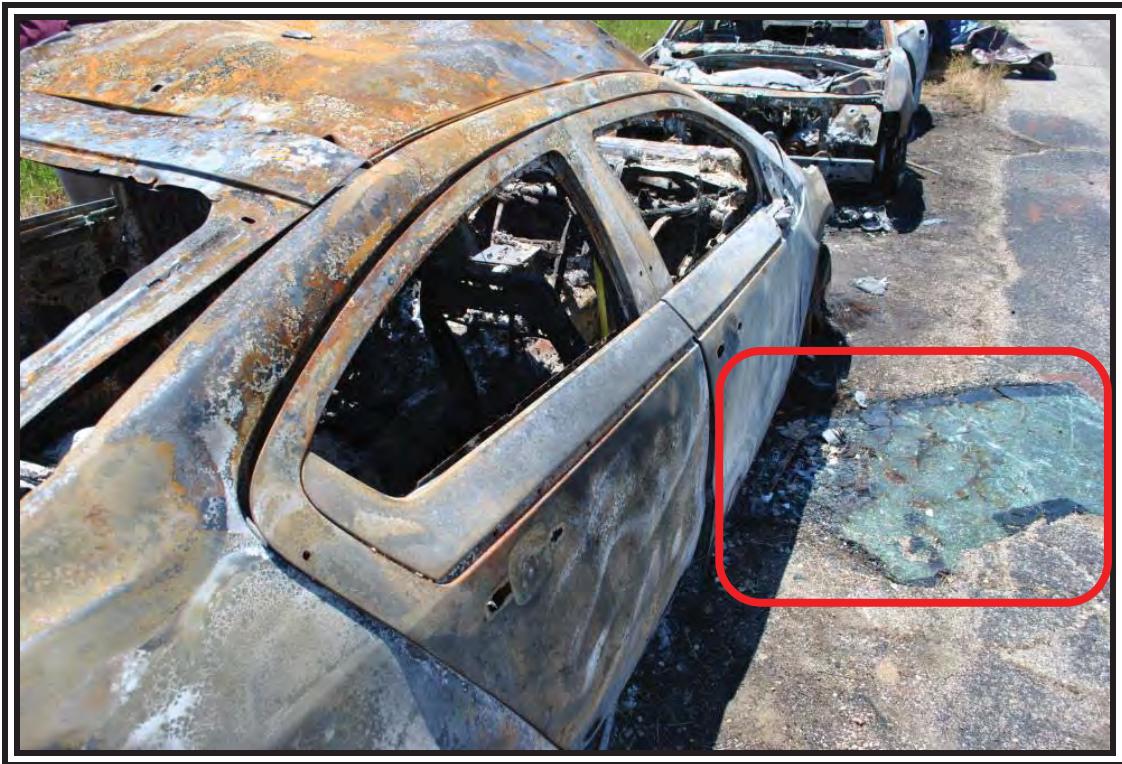
2011 Chevrolet Volt, displaced windshield glass laying face up

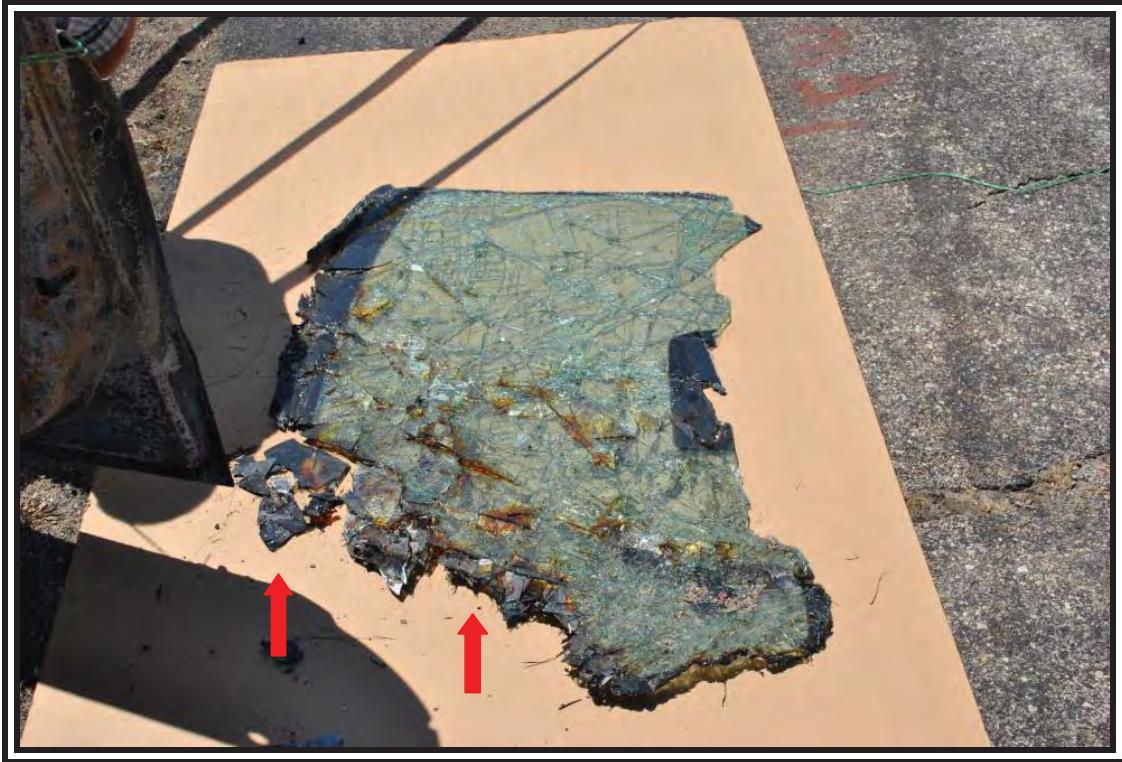
2011 Chevrolet Volt, recovered windshield glass exhibiting thermal damage at contact with burned vehicle

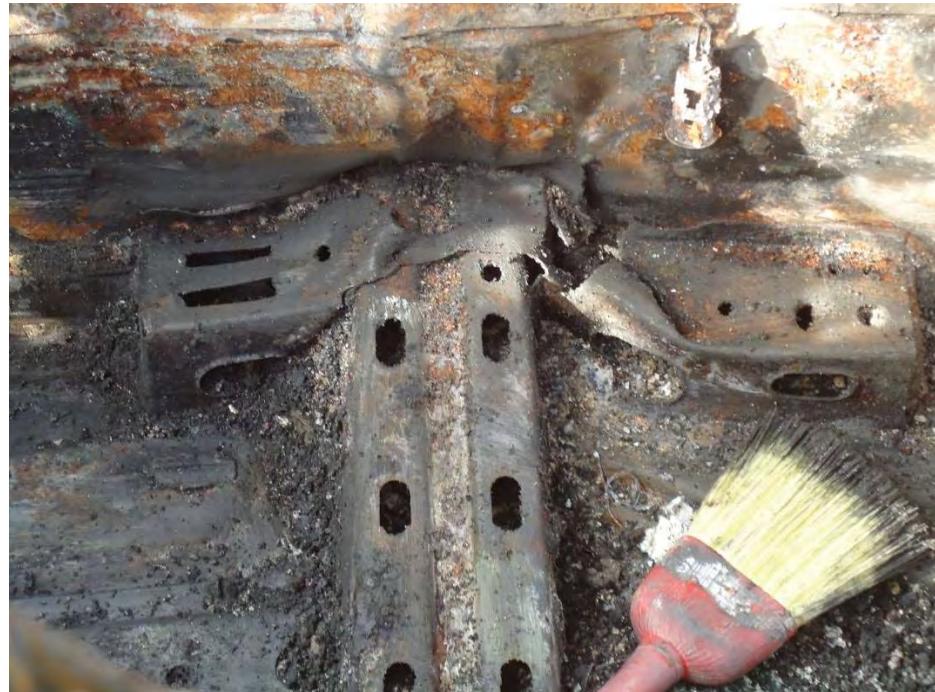
Figure 3.1-2. Crash Test Damage to the Outside of the Battery Compartment (Tunnel Section)

The initial inspection revealed that the transverse stiffener located under the driver's seat had penetrated the tunnel section of the battery compartment and damaged the lithium battery. A photograph of the damage to the outside of the tunnel is shown in Figure 3.1-2.

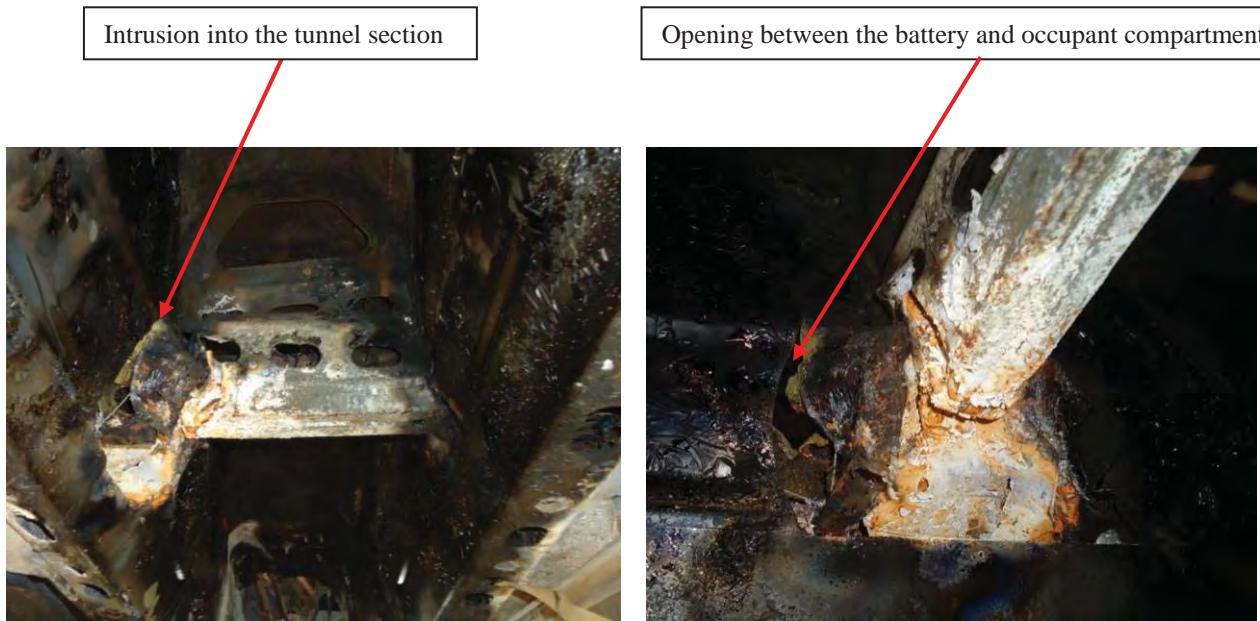
Figure 3.1-3. Crash Test Damage to the Inside of the Battery Compartment (Tunnel Section)

An inspection inside of the tunnel revealed that the transverse stiffener and tunnel structure had been pushed about 3 inches into the battery compartment and penetrated the side of the battery cover. A photograph of the inside of the tunnel section of the battery compartment showing the intrusion is provided as Figure 3.1-3 (left photograph).

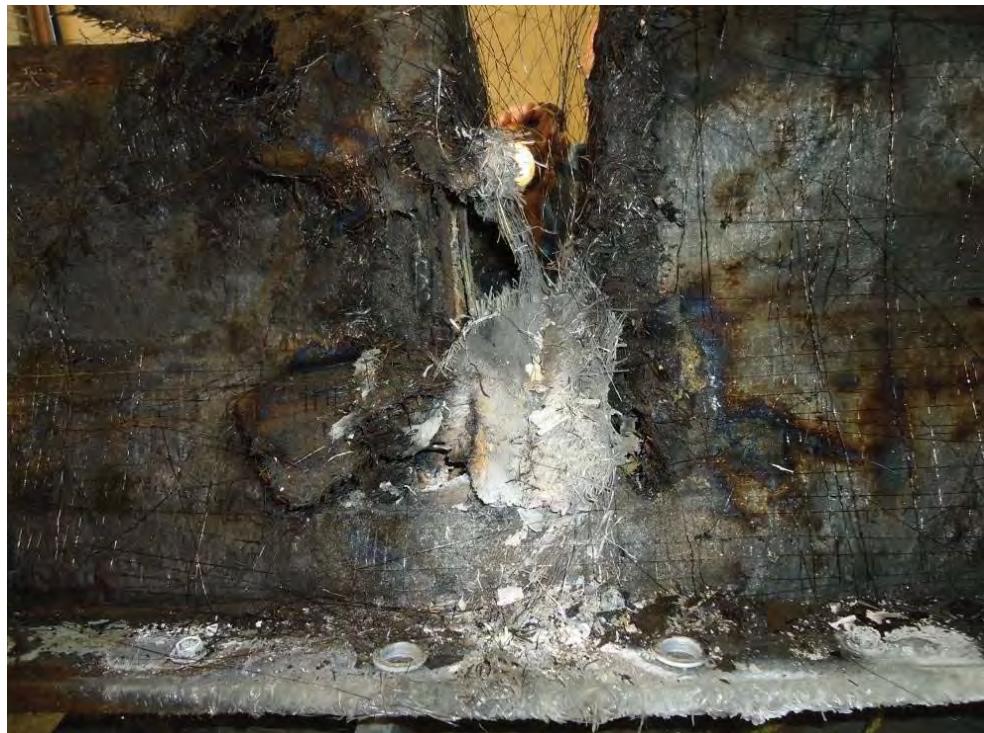
Figure 3.1-4. Battery Cover Damage at the Impact Location

The outer cover of the battery and the battery itself were damaged at this location and exhibited signs of higher thermal exposures. The fiberglass structure had been breached at this location and all of the resin within the structure had been consumed by the fire. This is evident by the white colored glass fibers in the damaged area as shown in the photograph provided as Figure 3.1-4. The battery cells in this area were also physically damaged during the crash test and will be discussed in the following section of this report.

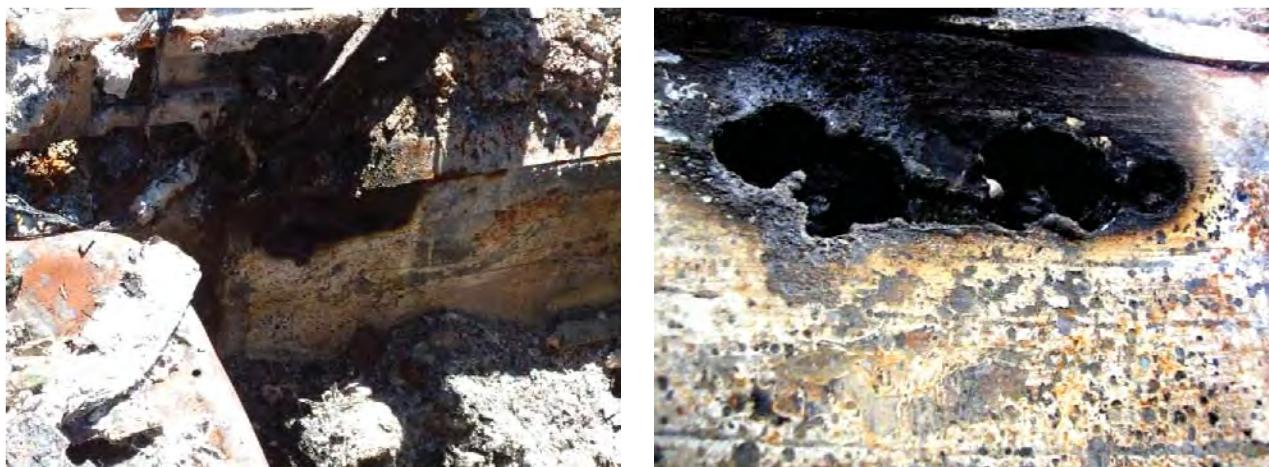
Figure 3.1-5. Holes in the Tunnel Section of the Battery Compartment Produced by Arcing

There were at least seven areas between the occupant and battery compartments that were breached during the event. It was concluded that these holes were produced as a result of the battery arcing (shorting) to the car chassis. It was determined that some of the battery connections had melted off during the fire energizing part of the battery support structure. A photograph of one of these arcing holes is provided in Figure 3.1-5. Additional information of this arcing is provided in the following section of this report.

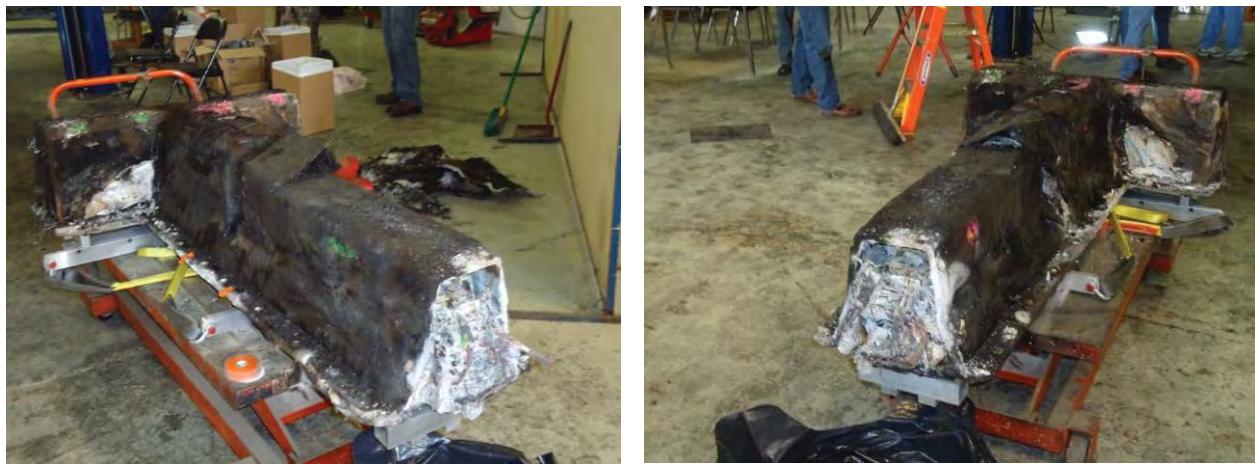
Figure 3.2-1. Battery Cover Photographs

3. All of the visible battery electronic components (wires, circuit boards, etc) were completely consumed by the fire.
4. There were at least seven holes in the battery cover created by arcing between the battery and the car chassis. These areas are indicated by the color spots (green and pink) on the photograph in Figure 3.2-1.

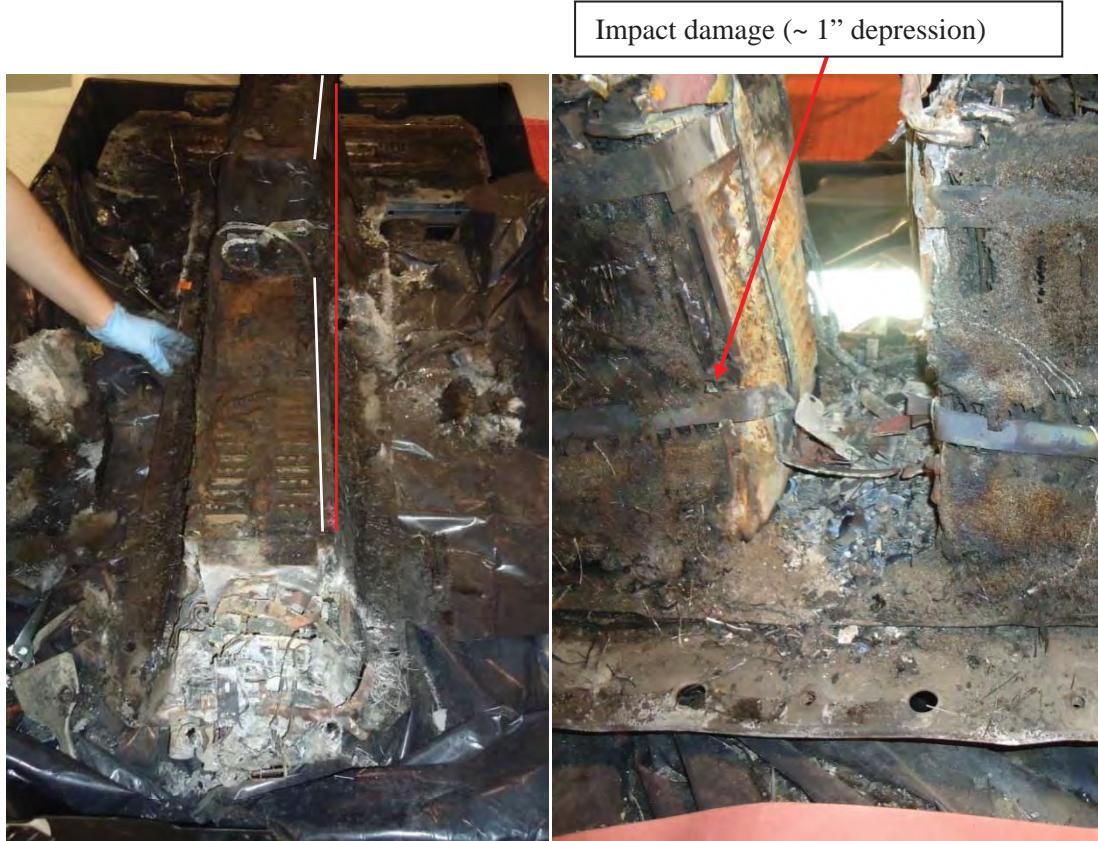
Figure 3.3-6. Physical Battery Damage

As a general observation, all of the visible combustible electronic components (wires, wire insulation, circuit boards, plastic housings, etc) were completely consumed by the fire. There was a limited amount of unburned plastic material located around the cooling line on the sides of the battery. This unburned material was melted and was covered with a layer of char which may have prevented the material from being completely consumed by the fire.

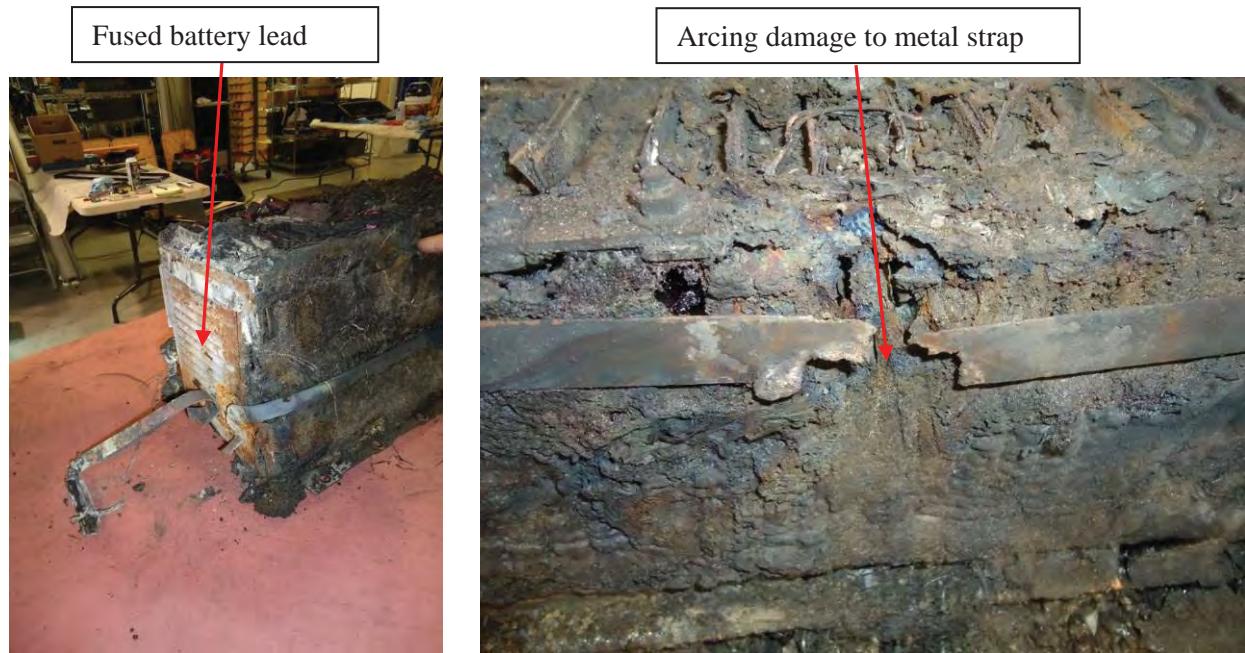
Figure 3.3-8. Typical Arcing Scenario/Remains

There were at least seven areas where the battery had arced to the inside of the battery compartment during the fire. This arcing was the result of the structural metal bands that run around the top of each module becoming positively charged during the fire. There were multiple areas where the battery leads had shorted and fused to this metal band or module end plates once the insulation on the lead had been consumed by the fire. Figure 3.3-8 (left photograph) shows a positive lead fused to the front plate of Module 2. The right photograph shows the damage to the band produced by the arcing. As stated previously, this arcing typically cut an opening into the side of the battery compartment (i.e., an opening between the battery and occupant compartments). This arcing caused the cells to heat-up adding additional energy the overall event.

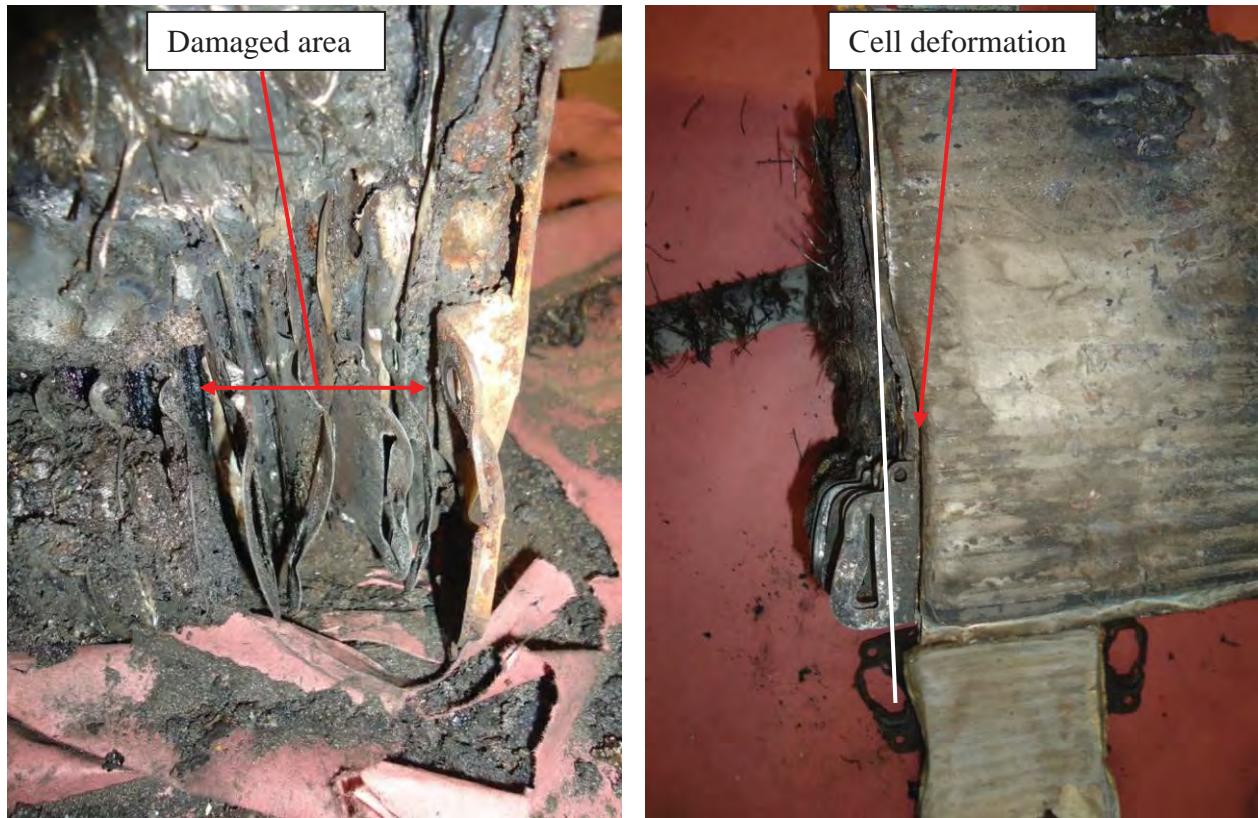
Figure 3.3-9. Side and Front View of Cells 198-204

An inspection of the first few cells (cells 198–204, cooling fins 100–102) revealed that the anode and cathode metallic sheets and the separators had been damaged during the crash test. A side view and front view of this area is provided in Figure 3.3-9. Upon removal of the cells, a distinctive crease was observed in the anode and cathode sheets of these cells and is shown in the photograph in Figure 3.3-10. The cooling fins also showed a similar amount/type of damage.

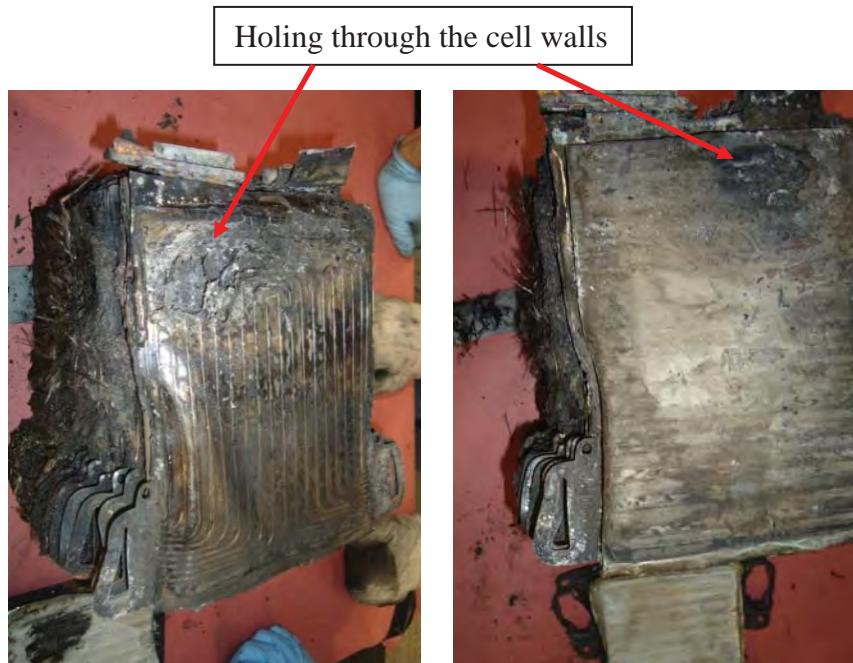
Figure 3.3-11. Remains of Cells 198–204

Even with the advances made by GM/LG on cell construction and chemistries, there is a good possibility that the physical damage to cells 198–204 (i.e., damage to the separator(s) within the pouch cells) that occurred during the crash test produced an internal short within the cell(s) that resulted in the release of flammable vapors (electrolyte) that were eventually ignited and initiated the fire within the Chevrolet Volt.

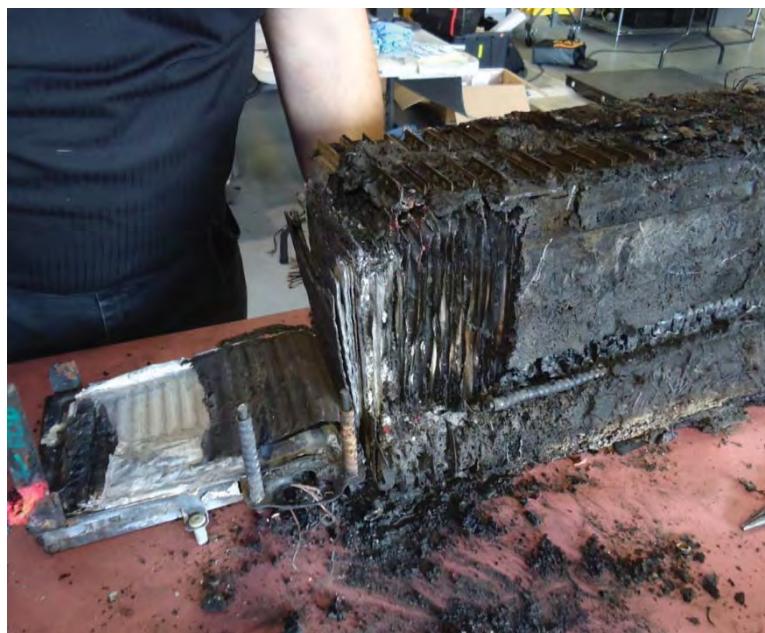
Figure 3.3-12. Side View of Cells 188–197

The initial inspection of battery pack indicated that the last few cells in Module 2 (cells 188–197, cooling fins 94–99) could have been damaged during the crash test. A side view of this area is provided in Figure 3.3-12. Upon removal of the cells, it was determined that the damage to the cell components (anode, cathode and separator) was superficial and did not appear to have caused an internal short within the cells; although the cells did undergo a thermal reaction during the event.

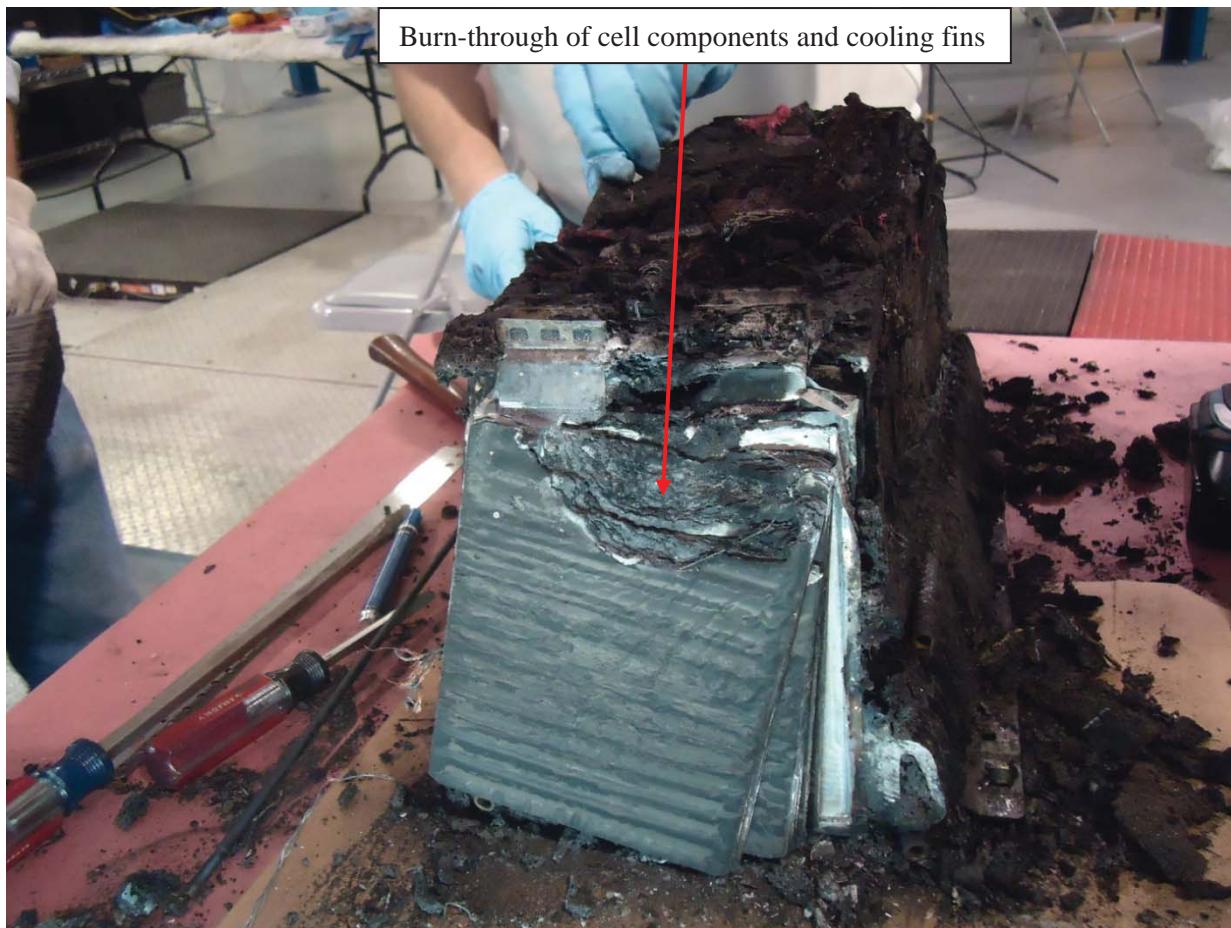
Figure 3.3-13. Remains of Cells 188–197 (“V” pattern)

The cells at the front end of Module 1 and both ends of Module 3 also had “V” shaped burn patterns similar to the one shown in Figure 3.3-13. Consistent with the findings of the previous discussion, these patterns were likely caused by external heating from a fire burning at these locations. Although these reactions were most likely caused by an external short, these are still considered to be “cell level” reactions since the current collector sheets were burned completely through at these locations.

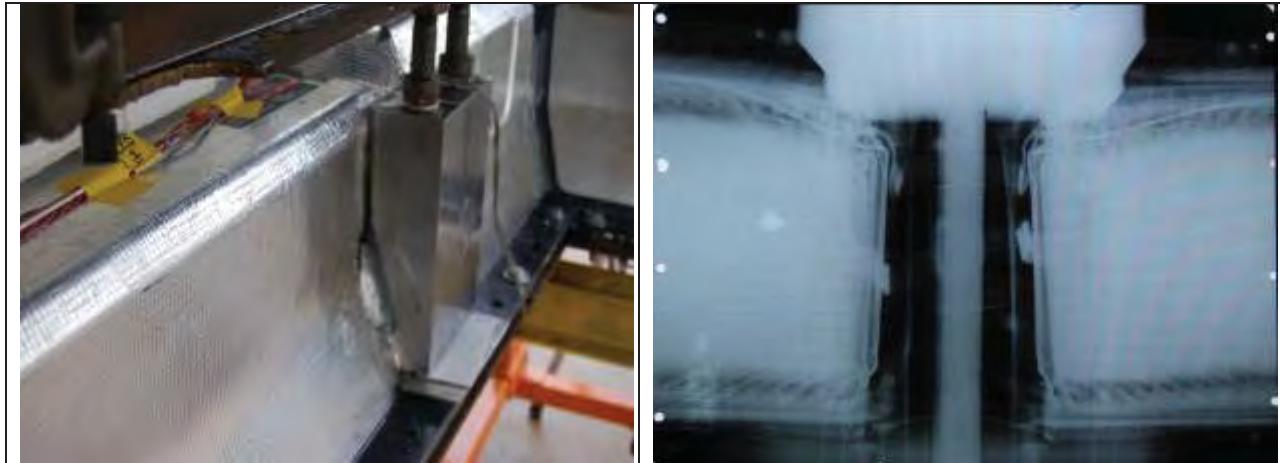
Figure 7.1 - Test 1 Battery Damage and X-Ray

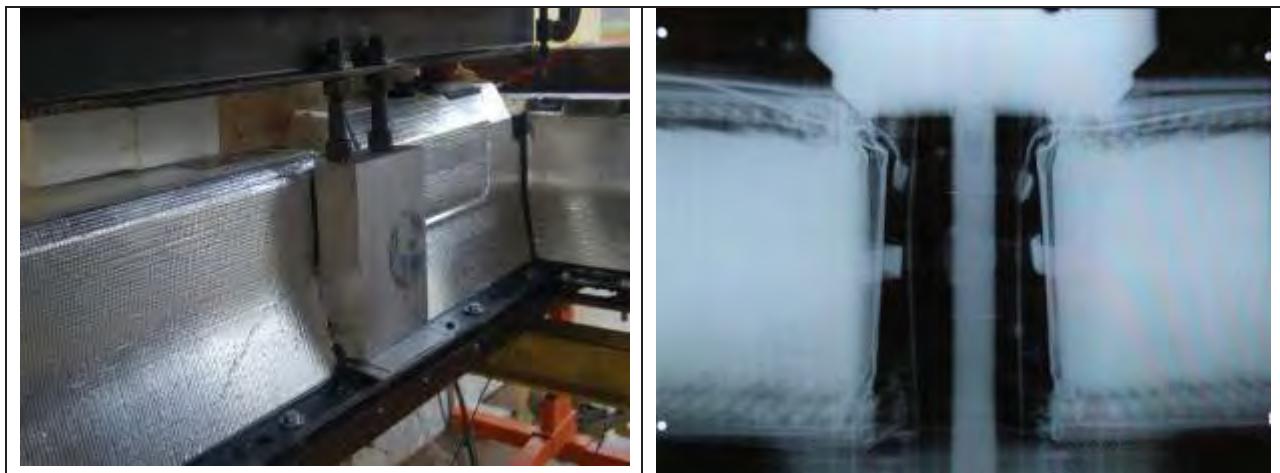
Figure 7.2 - Test 2 Battery Damage and X-Ray

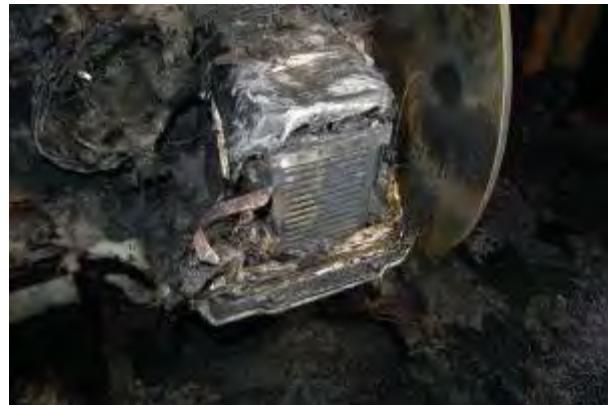
Figure 7.7 – Photograph Showing Cover Damage on the Driver's Side end of Module 3

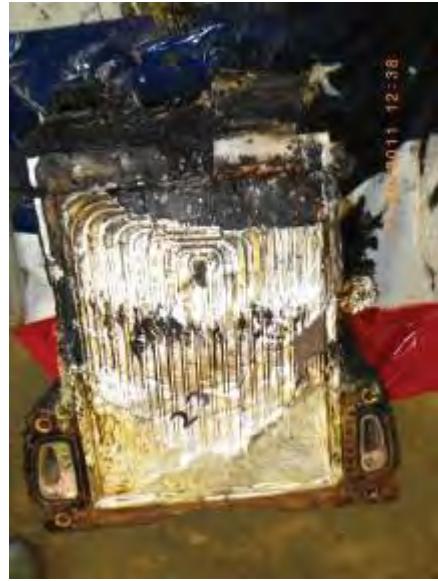
Figure 7.9 – Photograph Showing Cell Level Damage within Module 3

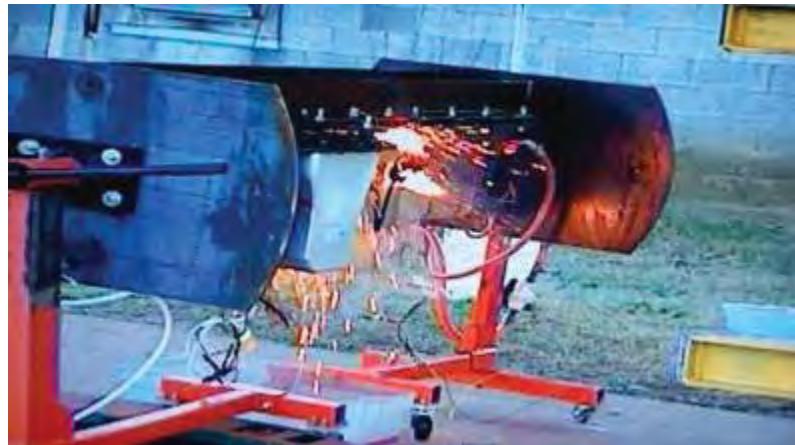
Figure 7.11 – Photograph Showing Flames and Sparks from Test 3 Battery

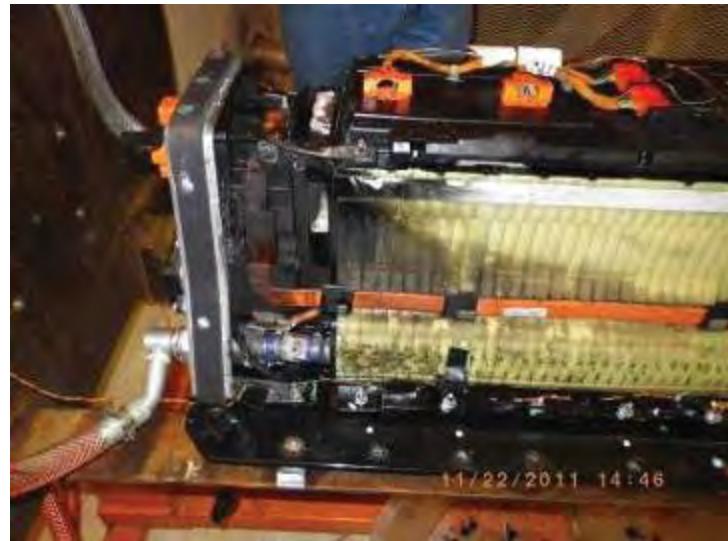
Figure 7.13 Arcing Damage to the Front of Module 1

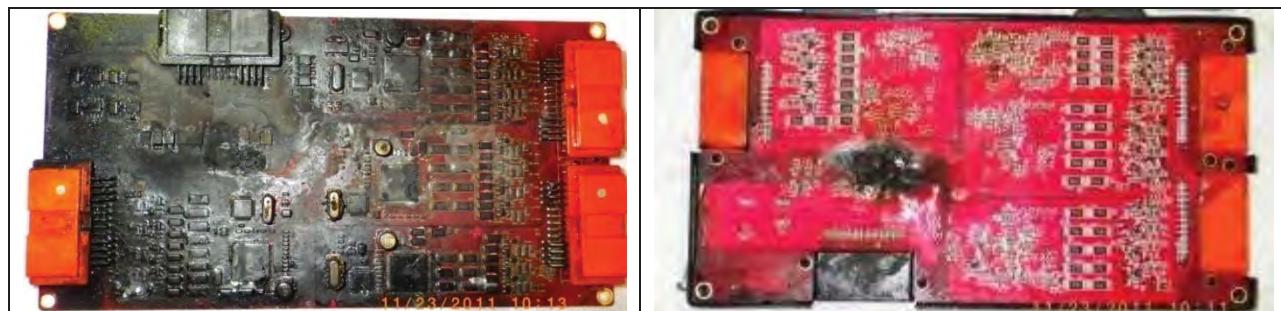
Figure 7.14 Arcing and Heating Damage to VTSM 1

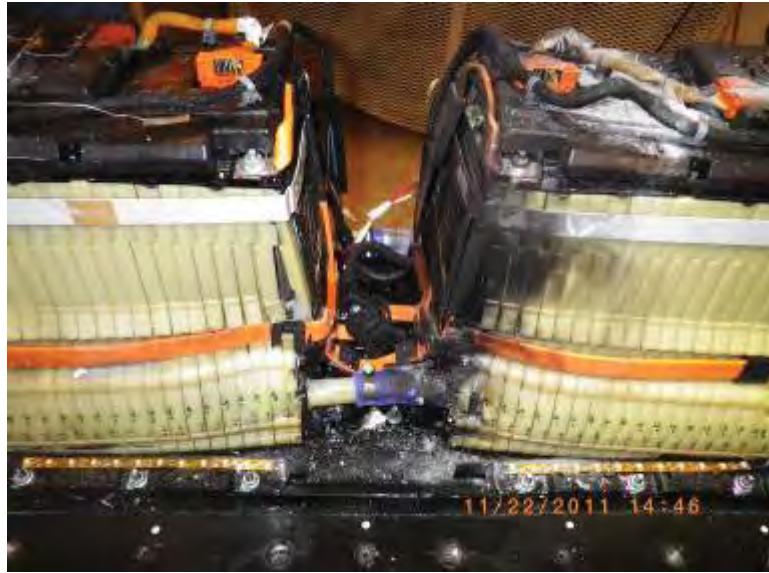
Figure 7.15 Arcing Damage to the Front of Module 2

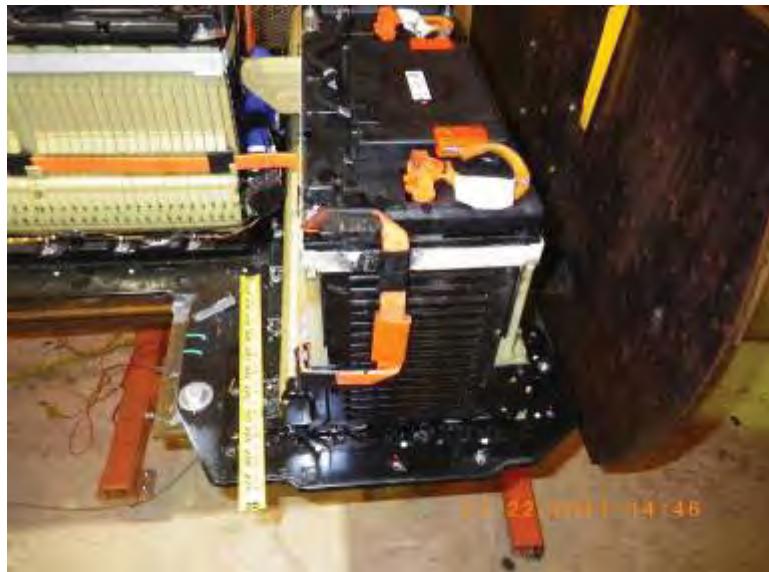
Figure 7.16 Arcing Damage at the Driver's Side End of Module 3

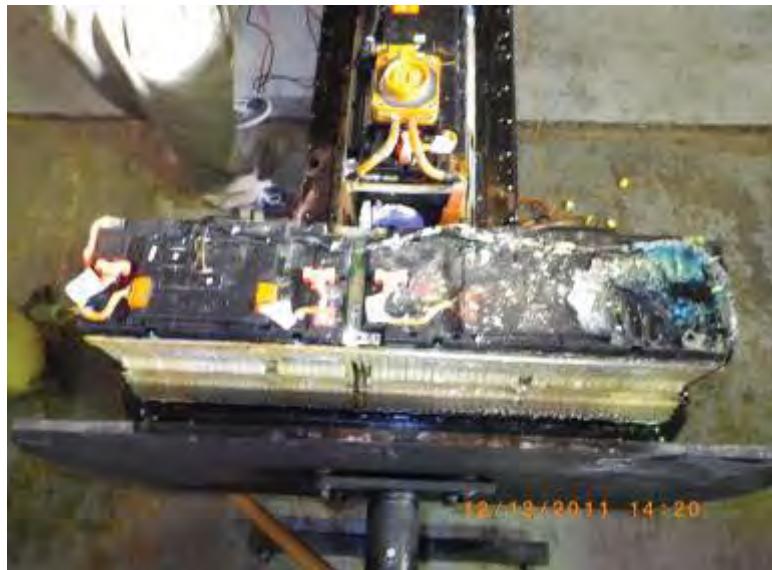
Figure 7.14 Fire Damage to Passenger Side End of Module 3

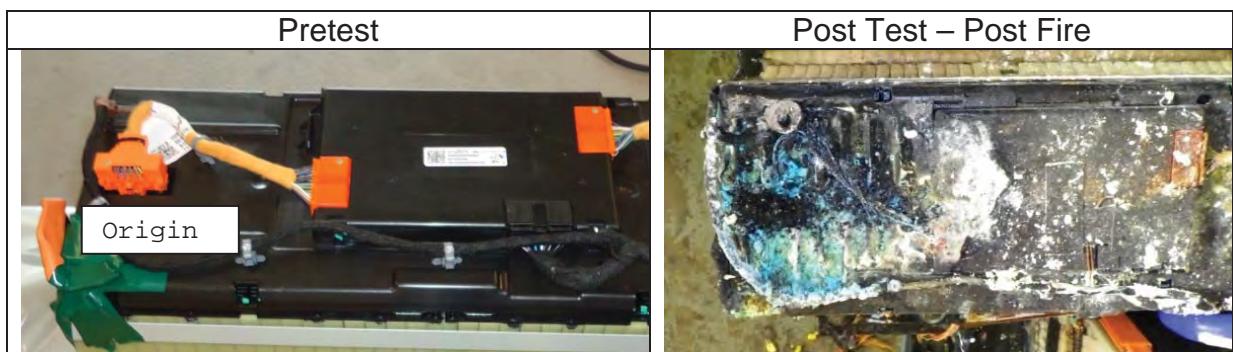
Figure 7.15 Fire Origin of Test 5 – Passenger Side End of Module 3
