U.S. Department
of Transportation
**National Highway
Traffic Safety
Administration**

DOT HS 811 573

January 2012

Chevrolet Volt Battery Incident Overview Report

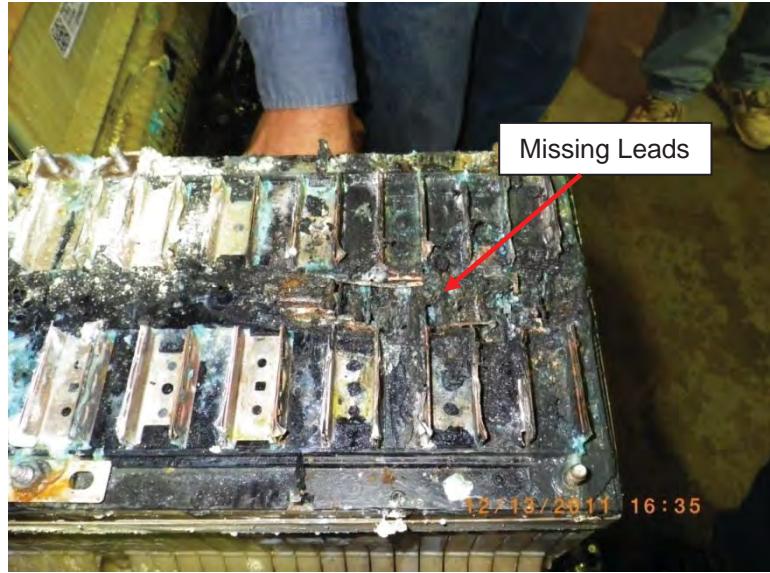
Figure 7.17 Fire Damage to the Bus Bar Leads
