# ODI RESUME

**Investigation:** EA 12-007  
**Prompted by:** PE12-007  
**Date Opened:** 09/13/2012  
**Investigator:** Ric Willard  
**Approver:** Frank Borris  
**Subject:** MCI Drive Shaft Safety Loop Failures

**Problem Description:** In the event of a drive shaft failure, the separated drive shaft is not adequately contained and can cause a loss of vehicle control.

## **1992-2012 MCI D-Series Bus Driveshaft Failure**

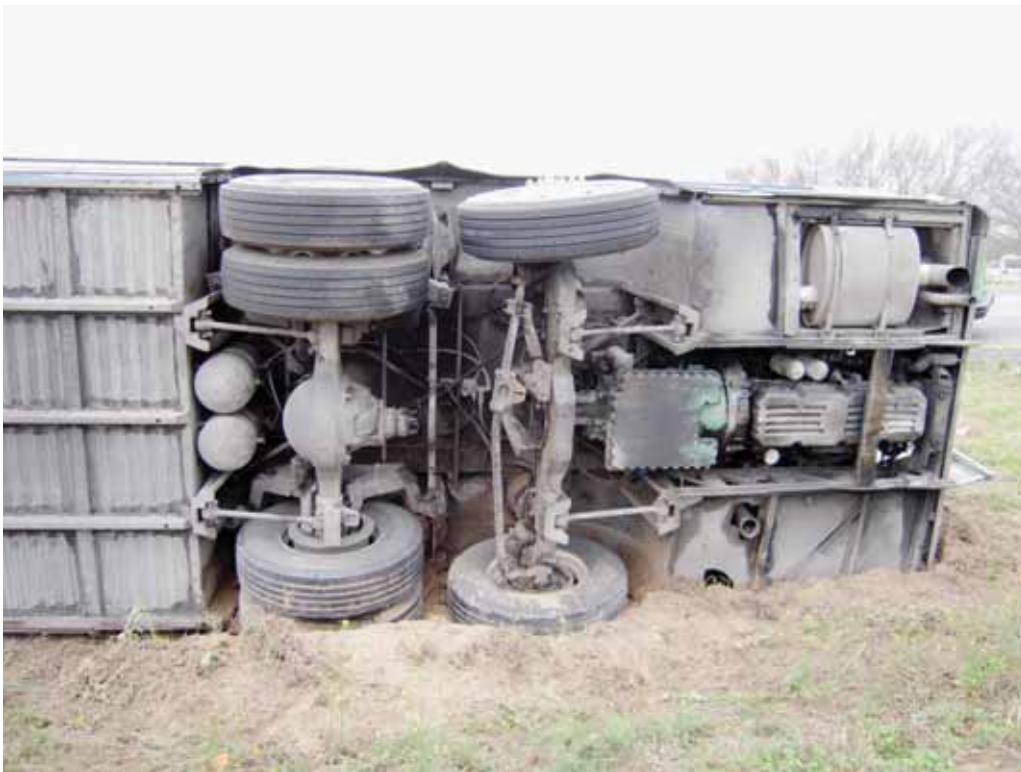
This photo in Figure 27<sup>9</sup>, taken by the DPS team, illustrates that the rear tag axle tires are drawn into a toe-in condition that was hypothesized and later proven to be capable of producing the single tire mark evident at the initiation of the marks leading to crash site. The first strikes to the tie rod from the disconnected rotating driveshaft bent the tie rod inward and pulled (in tension) the leading edge of the wheels towards each other. In a normal toe-in condition, the directional forces created by each tire will balance out to a relatively neutral state. However, this bus design incorporates a latching mechanism on the tie rod near the left wheel that prevents it from toeing-in and causes the right wheel to turn inward with approximately twice the angle. The right wheel remained toed-in until subsequent driveshaft strikes overcame the latching plates, which effectively rendered the rear tag axle free to swing from uncontrolled inputs. Reproductions of the single tire marking were later reproduced by VRTC using the fabricated pneumatic quick change toe-in tie rod that is shown in Section 4 of this report.

**Figure 27- Americanos 60630 Crash Scene Bent Tie Rod**

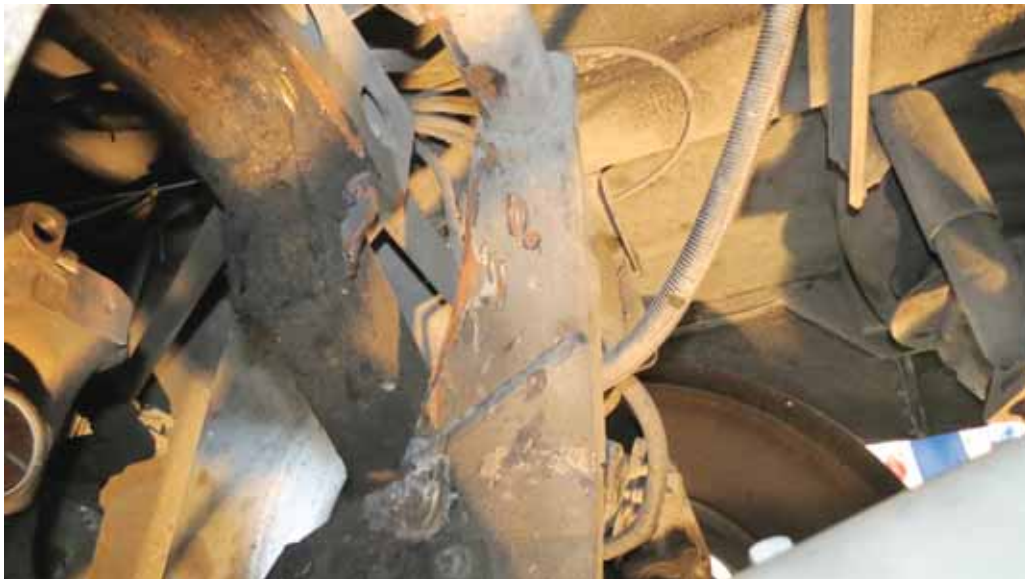
The initial tag axle inspection showed damage to multiple areas of the inner structure where the driveshaft passes through, and it revealed considerable impact and bending damage to the caster arms and latching tongue assembly, as shown in Figures 29 and 30. The bent latching tongue clevis in Figure 30 and the witness marks on the safety catch hoop indicate the axle rolled forward into a reversed caster position while in forward travel.

**Figure 29- Americanos 60630 Impact Damage to Tag Axle Caster Arms**

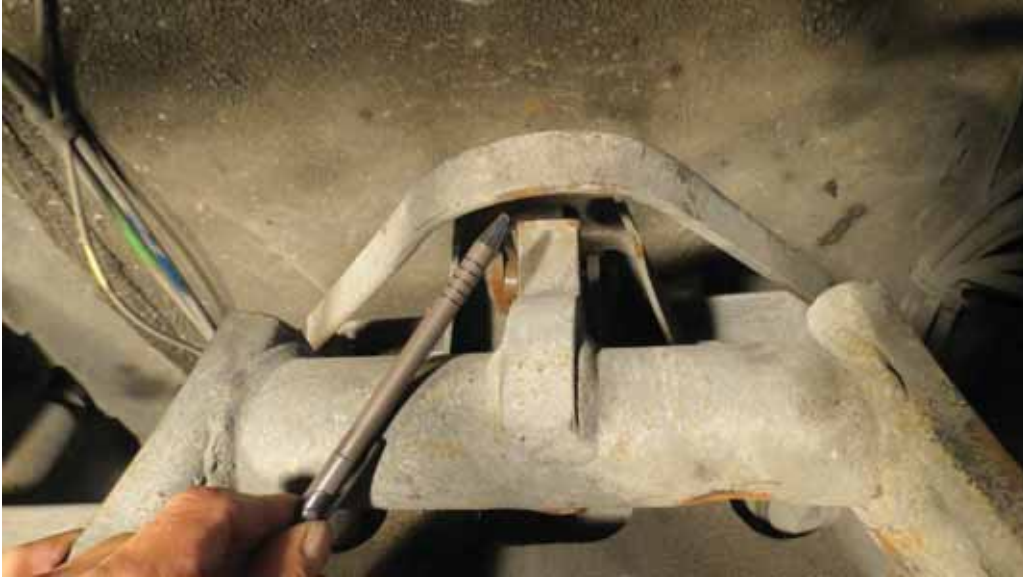
**Figure 30- Americanos 60630 Bent Caster Clevis and Witness Marks on Safety Catch Hoop**

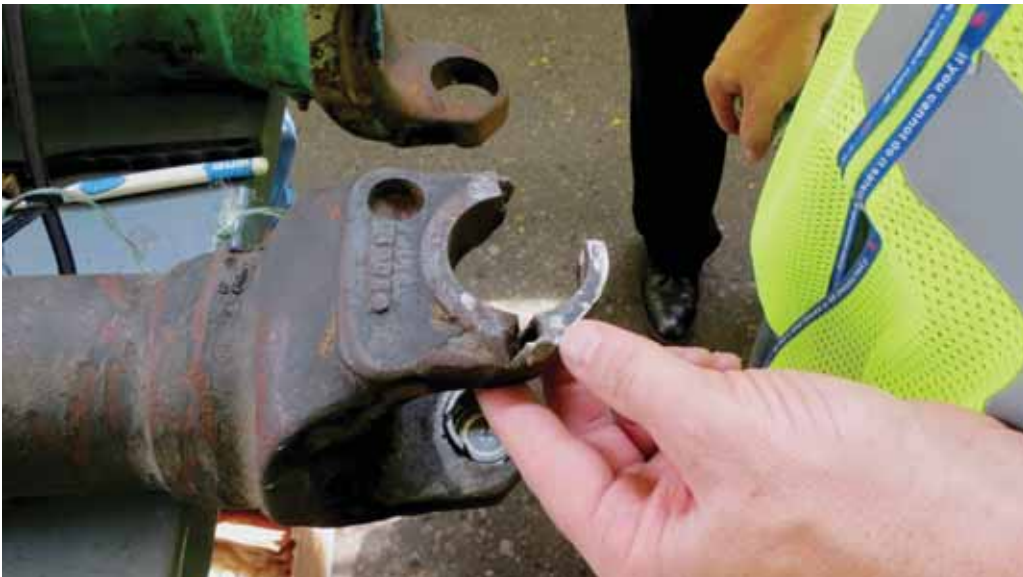
The driveshaft was found to have a fractured bearing journal ear, shown in Figure 31, and it was matched to an evidence piece found on the roadway towards the beginning of the tire markings at the crash scene, indicating that this component failed at some point prior to the crash.

**Figure 31- Americanos 60630 Driveshaft Fractured Piece Mate**

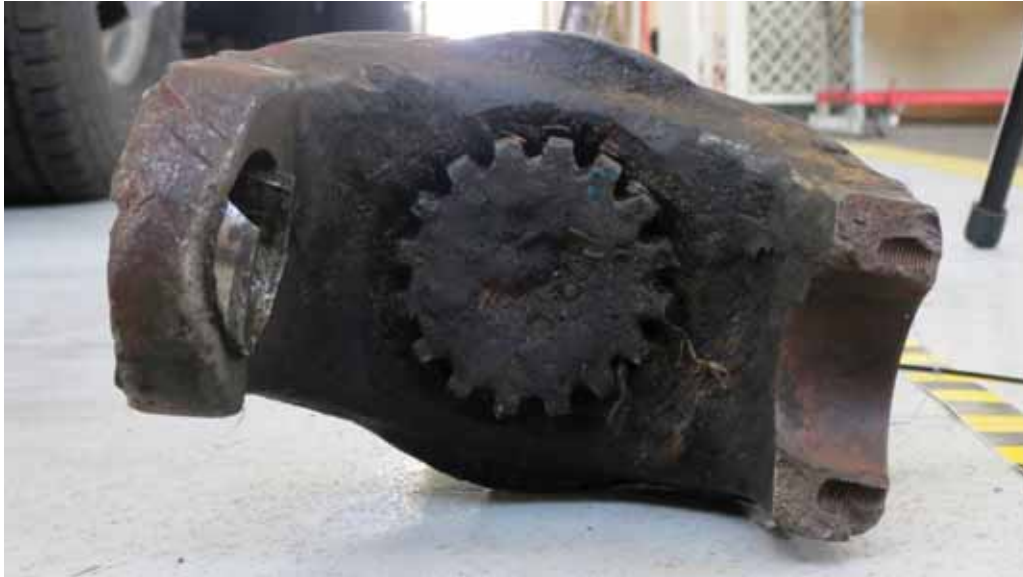
The telescoping driveshaft was also found in an over-compressed state, shown in Figure 32. It was determined the over-compression between the two telescoping components occurred as the end of the driveshaft wedged against the front face of the main axle beam. The witness

**Figure 32- Americanos 60630 Over-Compressed Driveshaft**

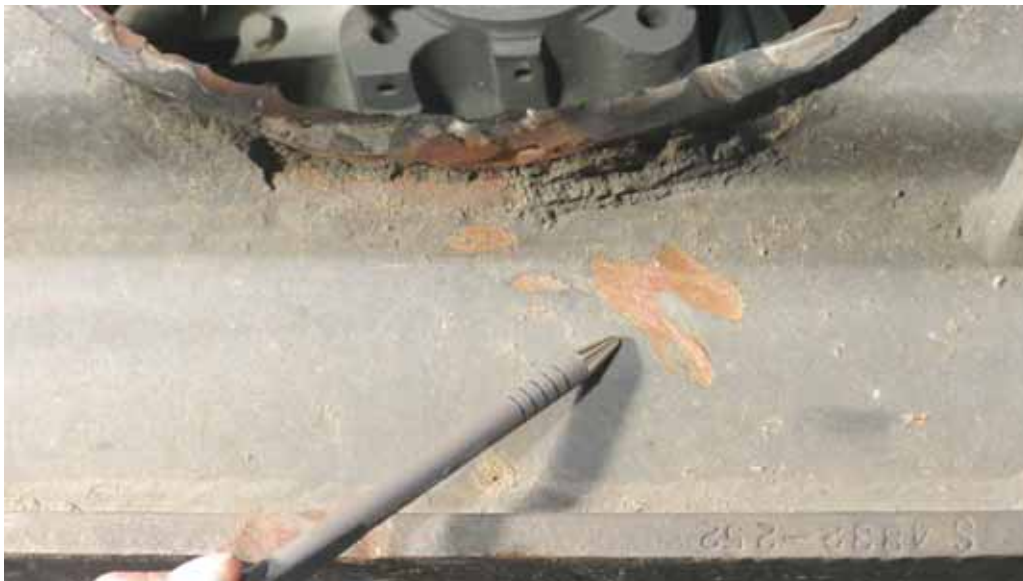
marks can be seen in Figure 33 and show deep gouge marks and displacement of metal as the rotating end of the shaft wedged against the face of the main axle beam as it escaped.

**Figure 33- Americanos 60630 Driveshaft Escape Gouging Marks**

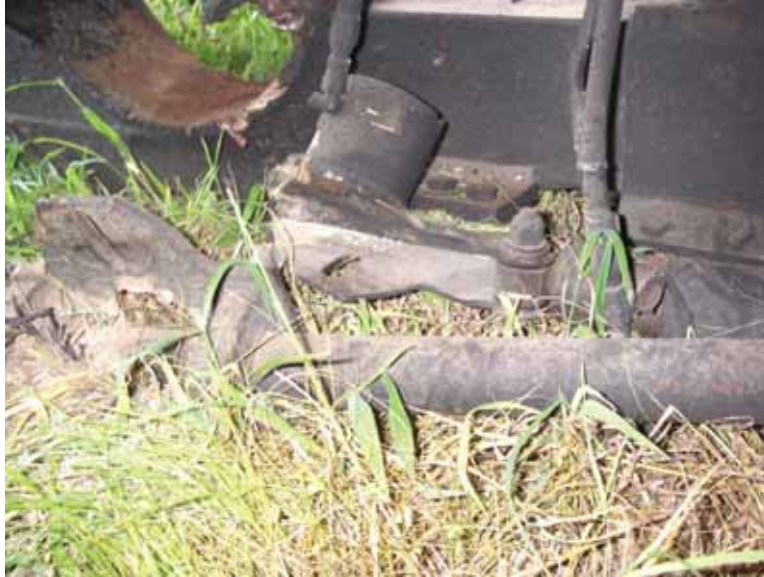
The inspection revealed the bus tag axle tie rod displayed the same tension bent signature with impact marks and a damaged latching mechanism, shown in Figure 37. Damage patterns were substantially similar, particularly with the pneumatic latching cylinder and the steel latching plates that were levered into failure as the tie rod was being bent.

**Figure 37- Greyhound 6352 Impact Damaged Tie Rod and Latch**

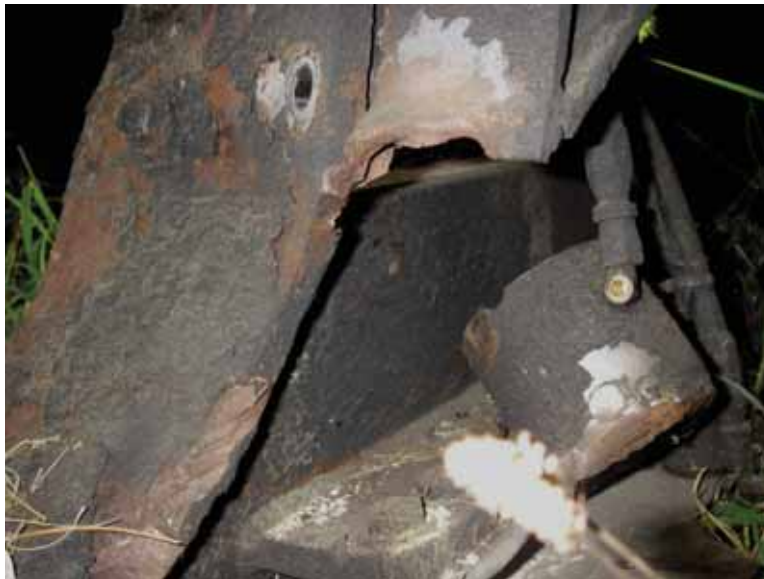
Some of the impact mark signatures and resulting damage to the tag axle caster arms and inner structure of the pass-through can be seen in Figure 38. These witness markings and damage were comparable to what was found on the Americanos 60630 crash evidence.

**Figure 38- Greyhound 6352 Impact Damage to Tag Axle Caster Arms**

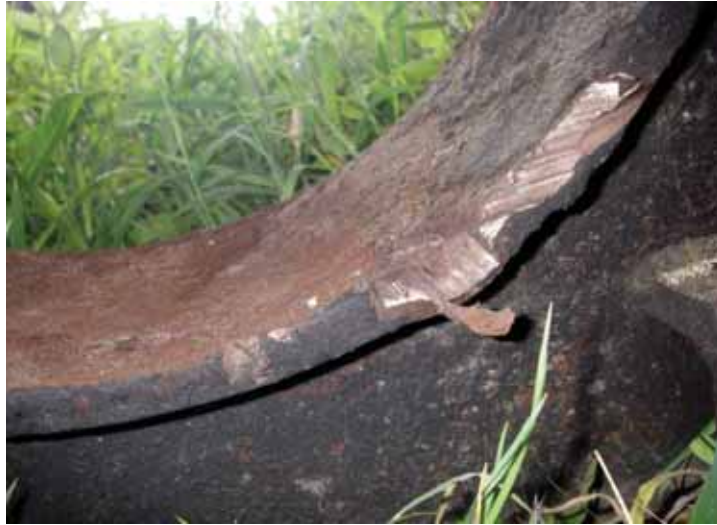
Metal gouging and displacement markings, shown in Figure 39, show the exiting path of the flailing driveshaft at the mouth of the pass-through directly above the tie rod. This type of damaged was typical in comparison to the Americanos 60630 tag axle structure. Witness marks on the front face of the main axle beam indicated the driveshaft wedged against the face and over compressing the driveshaft tubes, similar to the Americanos 60603 crash.

**Figure 39- Greyhound 6352 Impact Damage as Driveshaft Escaped Pass-Through**

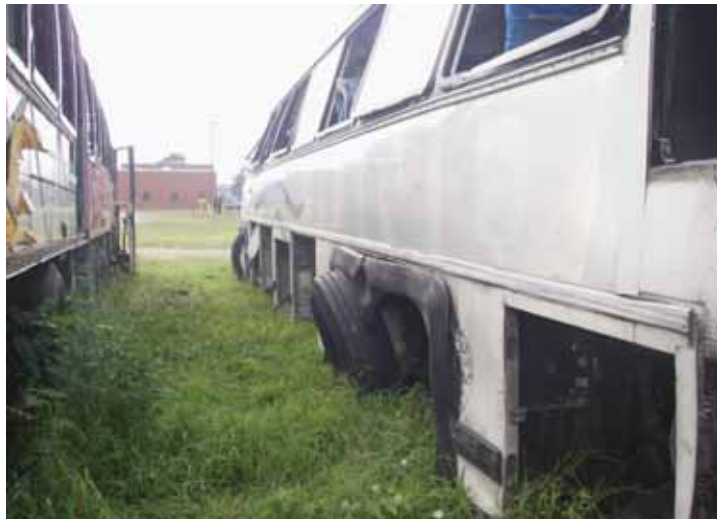
An image of the bus's deflated left outside drive dual tire can be seen in Figure 40. Note the minimal body damage on the left hand-hand side of the bus, with no side lateral distortion of the rear axles. This contradicted speculation that the tag axle was pushed laterally and caused the v-shaped bend in tie rod. Rather, the outer left drive axle wheel and tire assembly would have been the contacting point at the rear of the bus on the barrier because it extends beyond the tag wheel and tire assembly; this hypothesis is supported by the deflation of the drive axle tire. With the left drive wheel deflated, more load and therefore more controlling force would be transferred to the now free-steering tag axle when the tie rod was released.

**Figure 40- Greyhound 6352 Deflated Outside Drive Tire Damage**

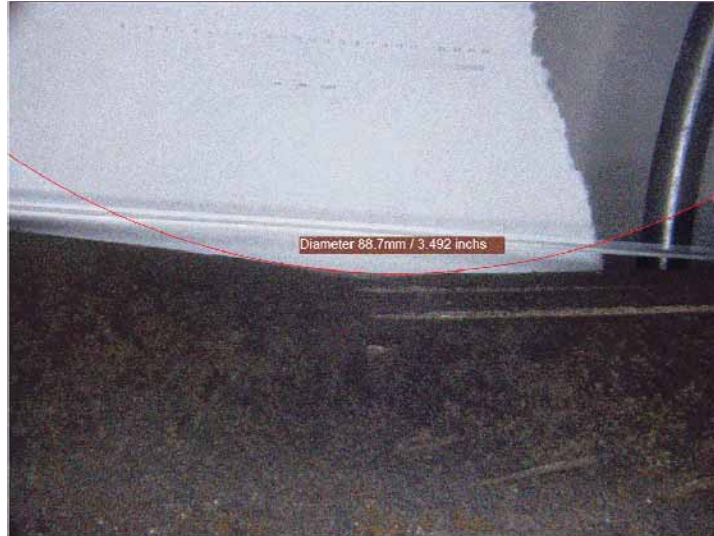
The tie rod of Greyhound 6352 was retrieved for a preliminary inspection of the impact marks and how they would characterize to the driveshaft. Again the tie rod was found to be bent in tension. Based on the witness marks, it appeared to be most likely that the tension bending of

the tie rod was caused by the driveshaft impacting. The impact damage to the tie rod was examined under a high magnification digital video microscope. The radius of the impact was measured for comparison to the driveshaft tube diameter using the microscope's dimensioning software shown in Figure 41.

**Figure 41- Greyhound 6352 Tie Rod Impact Radius Measurement**

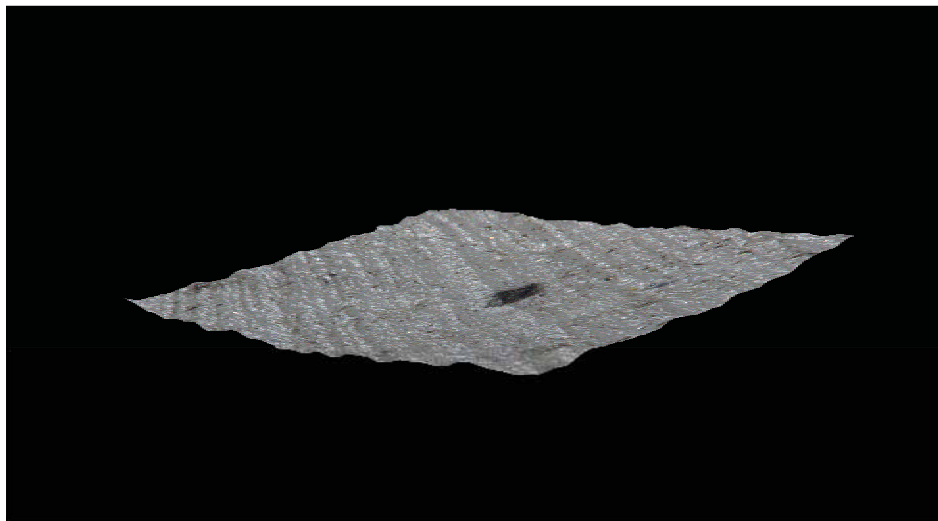
**Figure 42- Greyhound 6352 Tie Rod Impact Clay Impression**

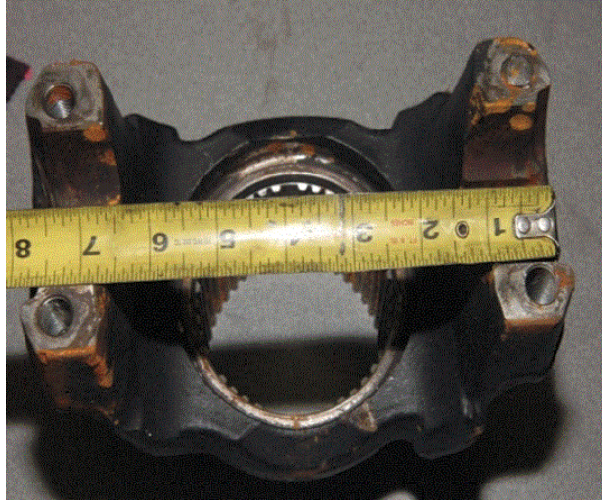
**Figure 46- Greyhound 6934 Transmission Hub Damage**

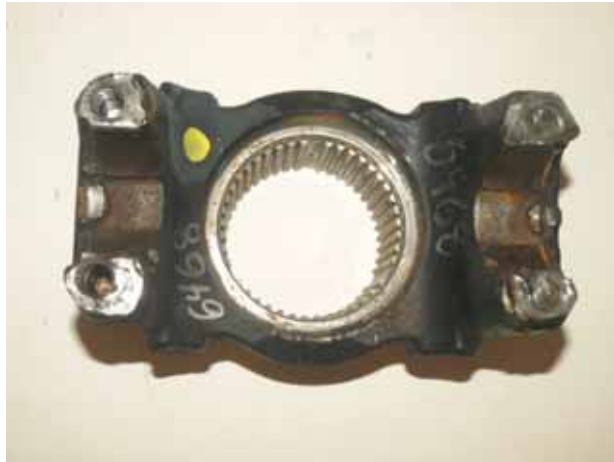
**Figure 47- Greyhound 6468 Transmission Hub Damage**

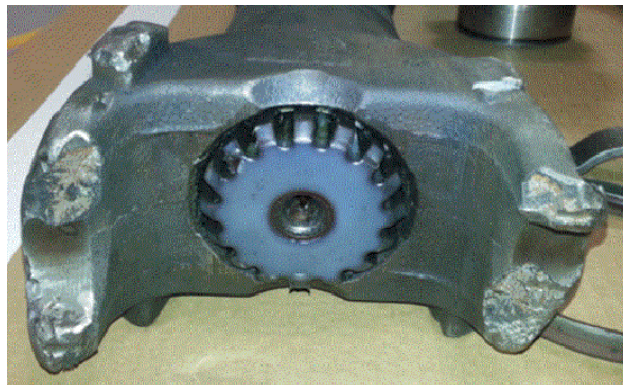
**Figure 48- Greyhound 6468 Fractured Cast Journal Ear**

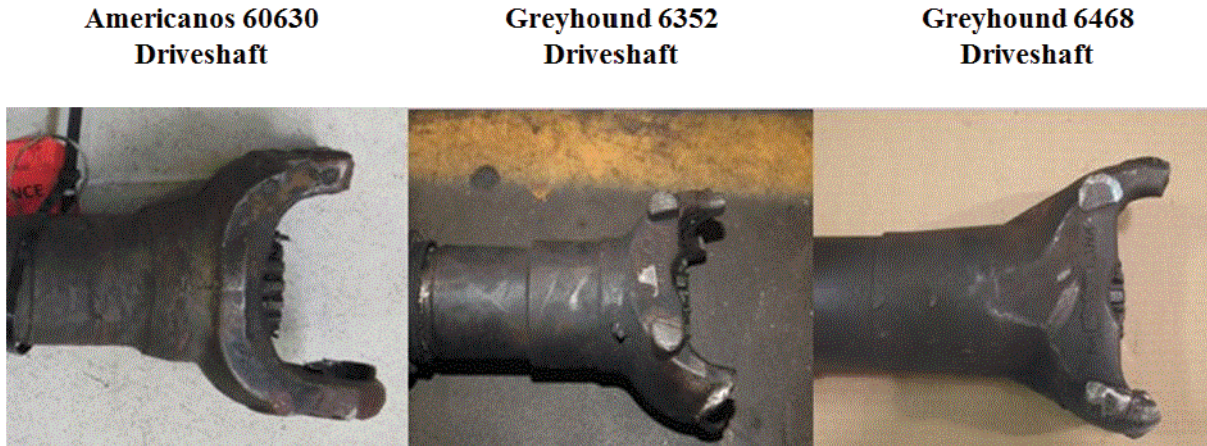
**Figure 49- Failed Driveshaft Evidence Comparison**

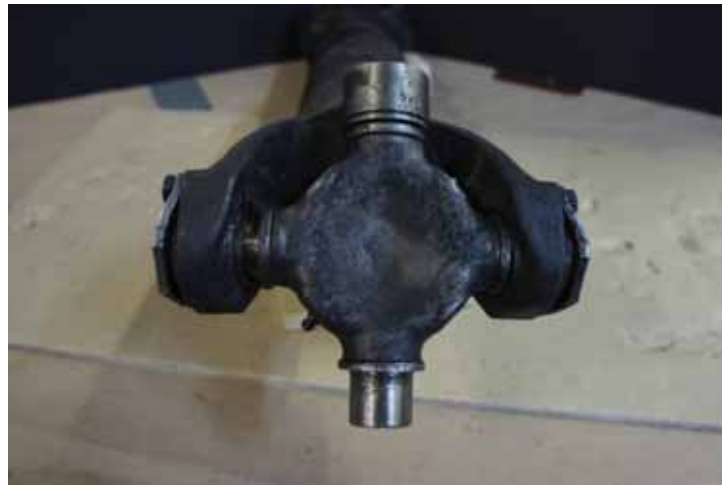
**Figure 52- Greyhound 6352 Drive Axle U-Joint Overload**

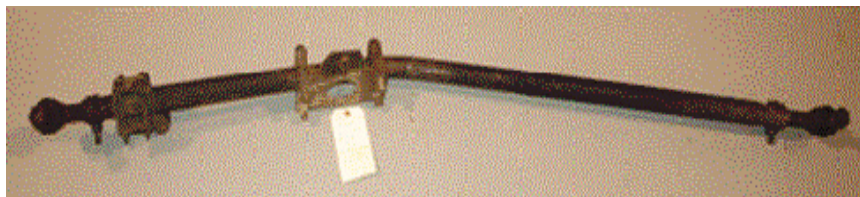
**Figure 55- Greyhound 6352 Signature Bent Tie Rod**

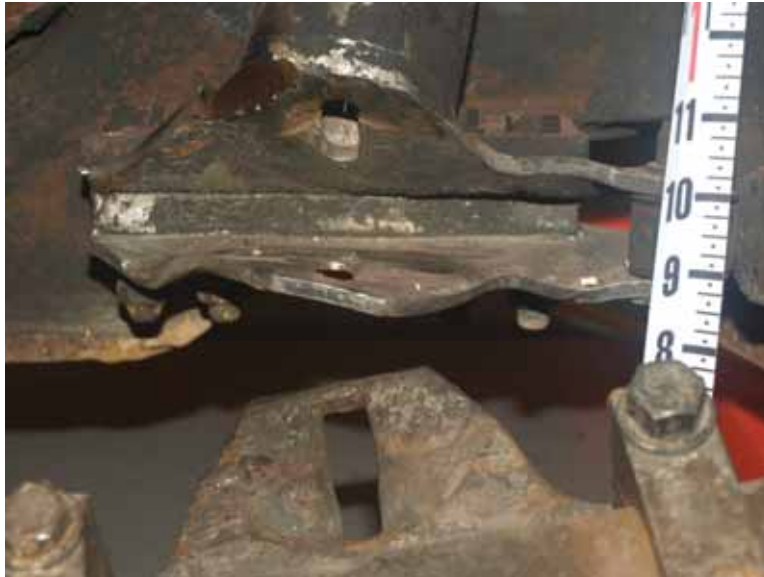
**Figure 58- Greyhound 6352 Defeated Tag Axle Tie Rod Latch**

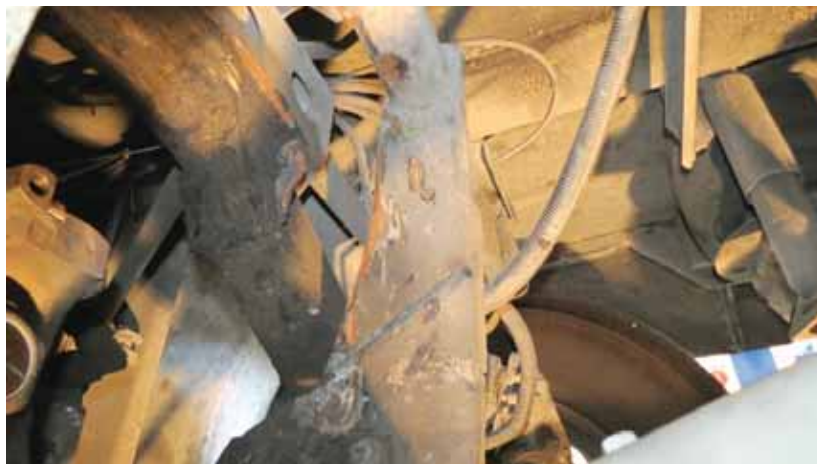
**Figure 59- Americanos 60630 Caster Arm Levered Into Negative Caster by Driveshaft**

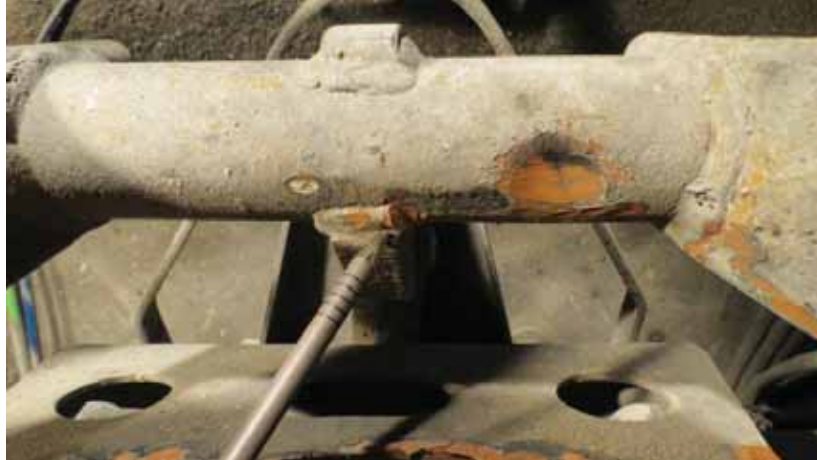
**Figure 62- Americanos 60630 Heavy Impact Damage to Caster Latch Arm**

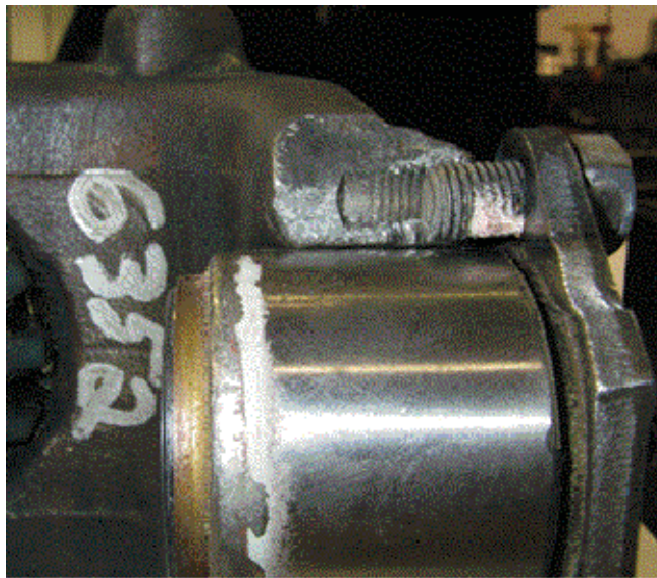
**Figure 64- Greyhound 6352 Reassembled Fractured Bearing Journal**

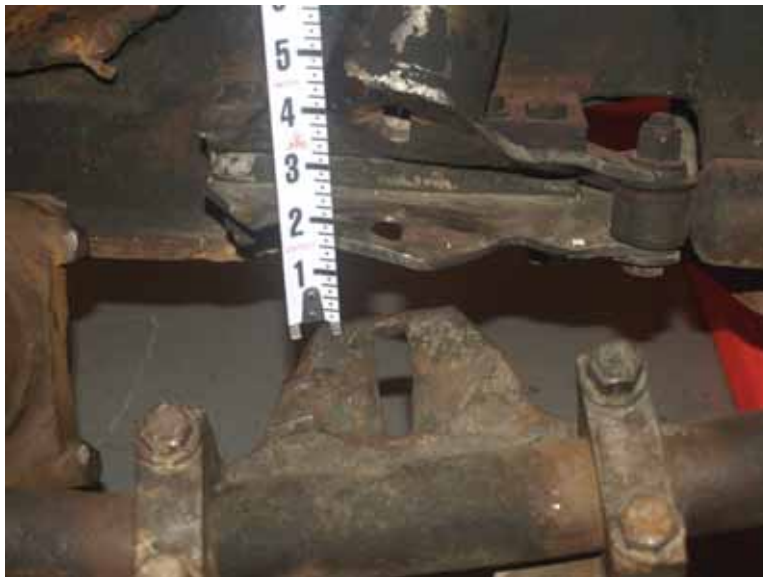
**Figure 66- Greyhound 6352 Separated Tie Rod Latch Plates**

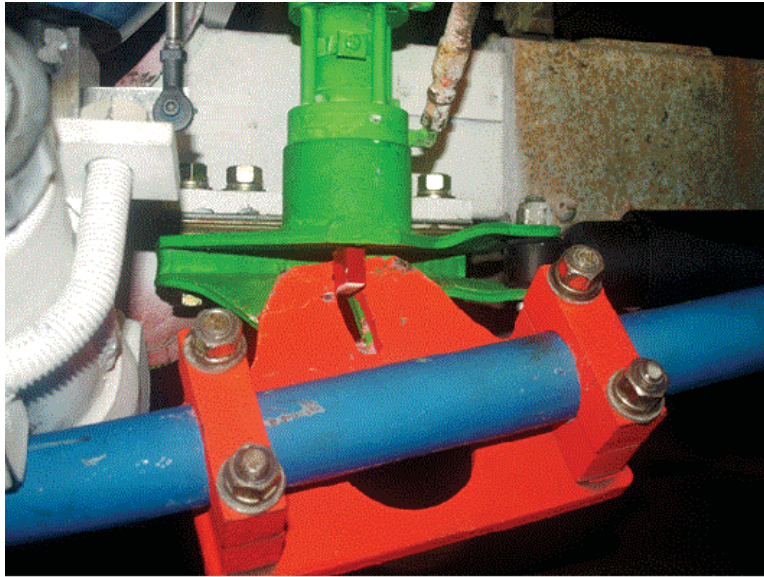
**Figure 75- Defeated Latch Plates Yielded from Signature Bending**
