ODI RESUME

Investigation: EA 12-009
Prompted by: PE10-019

Subject: Floor mat interference with accelerator

Products: 2006-2011 Ford Fusion, Mercury Milan and Lincoln MKZ

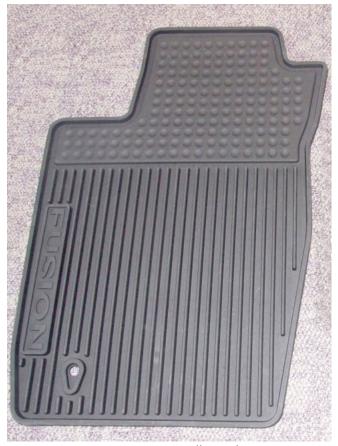
Figure 1: 6E5J all weather mat

NHTSA testing determined that the original accessory all-weather mat with a single retention clip (Figure 1), may interfere with accelerator pedal return to idle with the mat retained by the clip and rotated clockwise. Both the single-and double-clip (Figure 2) all-weather floor mats may interfere with the accelerator pedal return to idle when the mats are not secured by the retention clip(s). Testing showed that this can occur if the mats are moved forward from the clipped position approximately two inches into a position in which the rear edge of the mats will abut the retention clip (s) when installed singly and align with the clip(s) when stacked on another floor mat.

Owners that purchased the subject all-weather floor mats as a factory installed accessory with their new vehicle will be notified to return their all weather floor mats to their Ford or Lincoln Dealership in exchange for replacement mats. Owners of all other potentially affected vehicles will be notified that, if they have an affected Ford driver's side all weather floor mat, they should return their mats to the dealership in exchange for replacement mats.
