**National Highway  
Traffic Safety  
Administration**

# ODI RESUME

**Investigation:** PE 12-005  
**Date Opened:** 03/07/2012  
**Investigator:** Steve Mchenry  
**Approver:** Frank Borris  
**Subject:** Stuck throttle

**Manufacturer:** Ford Motor Company  
**Products:** MY 2005-06 Ford Taurus & Mercury Sable  
**Population:** 546,082

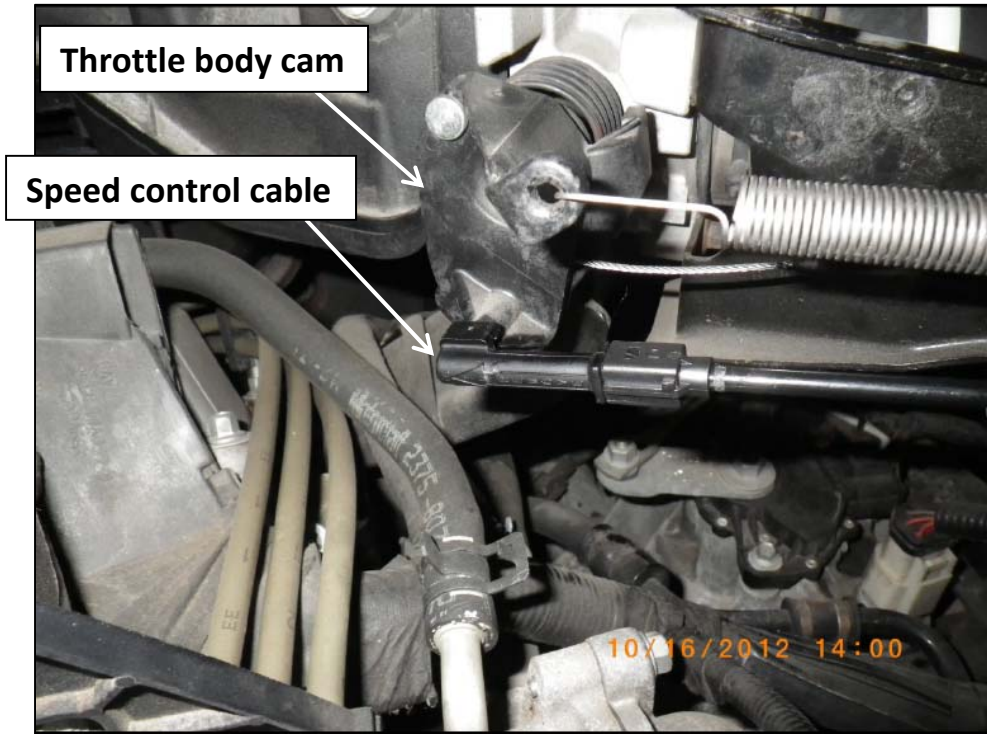
Figure 1 - Exemplar speed control cable and throttle body cam, 2005 Ford Taurus with Vulcan engine.

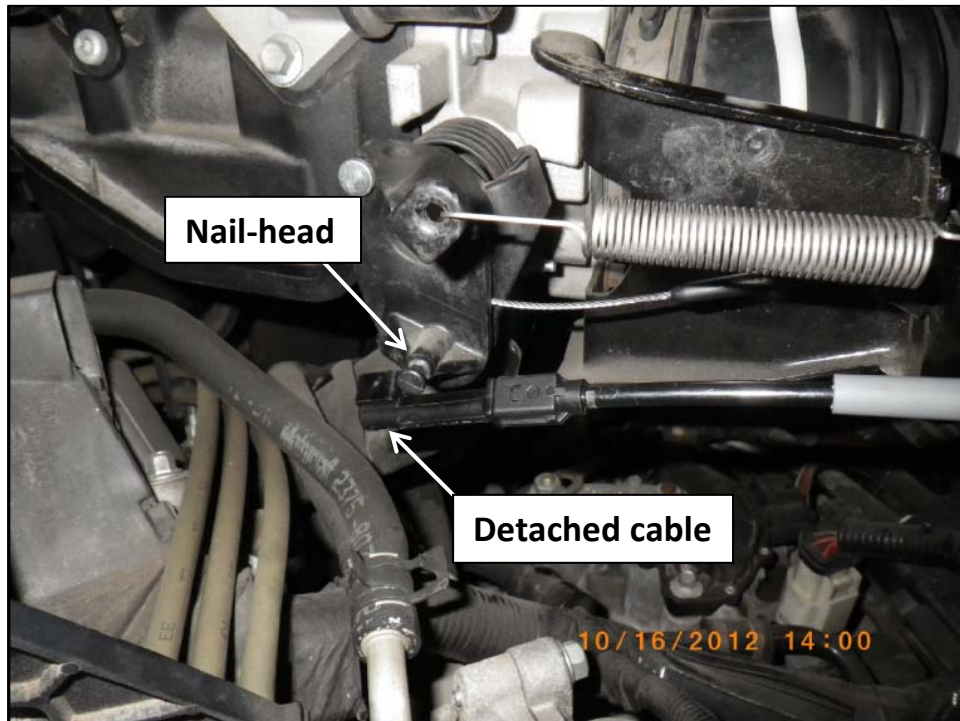
Preliminary Evaluation (PE)12-005 was opened to investigate allegations of speed control cables detaching from the throttle body and subsequently interfering with the throttle closing fully to the idle position in model year (MY) 2005 and 2006 Ford Taurus vehicles. The speed control cable, throttle body attachment arm ("nail head") for the speed control cable, cable mounting bracket and cable routing for the MY 2005 and 2006 Ford Taurus are common to all MY 2004 through 2006 Ford Taurus and Mercury Sable vehicles equipped with either the 155 HP 3.0L 2-valve Vulcan engine or the 200 HP 3.0L 4-valve Duratec engine (the "subject vehicles"). Figures 1 and 2 show the throttle body cam and speed control cable installed and a cable interference condition caused by contact between a detached cable and the "nail head."

Ford's assessment of the condition in incident vehicles noted that the interference conditions produced tended to be short in duration as the cable end tended to dislodge itself from the throttle body due to vibration, road loads or engine roll in addition to tapping the acceleration pedal. Ford inspected three incident vehicles and measured maximum throttle openings of 5.8% to 14.9%, resulting in engine speeds ranging from 1600 to 2200 rpm with the transmission selector in Drive. A Ford stack-up analysis of the speed control cable length from the attachment bracket to the throttle body indicated a maximum theoretical throttle opening of 16.4% that could result from the alleged defect.

Figure 2 - Detached speed control cable caught on throttle cam nail-head, 2005 Ford Taurus with Vulcan engine.
