**National Highway
Traffic Safety
Administration**

ODI RESUME

Investigation: PE 12-025
Date Opened: 09/14/2012
Investigator: Derek Rinehardt
Approver: Frank Borris
Subject: Loss of Steering Control
Date Closed: 04/26/2013
Reviewer: Jeff Quandt

Manufacturer: Ford Motor Company
Products: MY 2005 - 2008 Ford Crown Victoria Police Interceptor Models
Population: 195,000
Problem Description: Separation of the lower steering column shaft from the upper steering column shaft resulting in a loss of steering control.

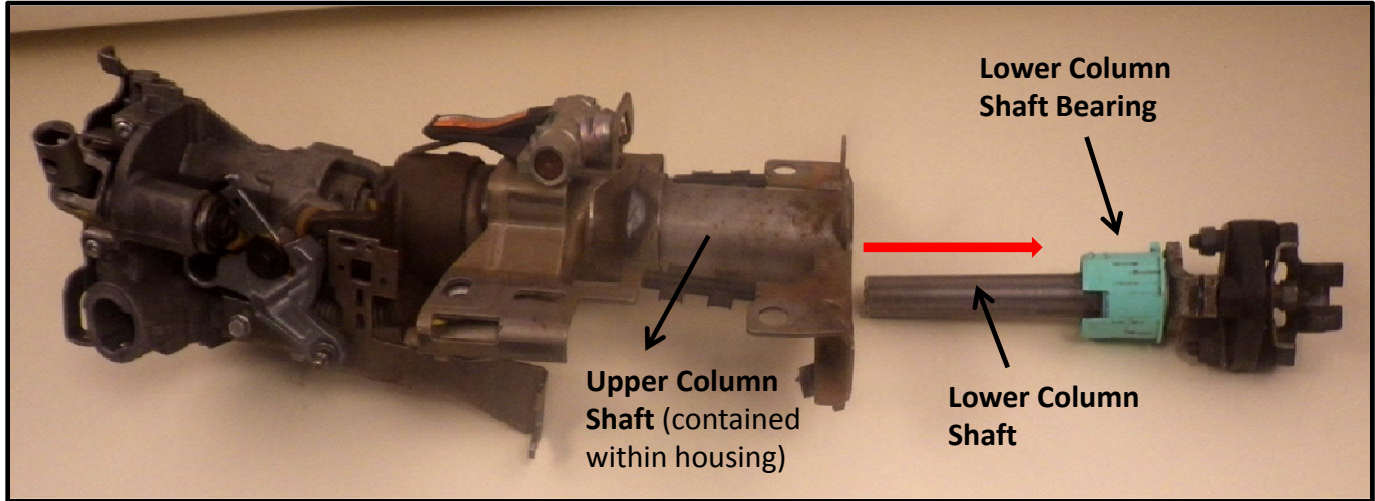
In response to the Office of Defects Investigation's (ODI) Information Request (IR) during PE12-025, Ford provided 2 complaints and 9 warranty claims related to the alleged defect in the subject vehicles (see Figure 1 for an exemplar picture). ODI has received 5 complaints related to the alleged defect, including 1 related to an incident reported in one of the Ford complaints. The incident rate involving subject vehicles is 7.7 per 100,000 vehicles (15 total incidents). Five of the 15 incident vehicles were associated with a prior history report of a frontal impact incident.

Lower Steering Column Shaft Complete Separation

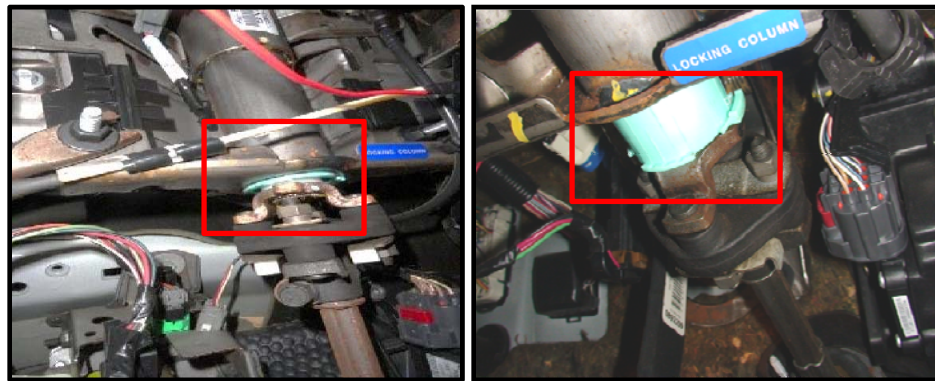
Figure 2

ODI also identified 42 reports (39 reports associated with subject vehicles and 3 reports associated peer vehicles) of

the lower steering column shaft bearing displacement that did not result in complete separations of the upper to lower steering column shafts (see Figure 2). Vehicles with this condition were identified during inspections of police fleets or during vehicle repairs for complaints of looseness, binding or noise in the steering system while turning.

Lower Column Shaft Bearing Displacement

Displaced Lower Bearing
