**National Highway
Traffic Safety
Administration**

ODI RESUME

Investigation: PE 12-033
Date Opened: 10/24/2012
Investigator: Steve Mchenry
Approver: Frank Borris
Subject: Speed control cable damage

Manufacturer: Ford Motor Company
Products: MY 2000 - 2003 Ford Taurus/Mercury Sables w/Duratec engines
Population: 467,719

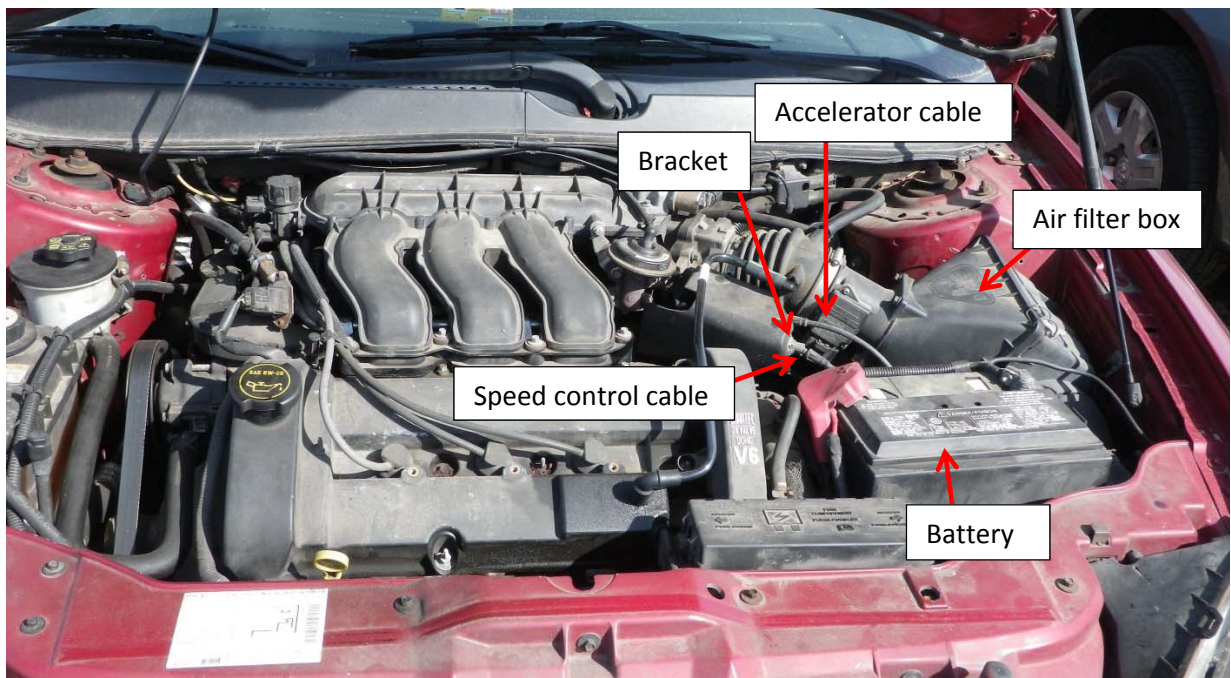
Figure 1. Engine compartment layout.

Figure 1 shows the location of the Speed Control Cable in the engine compartment and the proximity of the battery and air filter. The failure mode of the cable assembly is associated with the plastic collar used to secure the cable to a bracket near the throttle body (Figure 2). Damage to one or both retention tabs used to secure the cable ferrule within the collar may allow the ferrule to become disconnected from the collar when the throttle is opened during accelerator pedal application. Additional examples of Speed Control Cables with damaged collar retention tabs and partial ferrule displacement are shown in Figures 3 through 5. If the displacement pulls the ferrule completely out of the collar, the ferrule end may contact the face of the collar when the accelerator pedal is released and the throttle is returning to idle (Figure 6). This results in a throttle stuck at approximately 26-29% open. Testing conducted at NHTSA's Vehicle Research and Test Center found that brake booster vacuum may become depleted, resulting in reduced brake effectiveness, if the brake is applied repeatedly when the throttle is stuck at this position.

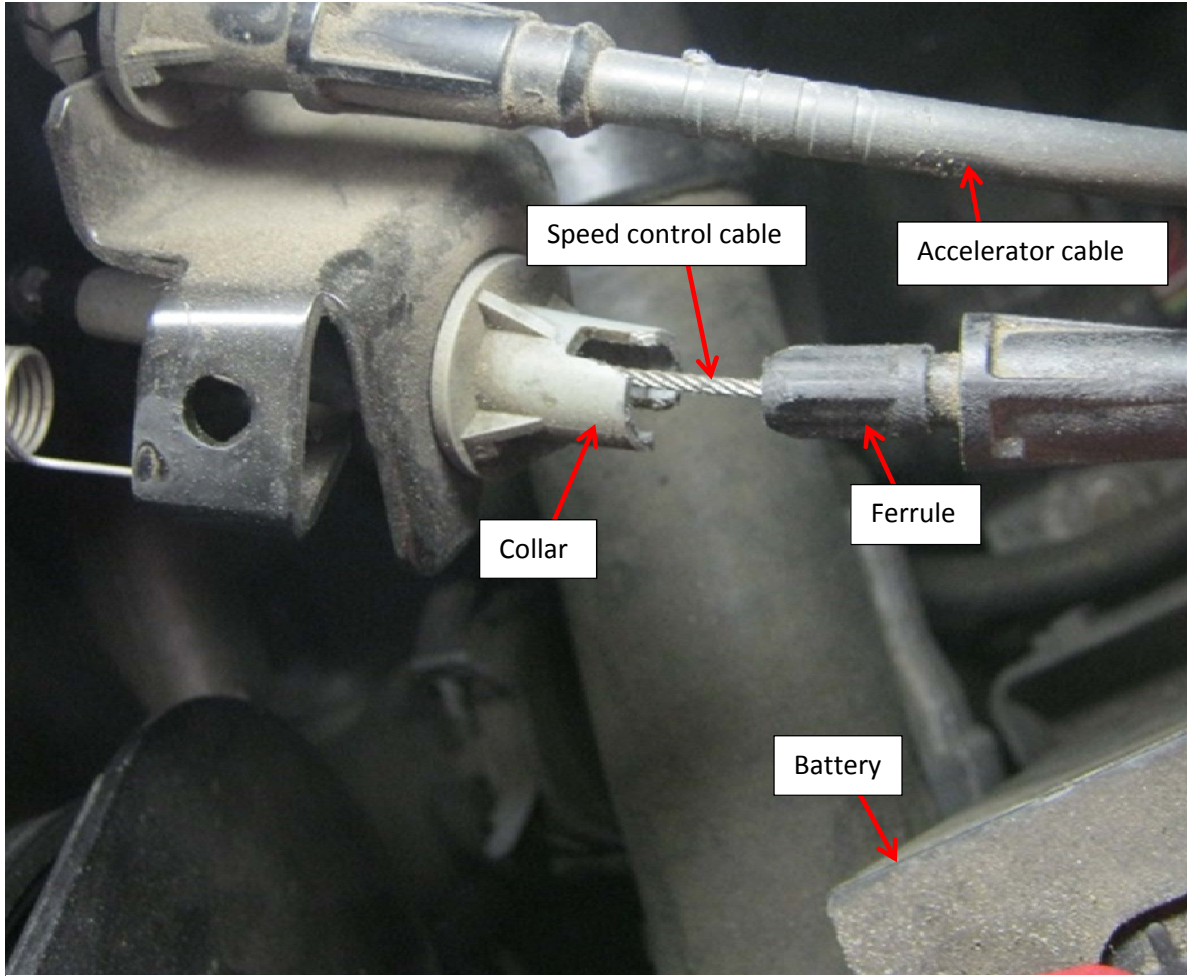
Figure 2. Damaged speed control cable collar during accelerator pedal application (throttle partially open), resulting in displaced ferrule.

On June 21, 2013, Ford initiated Customer Satisfaction Program 13B04 to address a concern with Speed Control Cable damage in certain model year (MY) 2000 through 2003 Taurus and Sable vehicles equipped with 3.0L 4V Duratec engines and built at the Chicago assembly plant. In the dealer letter for the program, Ford indicates that the Speed Control Cables on affected vehicles may be susceptible to damage or becoming partially disconnected during under hood vehicle maintenance (e.g., replacing a battery or changing the air filter) and that a damaged Speed Control Cable could interfere with the throttle's full return to idle when the accelerator pedal is released. Ford's program instructs dealers to inspect the Speed Control Cables and replace any with any portion of either collar retention tab missing. Dealers will install a Collar Reinforcement Clip at the Speed Control Cable collar in all vehicles.

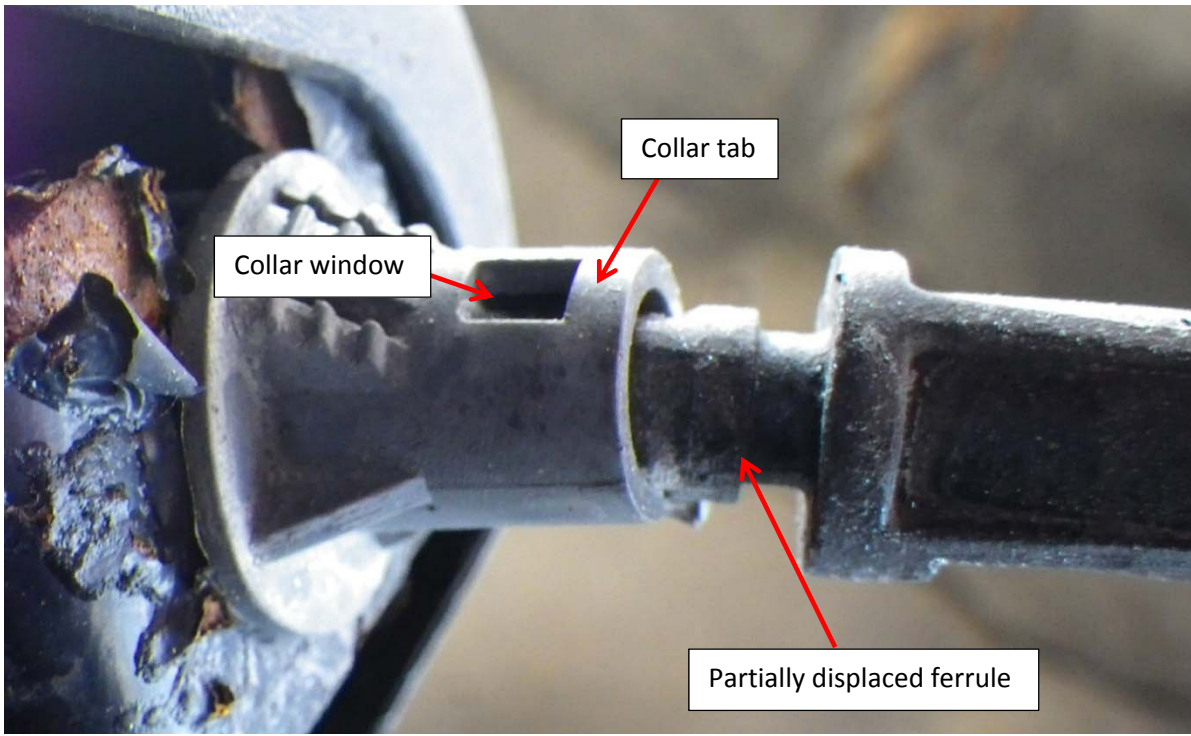
Figure 3. Damaged collar with unretained ferrule (broken tab is not visible in this view).

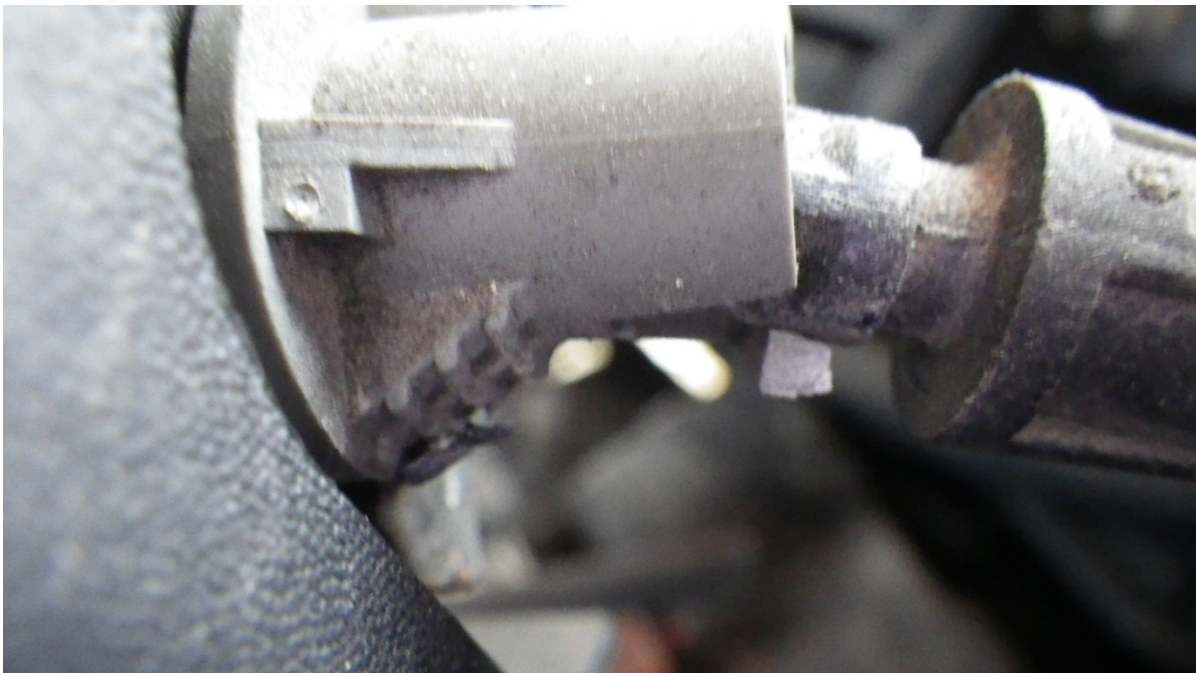
Figure 4. Fractured collar tab with unretained ferrule, side view.

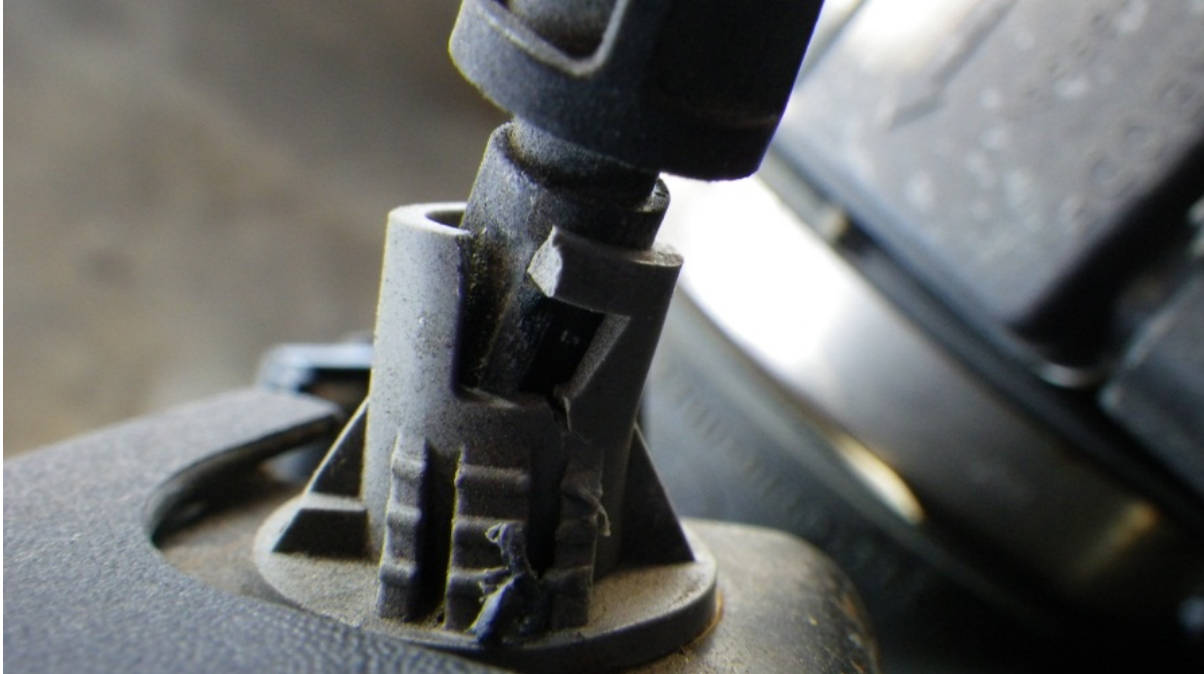
Figure 5. Fractured collar tab with unretained ferrule, bottom view.

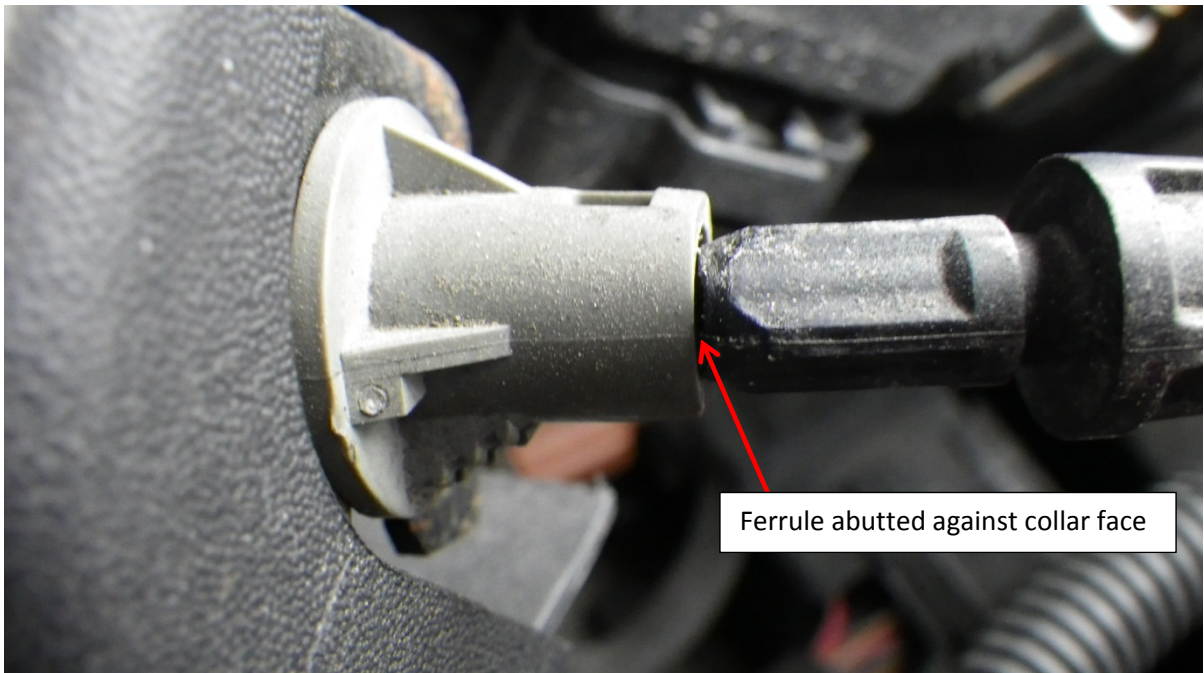
Figure 6. Stuck throttle condition associated with Speed Control Cable collar damage. Ferrule is abutted against collar face during throttle return to idle following release of the accelerator pedal.
