**From:** Neff, Joshua (NHTSA)  
**Sent:** Tuesday, September 18, 2012 12:42 PM  
**To:** Howell, Rosa (NHTSA)  
**Subject:** FW: Southern Honda Powersports (a/k/a Big Red Powersports, LLC),

**From:** Carlos Smith [<mailto:ccsmith@millermartin.com>]  
**Sent:** Tuesday, June 19, 2012 5:06 PM  
**To:** Borris, Frank (NHTSA)  
**Cc:** Piazza, John (NHTSA); Kyle Eiselstein  
**Subject:** Southern Honda Powersports (a/k/a Big Red Powersports, LLC), - Confidential - Privileged and/or Work Product

### 2002-2005 VFR800/A Wire Harness Replacement

### 2006-2007 VT600C/CD Fuel Valve Diaphragm Replacement

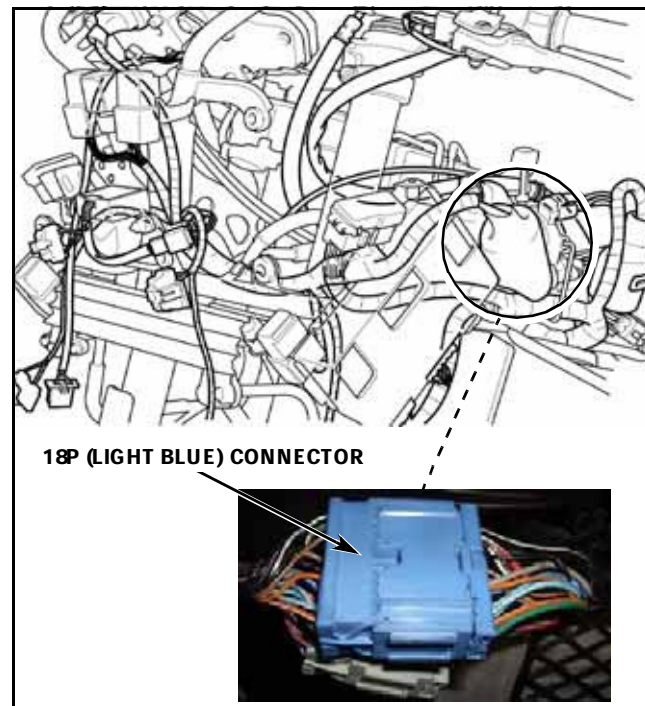
Inspect the 18P connector (light blue) inside the protective sleeve for any burnt, melted, or discolored condition.

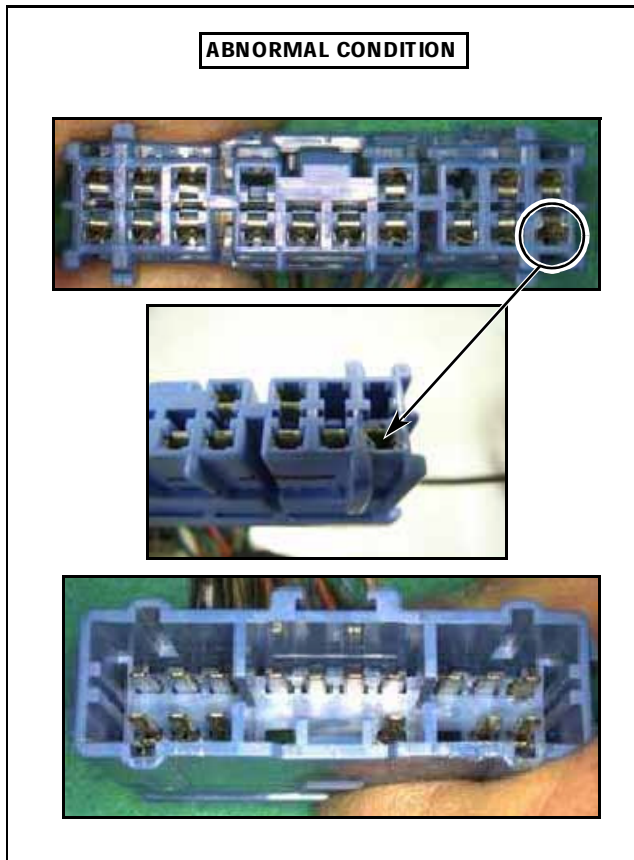
If the 18P (light blue) connector is in abnormal condition as shown below, contact TechLine at (800) 421-1900 option 9.

**NOTE:** If the 18P connector (light blue) is melted, unable to disconnect, or modified, contact TechLine at (800) 421-1900, option 9, prior to starting the repair.

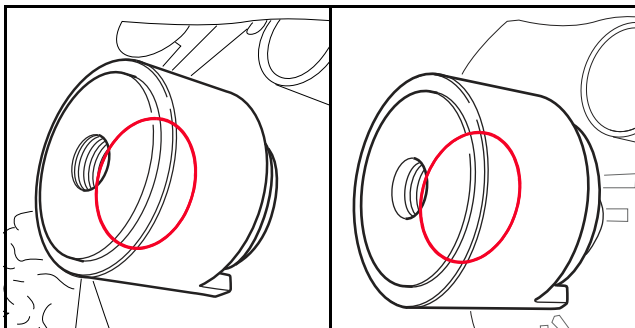
- If the inner piece is higher than the outer piece as shown in both images below, proceed with the FUEL TANK REPLACEMENT.

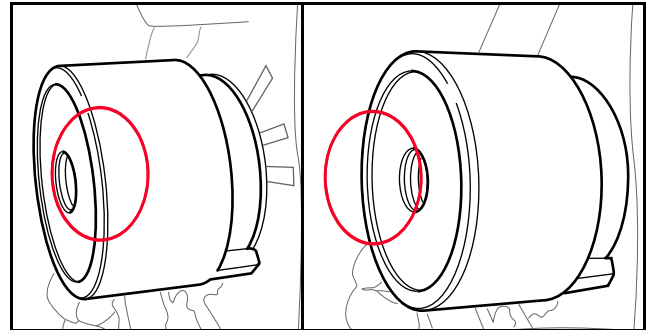
- If the inner piece and outer piece are of the same height or the inner piece is lower than the outer piece as shown below, the fuel tank is not defective. Do not replace the fuel tank.
