Subject: ACTION: PE12-028 Memo to Public File

On November 14, 2012, ODI held a meeting with representatives of Honda at the Vehicle Research and Testing Center (VRTC) in East Liberty, Ohio to discuss PE12-028. A redacted copy of the presentation by Honda is attached. Confidentiality for the redacted portions was requested by Honda.

NHTSA ODI Meeting: 05M PILOT VSA

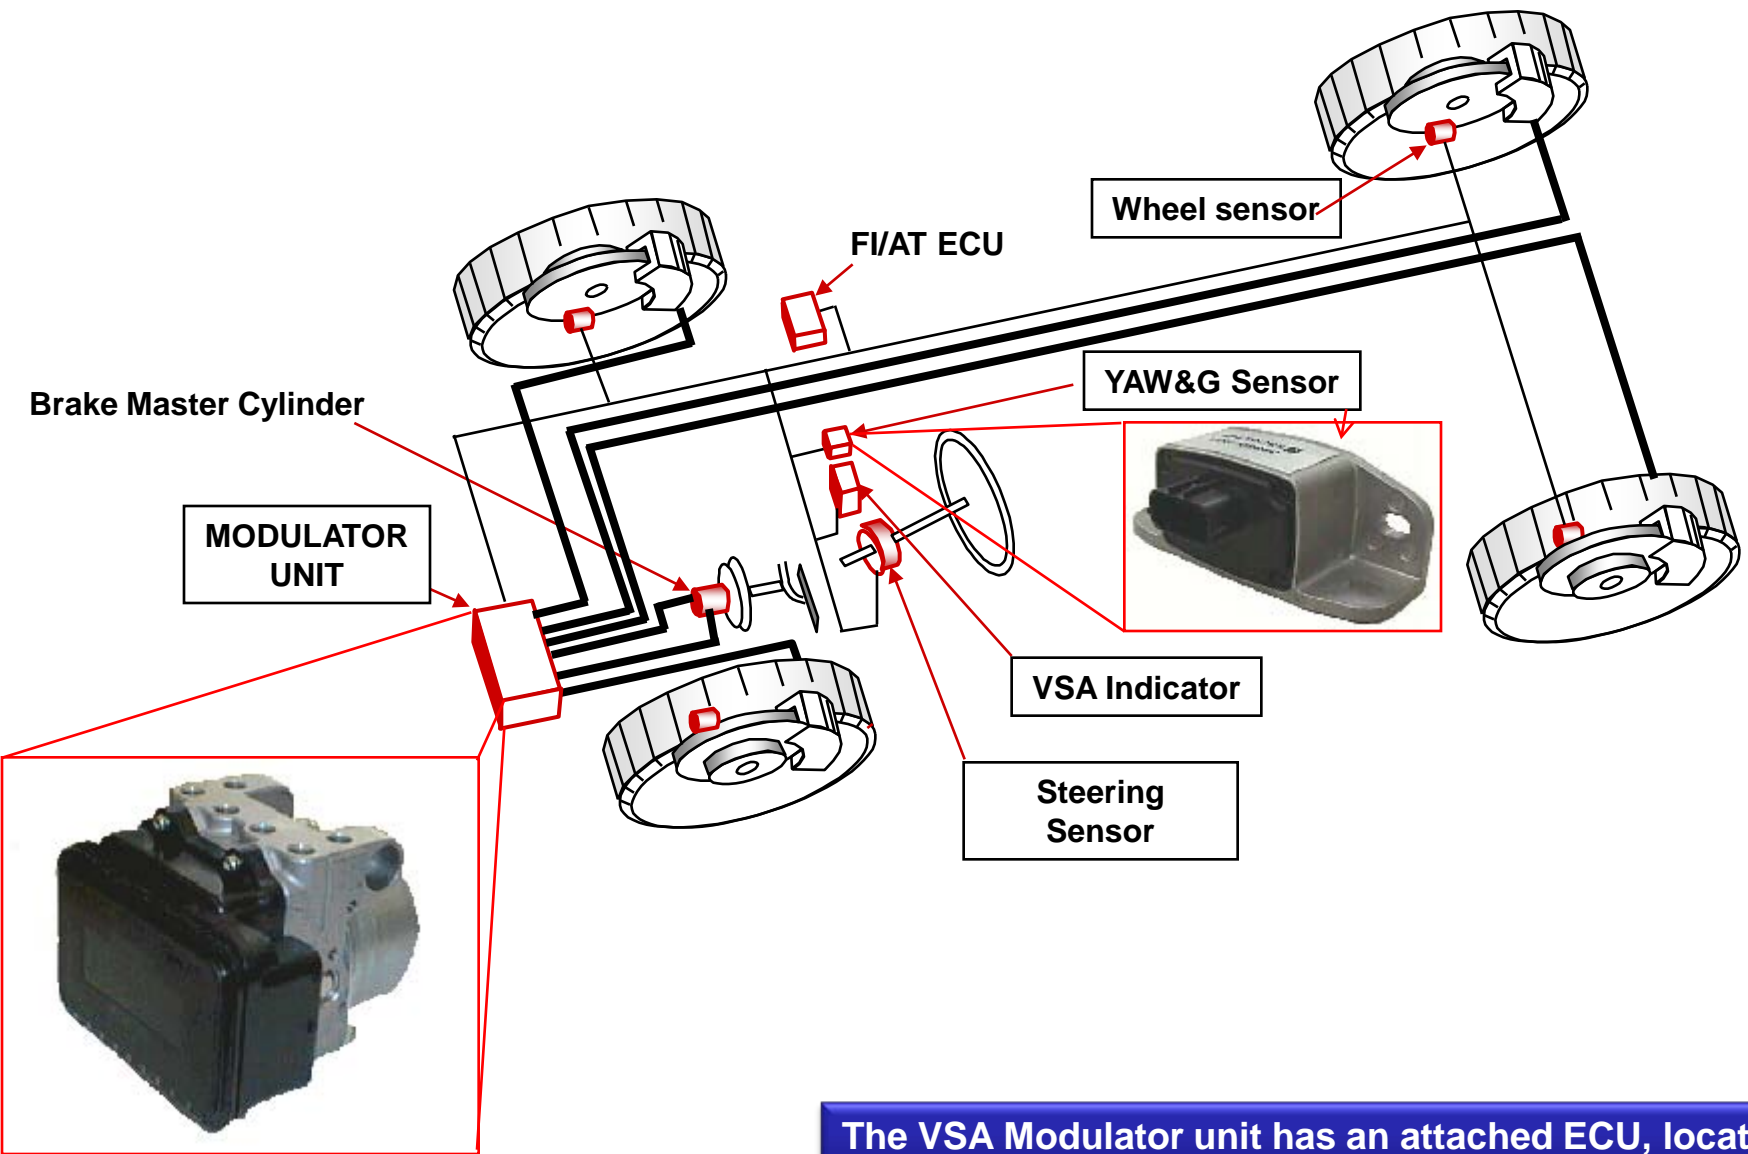
The VSA Modulator unit has an attached ECU, located in the front left corner of the engine bay.

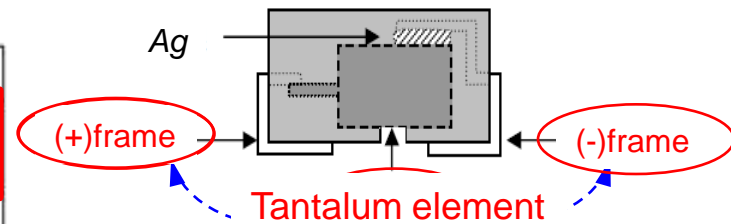
Abnormal resistance value inside tantalum capacitor are assumed to have caused the problem. We are continuing to study this phenomenon.

Measured internal resistance on (+) frame.

Measured internal resistance on (-) frame

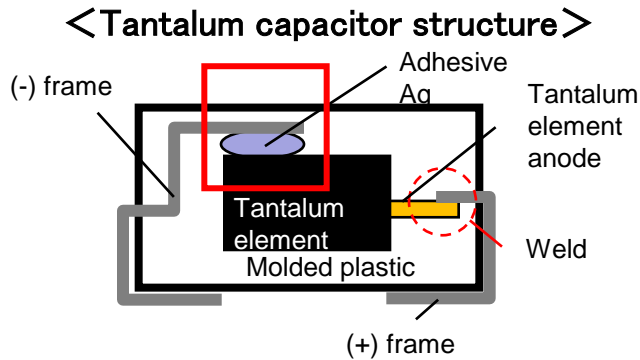
Melted Sn plating was found on peeled surface of negative pole frame.

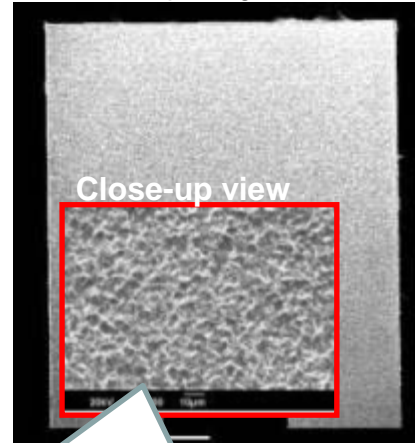
< New Sn plating frame >

Grained plating can be confirmed

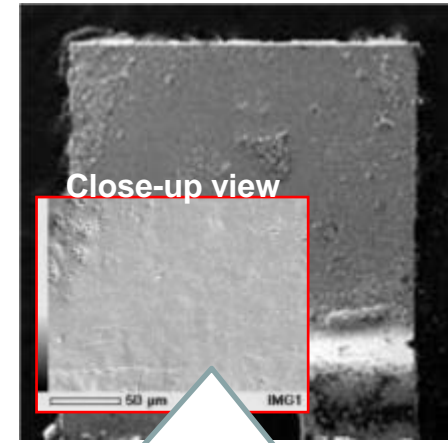
< Failed frame >

Grained plating can not be confirmed, and Sn plating is melted.

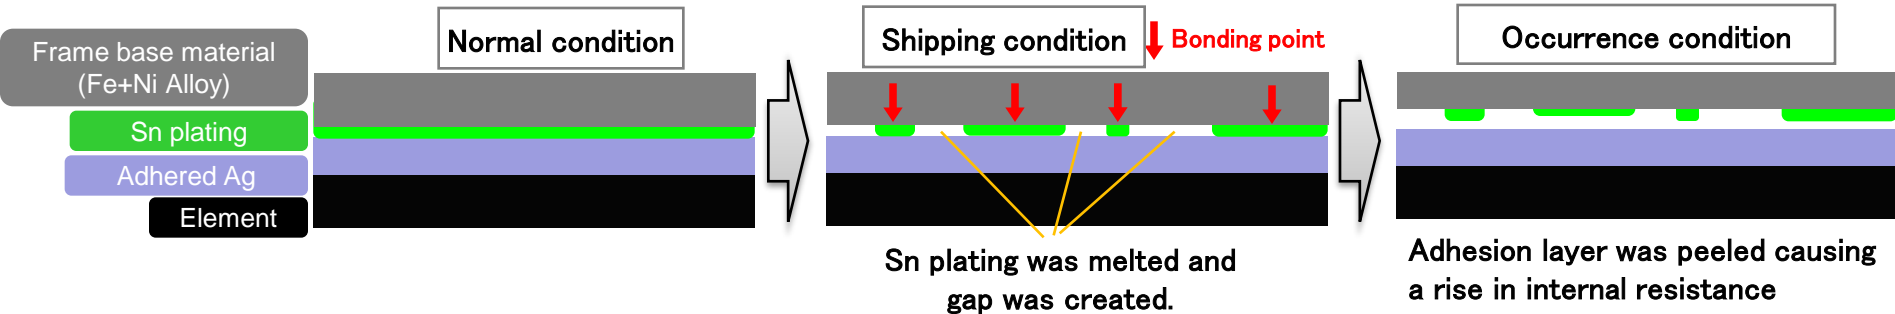
Most of Sn plating on the adhesion surface of the negative pole frame was melted. This seems to have created a gap on the boundary surface. As a result, the adhesion area greatly reduced.

Therefore, adhesion between negative pole frame and capacitor element became unstable, rising ESR.

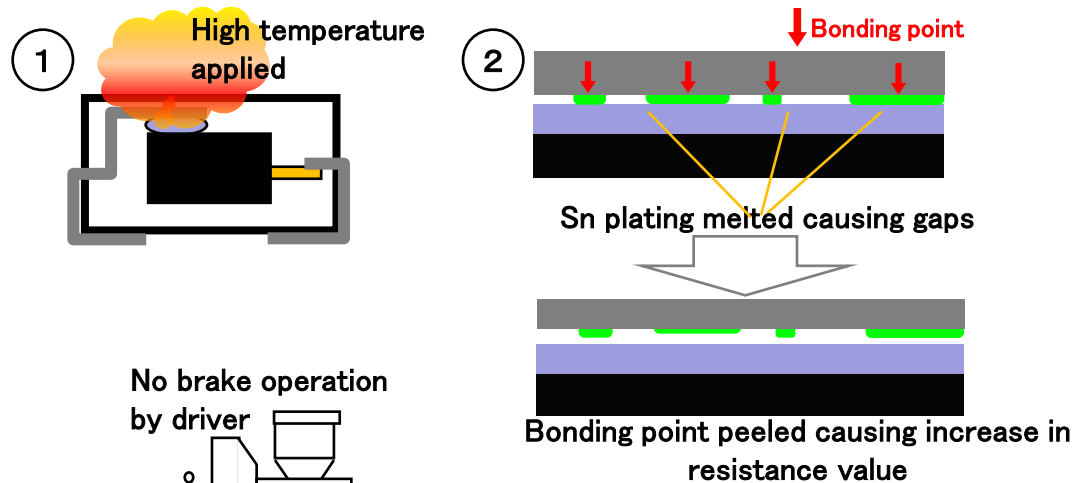
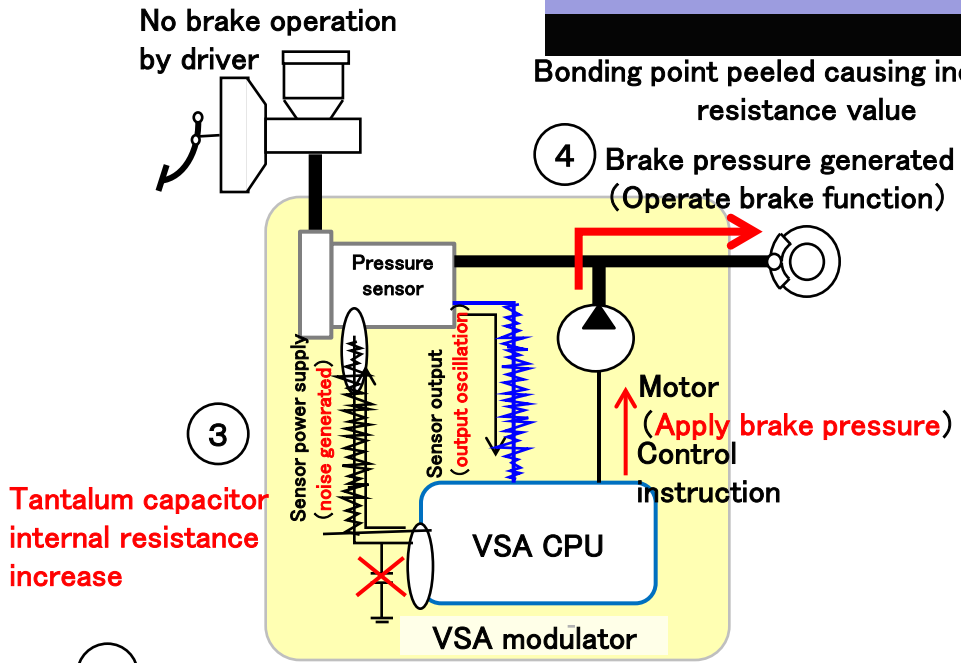
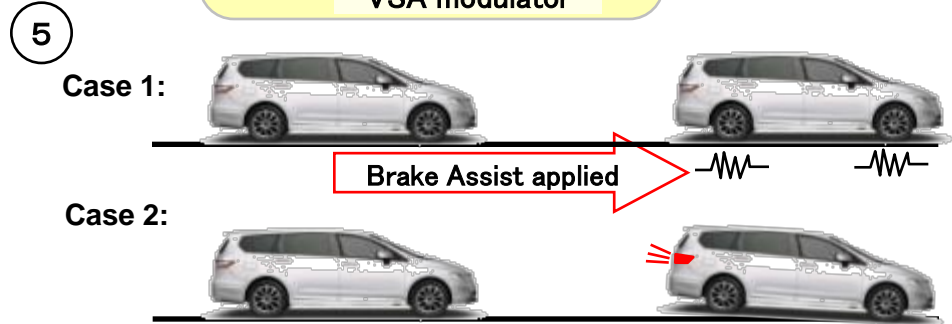
① If reflow furnace temperature setting exceeded target level during ECU manufacturing it could cause the capacitor frame Sn plating to melt

② Adhesion layer of Ag (silver solder) is reduced and bonding between cathode frame and element separates, resulting in high internal resistance.

③ Power supply of pressure sensor cannot remove noise and oscillation.

④ ECU judges increase of pressure sensor output and activates brake assist function for 200 msec.

⑤ Light brake application occurs, if brake pedal is applied BA is engaged.

Case 1: Without brake pedal applied:
BA activation is for 200ms. After that, it will be cease until the next noise level peak.

Case2: Brake pedal applied :
BA activation. (ABS activation). After brake pedal is released, BA activation does not continue.

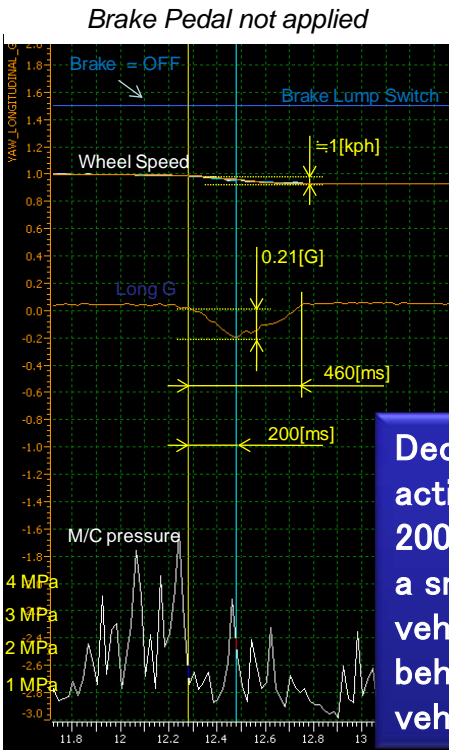
Decel during BA activation is 200ms, 0.21G. It has a small impact to vehicle behavior, depending on vehicle speed.

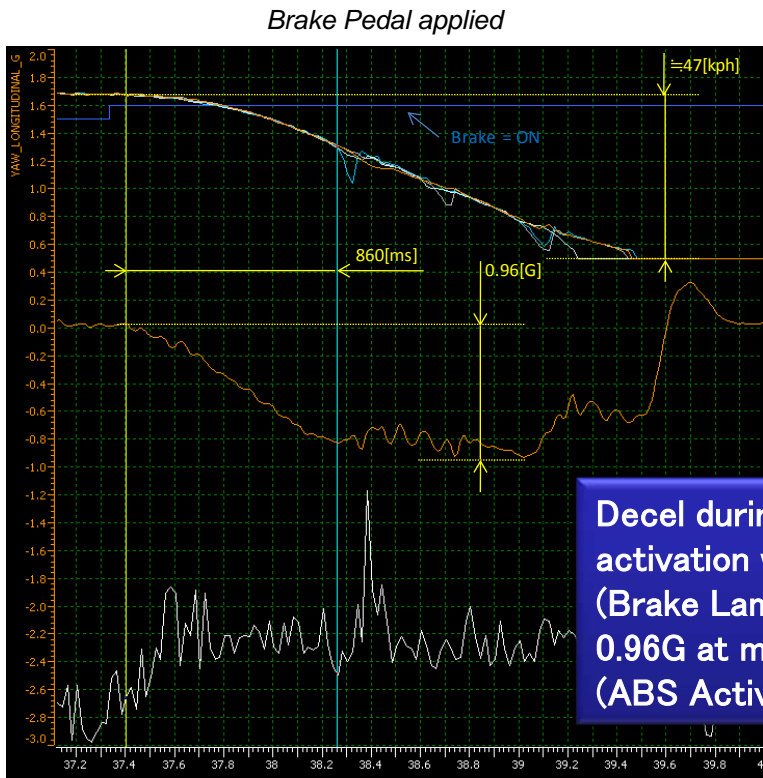
Decel during BA activation with braking (Brake Lamps ON) is 0.96G at max., 0.6 G ave. (ABS Activated)

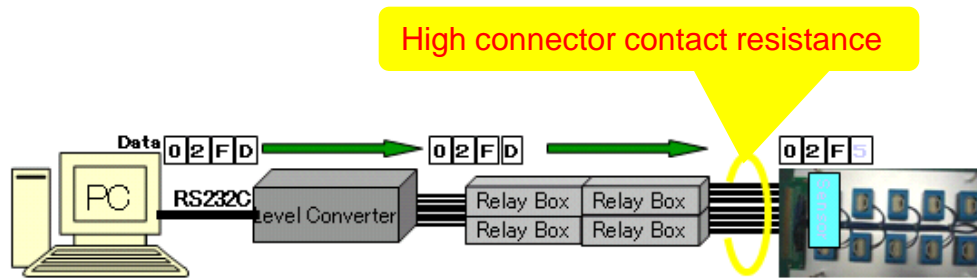
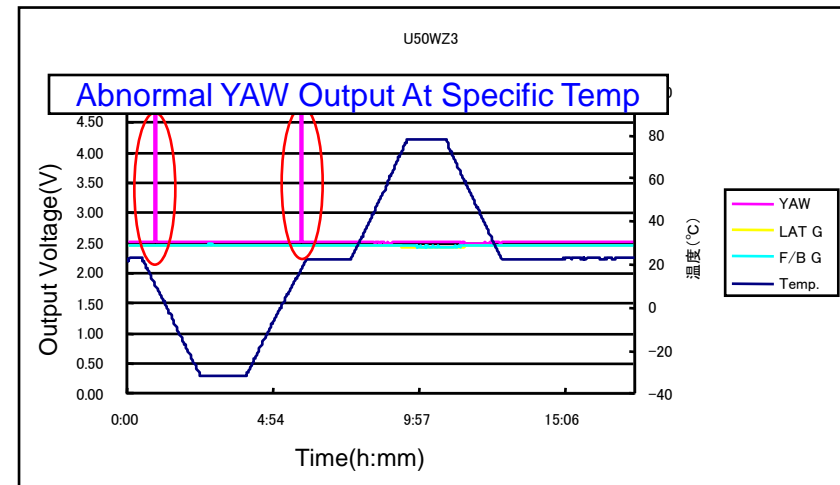
【 EEPROM Production Process 】

- Yaw Sensor EEPROM internal temp compensation data written with error.
- Sensor behavior: When NG temp is reached the YAW output sticks at 5V

▪ When interruption (incl. high resistance) occurs during data writing to the EEPROM, communication V level fluctuates, resulting in writing of abnormal value.

- **YAW Sensor C/M** : Added EEPROM data inspection process after temperature compensation (Jan 18, 2005@ supplier, HM Factory Apr 2005)
- **VSA Modulator Failsafe Software C/M** : Control specification added to prevent activation from YAW output If input is over 4.7V or under 0.3V for 60msec continuous, VSA operation is stopped. (06M Software C/M)

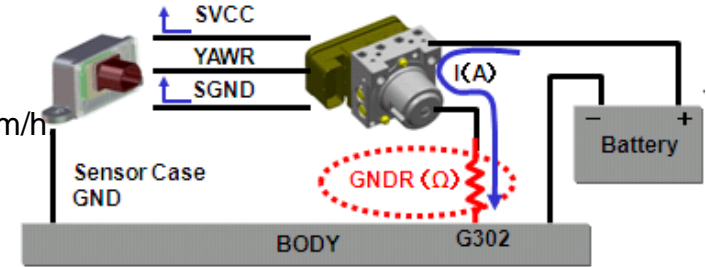
C/M Spec: Logic for confirming yaw sensor output value within normal voltage range (under 4.7V, Over 0.3V)

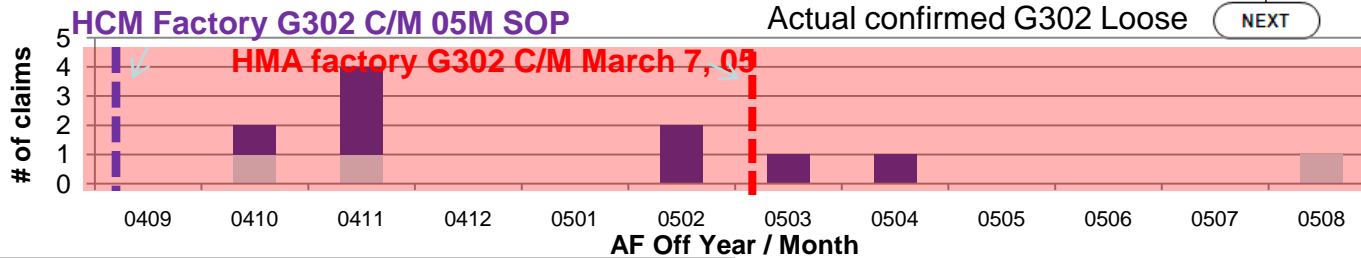
05M Pilot - G302 Dealer Contentions

YAW output error is triggered by system activation, meaning it occurs upon the activation of initial diagnosis (15km/h), which always follows IG ON. Behavior is the same as EEPROM defect. Warning is possible and the defect occurs at low speed; therefore it is not considered dangerous in nature.
