**National Highway  
Traffic Safety  
Administration**

# Memorandum

**Subject:** VOQ 10487624 owner documentation of fuel leak

**To:** Public File - PE12-036

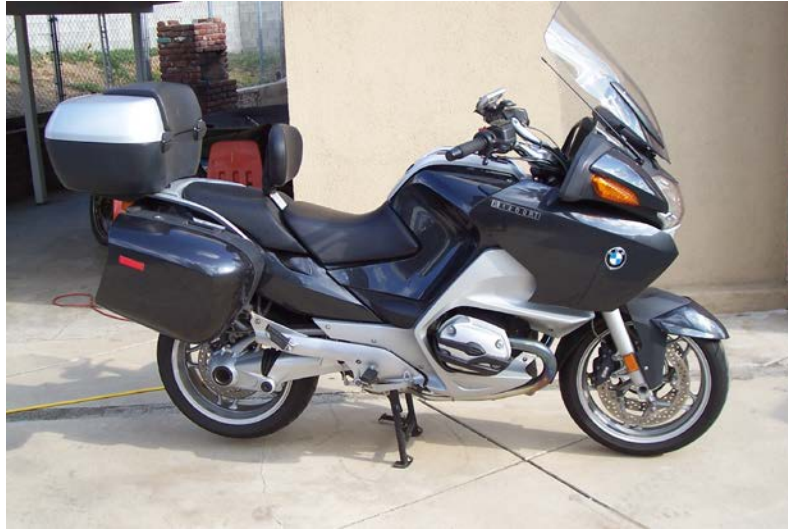
Following up on the referenced VOQ, ODI contacted the owner of a MY2006 BMW R1200 RT (one of the subject models in this PE). Subsequently, he provided a video of the leak condition with the fuel system pressurized when the ignition was turned on. Photos were also provided documenting the leak location...at the interface between the in-tank fuel pump housing and its output quick connect nipple...precisely the situation we are investigating in PE12-036.

**Photo 1 - Motorcycle documented in VOQ 10487624**

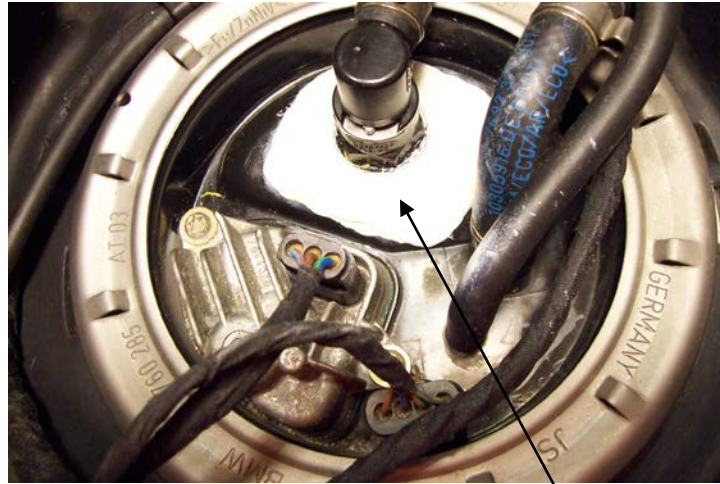
**Photo 1 - Owner's attempted epoxy repair**

The owner claims that at no time was the nipple manipulated prior to, or during, the repair. Unfortunately, the repair failed and the "leak" remained as before. With that, the owner stopped using the motorcycle.

Subsequently we contacted the owner to learn more. He told us that, after learning that he would have to replace the entire pump assembly at a cost of approximately \$350.00, he decided he would attempt a repair by topically applying an epoxy paste over the cracked pump/nipple interface.
