**CRA ON-SITE AIR BAG DEPLOYMENT CRASH INVESTIGATION  
SCI CASE NO.: CR13006**

**OFFICE OF DEFECTS INVESTIGATION**

**VEHICLE: 2013 HYUNDAI ELANTRA**

**LOCATION: FLORIDA**

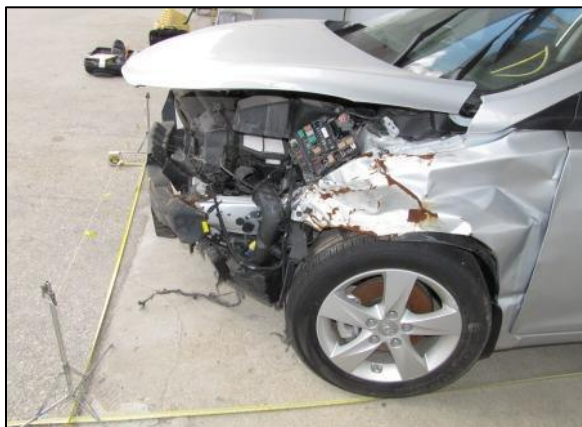
The front left corner area of the Hyundai impacted an unknown vehicle. The direct contact

damage began 34 cm (13.5 in) left of the vehicle's centerline and extended 29 cm (11.5 in) left to the bumper corner. Maximum crush was 11 cm (4.3 in) located at the corner of the bumper beam. The impact also displaced the left frame rail rearward 3 cm (1 in). The corner engagement involved the leading edge of the left front fender and the tire/wheel assembly (**Figure 2**). The fender and substructure were displaced downward and rearward. The tire/wheel engagement displaced the left wheelbase 12 cm (4.6 in) rearward, restricting the left front tire against the aft surface of the inner fender. The Collision Deformation Classification (CDC) for this event (Event 1) was 12FLEE5.

**Figure 2. Front left damage to the Hyundai.**

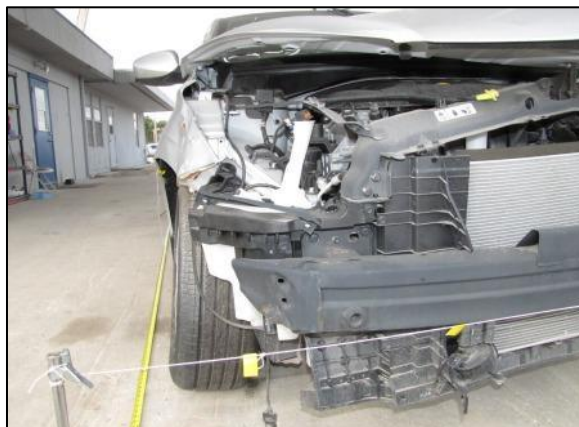
**Figure 3. Front right damage to the Hyundai.**

The right corner of the Hyundai impacted a second vehicle. The direct contact damage began 64 cm (25 in) right of the centerline and extended 5 cm (2 in) to the corner of the bumper beam (**Figure 3**). The end of the bumper beam was crushed 2 cm (0.8 in). The right front fender engaged the other vehicle as the vehicles rotated in opposite directions. The CDC for this event (Event 2) was 12FRES4.

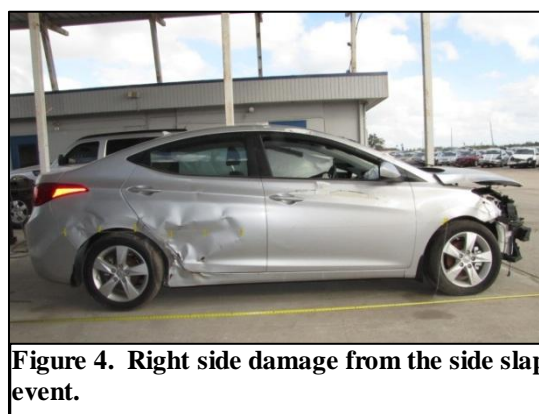
The second vehicle side slapped the right side of the Hyundai (Event 3). The direct contact damage consisted of a black tire transfer to the right rear door and abrasions and dents to the door, C-pillar dogleg, and the right quarter panel (**Figure 4**). The direct damage began 29 cm (11.25 in) aft of the right rear axle and extended 123 cm (48.25

**Figure 4. Right side damage from the side slap event.**

in) forward to the mid aspect of the right rear door. The combined induced and direct contact damage began 41 cm (16 in) aft of the referenced axle and extended 135 cm (53 in) forward to the mid door. Maximum crush was 6 cm (2.25 in) and was located at the forward edge of the wheel opening, 39 cm (15.5 in) above the ground. The crush profile along the damage plane was as follows: C1 = 0 cm, C2 = 0 cm, C3 = 3 cm (1.1 in), C4 = 3 cm (1 in), C5 = 2 cm (0.6 in), C6 = 0 cm. The CDC for this event (Event 3) was 03RZEW1.

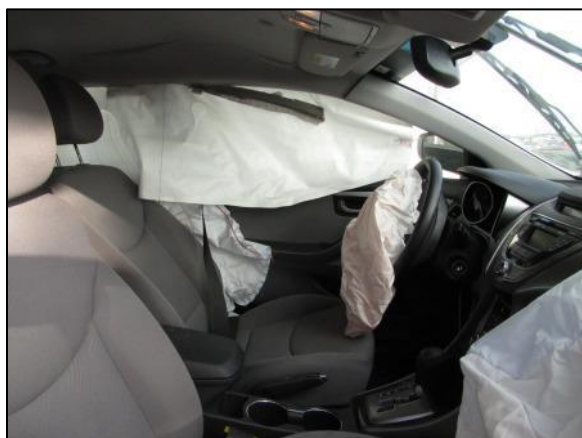
**Figure 5.** Deployed air bags in the driver's position of the Hyundai Elantra.

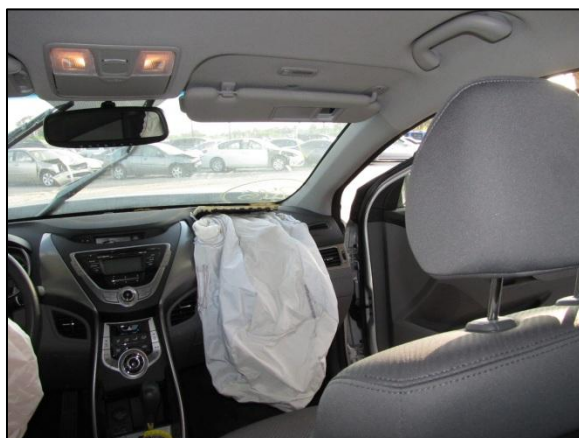
**Figure 6.** Deployed front right air bag of the Hyundai.

The front right air bag (**Figure 6**) deployed from a top-mount module in the right upper instrument panel. The cover flap was hinged at the forward edge and measured 24 cm (9.6 in) laterally and 12 cm (4.75 in) vertically. Measured dimensions of the deployed front right air bag were 36 cm (14.25 in) in width, 61 cm (24 in) in height, with a 56 cm (22 in) maximum excursion from the edge of the cover flap rearward. The air bag was vented by four ports, with

two on each side at the 3 and 9 o'clock positions. The front right air bag was not tethered. Similarly to the driver air bag, there was no occupant contact evidence or damage to this air bag.

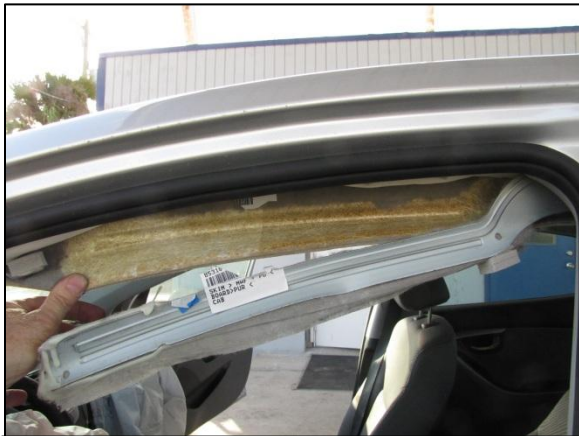
A thin gauge sheet metal reinforcement (stamped sheet metal) was applied to the top outer aspect of the matted-fabric headliner. This reinforcement was believed to add rigidity to the headliner during the manufacturing/installation process of the headliner to the vehicle. The reinforcement was 94 cm (37 in) in length and was approximately 3 cm (1.2 in) in height. It was applied to the top outer edge of the headliner with two-sided fabric tape. The two-sided tape was applied to the inner aspect of the reinforcement and to the matted headliner material. The matted surface of the headliner did not allow for proper adhesion of the reinforcement. A bead of liquid-type adhesive or hot glue was applied to the leading and trailing ends of the reinforcement, apparently to aid in the adhesion of the reinforcement to the headliner. **Figures 7 and 8** depict the reinforcement.

**Figure 7.** View from the exterior of the partially separated headliner reinforcement into the driver's compartment.

During the deployment of the left IC air bag, the leading edge of the reinforcement separated from the headliner. The separation resulted from the tape and the glue disengaging from the inner surface of the headliner. The tape remained fused to the sheet metal reinforcement. The overall length of the separation of the reinforcement was 52 cm (20.5 in) with the leading edge extending 9 cm (3.5 in) below the roof side rail. This sheet metal reinforcement

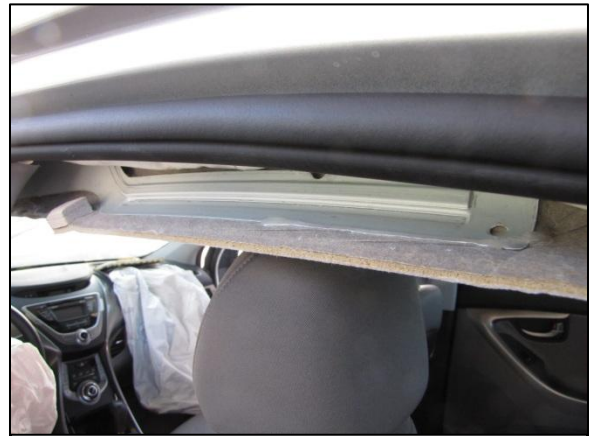
**Figure 8.** Exterior view of the back half of the reinforcement still attached to the headliner over the second row left position.

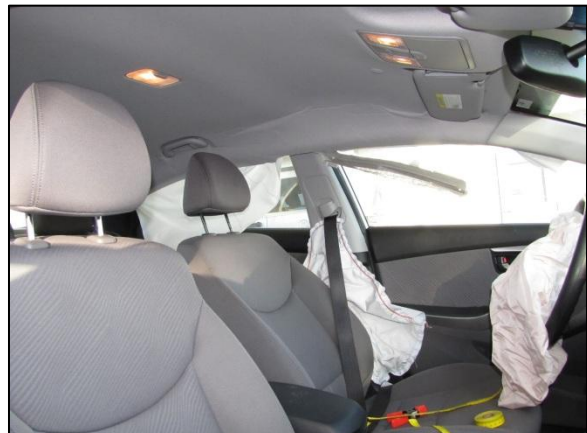
**Figure 9.** Partially separated headliner reinforcement against inside surface of the left IC air bag.

protruded into the occupant compartment on the inside aspect of the deployed IC air bag (**Figure 9**). A barcoded label was applied to the reinforcement and headliner that provided the following:
