On-Site Inflatable Curtain Air Bag/Headliner Defect Investigation

SCI Case No. DS13001

Office of Defects Investigation

Vehicle: 2012 Hyundai Elantra

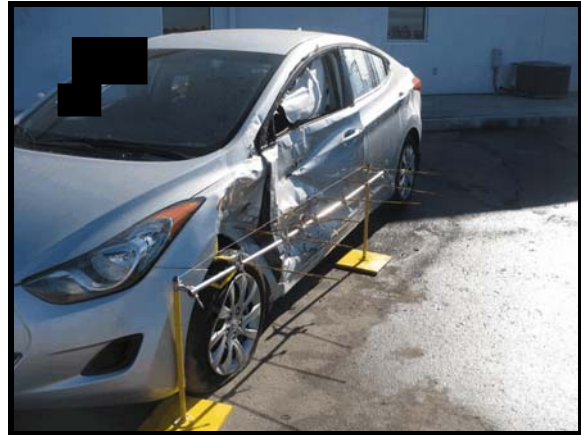
The Hyundai sustained moderate left side damage as a result of the impact with the other vehicle (**Figure 5**). The direct damage began 16.0 cm (6.3 in) forward of the front axle and extended 128.0 cm (50.3 in) rearward. The Field L began 16.0 cm (6.3 in) forward of the front axle and extended 164.0 cm (64.5 in) rearward. Six crush measurements were documented at the mid-door level as follows: $C_1 = 0$ cm, $C_2 = 3.0$ cm (1.2 in), $C_3 = 7.0$ cm (2.8 in), $C_4 = 4.0$ cm (1.6 in), $C_5 = 13.0$ cm (5.1 in), $C_6 = 0$ cm. The maximum crush was located between C_4 and C_5 and measured 17.0 cm (6.7 in). The height of the maximum door crush was 47.0 cm (18.5 in) and the Door Sill Differential (DSD) was 6.0 cm (2.4 in). The Collision Deformation Classification (CDC) for the side impact with the other vehicle was 08LYAW3.

Figure 5. 2012 Hyundai Elantra, side damage

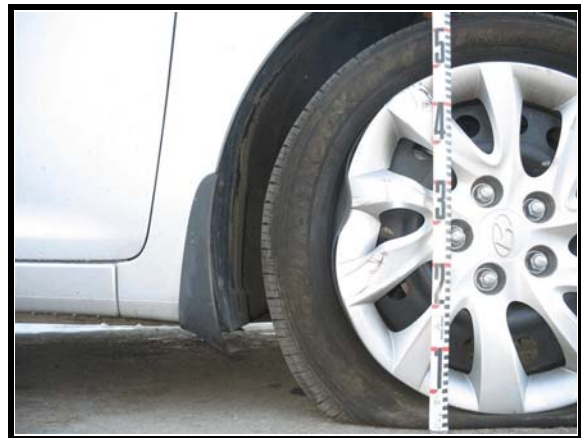
The Hyundai sustained minor damage to the right front tire that was caused by a curb impact (**Figure 6**). The rim was deformed 2.0 cm (0.8 in) and the tire was de-beaded. The CDC for this impact was 12FRWN3.

Figure 6. 2012 Hyundai Elantra, right front rim damage

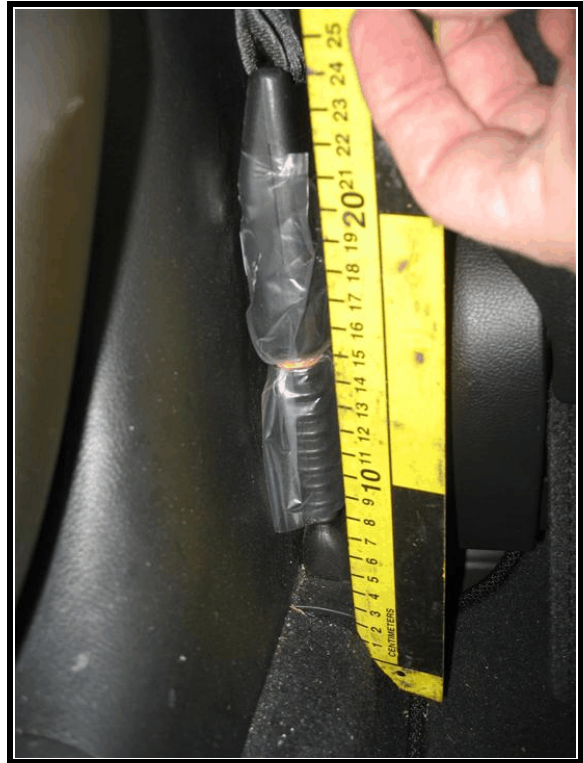
Figure 7. Left anchorage pretensioner

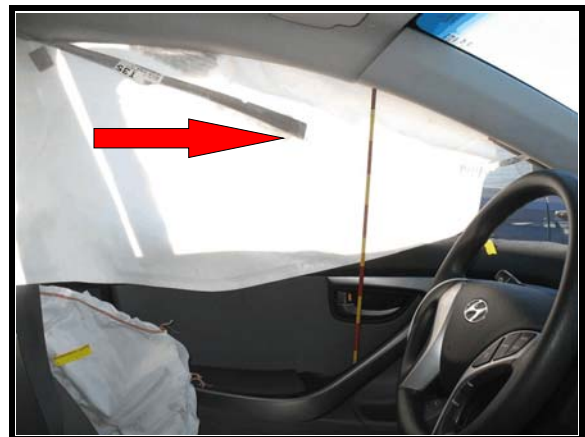
The left IC air bag deployed through the headliner from the module mounted to the roof side rail (**Figure 8**). The air bag was rectangular in shape with an overall length of 166.0 cm (65.3 in) and an overall height of 37.0 cm (14.6 in). The air bag overlapped the lower window frame by 7.0 cm (2.8 in). The leading edge of the air bag was attached to the A-pillar by a 8.0 cm (3.1 in) tether. The air bag extended to the C-pillar, providing coverage for both seating rows. At a point 121.0 cm (47.6 in) forward of the C-pillar, the air bag height decreased until it measured 14.0 cm (5.5 in) at the A-pillar. Aft of the A-pillar, there was a triangular area of side glass not covered by the air bag. The area measured 25.0 cm (9.8 in) in length and 14.0 cm (5.5 in) in height. There was no contact evidence or damage to the air bag. The left seat-mounted side air bag deployed forward from the seat back. The air bag was semi-circular in shape with a height of 47.0 cm (18.5 in) and width of 20.0 cm (7.9 in) extending forward from the seat back. The air bag was configured with a 9.0 cm

Figure 8. 2012 Hyundai Elantra, left IC air bag. Metal stiffener identified by red arrow.

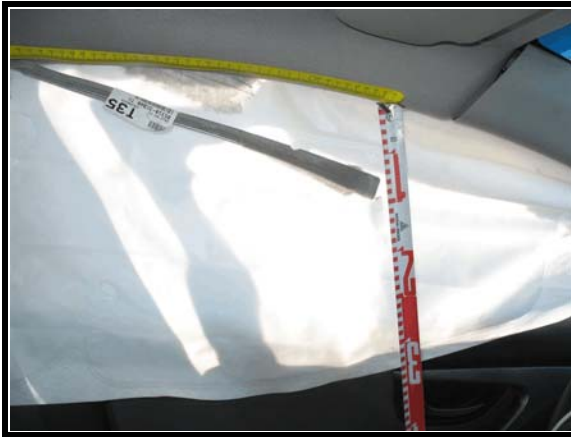
During the left IC air bag deployment, a metal support bracket/stiffener that was attached to the headliner partially detached from the front and was displaced downward into the passenger compartment (**Figure 9**). The support bracket was glued/taped to the liner and measured 93.0 cm (36.6 in) in total length. The exposed section began 4.0 cm (1.6 in) forward of the B-pillar and extended 42.0 cm (16.5 in) forward from that point (**Figure 10**). The end of the bracket was 4.0 cm (1.6 in) wide, V-shaped, and 1.5 cm (0.6 in) deep (**Figure 11**). The end was located 9.0 cm (3.5 in) below the liner and 15.0 cm (5.9 in) above the window frame. The aft end of the bracket remained affixed to the roof liner (**Figure 12**). A recall involving the support bracket was reported on April 1, 2013 (NHTSA Campaign Number: 13V11500).

Figure 9. 2012 Hyundai Elantra, left IC air bag metal stiffener

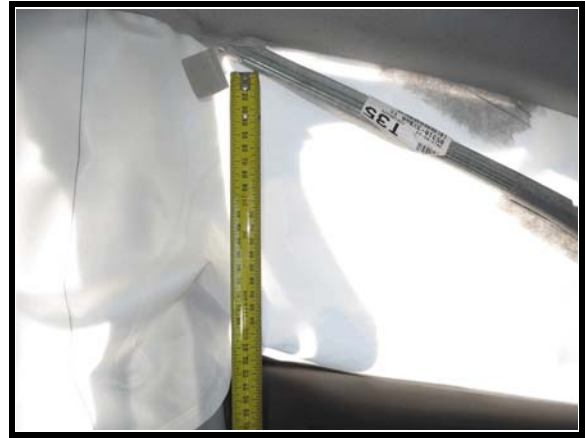
Figure 10. Stiffener position just forward of B-pillar

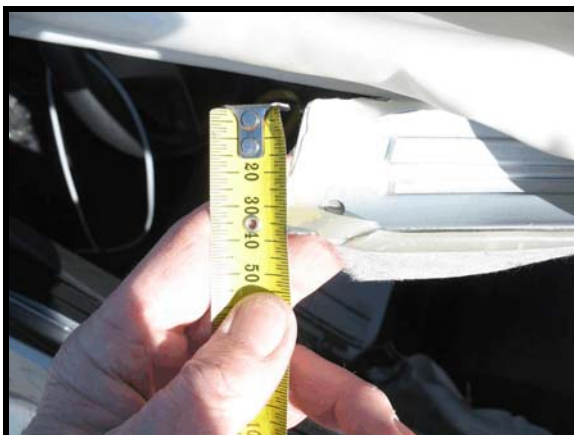
Figure 11. Forward end of metal stiffener

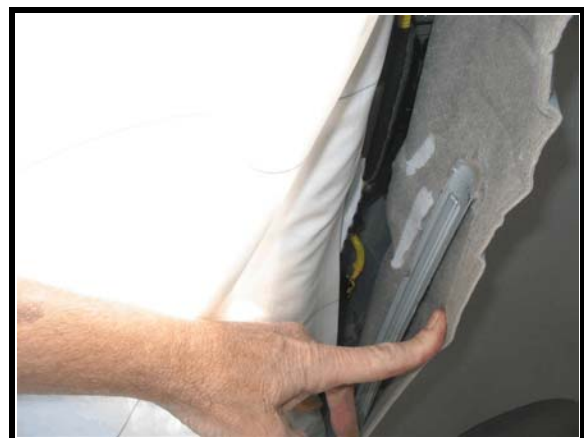
Figure 12. Aft aspect of metal stiffener (looking forward)
