**FTS Report**

Dealer Code	Model*	Year*	Mileage*	VIN*	Route to
FL080	SantaFe	2011	1220	5XYZG3ABXBG007975	FTS

**Subject\*:**  
2011 SANTA FE CM HARD TO STEER.

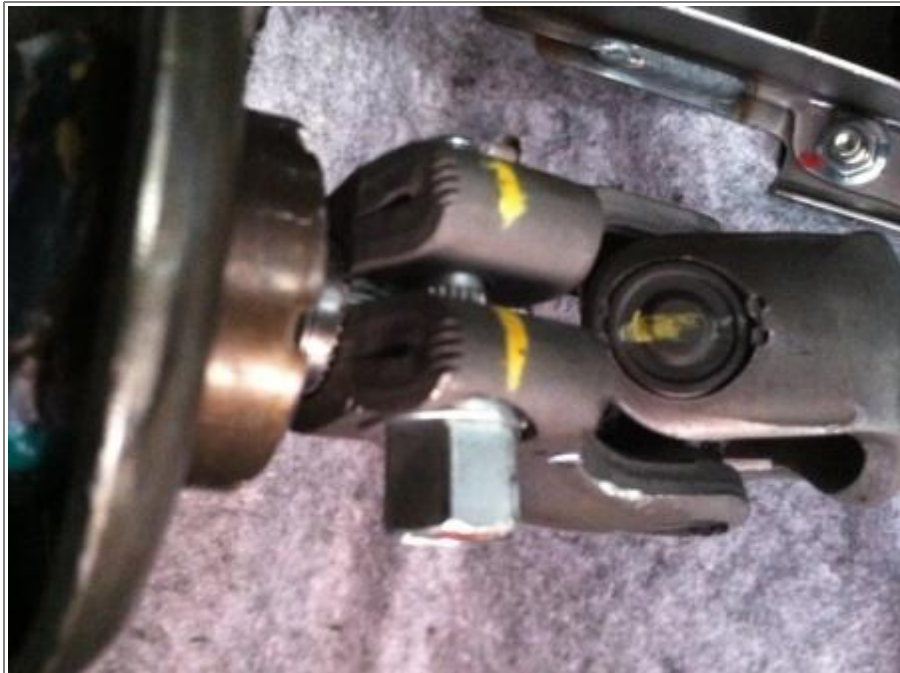
**Condition\*:**  
BOLT BACKED OUT OF COLUMN, DAMAGING STEERING ANGLE SENSOR AND CLOCKSPrING. REINSTALLED BOLT AND TORQUED TO CORRECT SPECS. REPLACED STEERING ANGLE SENSOR AND CLOCKSPrING.

LOWER STEERING COLUMN JOINT BOLT WAS UNDER TORQUED

STEERING SHAFT BOLT AFTER  
FINAL TORQUE

RE-TORQUE SHAFT BOLT, INSTALL CLOCK SPRING AND STEERING ANGLE SENSOR.
