DP12-002

ATTACHMENT Q9

QARS VAS\_Unintended brake  
operation during driving 10-13-  
05(EJ) REDACTED Final

**QUALITY IMPROVEMENT SHEET (Q.I.S.)**

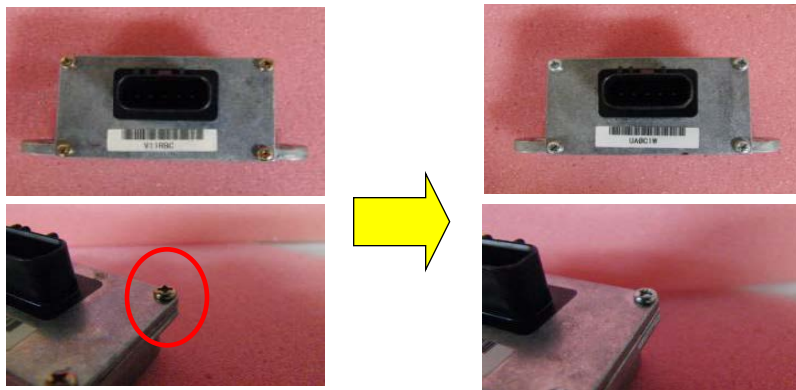
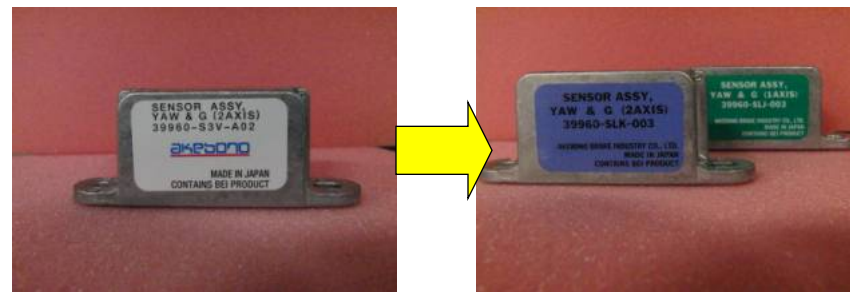
Forming screw (Plating change:Cr+6 ->Cr+3)

Non Pb free type -> Pb free type
