DP12-006

FORD

Appendix D

Appendix D - Litigation
Prevention Files

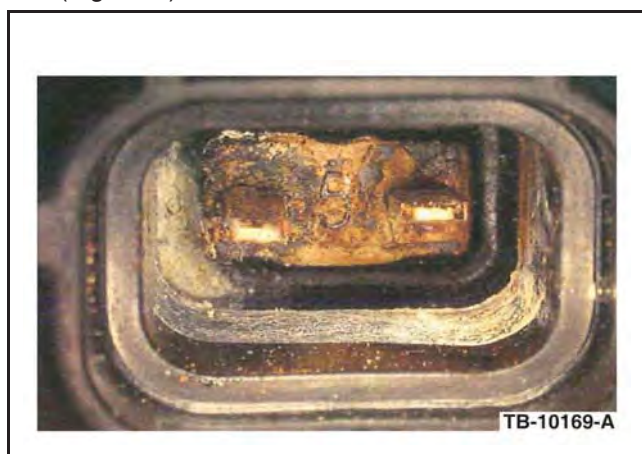
Figure 1 - Article 11-10-5

Engine temperature concerns may be due to corrosion at connector C1164.

3. If corrosion from water contamination is severe and terminals are rusted and disintegrated: (Figure 1)

- a. Cut off connector C1164 and install a new pigtail connector. Refer to instruction sheet.
 - b. Replace the CHT sensor. Refer to Workshop Manual (WSM), Section 303-14. Proceed to Step 4.
4. If corrosion is not severe, remove any water and thoroughly clean connector C1164 and the CHT sensor.
 5. Before reattaching the CHT sensor cover to the cam cover, clean the cam cover and CHT sensor cover with Motorcraft® Metal Brake Parts Cleaner.

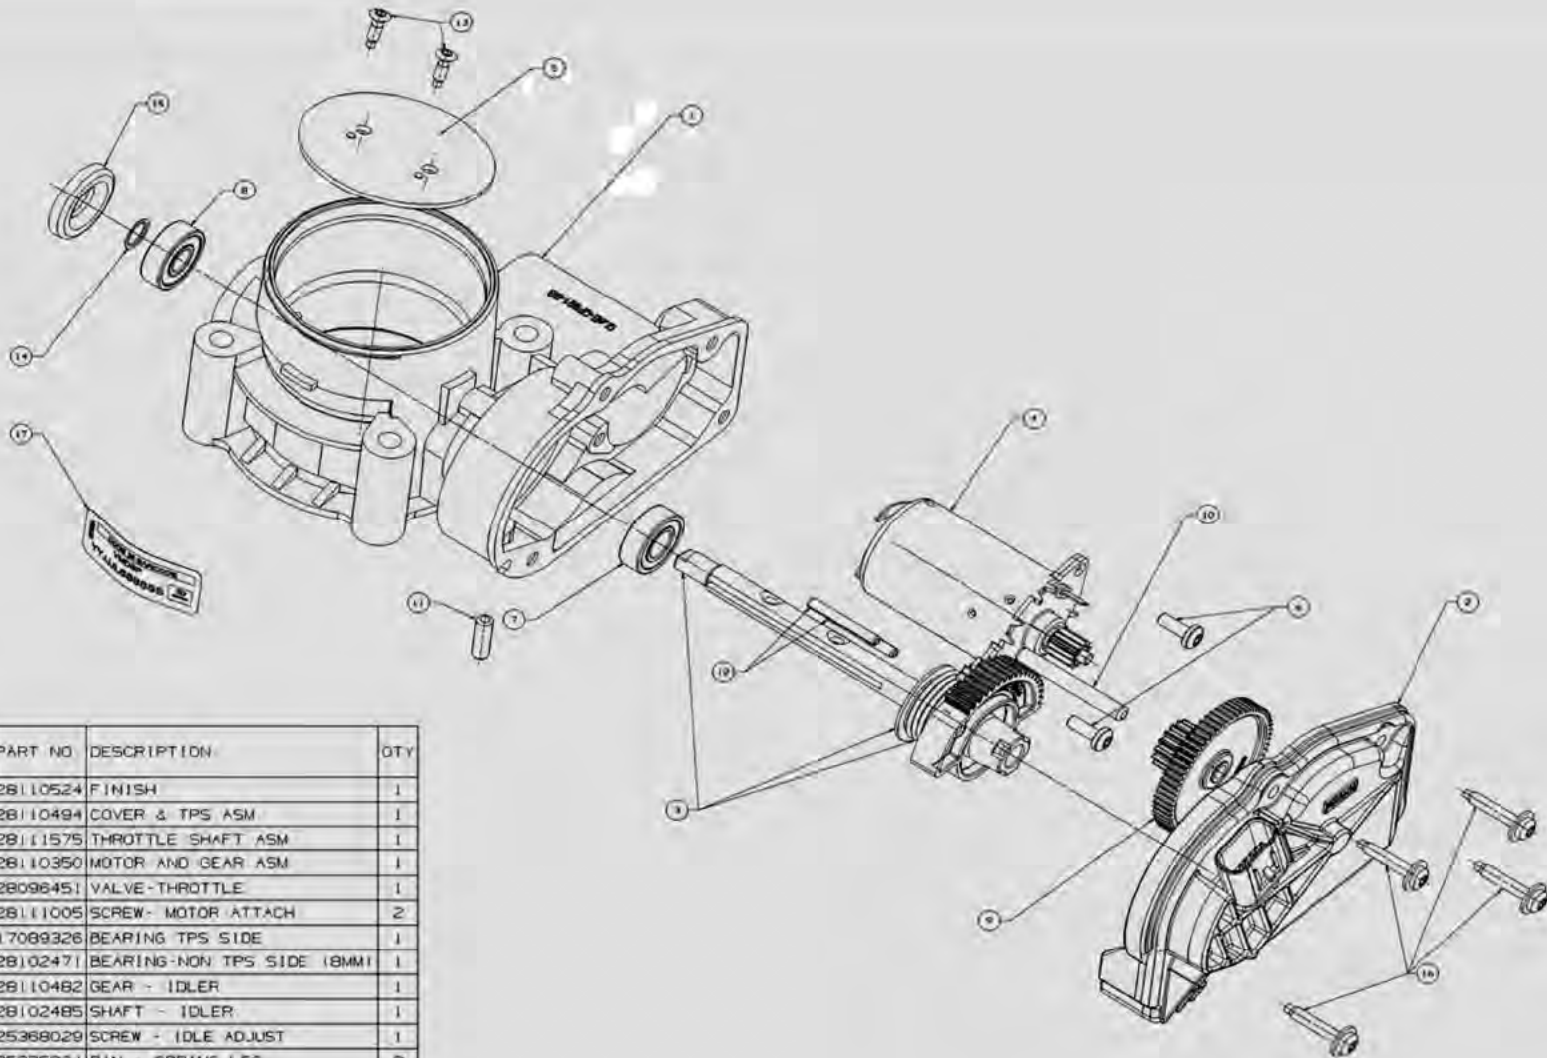
[REDACTED]
Here is an exploded view of the 9L8E-9F991-BB. I hope this helps.

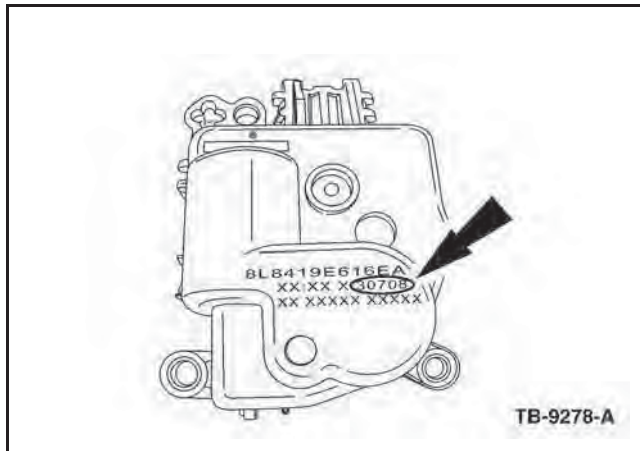
Figure 1 - Article 09-2-3

1. Remove temperature blend door actuator(s) per Workshop Manual (WSM), Section 412-01.
2. Inspect the 5 digit manufacturer's date code on the temperature blend door actuator. It will be the last 5 digits on the second line of manufacturer's data. The first three digits equal day of year. The last two digits equal year. (Figure 1)

- a. If the date code is 30708 or lower - replace the temperature blend door actuator assembly.

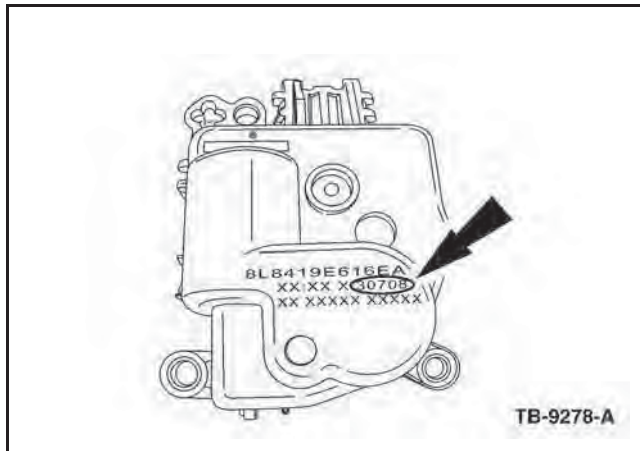
Figure 1 - Article 09-2-3

1. Remove temperature blend door actuator(s) per Workshop Manual (WSM), Section 412-01.
2. Inspect the 5 digit manufacturer's date code on the temperature blend door actuator. It will be the last 5 digits on the second line of manufacturer's data. The first three digits equal day of year. The last two digits equal year. (Figure 1)

- a. If the date code is 30708 or lower - replace the temperature blend door actuator assembly.
