DP12-006 FORD 12/14/2012 Appendix D - Litigation Prevention Files

Walle	d Lake, MI
RE:	2009 Escape
	VIN: 1FMCU94G09K

DP12-006 FORD 12/14/2012 Appendix I Non-Conf - Field Communications

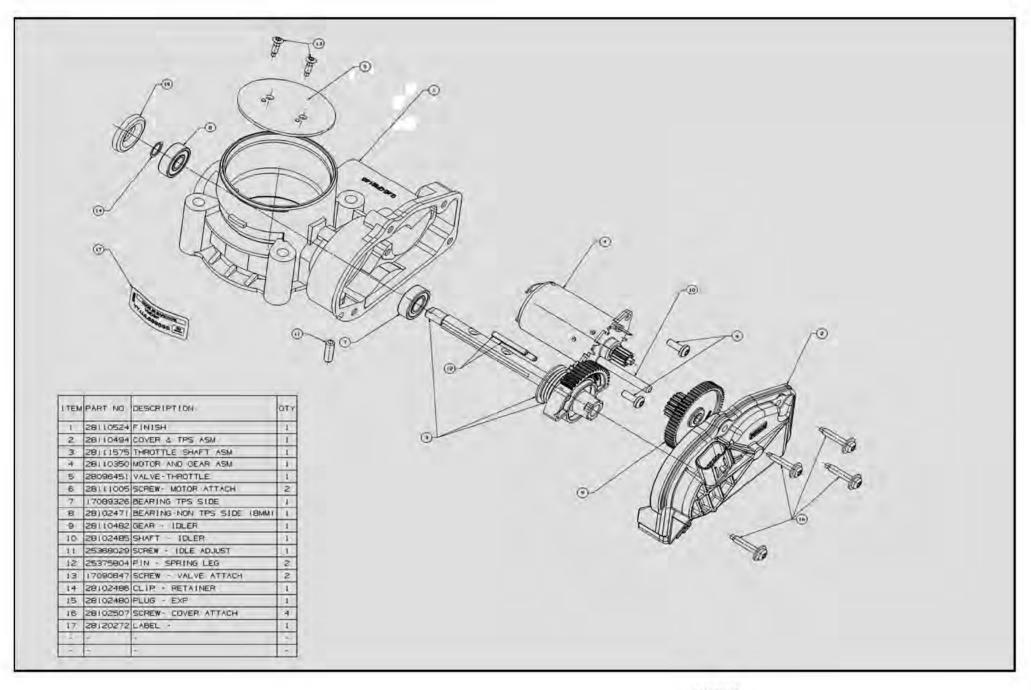
Here is an exploded view of the 9L8E-9F991-BB. I hope this helps.
