PRODUCT ALLEGATION RESOLUTION
PRELIMINARY INSPECTION
FIRE

Customer's Name: [REDACTED] Inspection Date: **10/25/2007**
 Vehicle Brand: Chevrolet Model: 2006 TrailBlazer
 File # 71-566155666 VIN: 1GNET16S166 [REDACTED]

Inspected By: Walter Danes / EAA

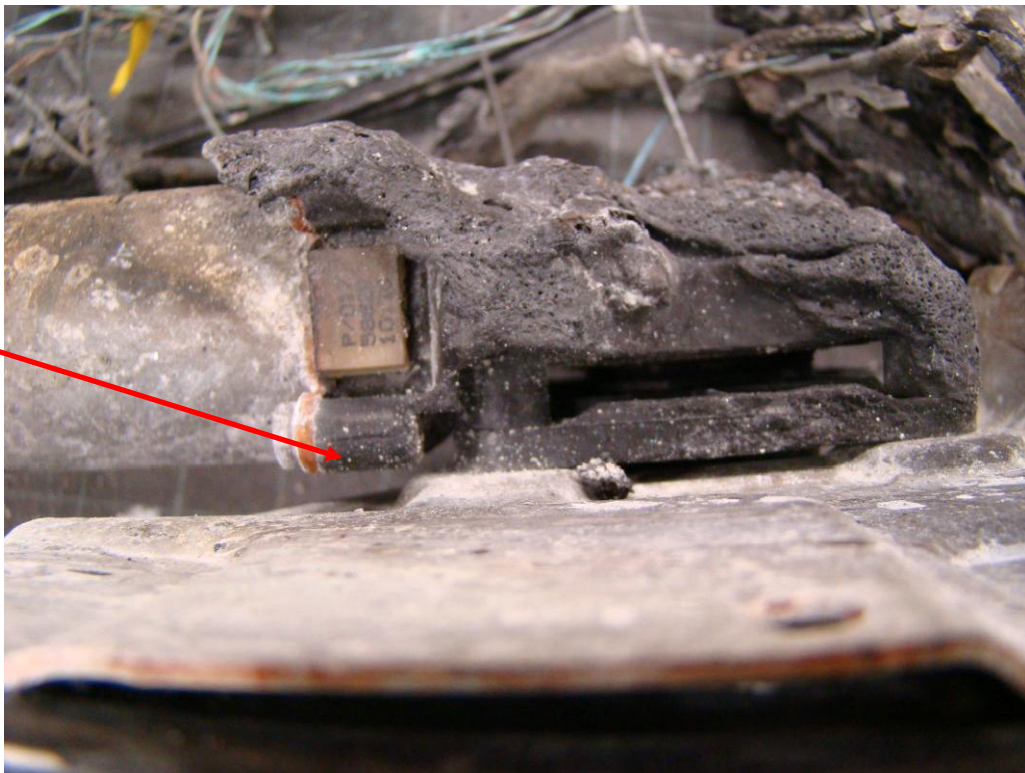
Photograph 1 The internal electrical door components.

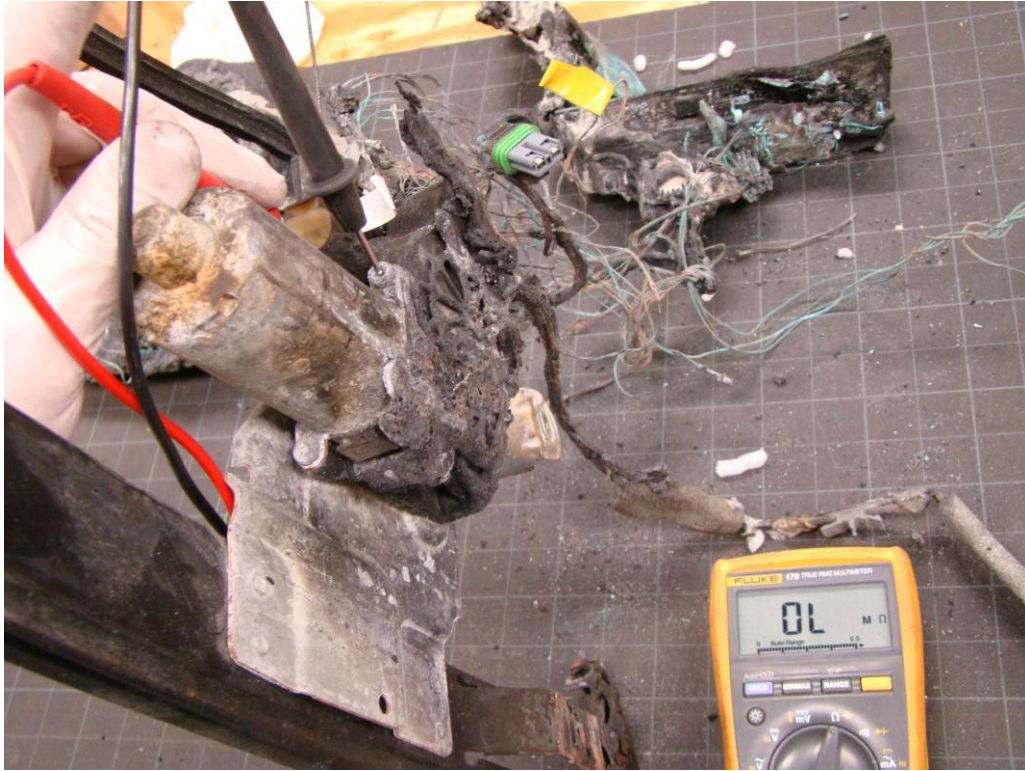
Photograph 2 The motor and pulley housing is shown above. Note the good condition of the lug which is directly mounted to the motor.

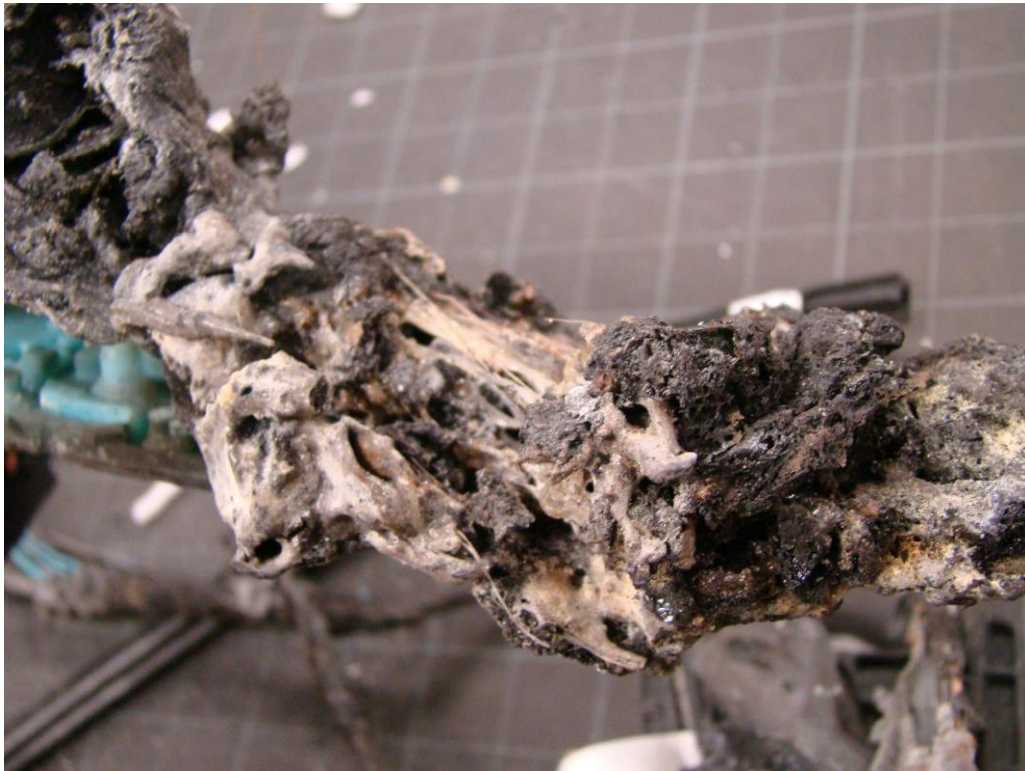
Photograph 5 The most severe damage is located on the control board. No evidence of unusual electrical activities was found during the nondestructive visual inspection.

Photograph 6 It is possible that the origin of the fire lies within the melted components or that the evidence was consumed in the fire.

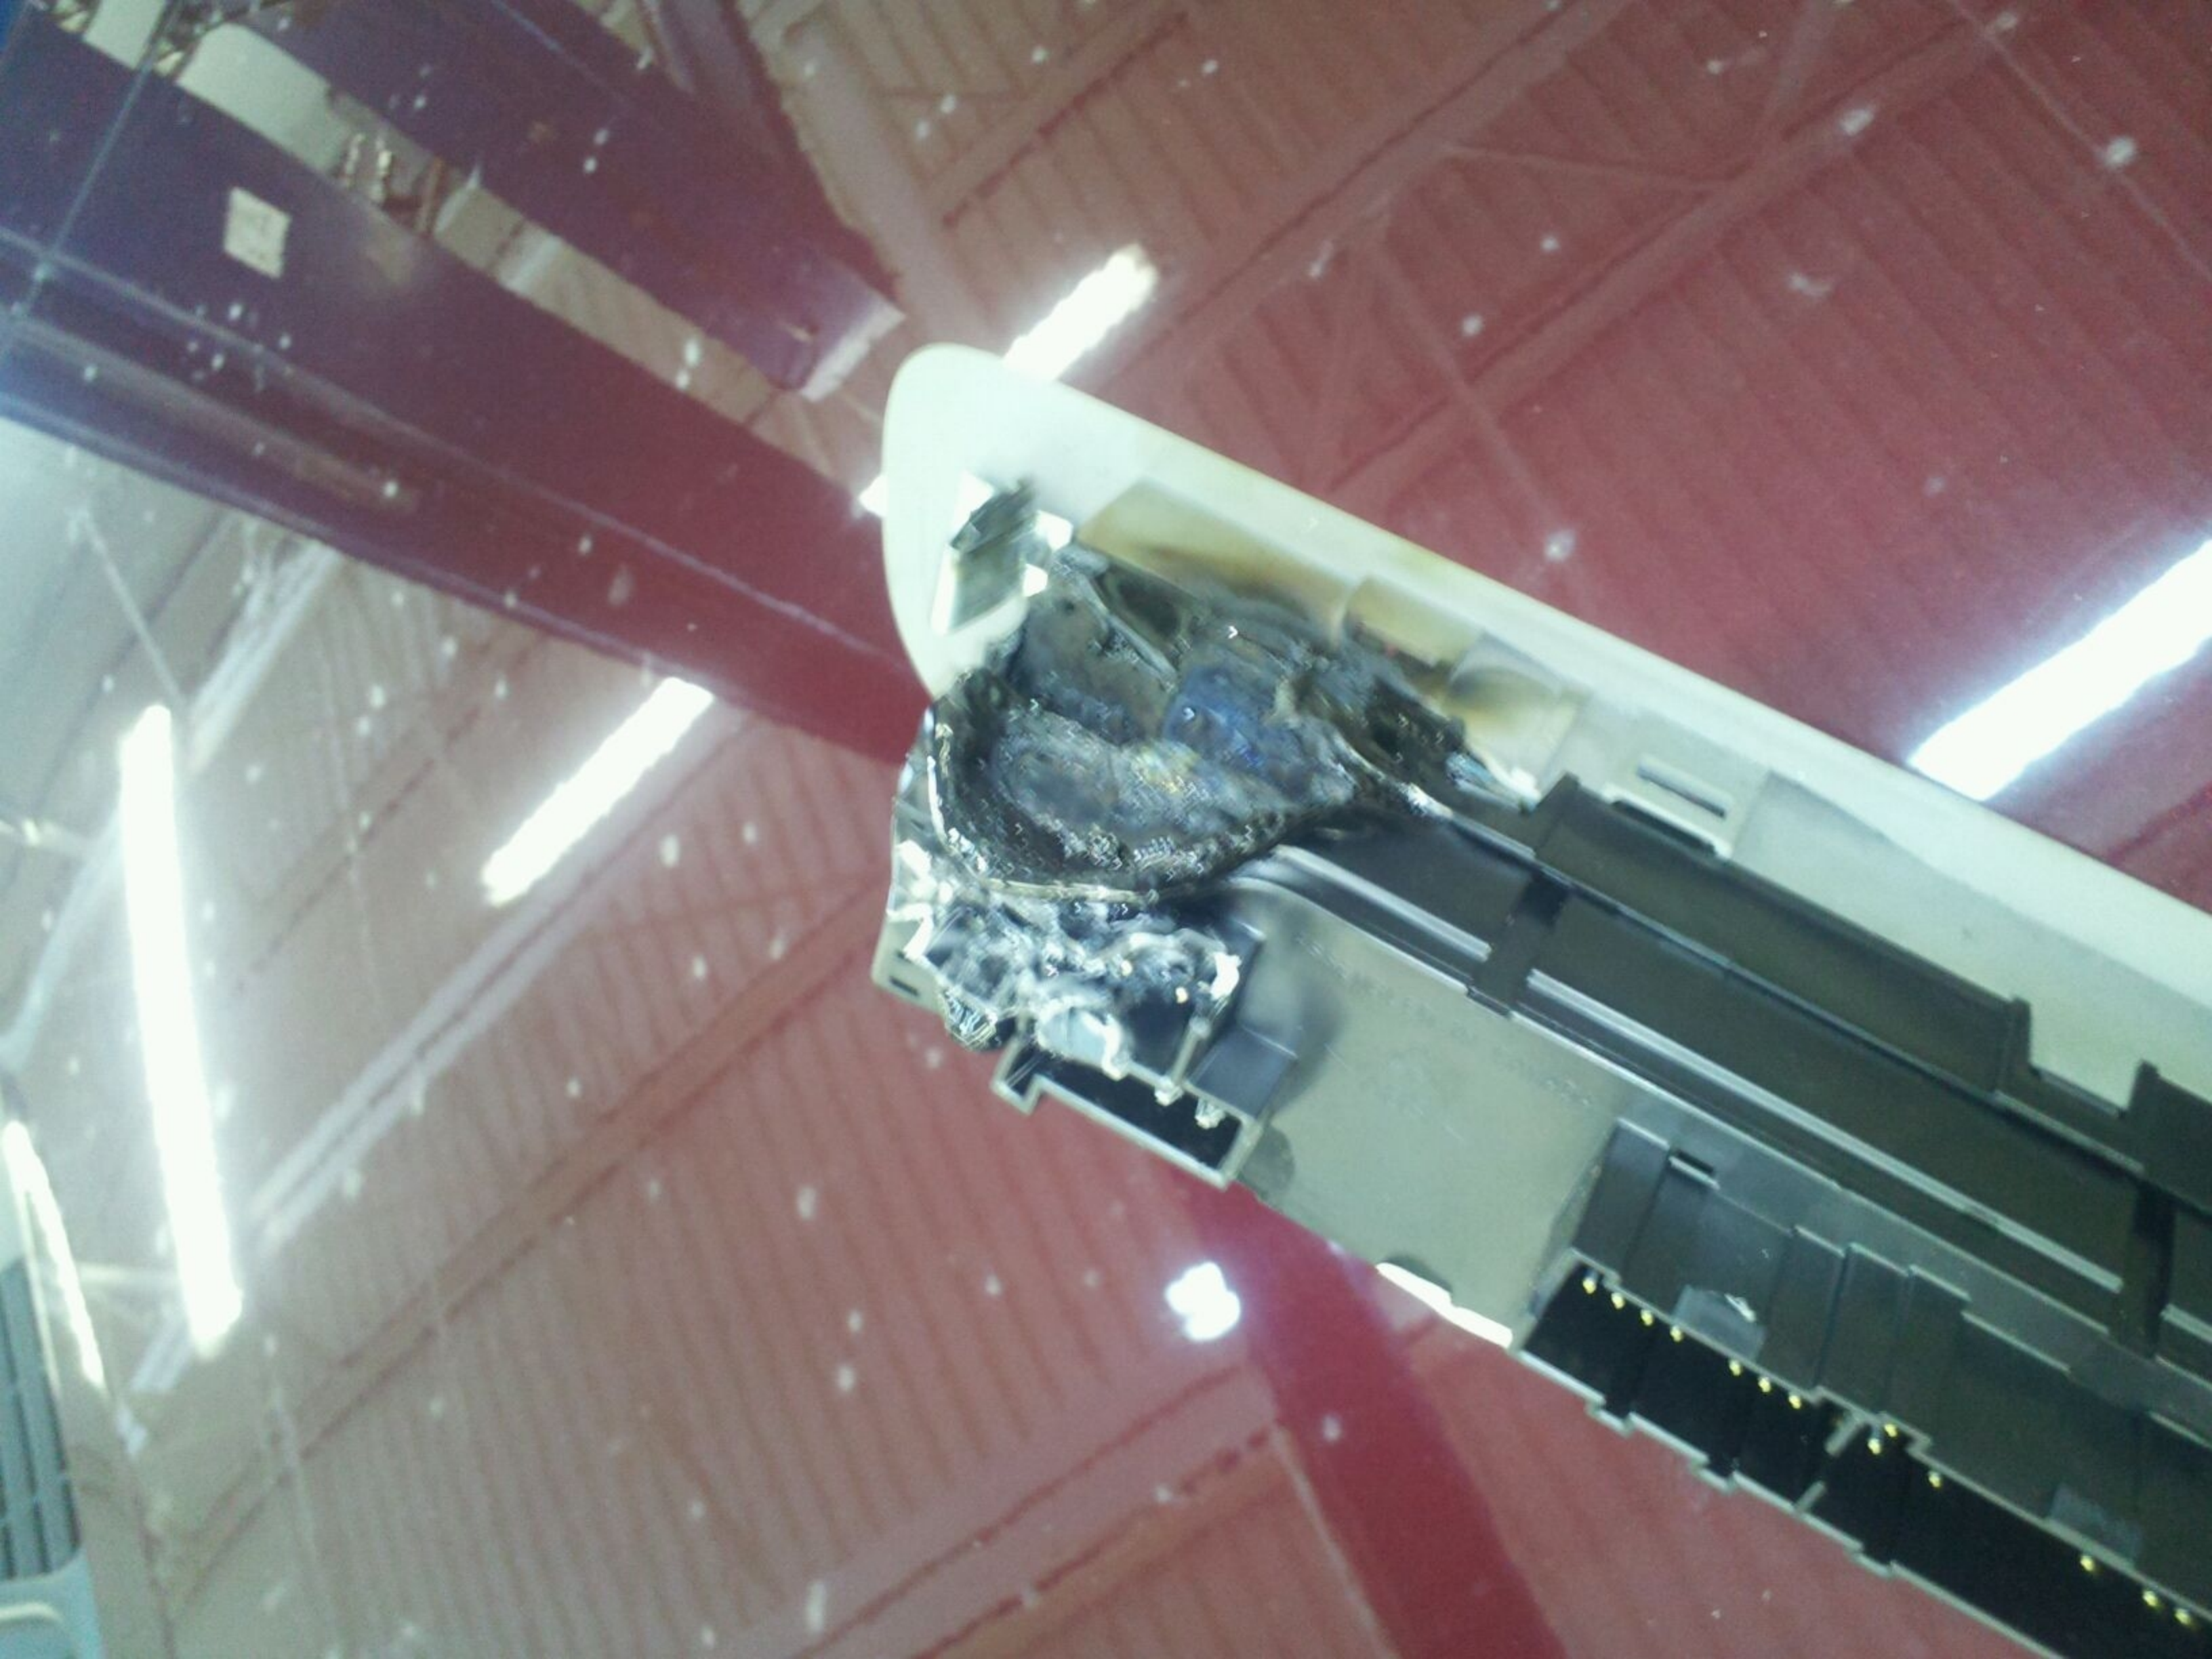
CUSTOMER STATES THAT D.S. DOOR SWITCH STARTED TO SMOKE.

SEE PICTURES; TECH INSPECTED AND FOUND BOTH CONNECTORS HEAVILY DAMAGED DUE TO HEAT

NEC. TO REPLACE SWITCH AND REWIRE BOTH CONNECTORS

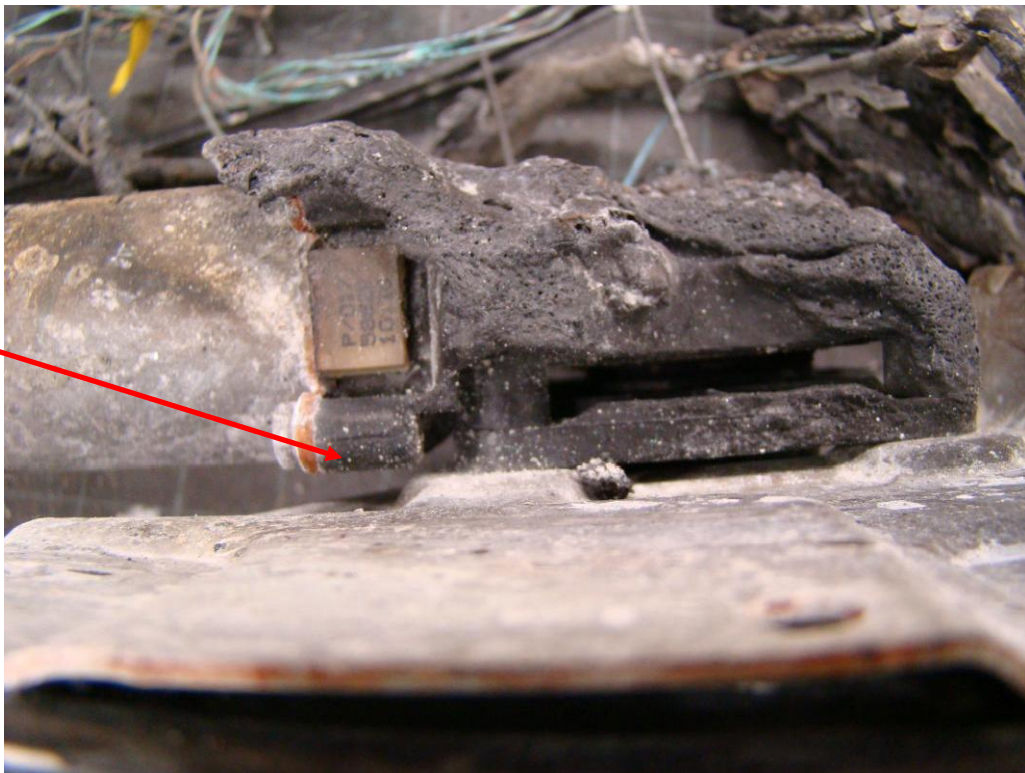
Photograph 1 The internal electrical door components.

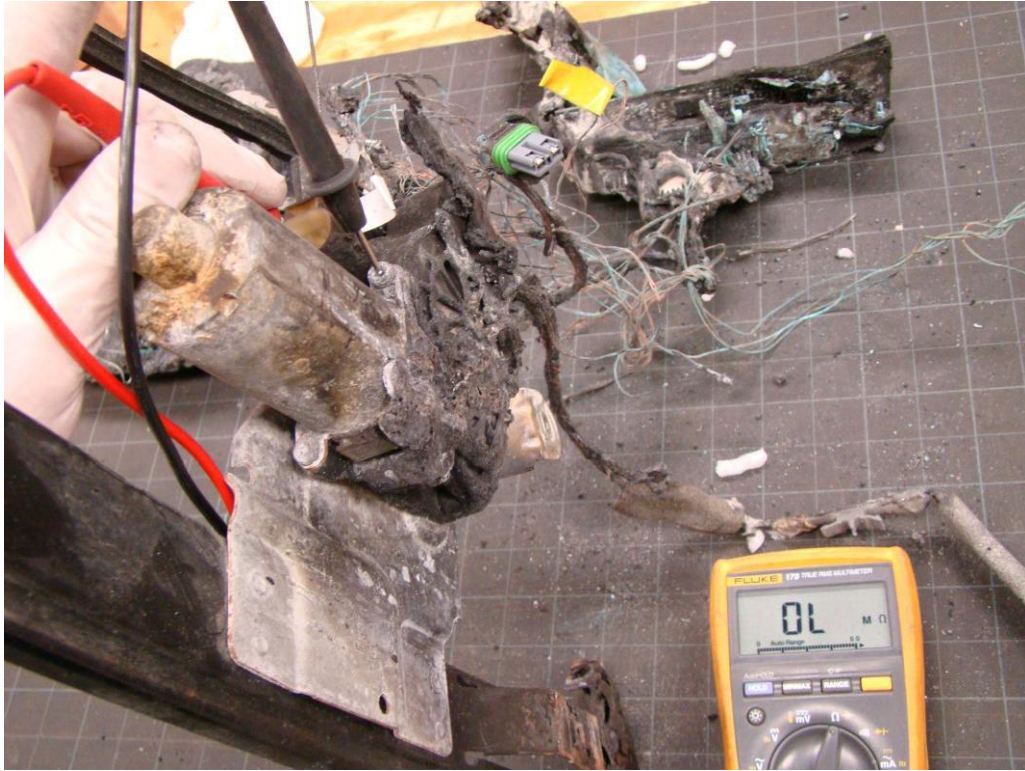
Photograph 2 The motor and pulley housing is shown above. Note the good condition of the lug which is directly mounted to the motor.

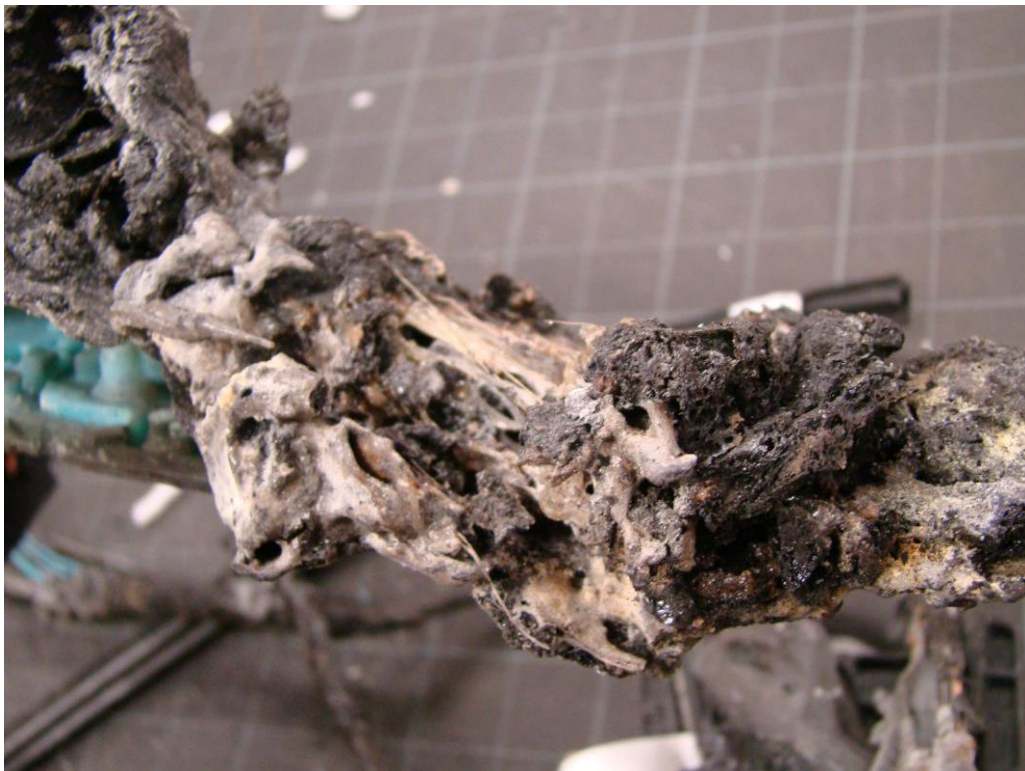
Photograph 5 The most severe damage is located on the control board. No evidence of unusual electrical activities was found during the nondestructive visual inspection.

Photograph 6 It is possible that the origin of the fire lies within the melted components or that the evidence was consumed in the fire.

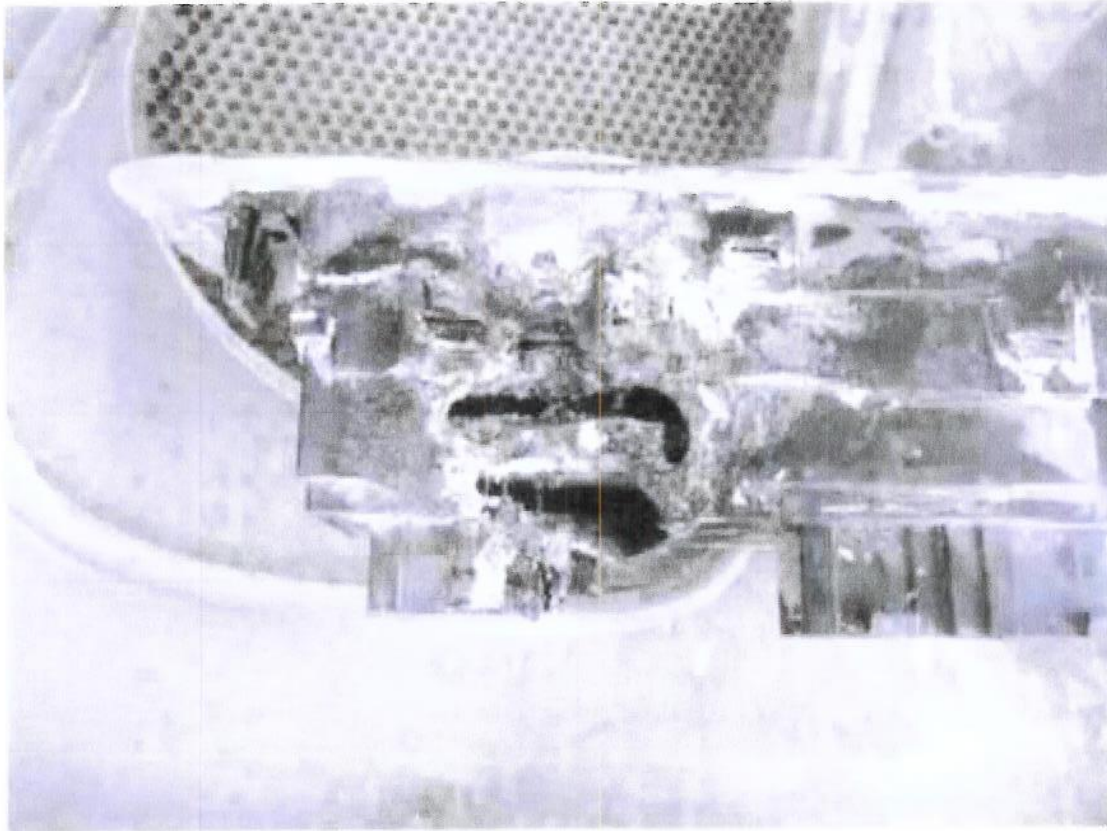
Claim Reference ID: 010171005942001

FIRE STARTED IN SWITCHES

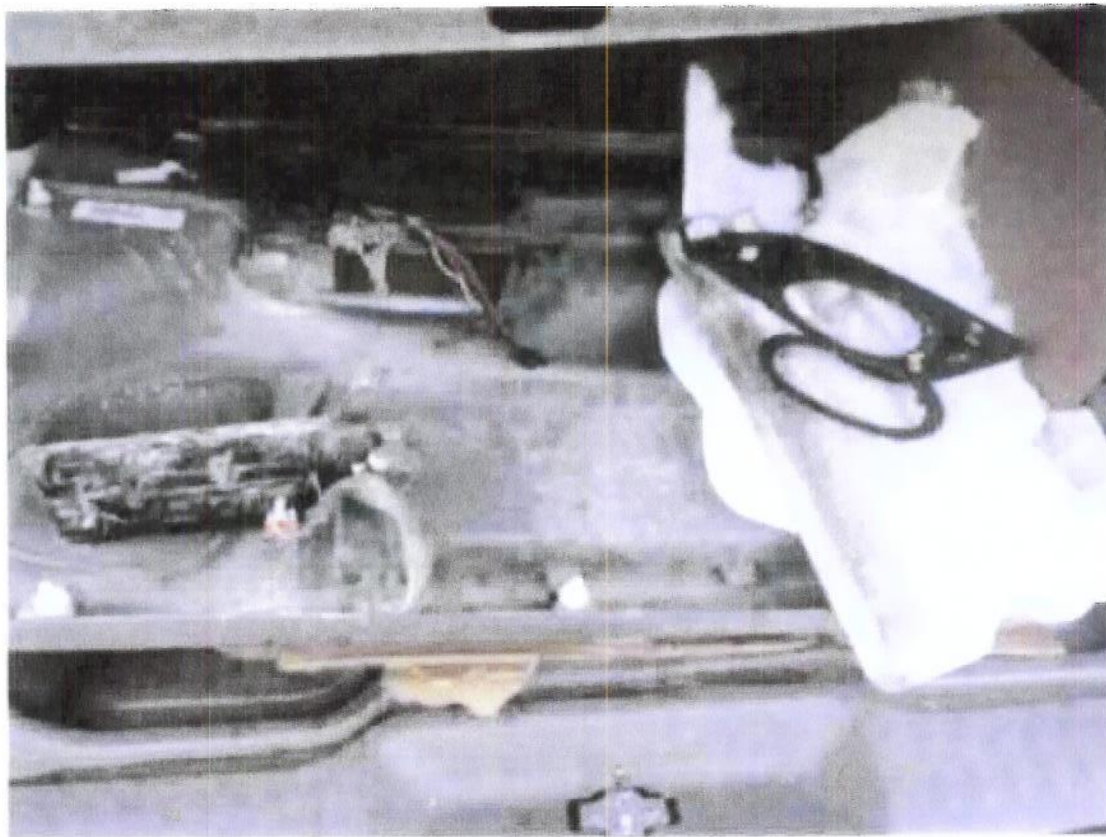
Claim Reference ID: 01017106944001

INNER PANEL DAMAGED

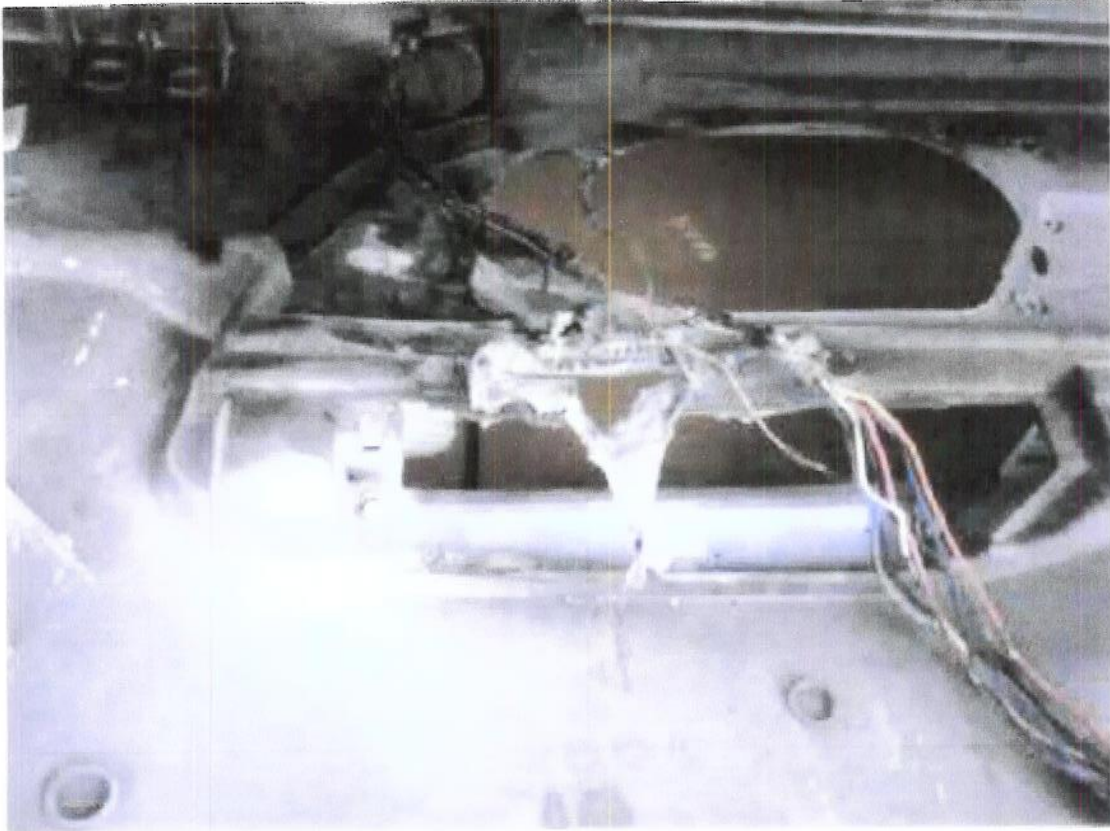
Claim Reference ID: 010171008547601

DOOE PANEL DAMAGED
