PE12-007

MCI

Response 10

# FULL VEHICLE TESTING AND TAG AXLE STEERING ANALYSIS

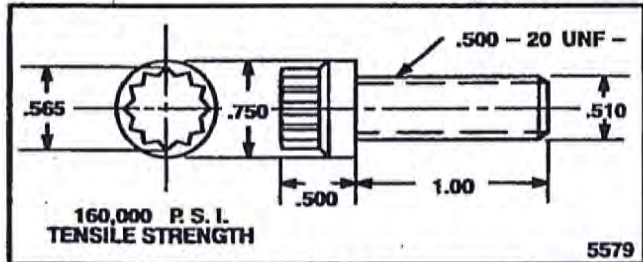
Figure 2. Driveshaft Half Round Yoke Bolts.

The recommended torque value for the retaining cap journal bearing capscrews is 35-39 foot-pounds (47-53 N-m). The recommended torque value for the half round journal bearing capscrews (Figure 2 is 115-135 foot-pounds (156-183 N-m).

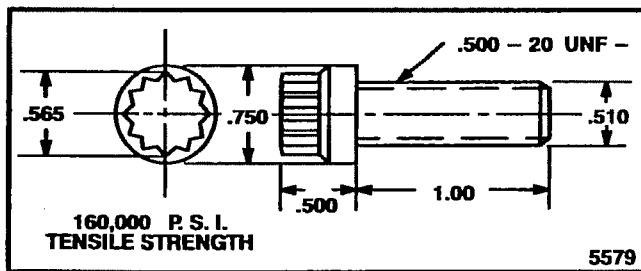
Figure 2. Driveshaft Half Round Yoke Bolts.

The recommended torque value for the retaining cap journal bearing capscrews is 35-39 foot-pounds (47-53 N-m). The recommended torque value for the half round journal bearing capscrews (Figure 2) is 115-135 foot-pounds (156-183 N-m).

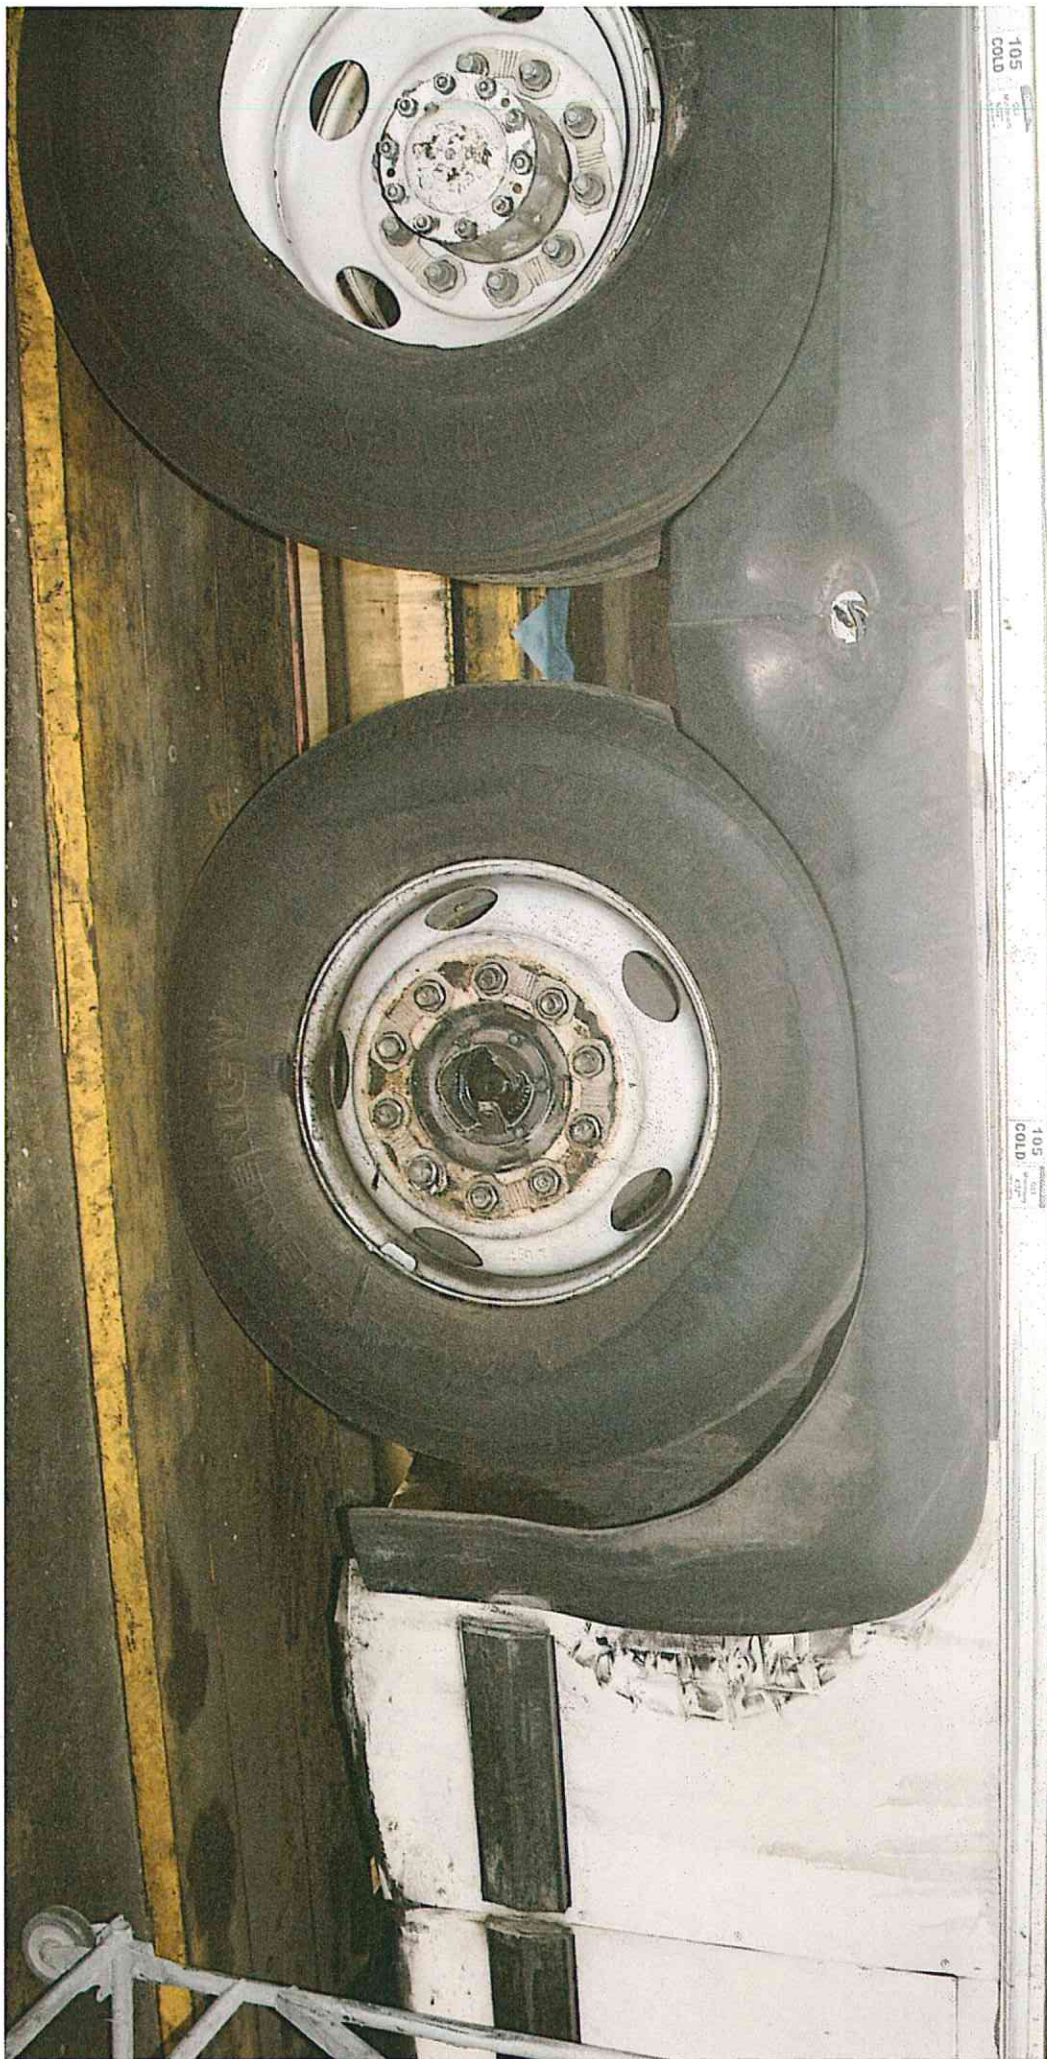
Photos - Damage Rear Drivers  
Side

**PHOTOS OF  
DAMAGE TO  
REAR  
DRIVER'S  
SIDE**

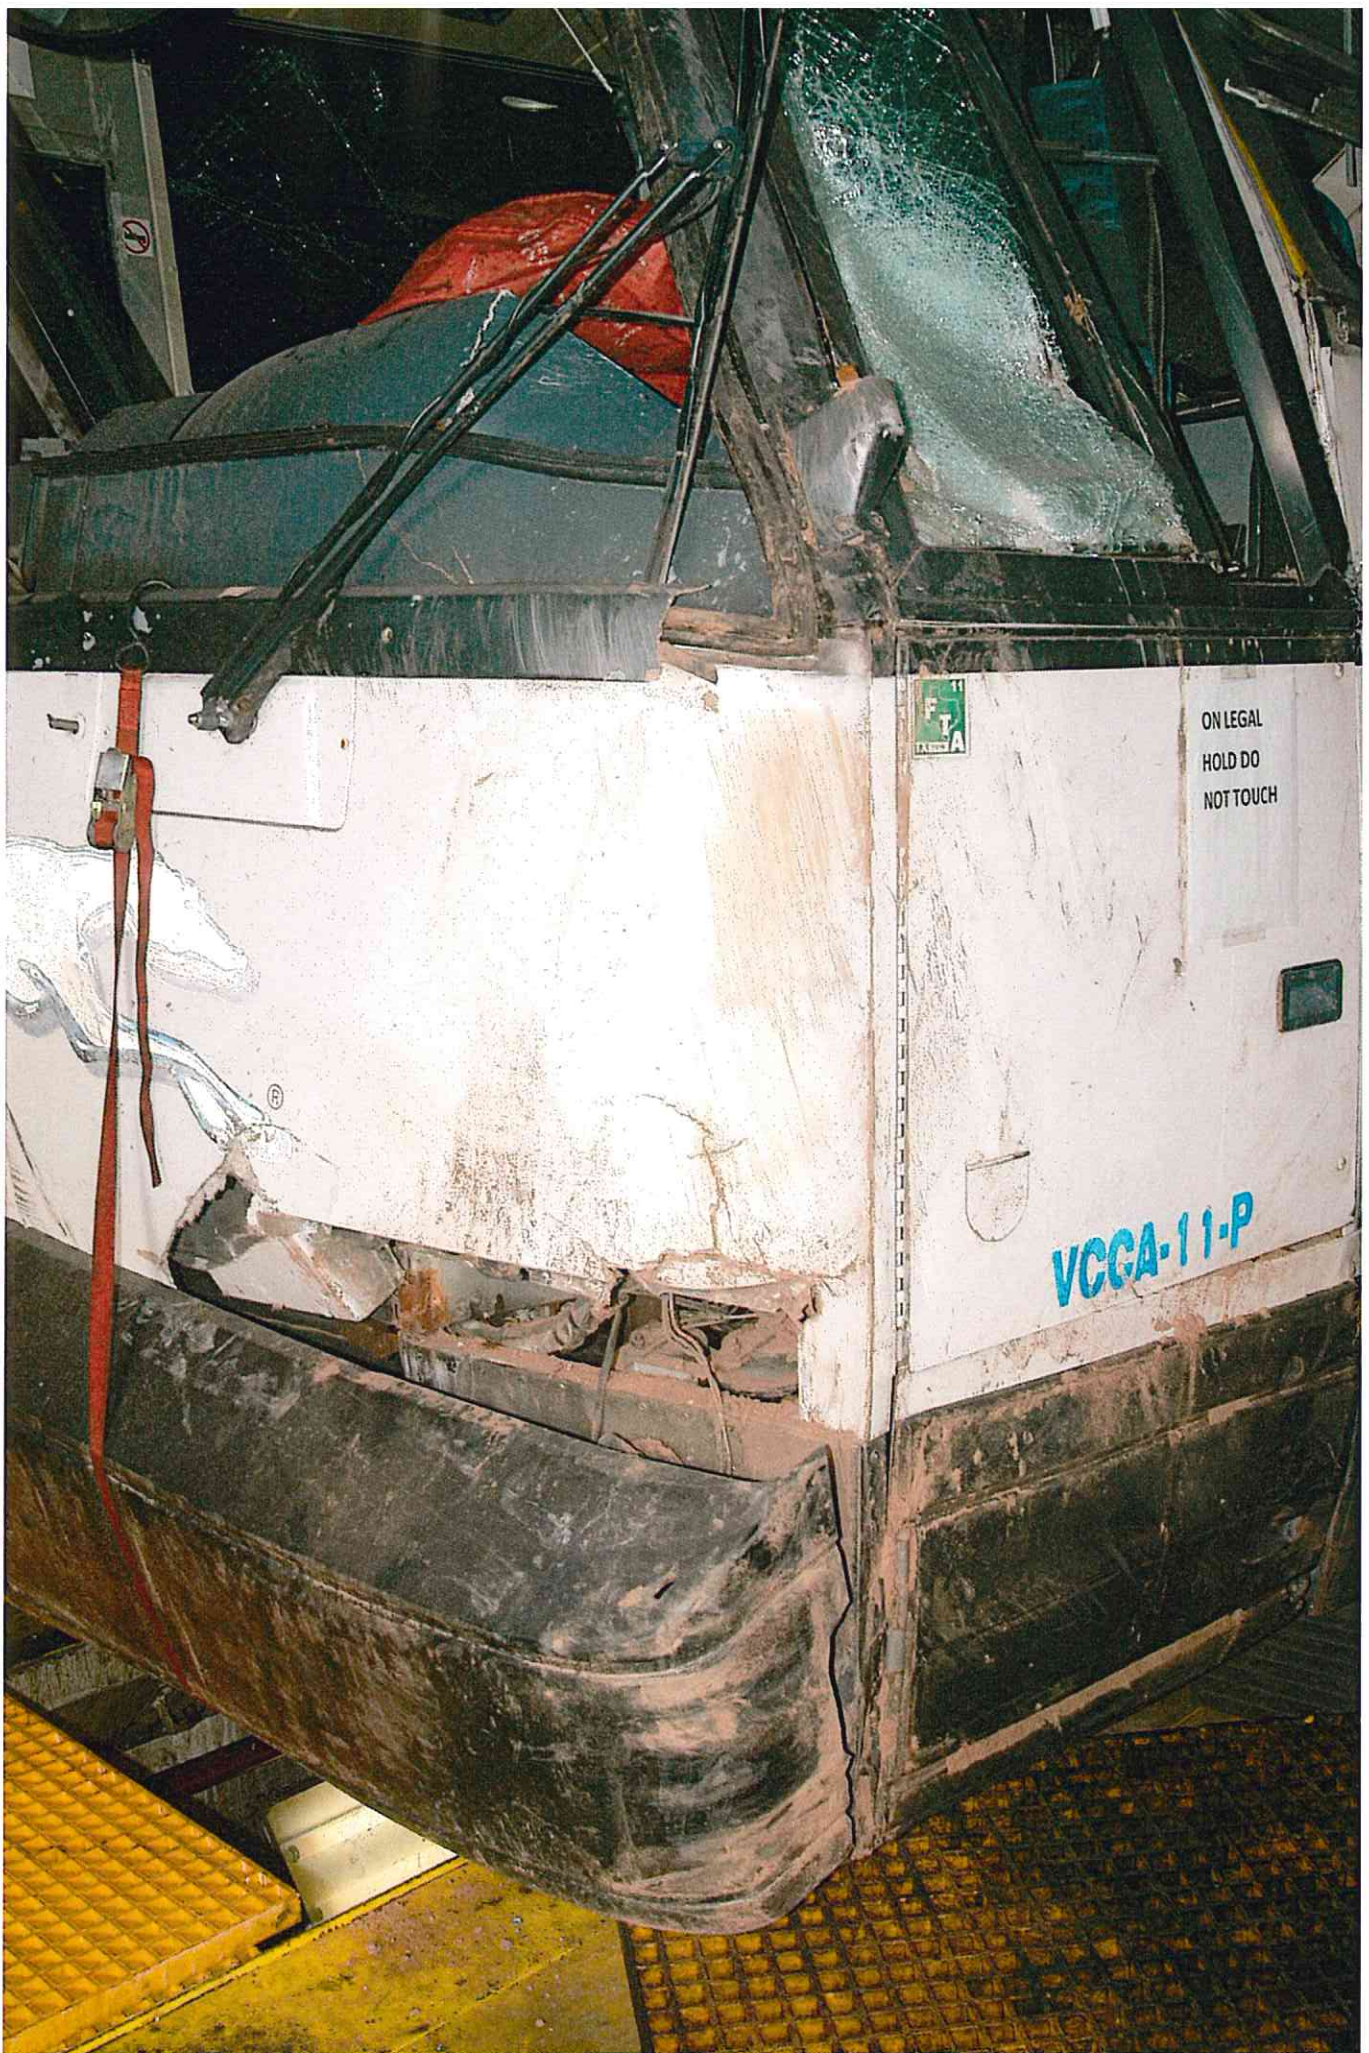
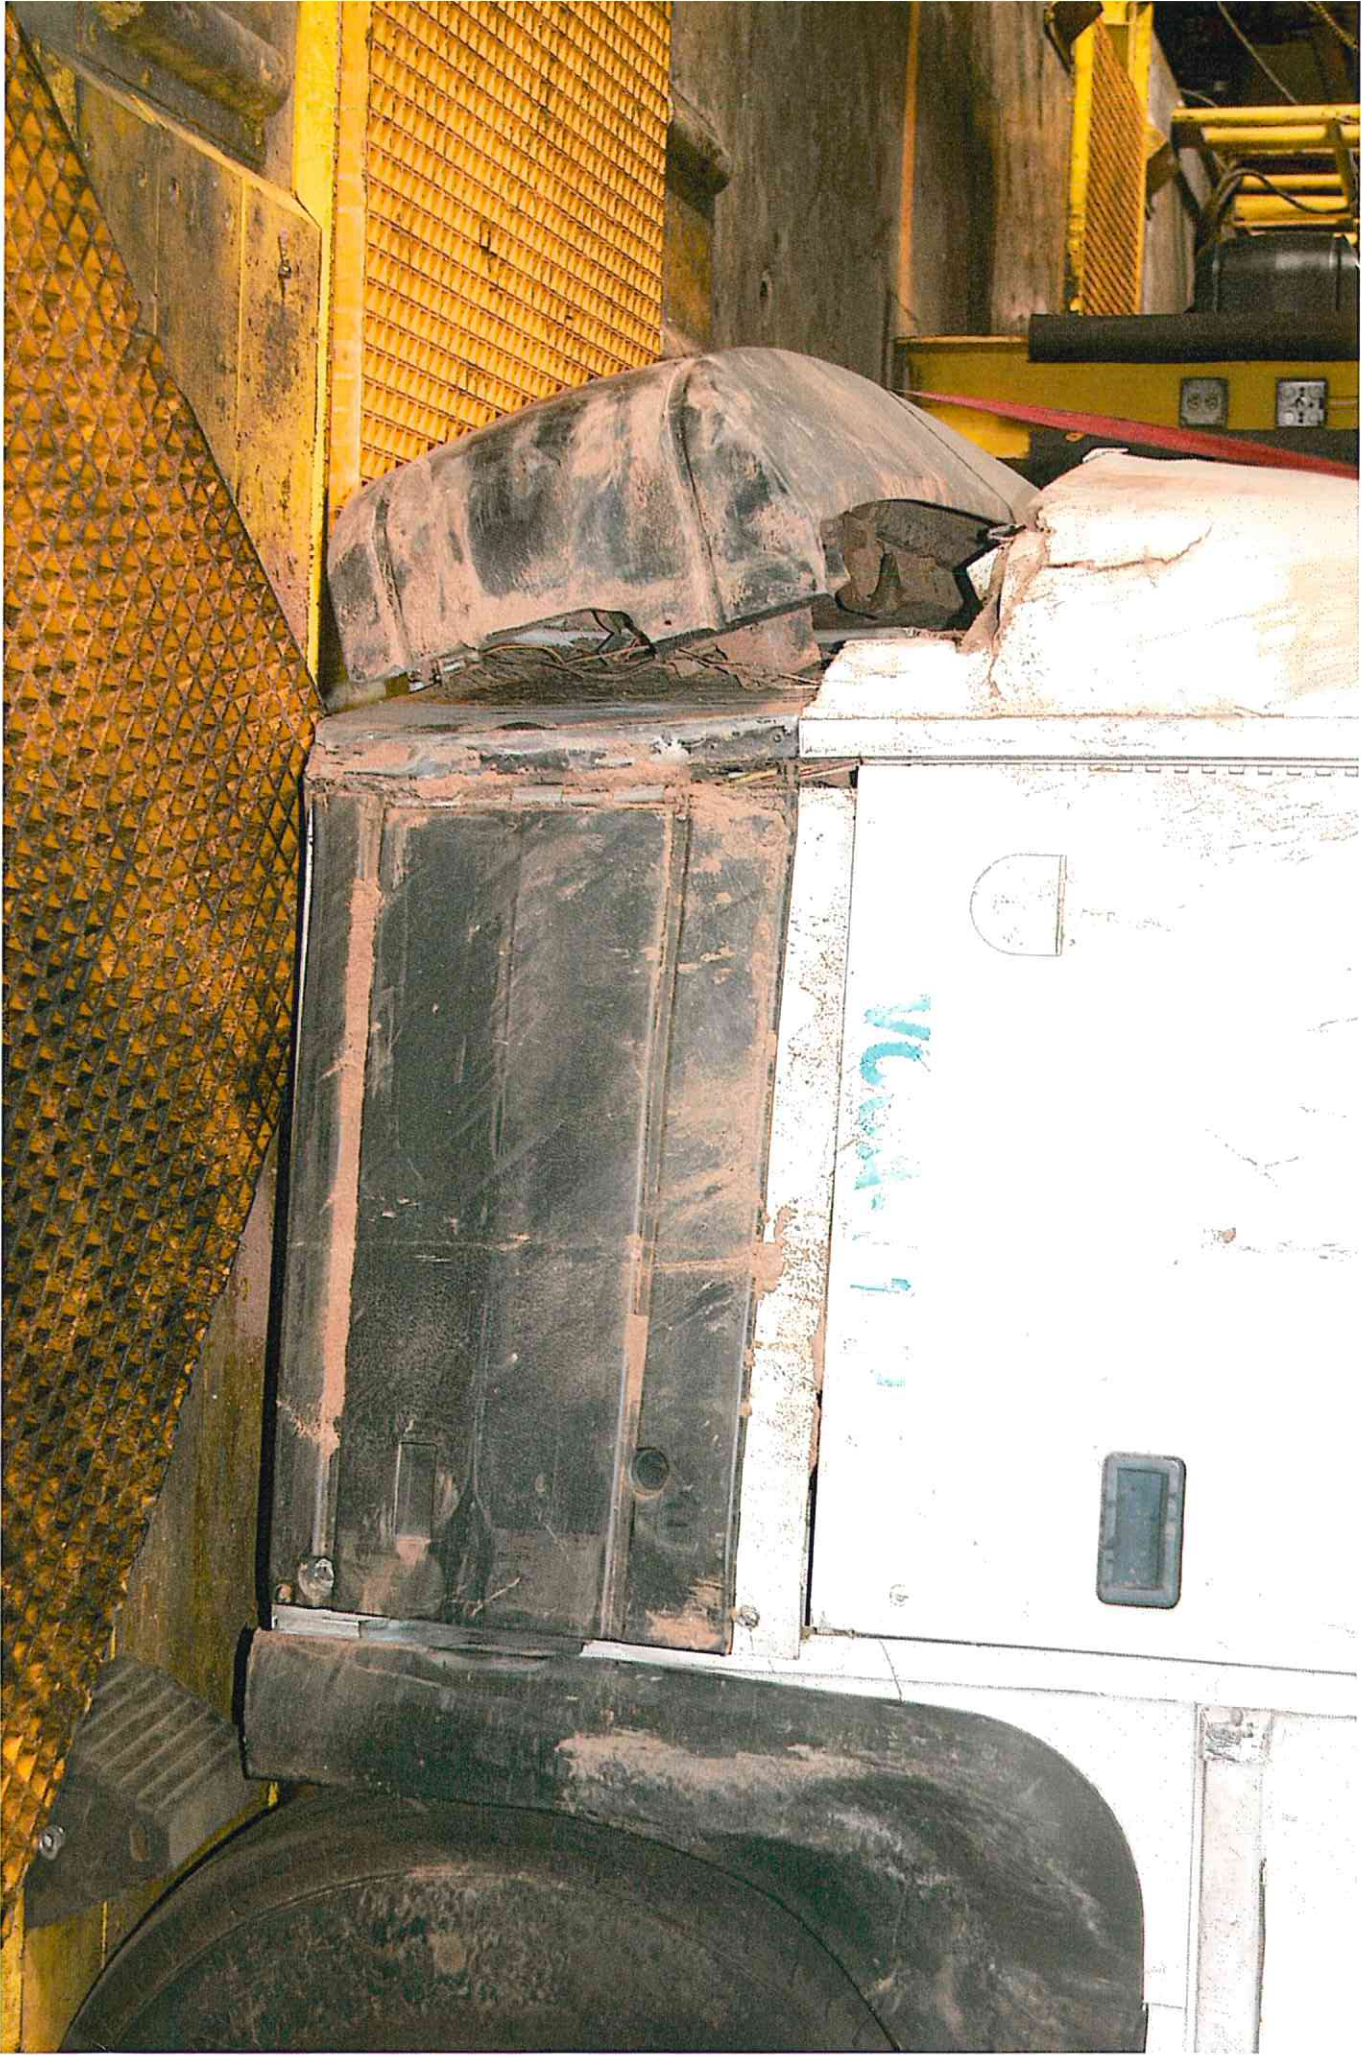
Photos - Damage to Front Left

**PHOTOS OF  
DAMAGE TO  
FRONT LEFT**

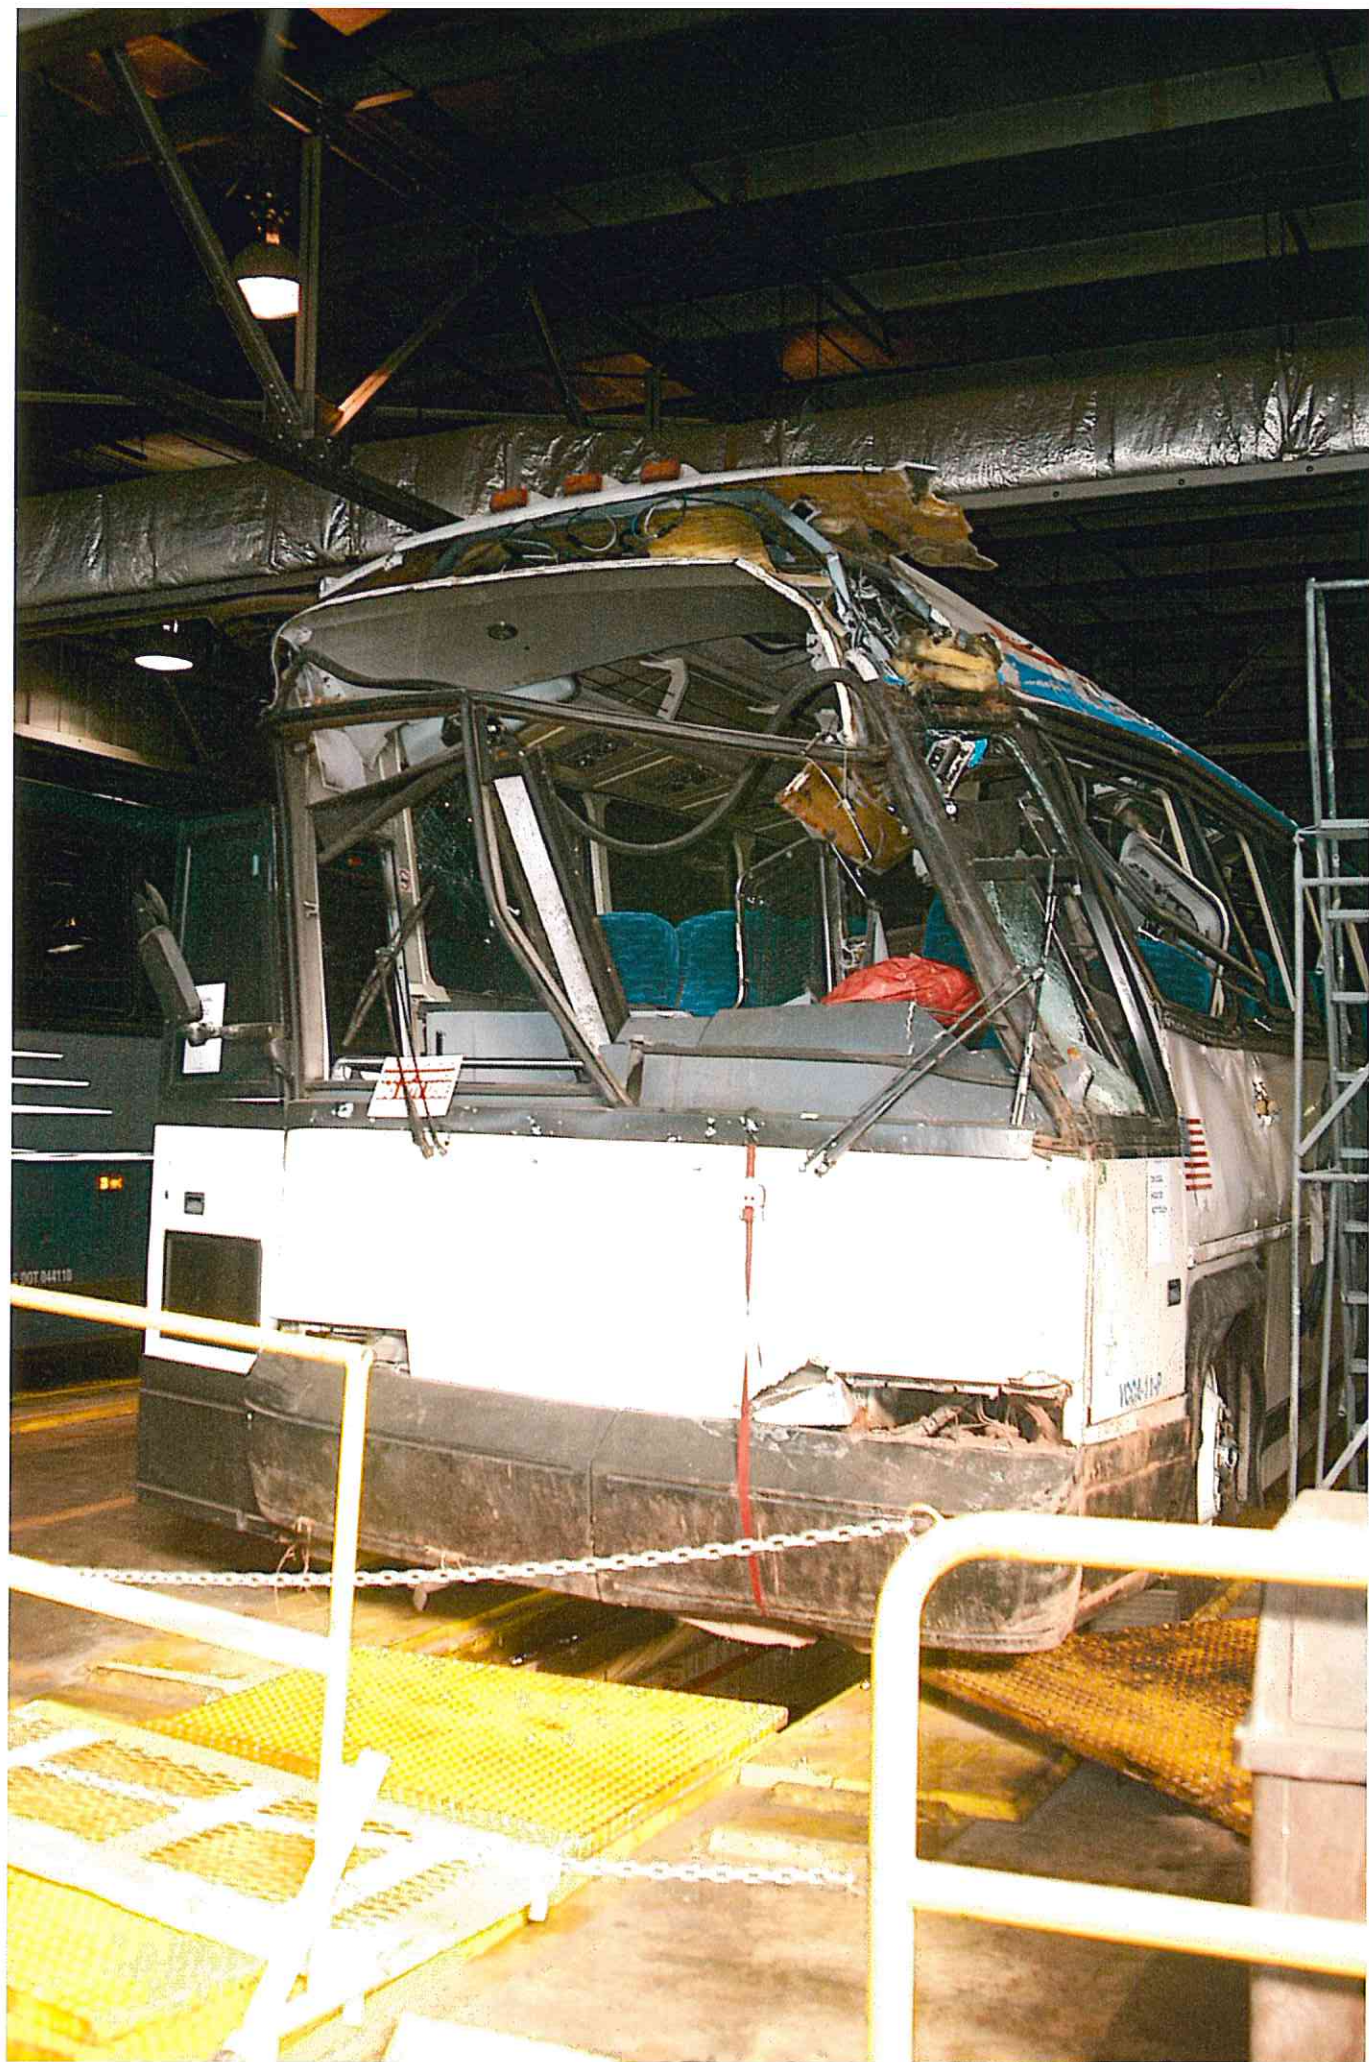
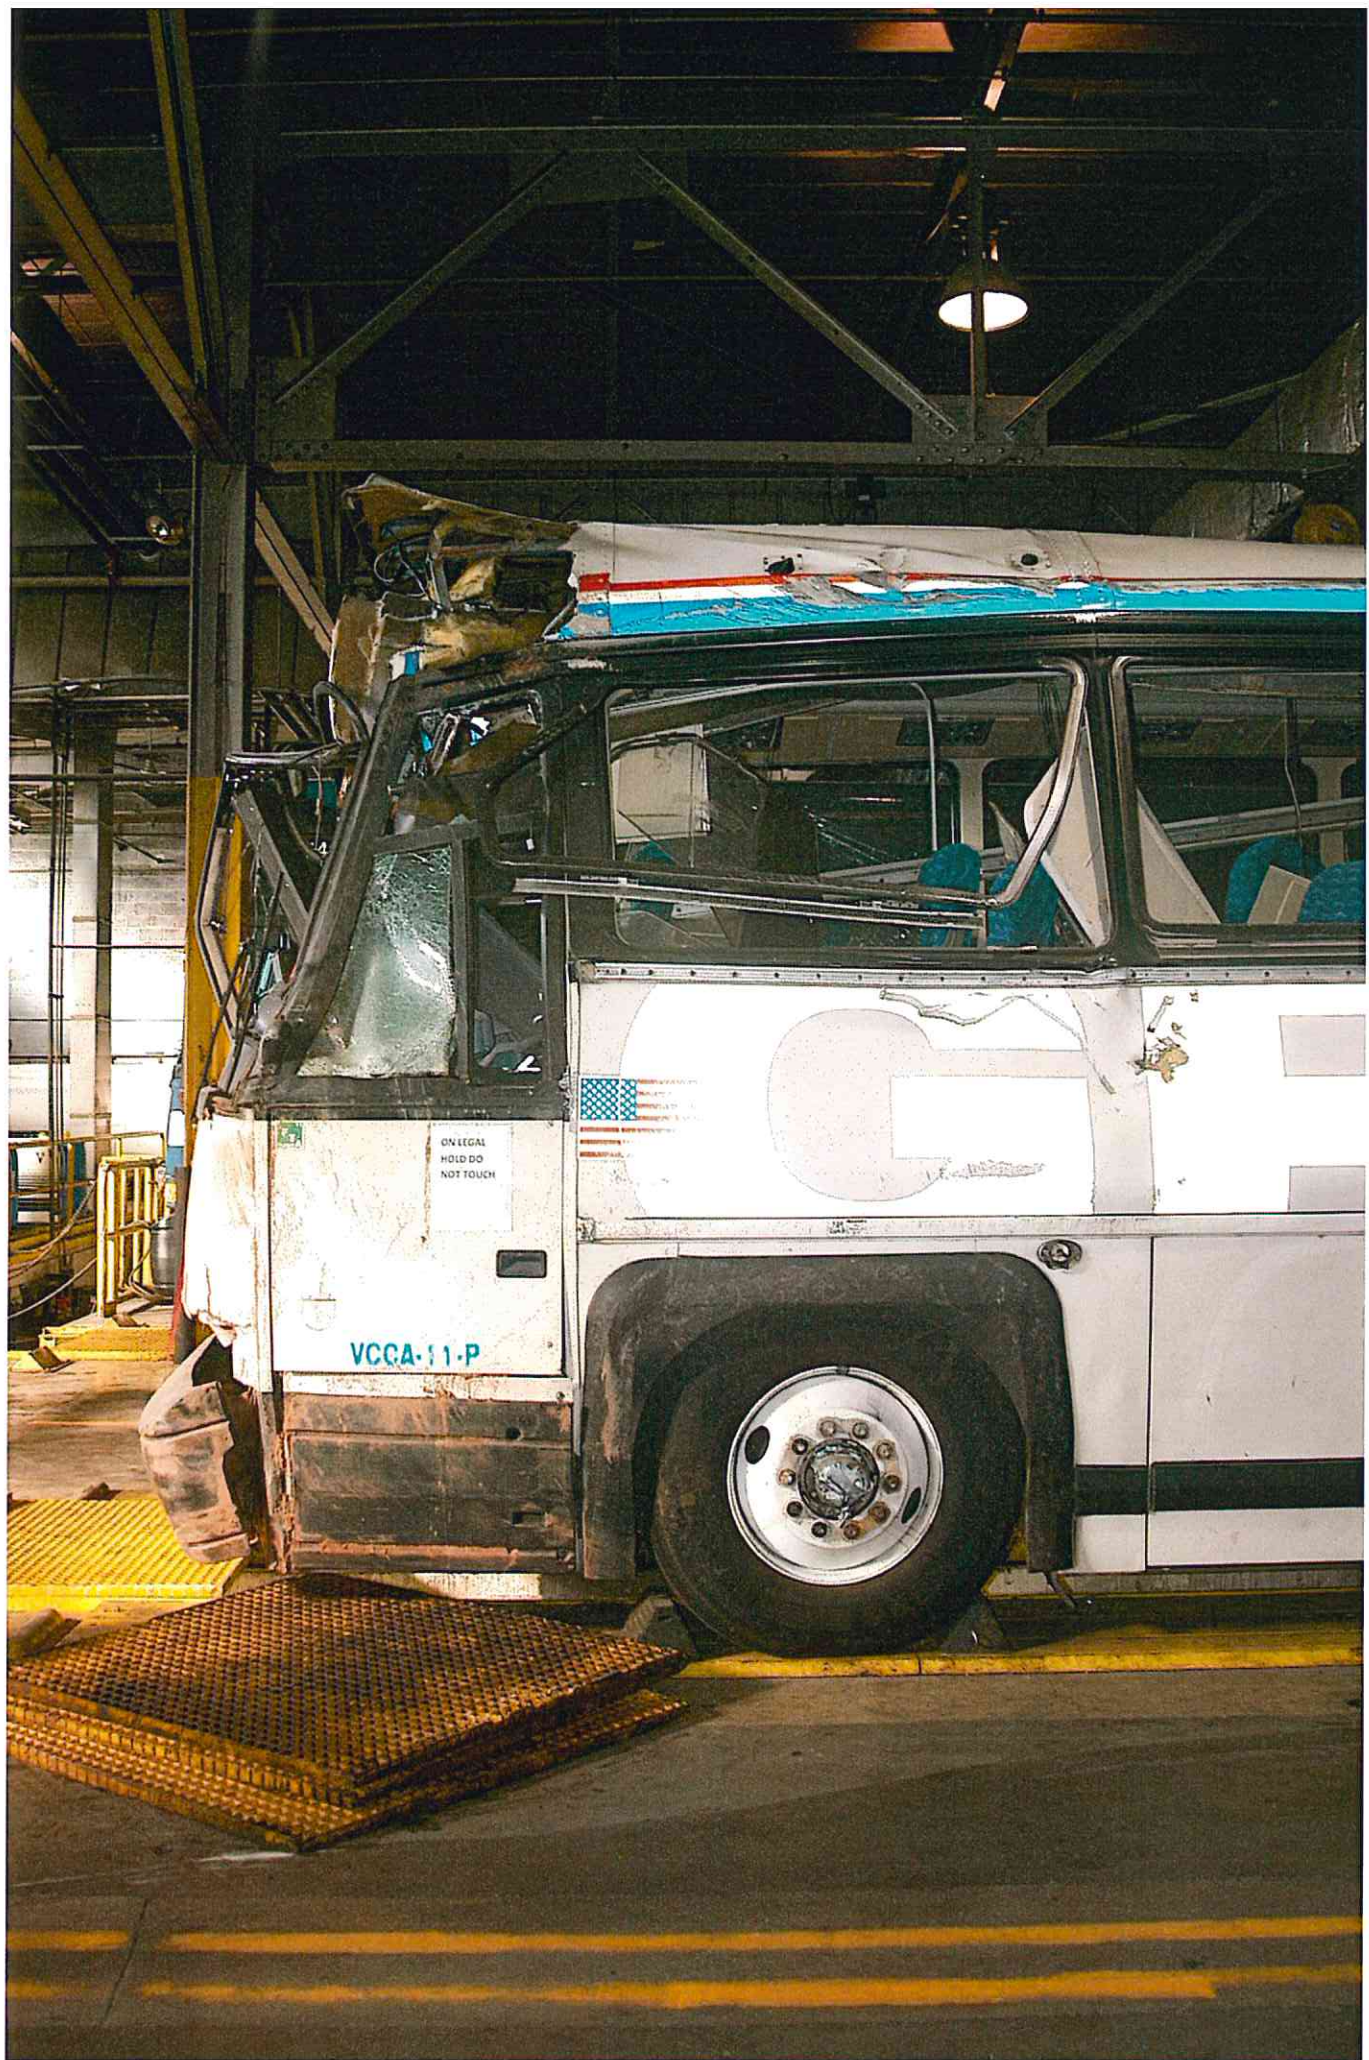
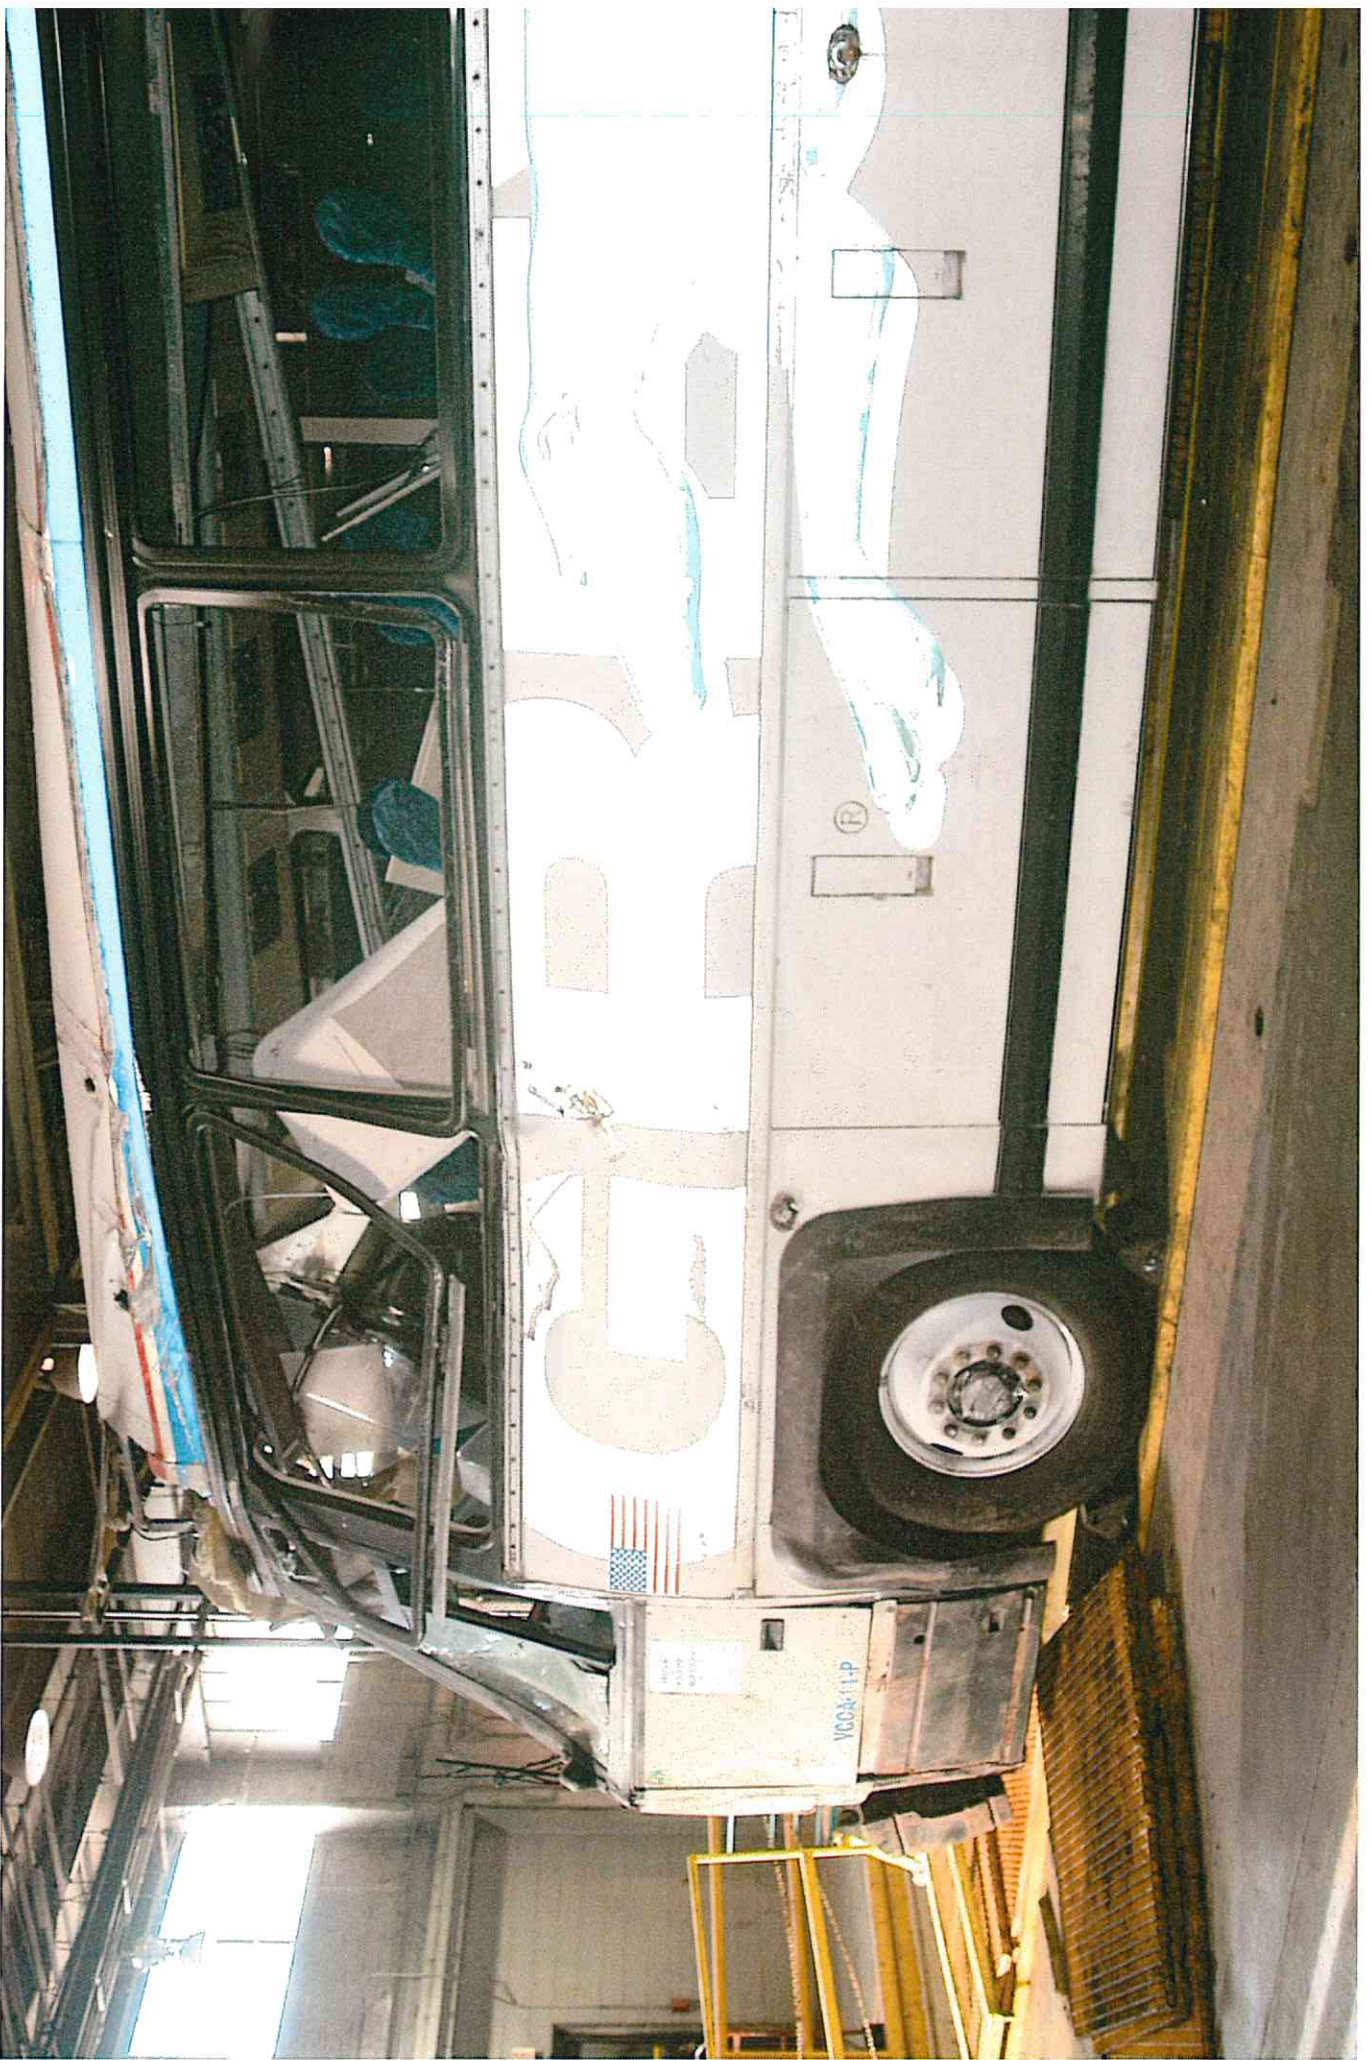
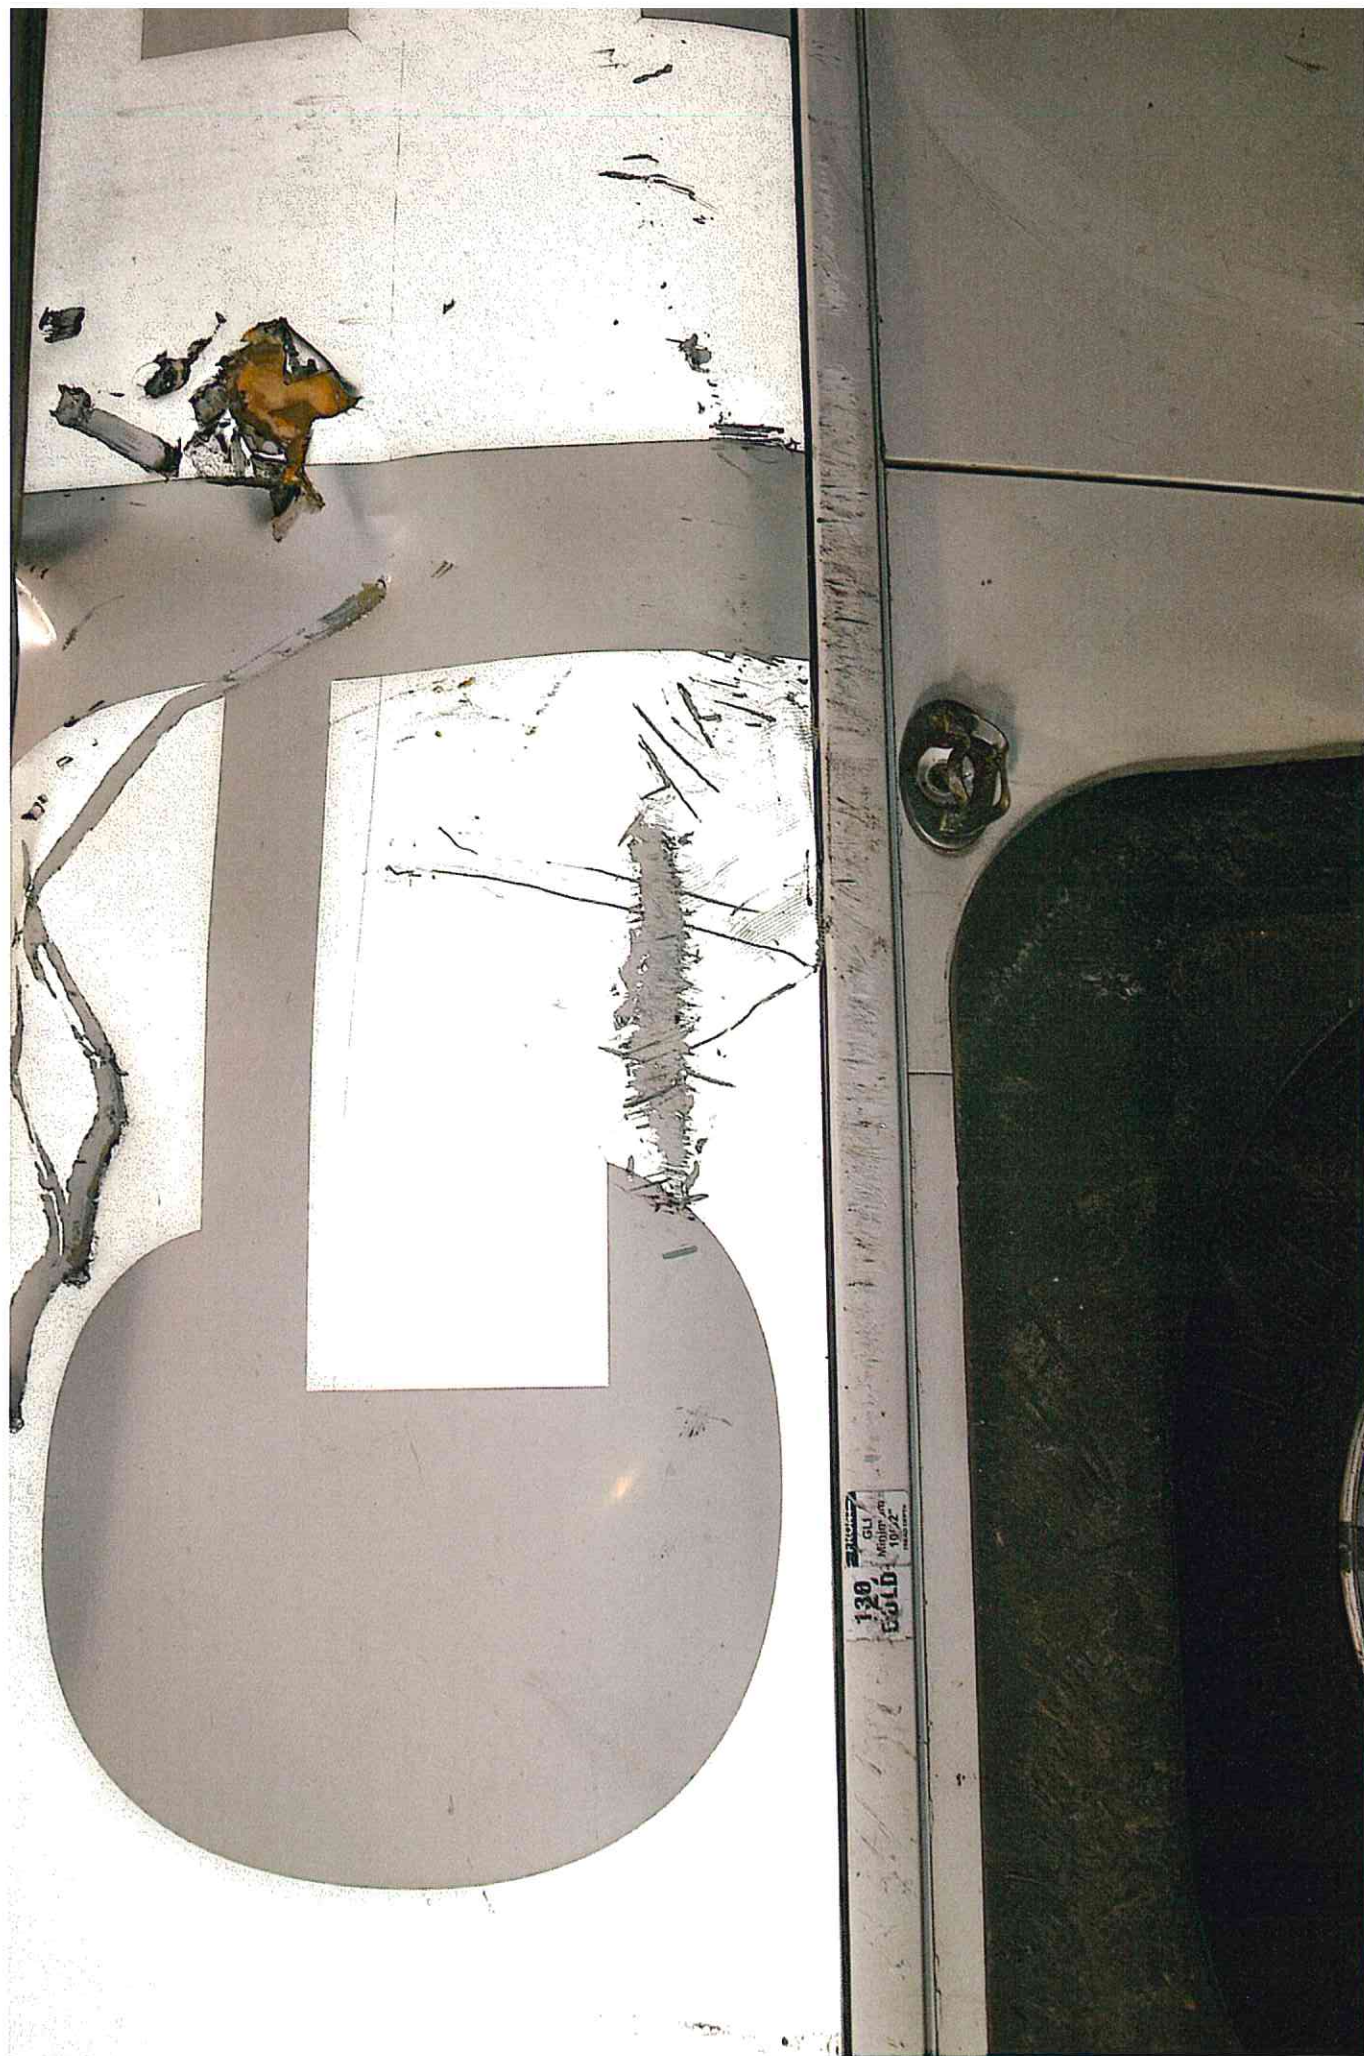
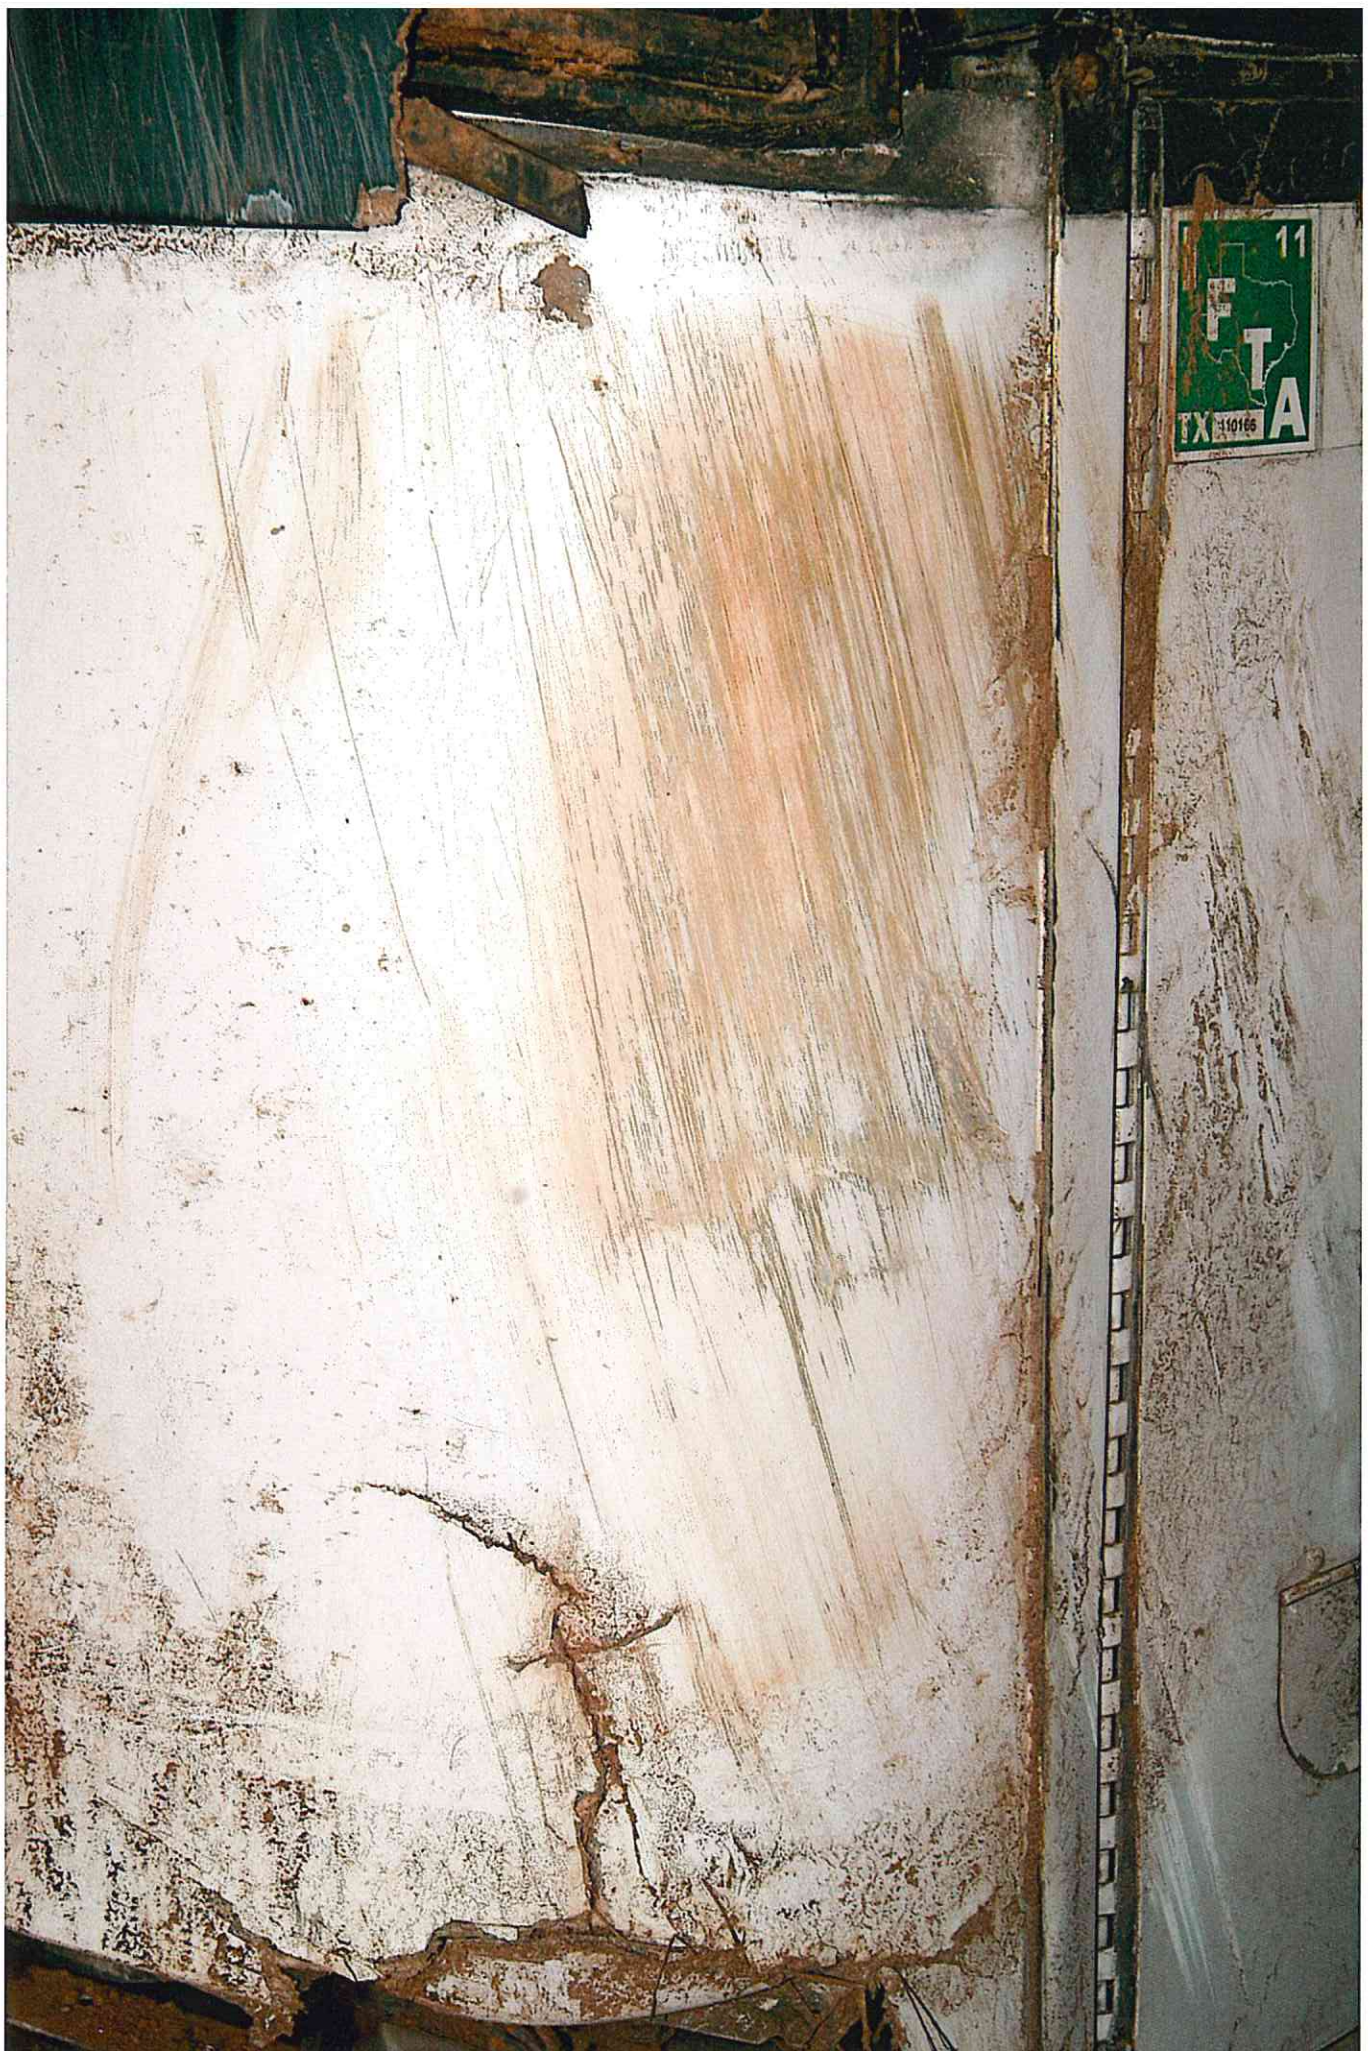
Photos of Rollover Damage

# **PHOTOS OF ROLLOVER DAMAGE**
