PE12-008

NAVISTOR TRUCK GROUP

Request 2 & 3

MC Unit 5218

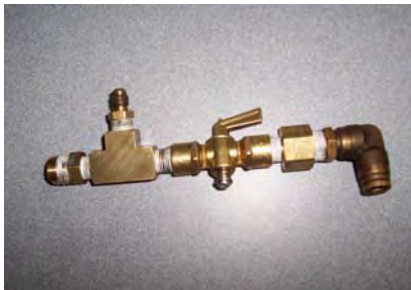
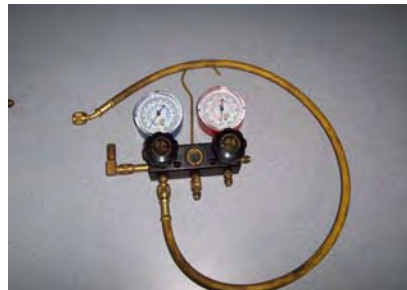
An air conditioning manifold set and a homemade shutoff device was fabricated and use for the testing. (see pictures below)

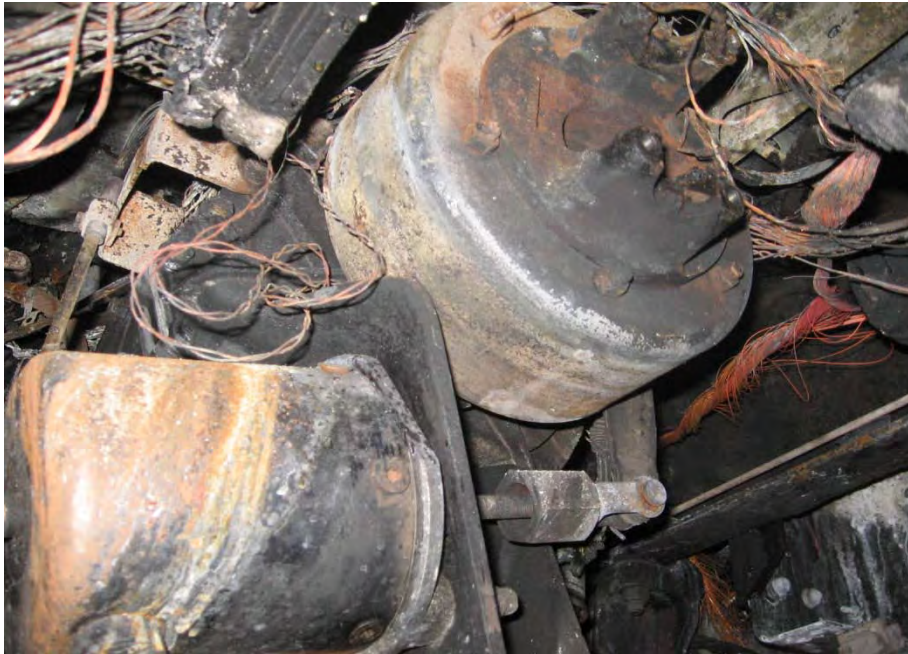
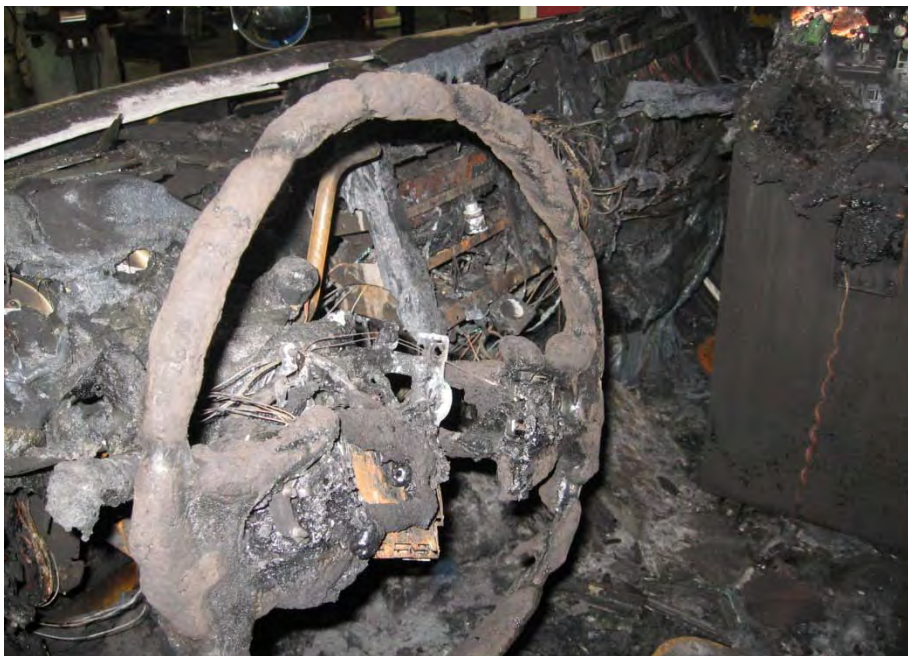
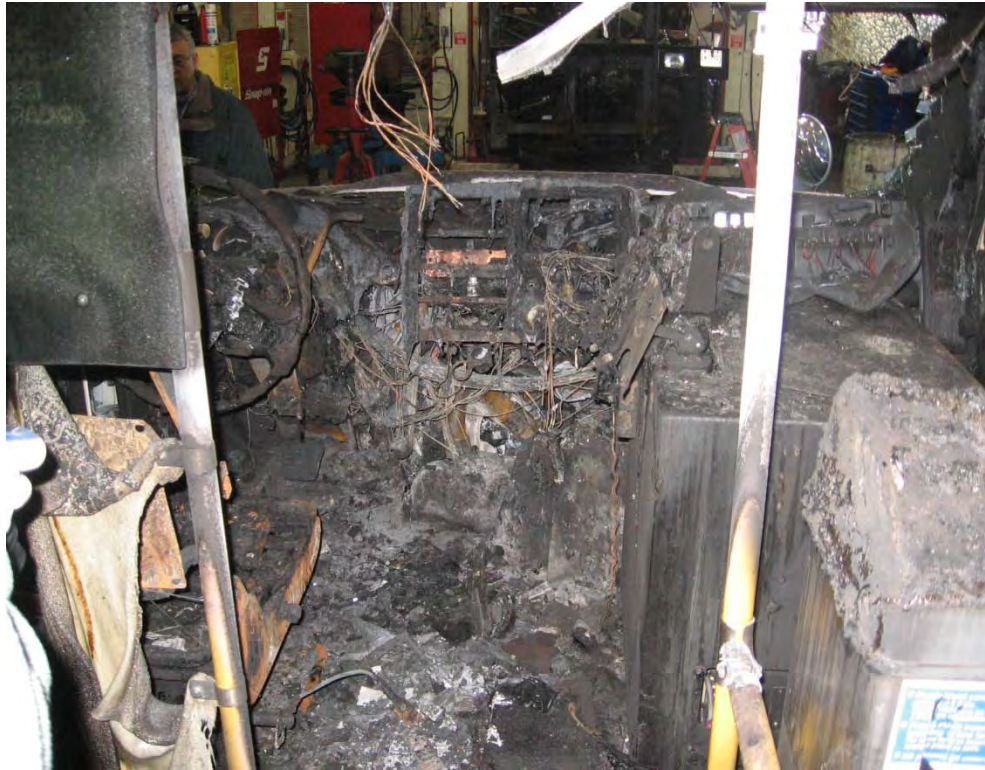
### **Inspection Observations**

The inspection of bus #075206 revealed that the most severe fire damage occurred above and adjacent to the rear of the transmission. The parking brake drum showed signs of extreme heat. The plastic “doghouse” above the transmission was destroyed by the fire which allowed the flames to penetrate the driver’s area of the bus. The dash panel, driver’s seat and all adjacent panels were totally destroyed by the fire. The heat from the driver’s area penetrated the ceiling panels and ignited the fiberglass roof cap, causing severe damage. It is alarming how fast the flames spread on this bus. Two buses from this fleet experienced major fires in 2010 and a third bus was destroyed in December of 2011. All four bus fires exhibited similar rapid rates of flame engulfment. The interior materials seemed to act as an accelerant for the fires. It definitely brings into question whether all the materials used in the interior of this model bus meet the requirements of the automotive interior flammability standard, FMVSS 302. This question will be addressed further in the recommendations section.

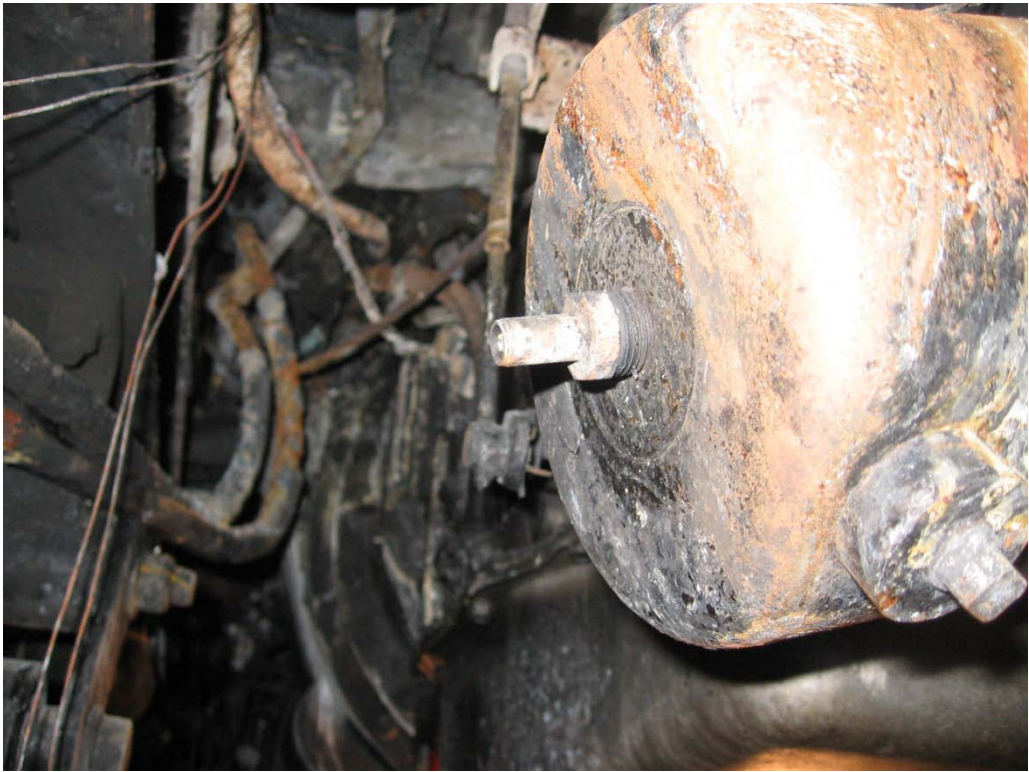
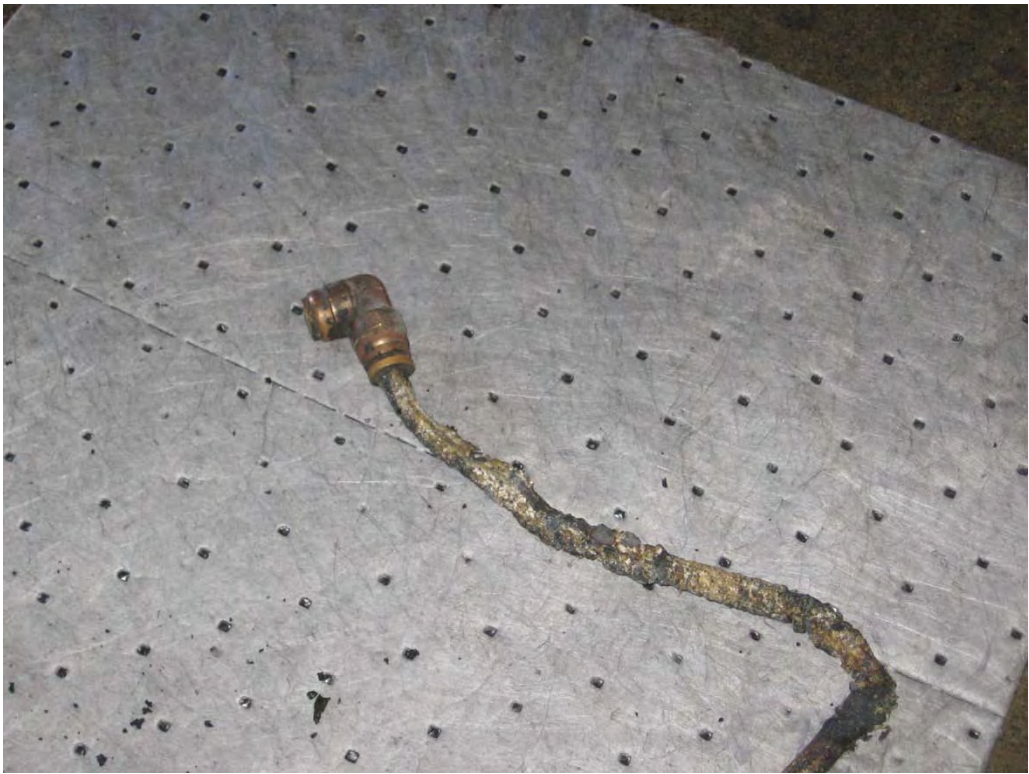
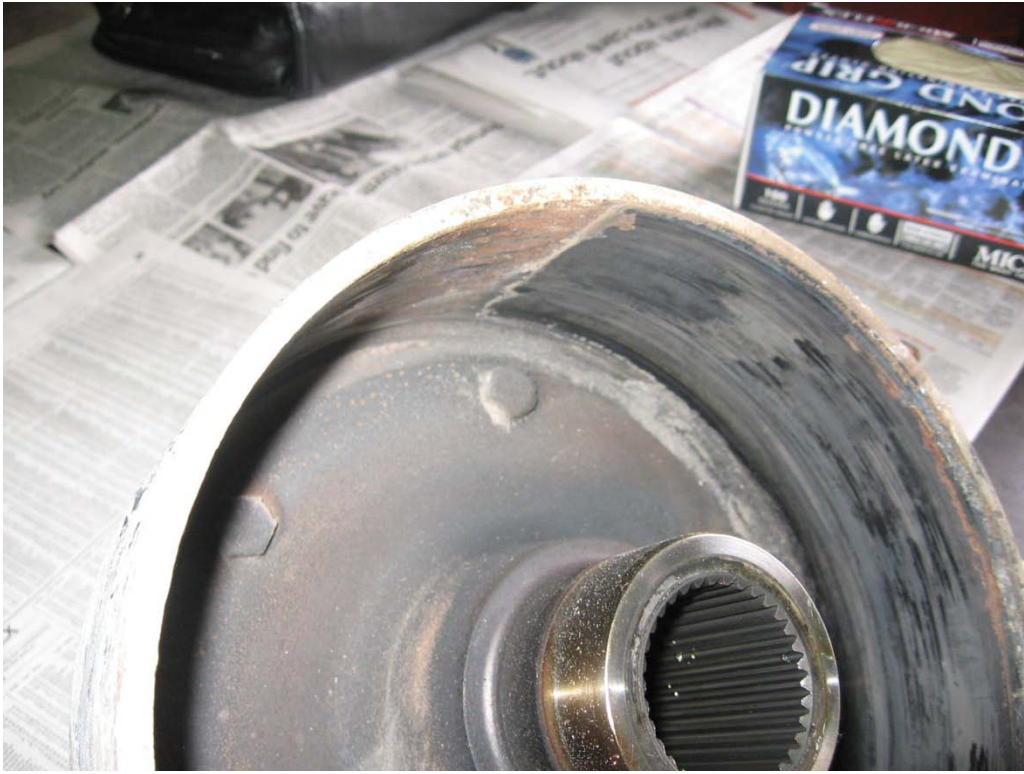
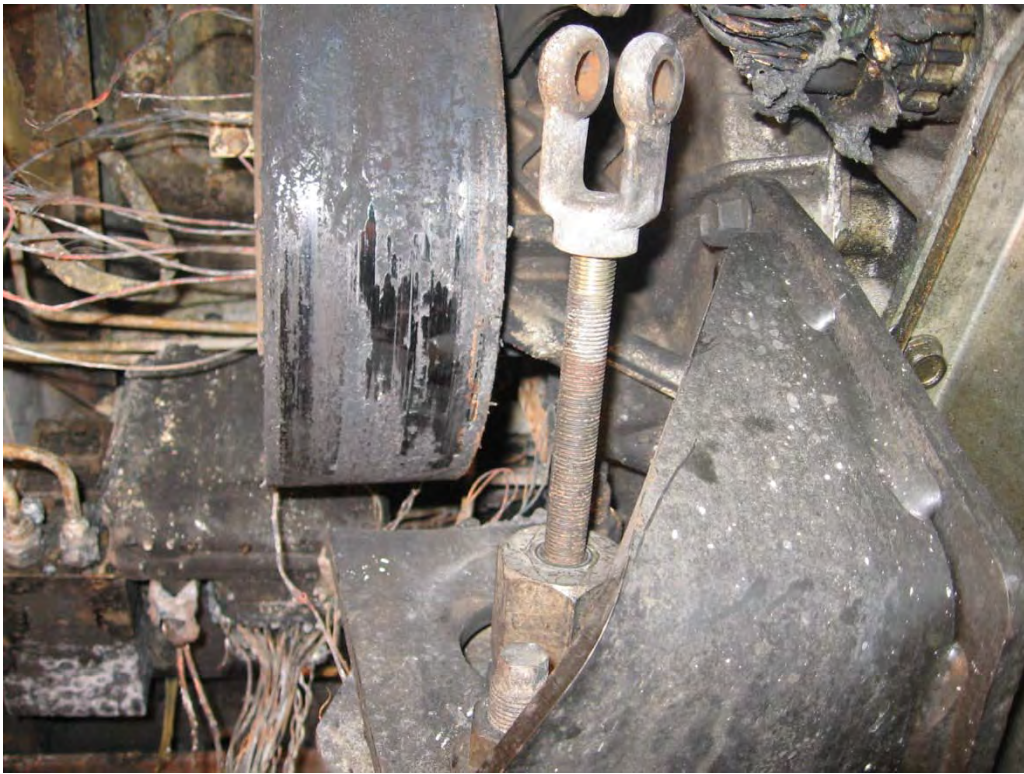
The evidence of high heat in the parking brake drum and the signs of intense heat above the rear of the transmission were exactly like that found in January 2011 when the team investigated a major fire on bus #075218. That investigation concluded that the fire had been caused by a parking brake that applied while the bus was operating. In that investigation the team discovered that the air fitting on the parking brake chamber had failed causing the parking brake chamber to apply. Closer examination of the parking brake on bus #075206 revealed signs of excessive heat in the outer circumferential area of the steel drum. The brake shoes had significant wear and the edges of the lining material were gray in color indicating they had severely overheated. The mechanism was in the full "on" position. There was no air line connected to the brake chamber but the inner portion of what appeared to be the swivel fitting was still threaded into the back of the chamber. About twelve inches of nylon air line with what appeared to be the other half of the swivel fitting was found under the bus at the scene of the fire. The team carefully examined the piece of line and concluded that it had been connected to the brake chamber and that the swivel fitting had failed prior to the fire exactly like the occurrence on bus # 075218 one year ago. The brake drum was removed from bus #075206; revealing that the surfaces of the drum were scored badly and the linings were severely overheated from dragging.

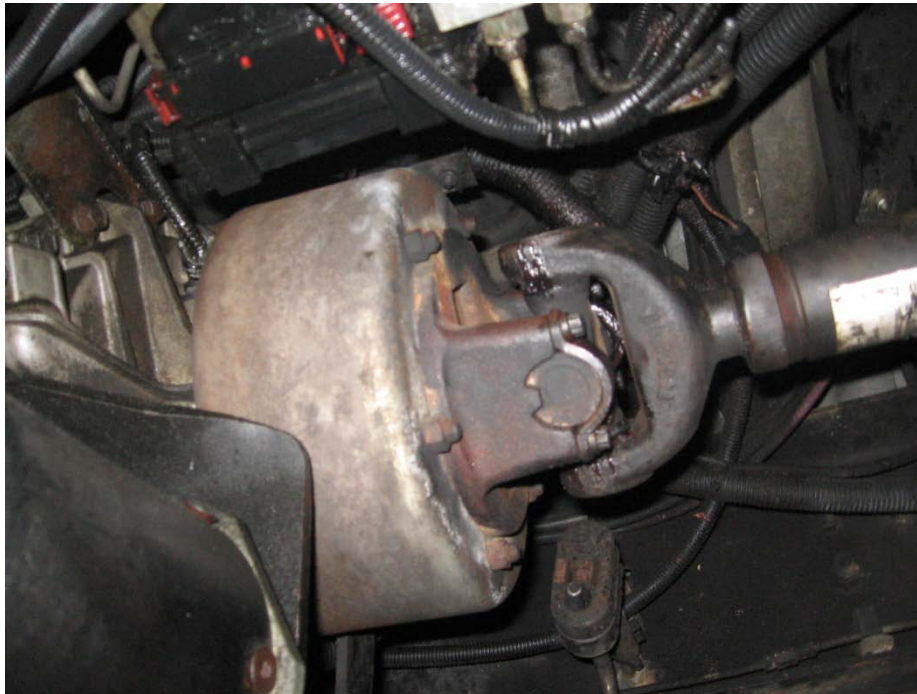
## **Fire Analysis**

The source of ignition for the fire on bus #075206 appears to have been the extreme heat that was generated when the parking brake applied by itself and began dragging as the operator deadheaded the bus northbound on [REDACTED]. The heat ignited the grease and oil soaked wire harnesses that are routed adjacent to the parking brake and caused the nylon fuel lines routed above the parking brake to melt and begin to leak. The leaking diesel fuel erupted into flames that quickly spread to the “doghouse” over the transmission. The photo below of an example bus shows the close proximity of the oil soaked wire harnesses and fuel lines to the parking brake drum.

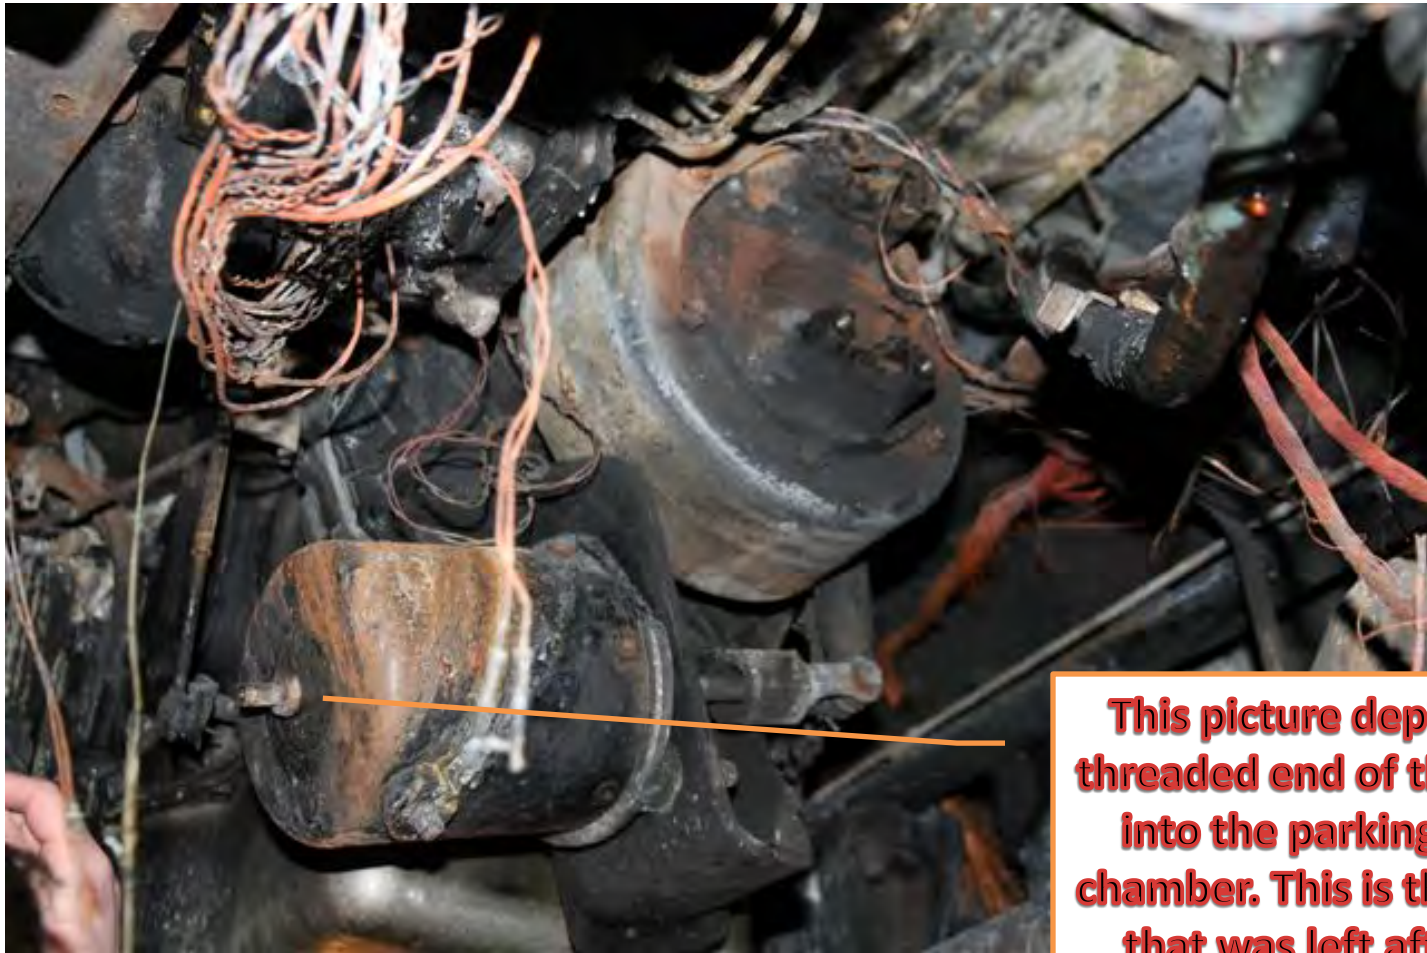
# Montgomery Co. 5206 Parking Brake Chamber Brass Fitting

**This picture depicts the threaded end of the fitting into the parking brake chamber. This is the nipple that was left after the swivel came off.**

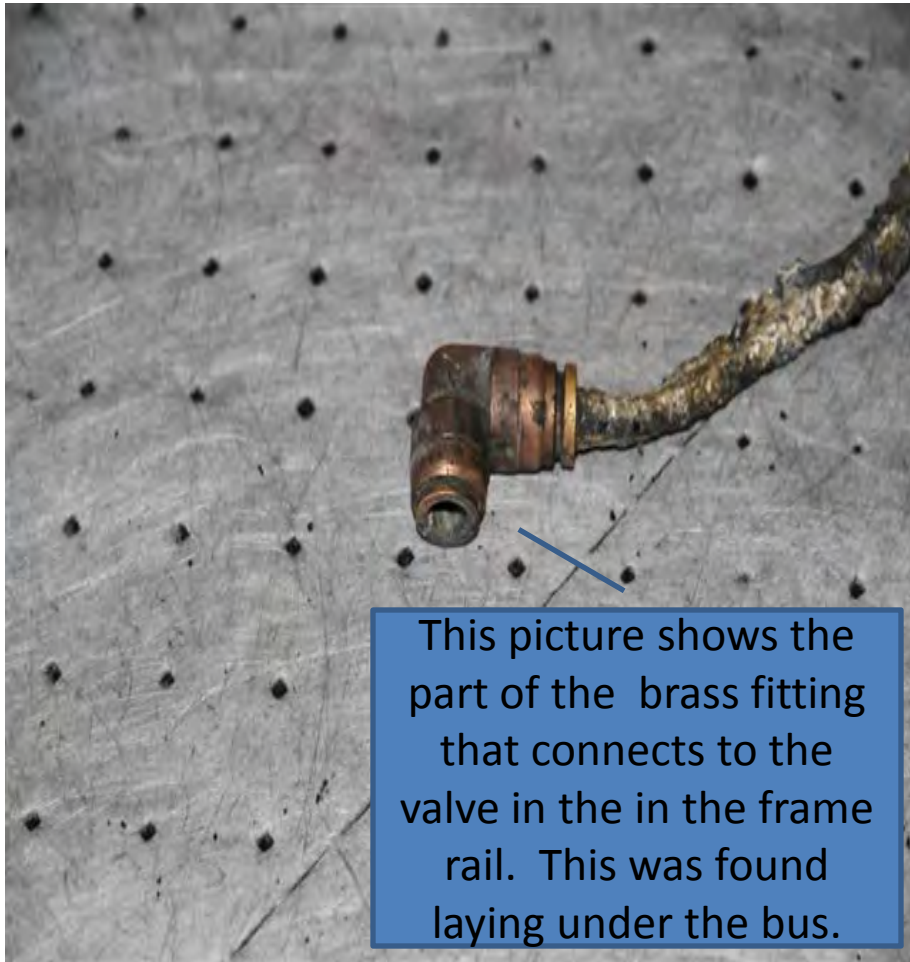
# Brass Fitting from unit 5206

This picture shows the part of the brass fitting that connects to the valve in the in the frame rail. This was found laying under the bus.

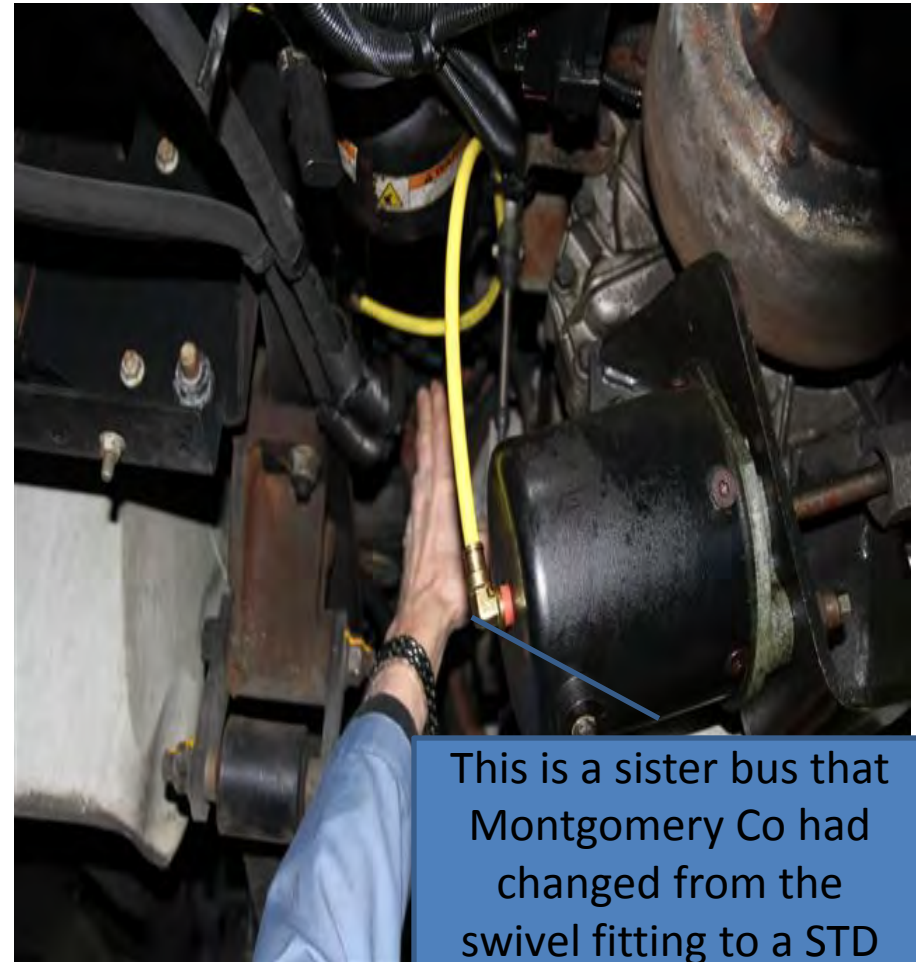
This is a sister bus that Montgomery Co had changed from the swivel fitting to a STD 45fitting

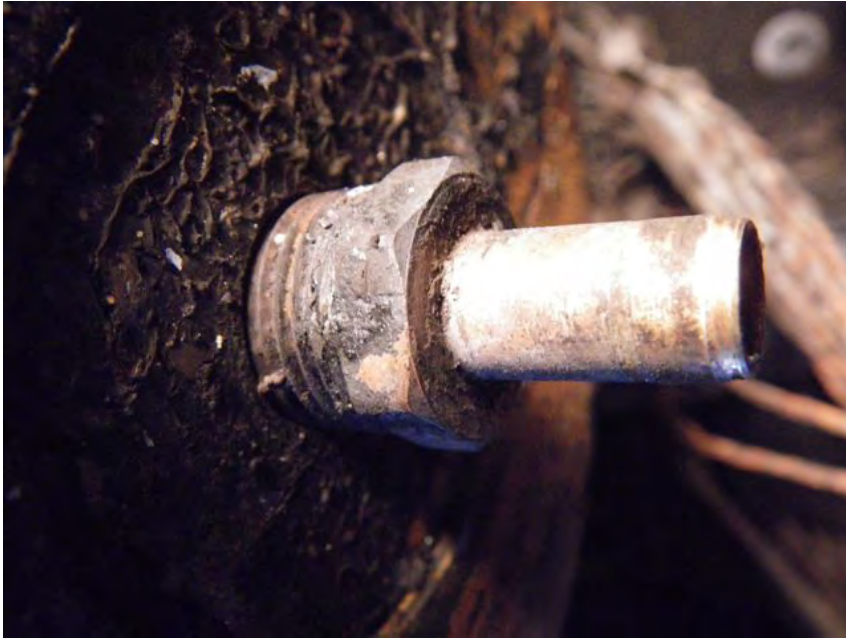
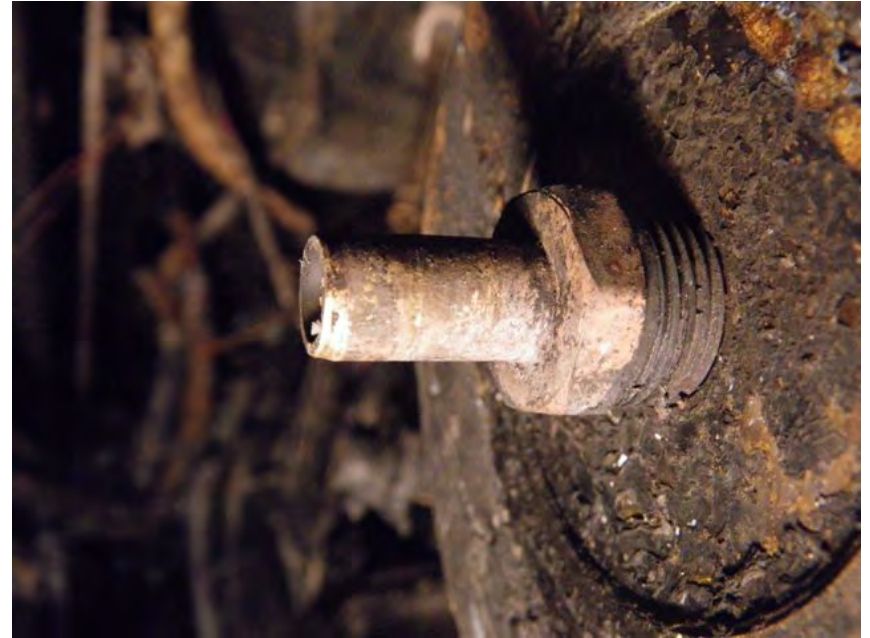
# Montgomery Co. Brass Fitting Parking Brake Chamber

If you look at the end of the nipple you see a small groove. This is where the flat snap washer locks into.

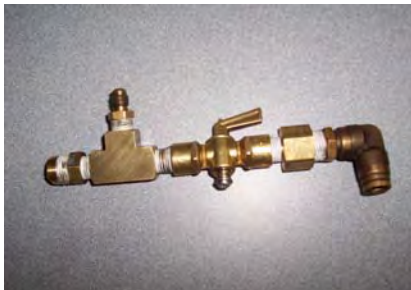
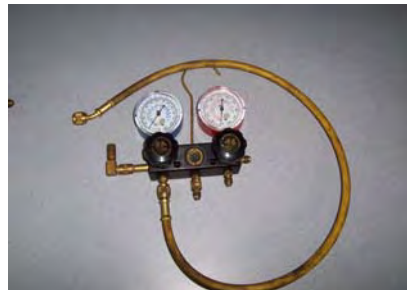
An air conditioning manifold set and a homemade shutoff device was fabricated and use for the testing. (see pictures below)
