PE12-010 GM 6/22/2012 Q_07_1 Sharepoint Cruze Discussion _ April 9, 2012#3526

Cruze Discussion – April 9, 2012

Focus of NHSTA Investigation

Alleged defect: Any one or more of the following symptoms or conditions:

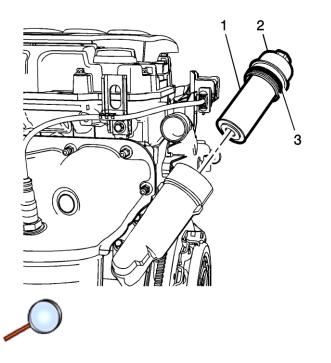
Caution: To prevent damage to oil filter cap ensure proper tool is used. Do not use an open end wrench which may cause damage to filter cap.

Note: Inspect oil filter cap for any cracks or damage. If oil filter cap is damaged it must be replaced.

3. Using a 24mm socket or closed end wrench loosen oil filter cap. Unscrew filter cap 3 turns and let oil filter and cap assembly drain in housing for 30 seconds.

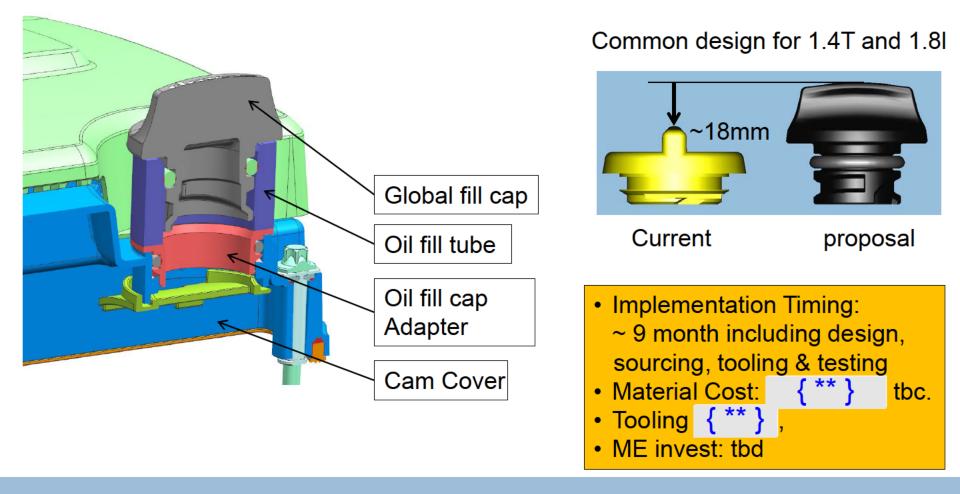
1. Oil Fill Cap - Service problems and possible improvements

- wrong installation of O-ring seal, damaged O-ring, 2 O-rings, or no seal ring present.

several cracked filter caps due to usage of wrong tools
 like belt wrench or pipe wrench (instead of hex. nut drive).

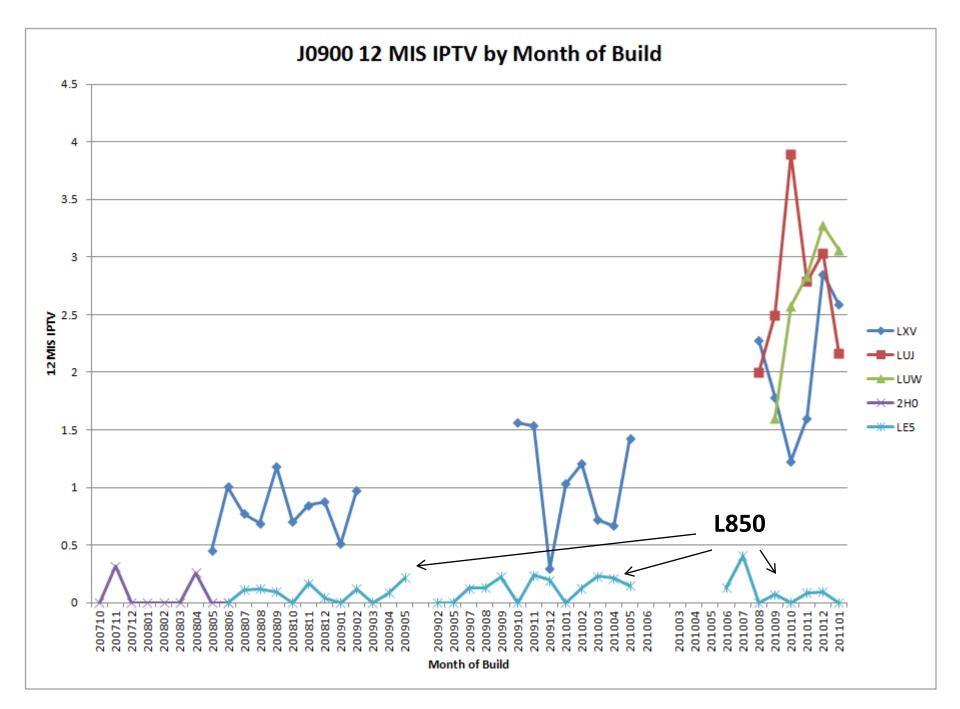
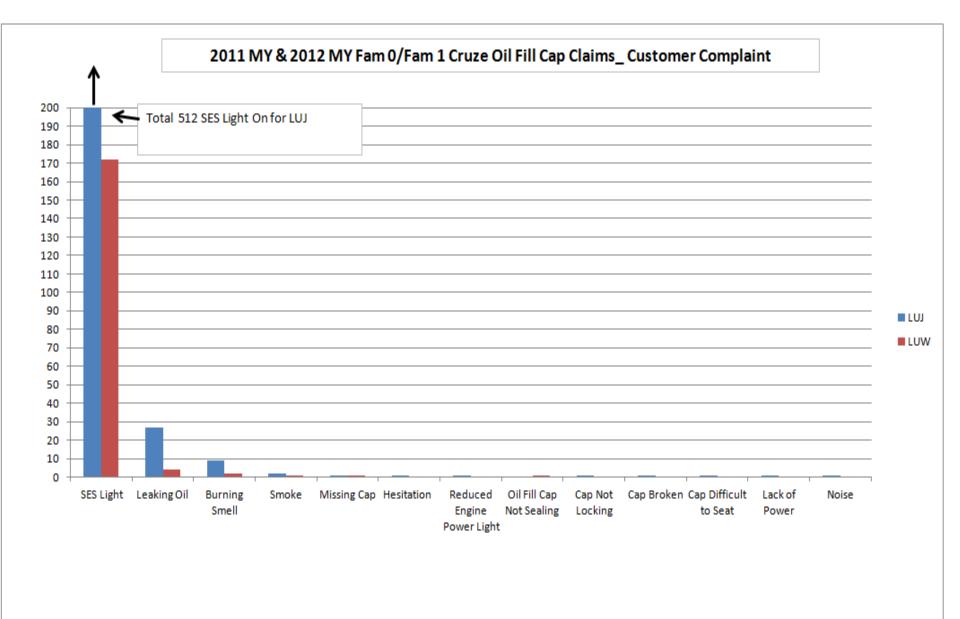
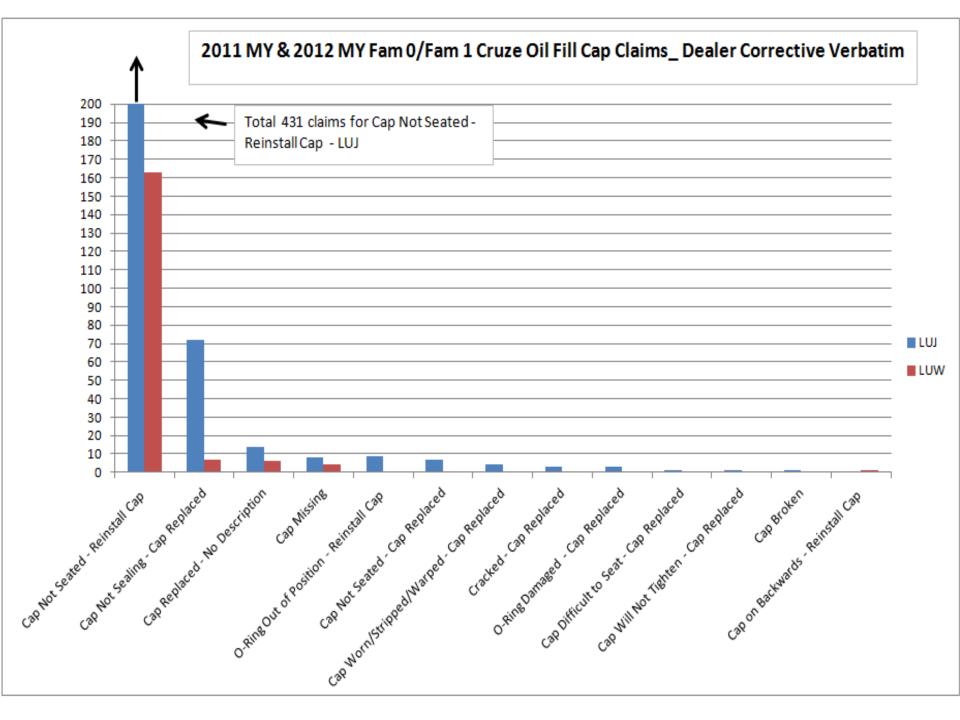
Fam 0 and Fam 1 Oil Fill Cap Warranty J0900 Oil Fill Cap Replacement Labor Code Summary

High number of claims (J0900) for loose or leaking oil fill caps. High percentage (60%) of claims state oil fill cap loose.

•Root Cause: Oil fill caps not installed properly after oil changes

- 44 Oil fill cap not seated after oil change
- 3 Oil dipstick not fully seated
- 1 70% alcohol in fuel
- 1 Oil pressure switch failure
- 4 could not determine root cause
