PE12-012

2011 NA Cruze Washington DC Issue

Fire Origin and Cause Analysis

DC Clutch System Analysis

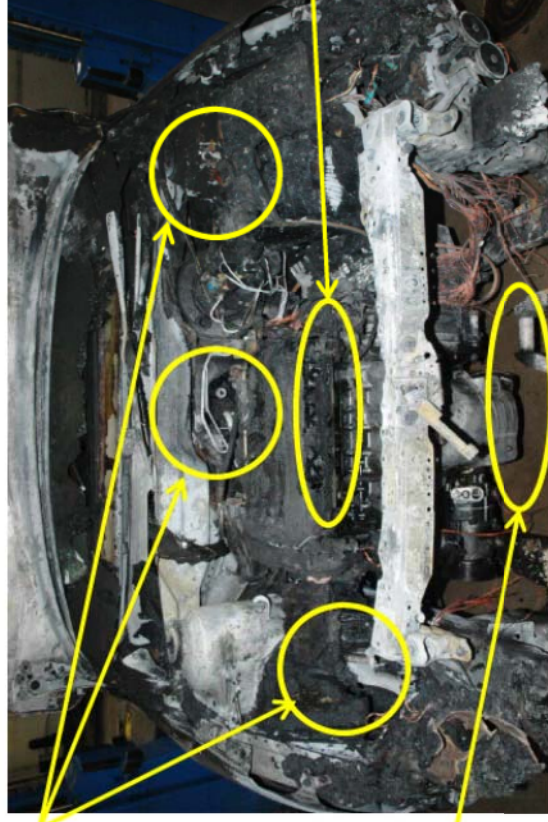
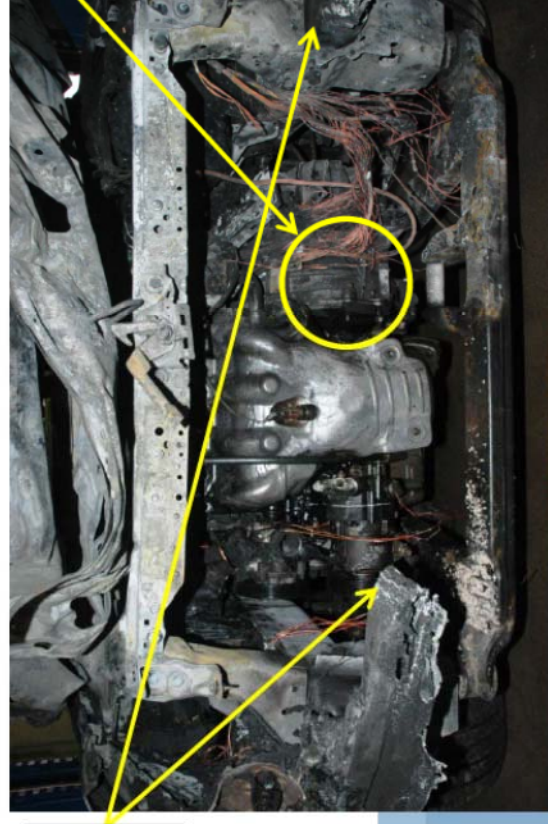
Fire Origin and Cause Analysis Vehicle Burn Patterns

Significant Amount of
Unconsumed Plastics

Front End and Belly Pan
Consumed Without
Significant Road Debris

Forward Left Bias Burn
Damage on Valve Cover

Left Bias Burn Damage
on Bumper Beam/Crush
Cans

Probable Area of Origin
Based on Vehicle Burn
Patterns

Electrical
No Evidence of Short
Circuits / Arching

Probable Heat Source
Hot surface Ignition

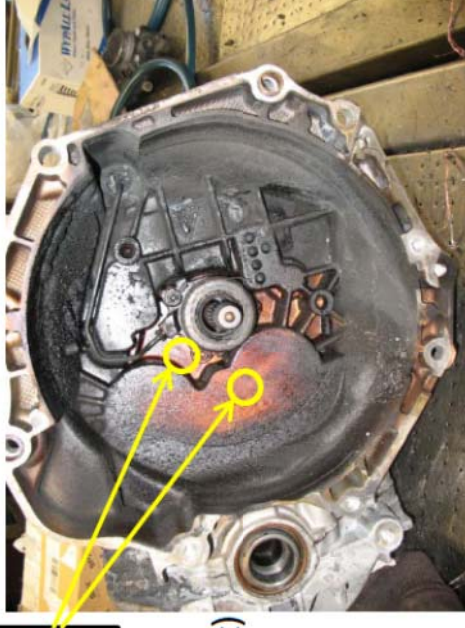
Sample Locations Testing
Positive For Brake Fluid In
The Clutch Housing

- Clutch plate friction material severely worn and burned
- Evidence of clutch metal to metal contact and extreme heat (red hot)
- Evidence of fire inside clutch housing
- Plastic / combustible clutch housing materials consumed
- Evidence of brake fluid found in the clutch housing

Conclusion:

Based on the information available at this time, it appears that the fire point of origin was in the clutch housing with the most probable cause being the result of brake fluid from the clutch hydraulic system auto igniting on a clutch hot surface.

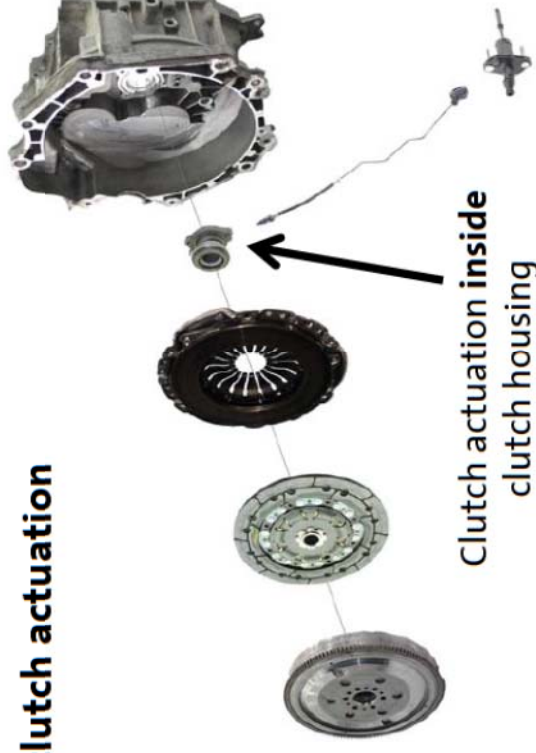
Chevy Cruze M32 1.4T Clutch system with CSC (Concentric Slave Cylinder) = **internal**

Root Cause - High energy slip conditions

- Extreme temperature conditions
- Annealed diaphragm springs
- CSC over-traveled
- Metal-to-metal contact of clutch to pressure plate
- Chemical analysis identified clutch fluid evident on inside walls of clutch housing
- Extreme temperatures resulting from continued clutch slip conditions
- Shifter knob missing
- Shift cable not fully locked into position

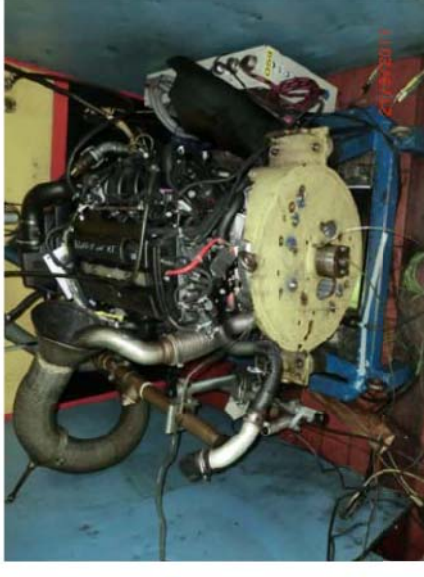
Thermal issue reproduced in GME-lab

- **Test condition:** Modified Hot Flywheel and Pressure Plate Burst Test (GMPT 1164)
 - Engine U18XFR, clutch set and clutch-housing on bench
 - Clutch plate fix, torque apply via controlled clutch closure
- **Test execution & observation:**
 - Severe clutch slip reproduced, 1000°C clutch temperature
=> extreme heat settings & CSC overtravel
 - CSC actuations lead to spontaneous combustions.
 - Ignited material dropped out of clutch housing drain hole 5 min after test
- **Analysis:**
 - Brake fluid pressed out of the overtraveled CSC identified as source of combustions.
- **Conclusion:**
 - Severe misuse can lead to thermal incident.
 - Stress condition during test similar to vehicle incident.

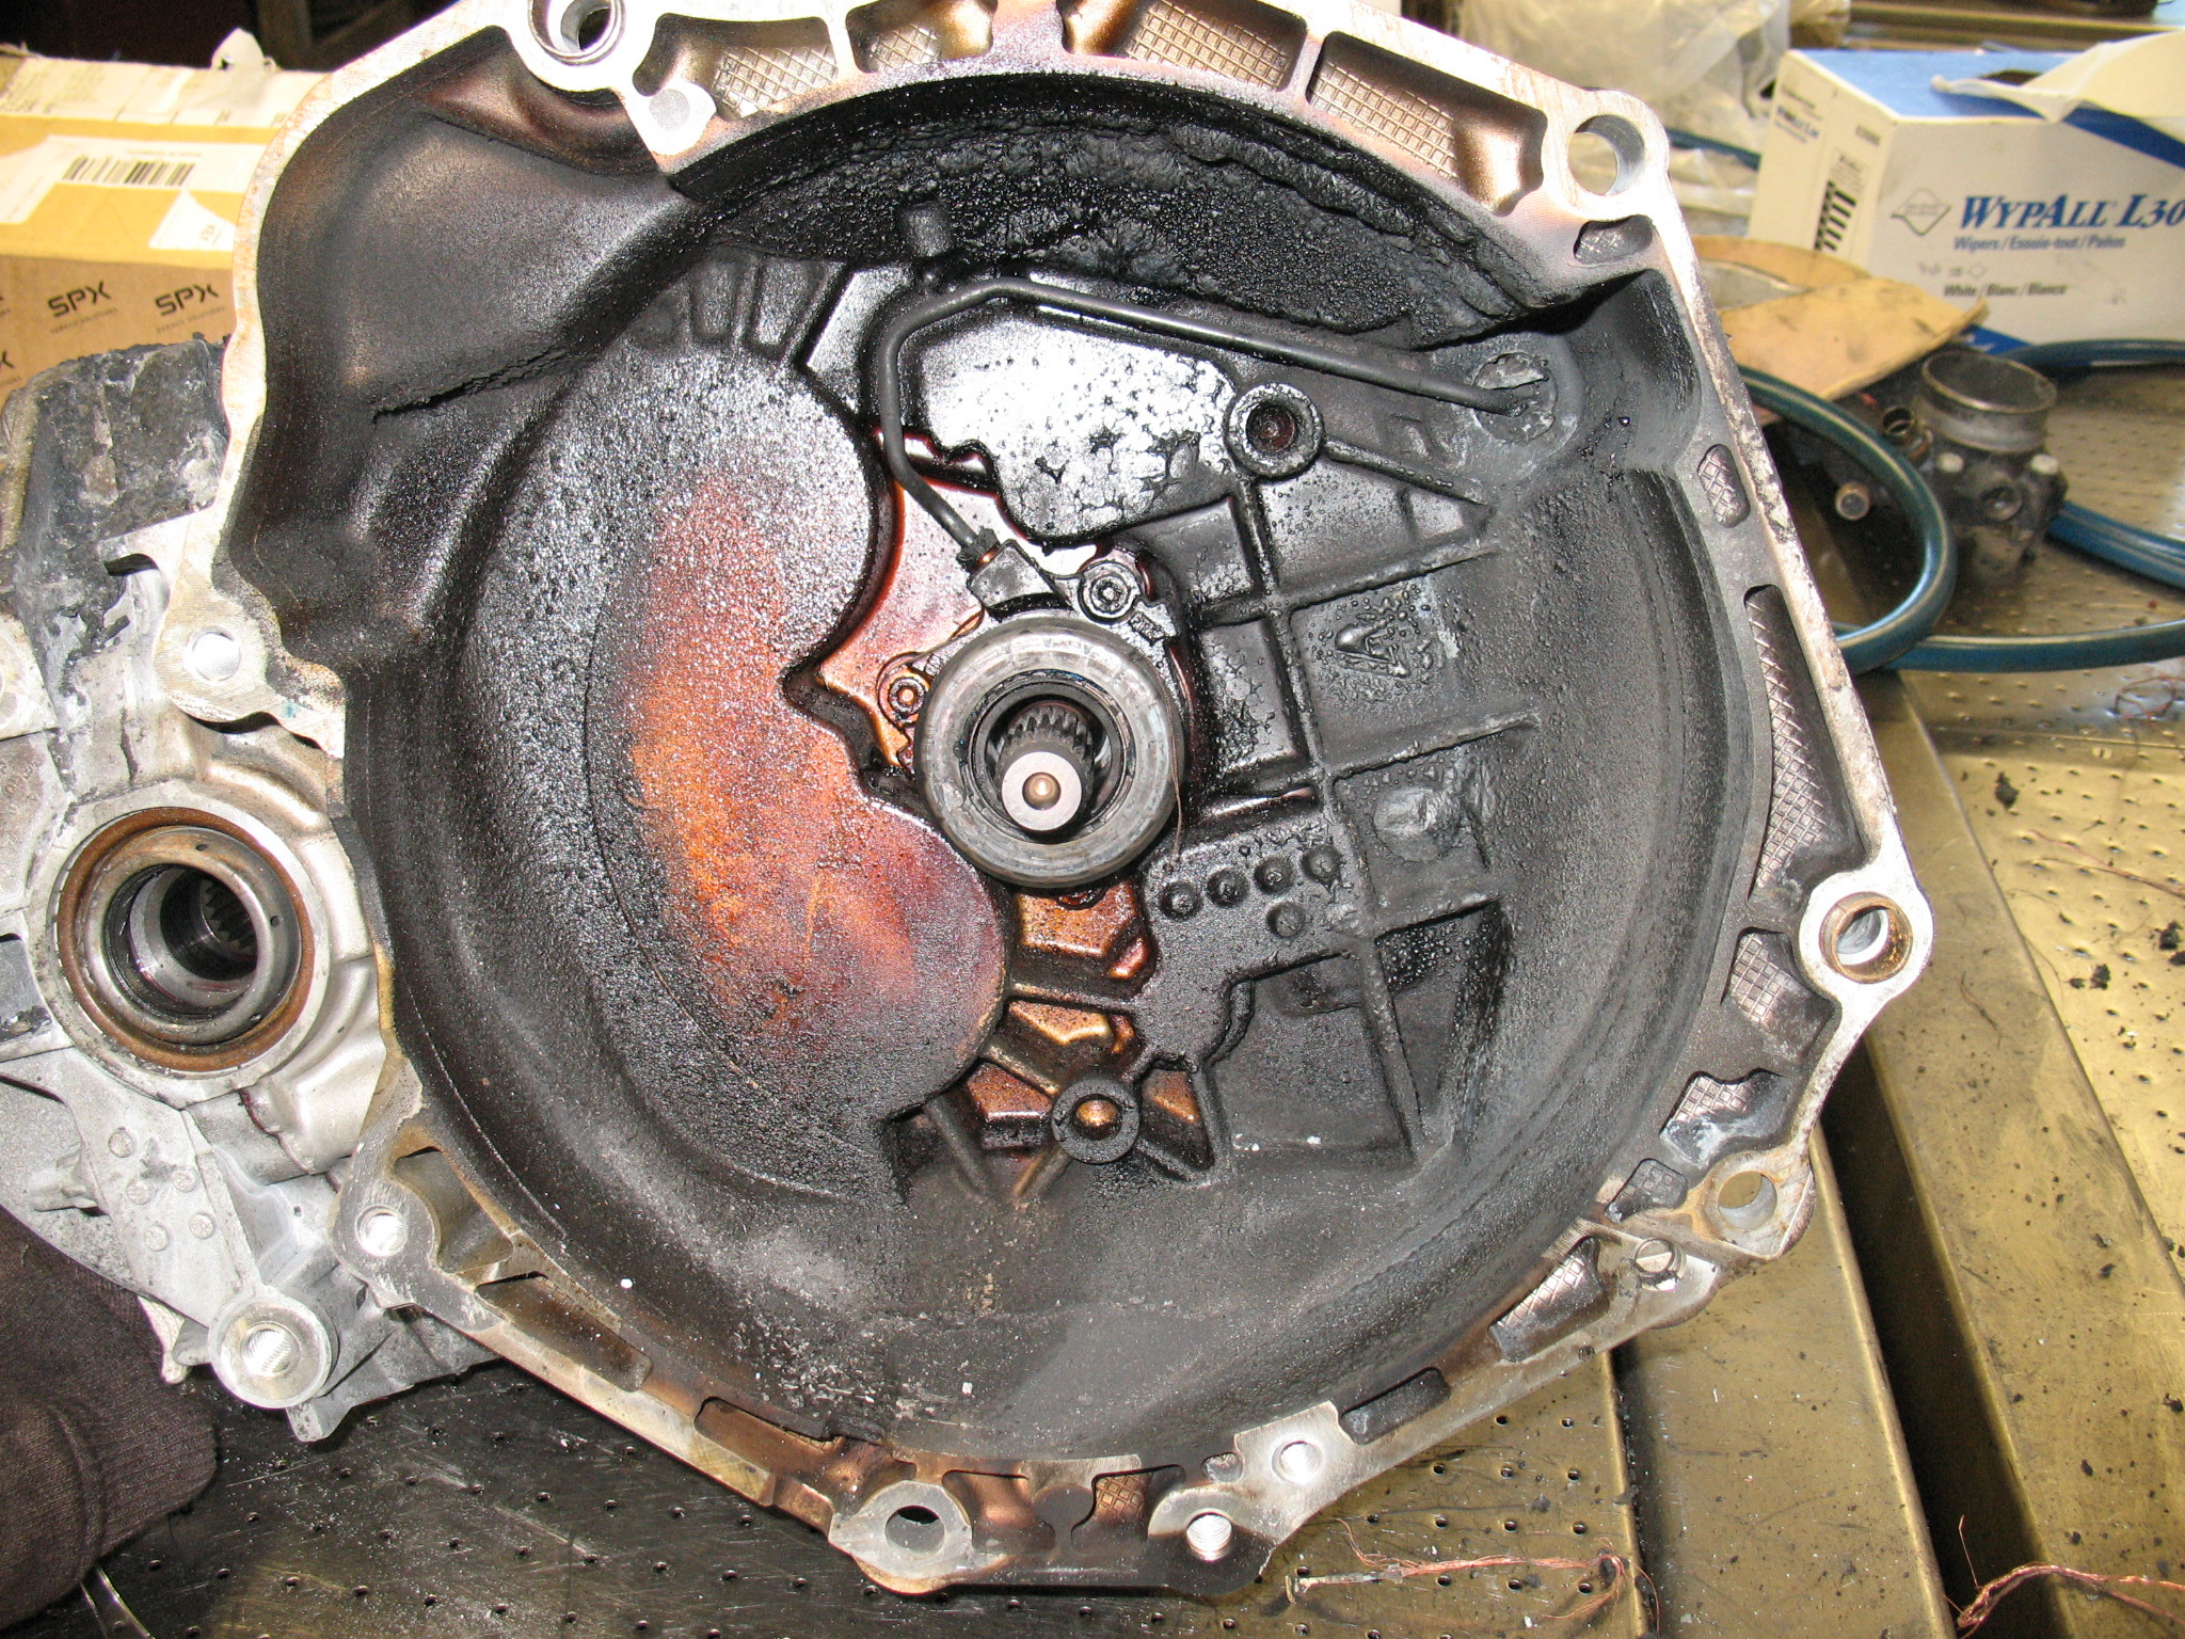
DC Vehicle Clutch Housing
Photo

- Fire existed inside clutch housing
- Paths into or out of Clutch housing – Bottom Drain, ½ shaft clearance cutout, Clutch Hydraulics Nylon 6-6 connector

- Color of cast Iron pressure plate (light grey) indicates it was red hot (+500°C)
- Diaphragm spring was hot enough to anneal / lose hardness, Diaphragm fingers dropped by 20 mm, CSC over Traveled due to continued driving

- Final chemical matching indicate Brake Fluid was on outside of CSC and rear of clutch housing
- Shift knob was missing
- Shift Cable was loose at auto show / attempted reattach for repair
