## Claim Detail Report

Vehicle Line: T/UB-EXPLORER [11-12]

**DEFECT DEFINITION for Y (Objective Metric):**  
Within the TRW EPAS electronics, there is a motor relay and a link relay. Failure of the motor relay primarily results in the TRW code B3A and failure of the link relay primarily results in the code B43.

**PROBLEM STATEMENT, SCOPE, AND GOAL**  
Find root causes of relay failures and implement corrective actions to eliminate this issue.  has highest repair rate at 0.35 R/1000 and problem will be scoped to it.

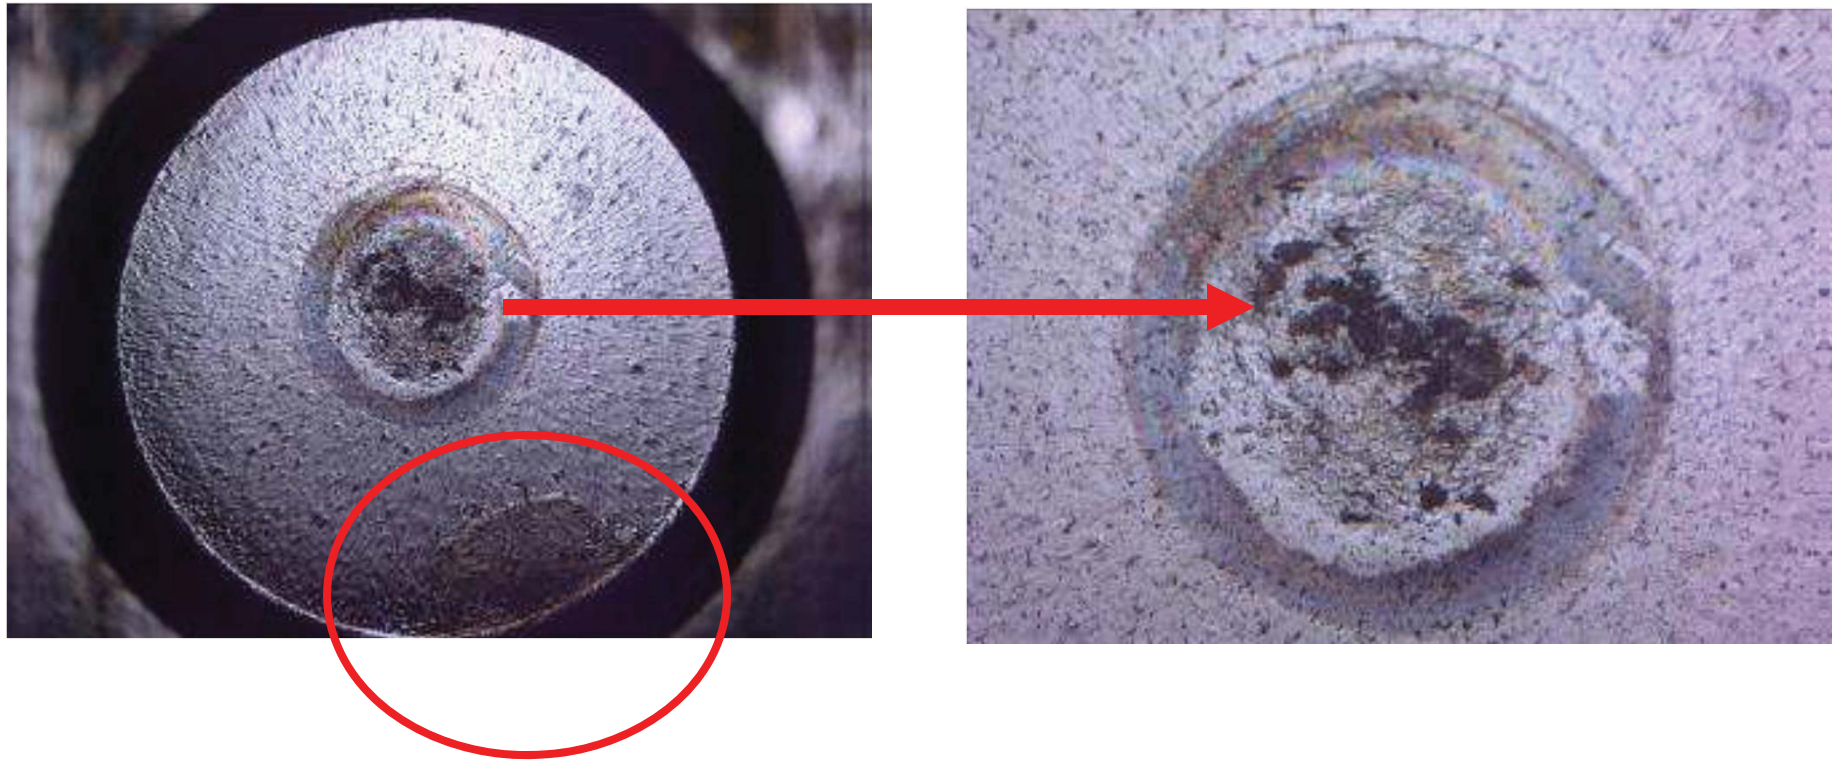
Example warranty return of relay contacts. Note the corrosion not only in the center of the contact but also on the edge (circled in red).

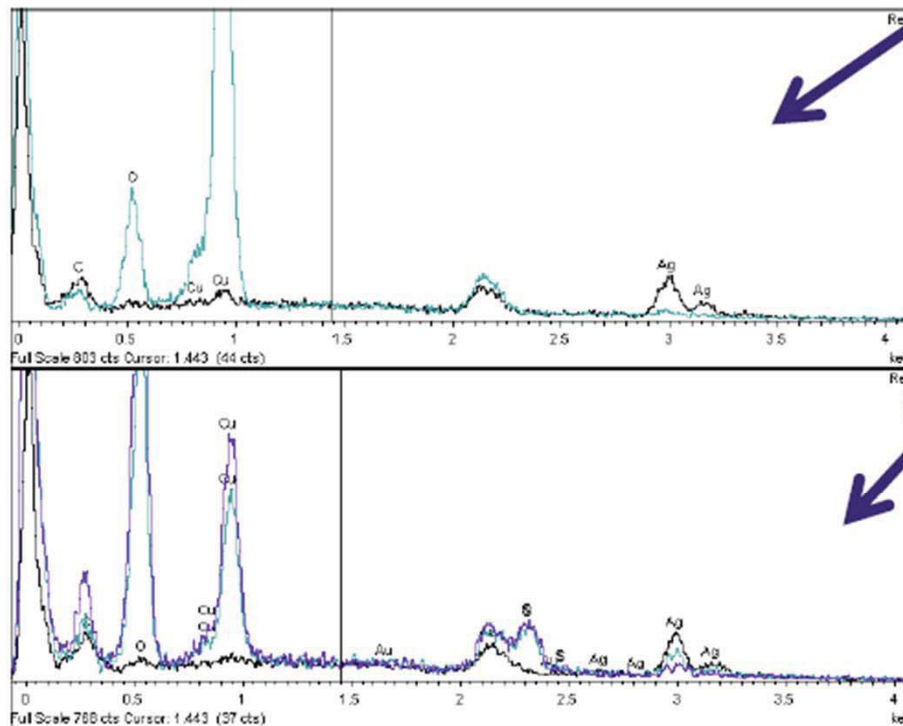
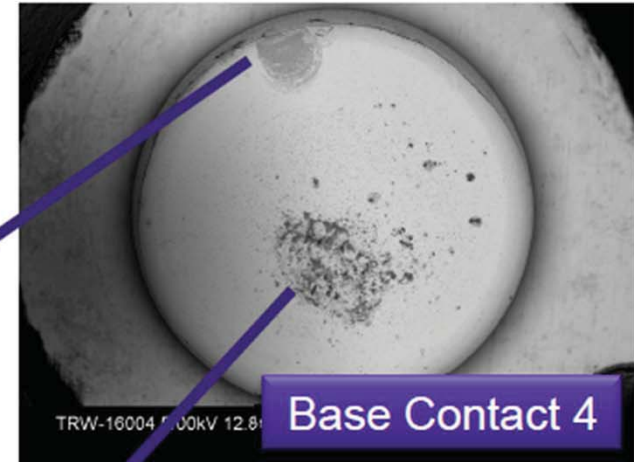
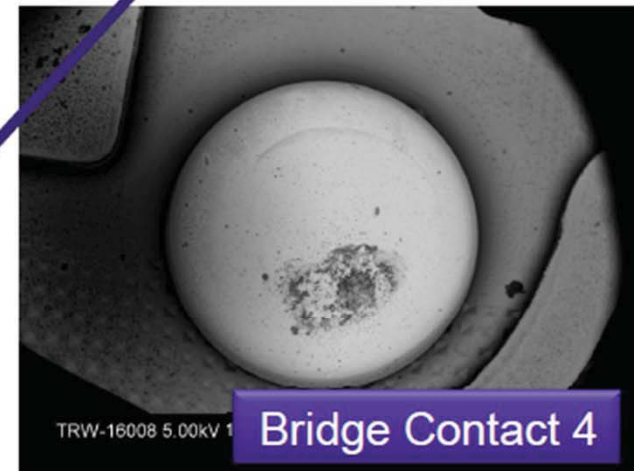
- Contact 4 showed contamination
- EDX analysis of affected area indicated the presence of sulphur and oxygen

Corrosion areas in both center and edge show presence of copper, sulphur and oxygen

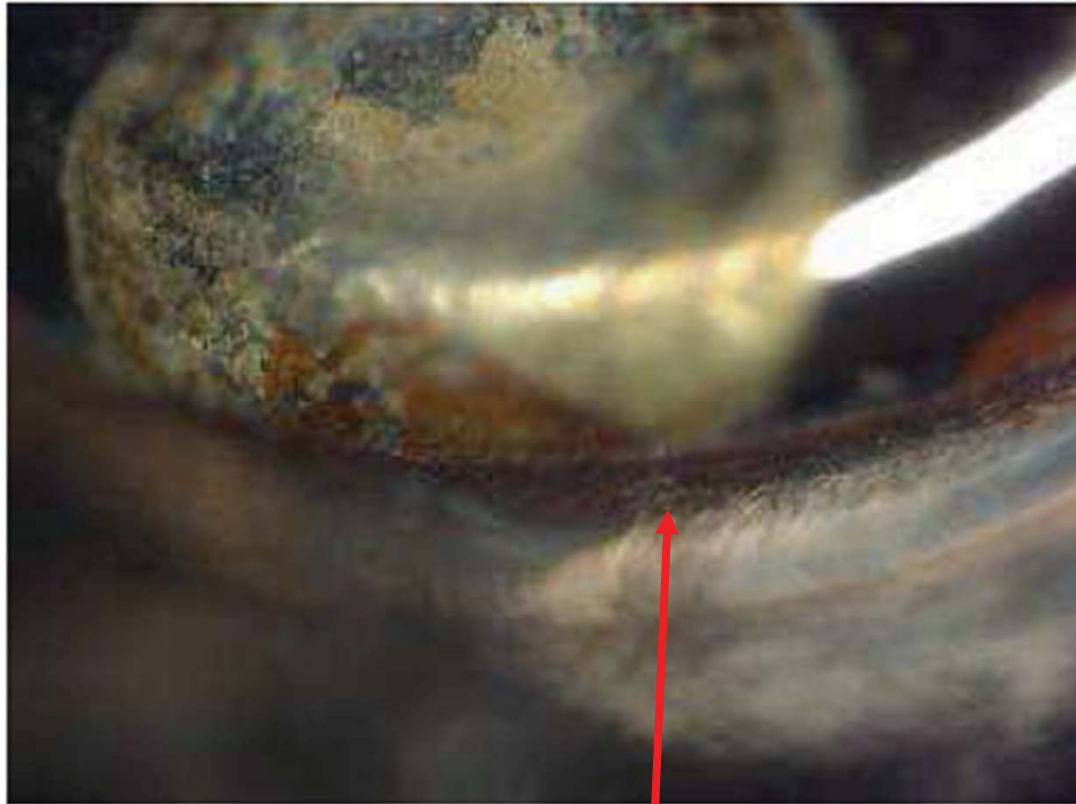
Analysis of the edge of the contacts shows contamination getting in between the bottom copper layer and the top silver layer. Further analysis by Tyco shows that there is actually a crack between the copper and the silver.

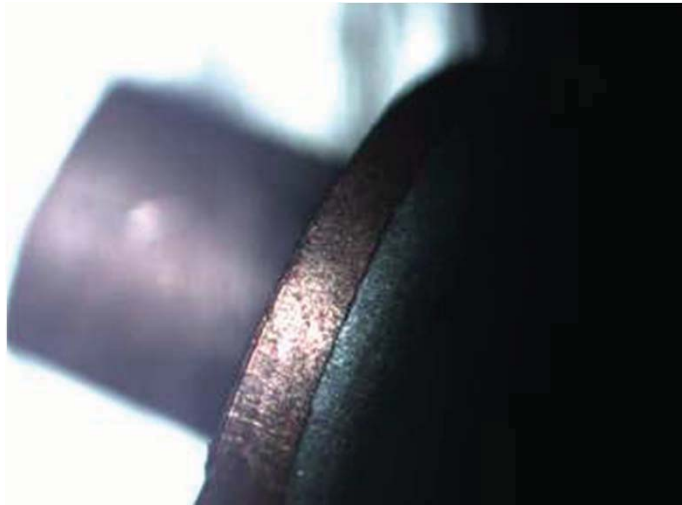
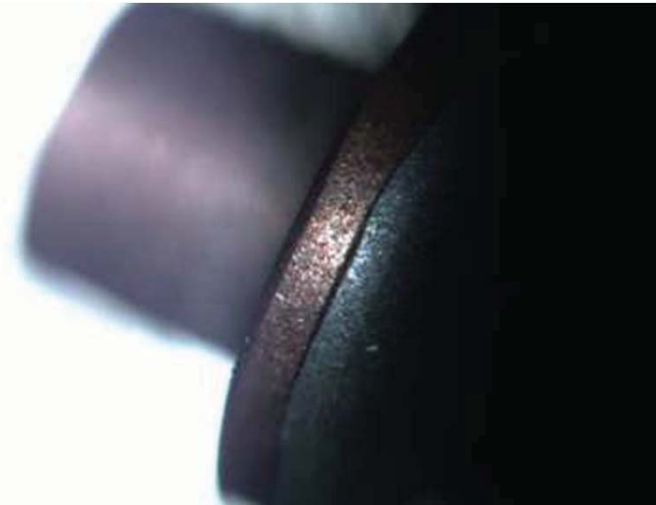
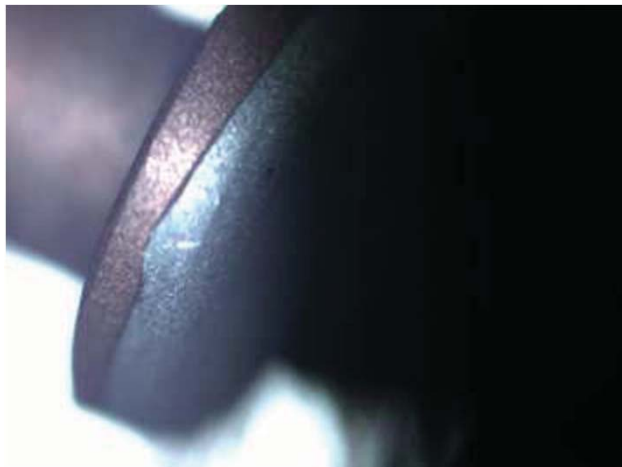
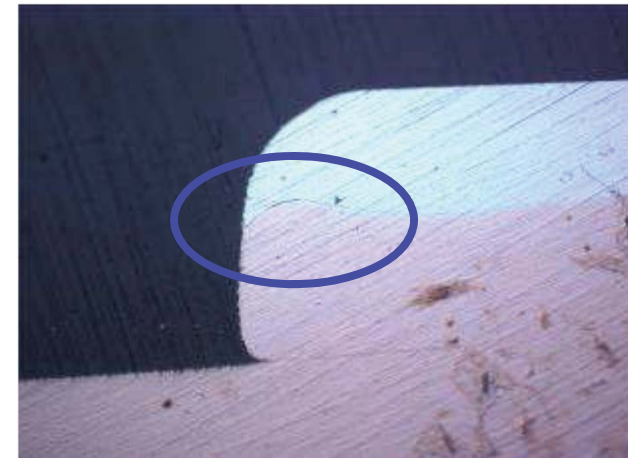
Goal of trials at Tyco was to produce cracks between copper and silver layers. They were successful in doing this using their press in Portugal.

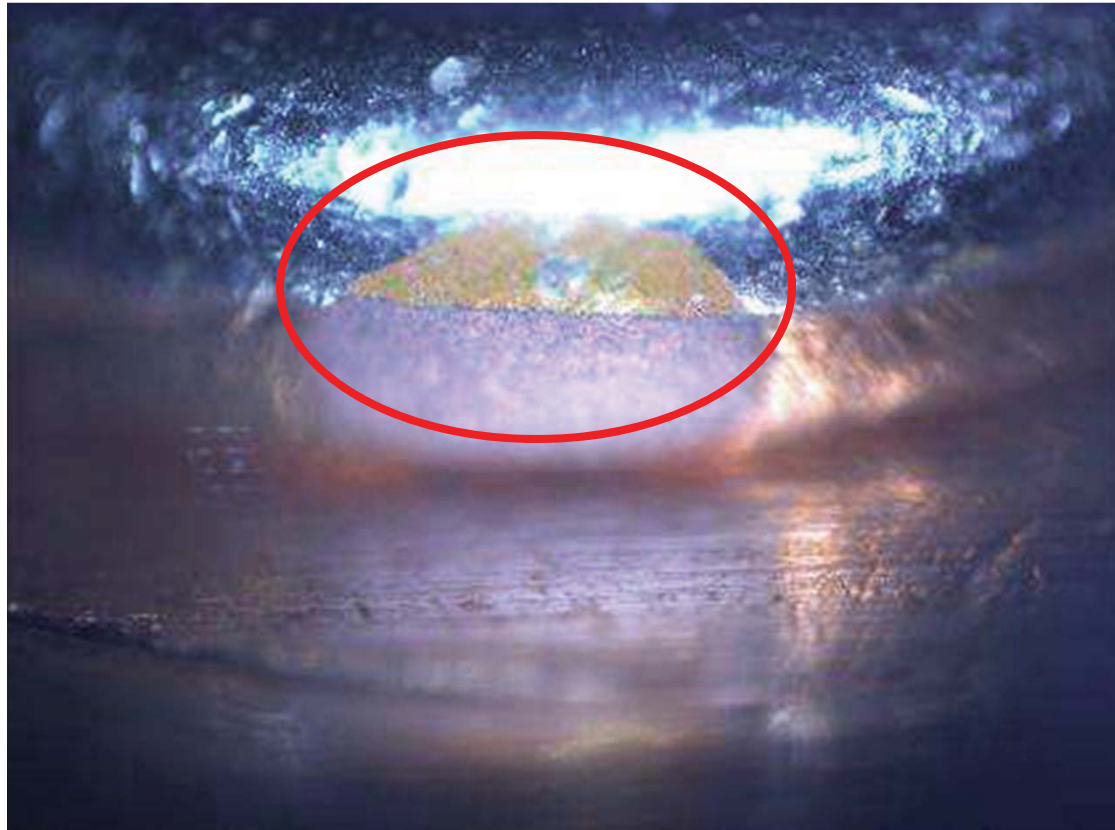
Humidity cycling of the part (40 degrees C, 95% humidity, 16 hours / 13 degrees C, 95% humidity, 8 hours) caused corrosion to develop in the area of the crack. This was repeated on 6 different parts with cracks between copper and silver layers. 20 virgin parts with no cracks were subjected to the same humidity test and none of them showed any signs of this type of corrosion.

- After the riveting tests, we can conclude that;
  - Rivets where the crack occurs in Doduco process exhibit the contamination.
  - Rivets where the crack is caused by TE's riveting process do not show any signs of contamination.
  - The set-up of the press, where the silver and copper are welded together, is the root cause for possible crack in the rivet.
  - The contamination source is Doduco
  - This contamination has copper and sulphate on its composition as seen in the complained relay.

- Check 10 rivet per bag (10,000/bag) under a microscope for evidence of cracks at Tyco.
- Scrap first 1000 parts everytime cold weld press starts up at Doduco. It was found that cracks occur when press first starts up.
- Clean feeder tube of any rivets after every set up/tool change after 1000 rivet scrap at Doduco. It was found that set up parts could potentially get into production.
- All actions implemented Aug 5, 2011

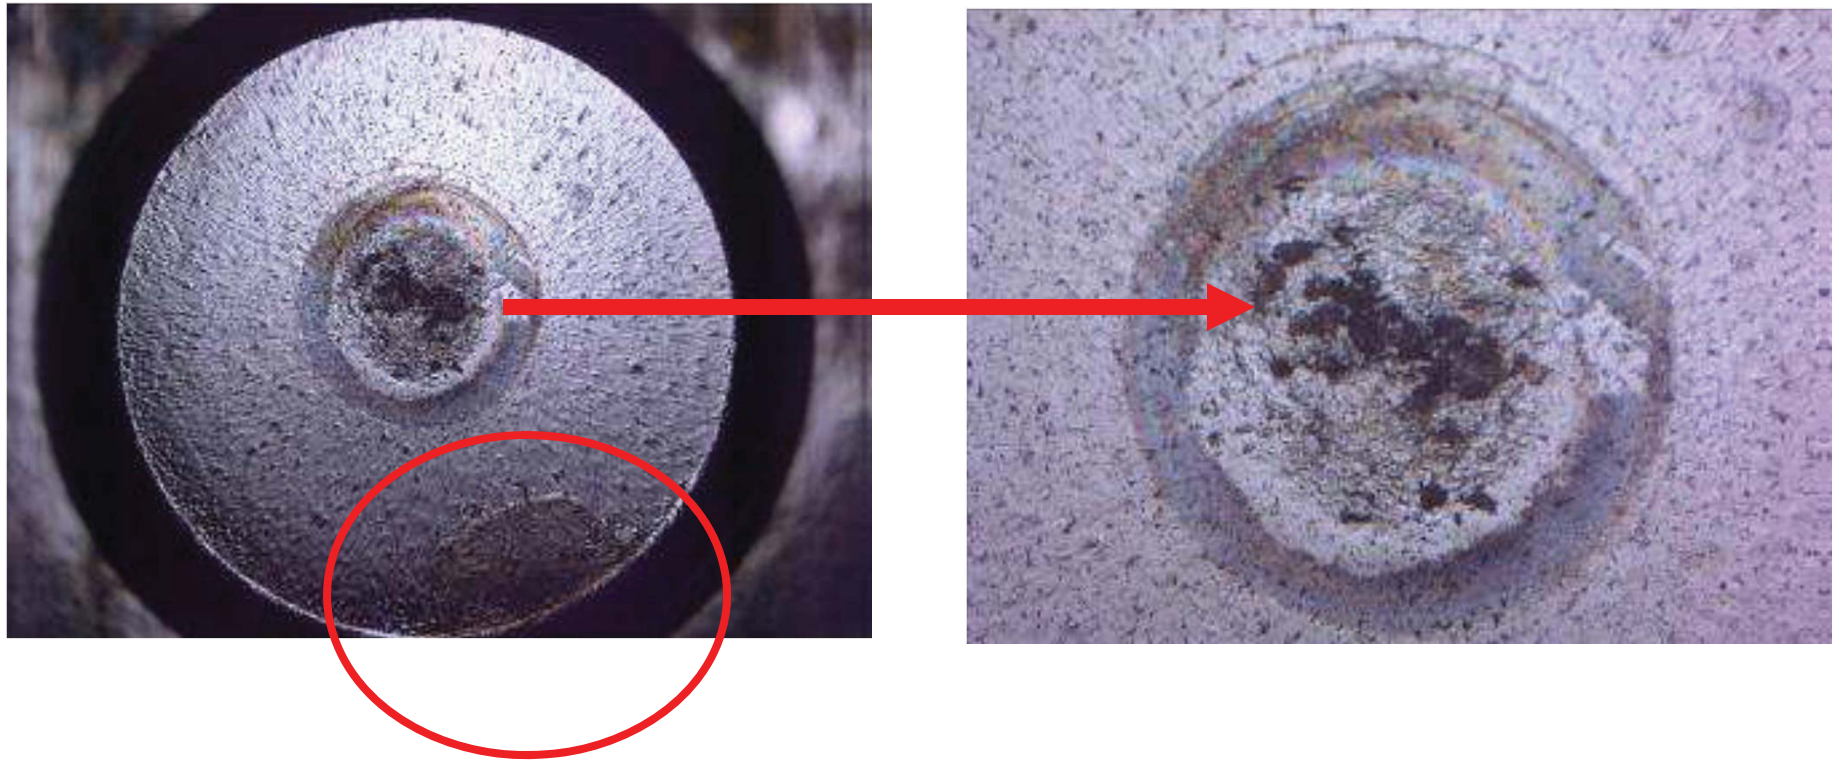
Example warranty return of relay contacts. Note the corrosion not only in the center of the contact but also on the edge (circled in red).

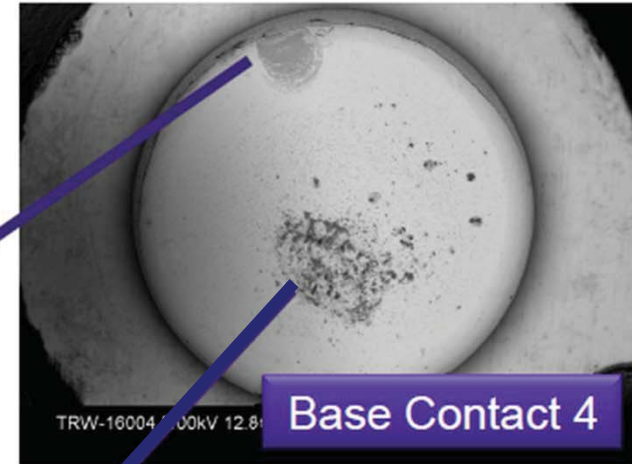
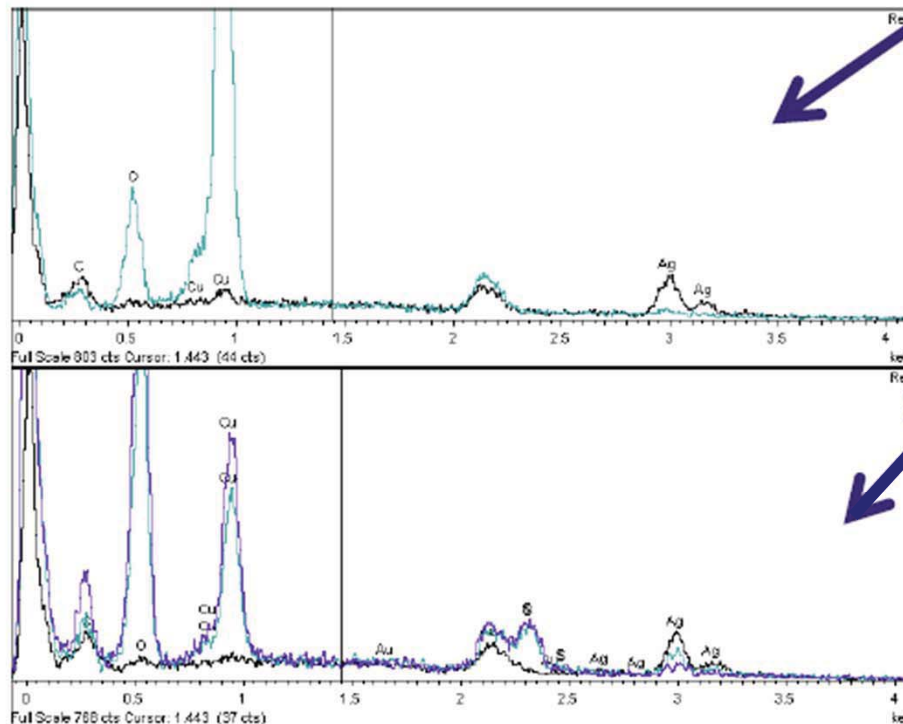
- Contact 4 showed contamination
- EDX analysis of affected area indicated the presence of sulphur and oxygen

Corrosion areas in both center and edge show presence of copper, sulphur and oxygen

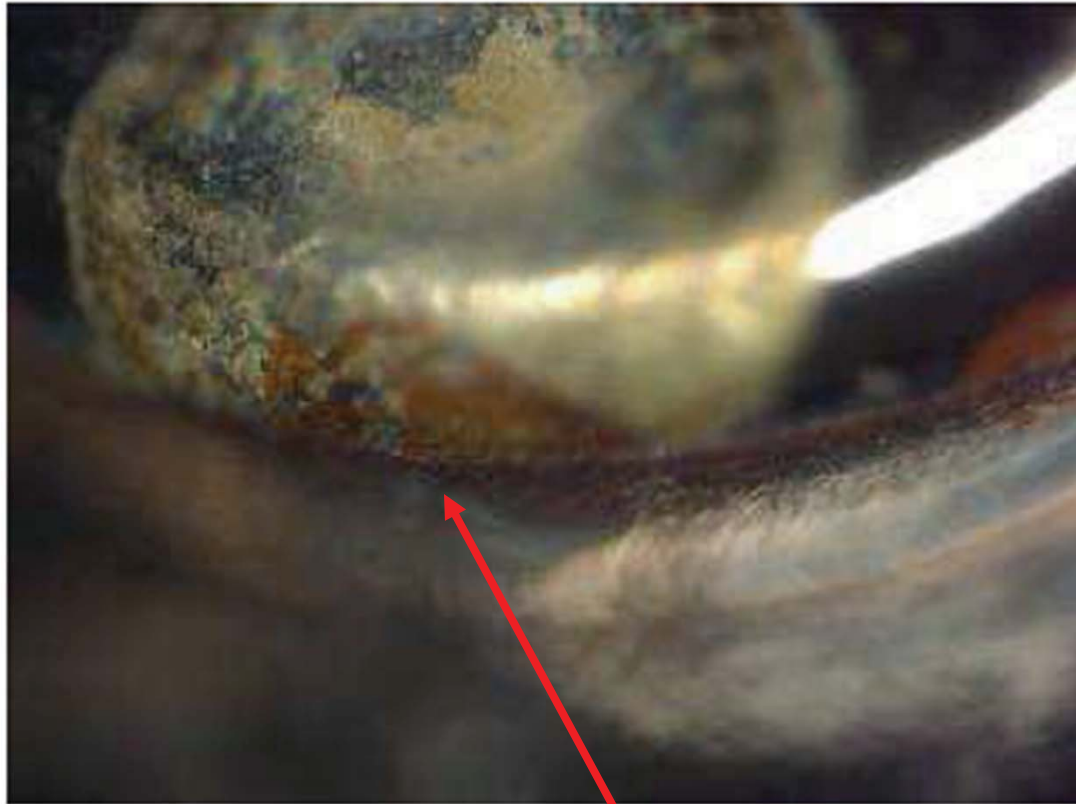
Analysis of the edge of the contacts shows contamination getting in between the bottom copper layer and the top silver layer. Further analysis by TE shows that there is actually a crack between the copper and the silver.

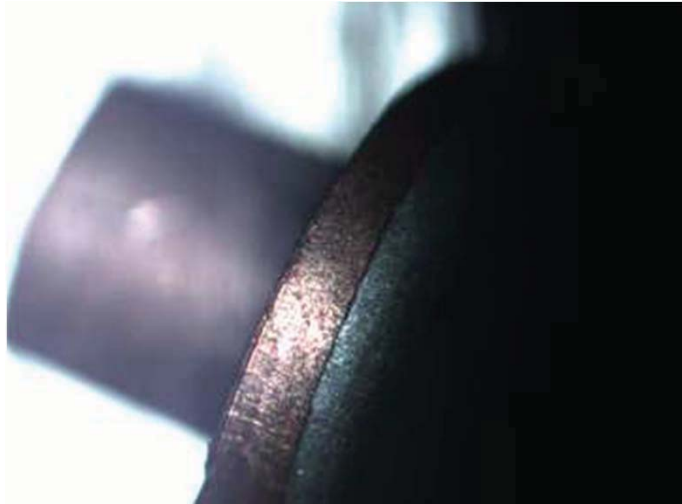
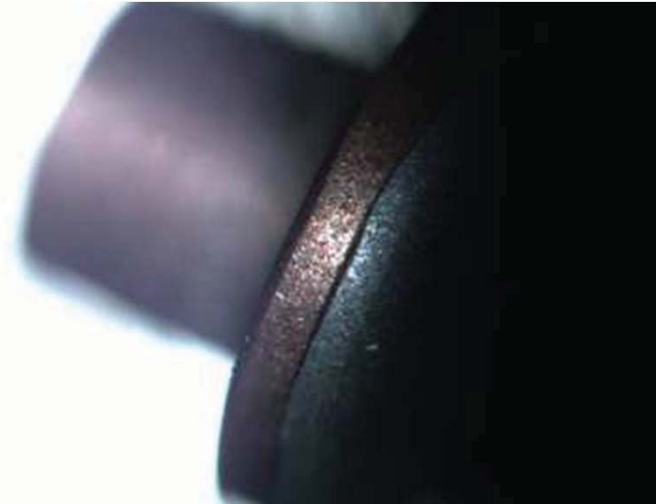
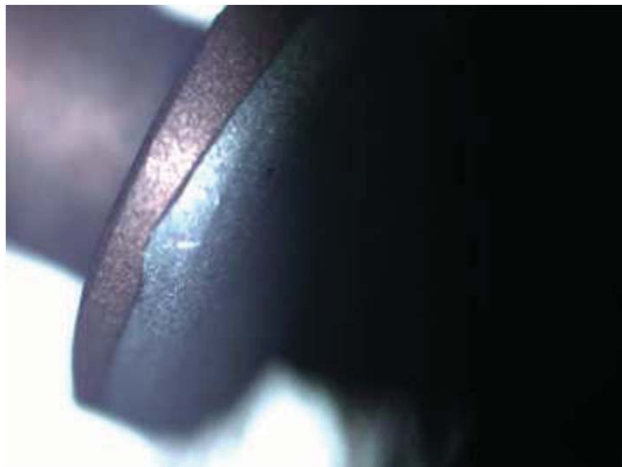
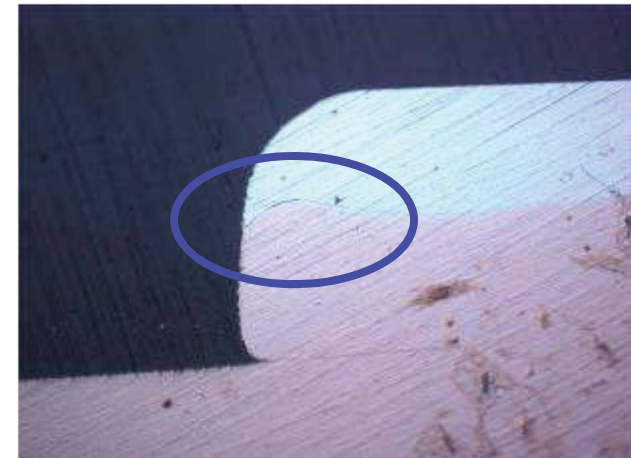
Goal of trials at TE was to produce cracks between copper and silver layers. They were successful in doing this using their press in Portugal.

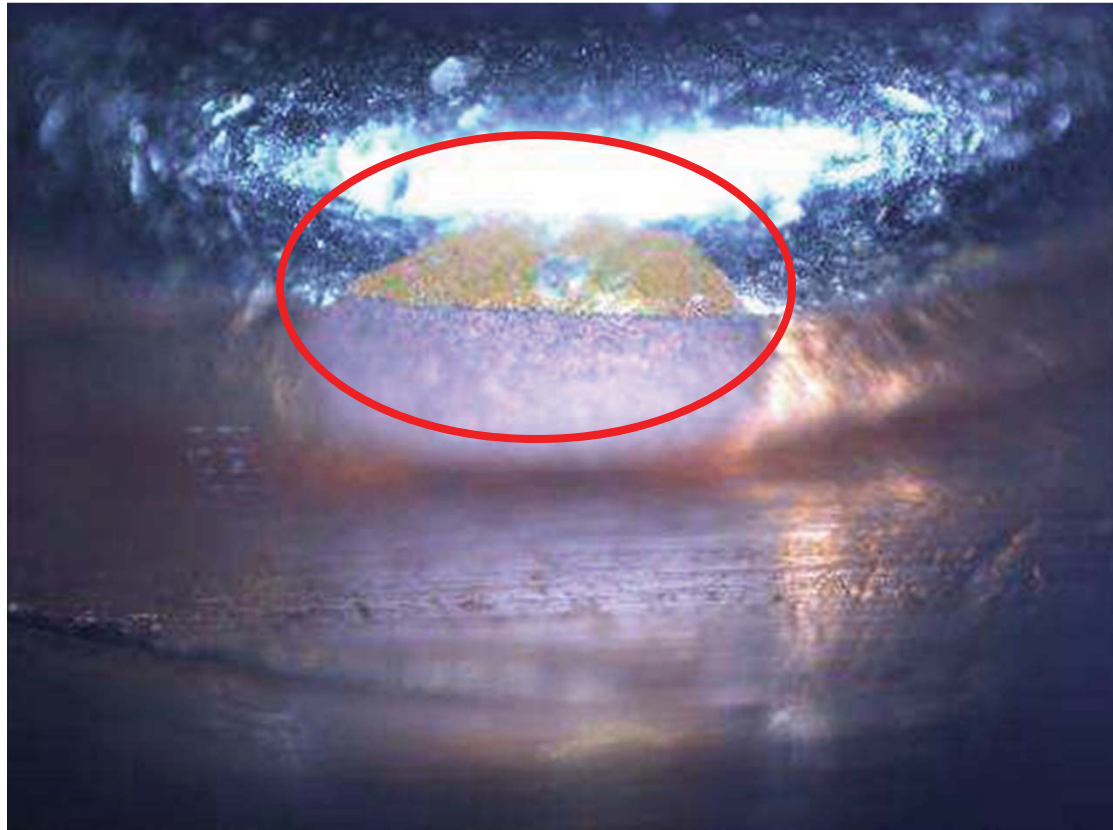
Humidity cycling of the part (40 degrees C, 95% humidity, 16 hours / 13 degrees C, 95% humidity, 8 hours) caused corrosion to develop in the area of the crack. This was repeated on 6 different parts with cracks between copper and silver layers created before the Doduco process. 20 parts with cracks created after the Doduco process were subjected to the same humidity test and none of them showed any signs of this type of corrosion.

- After the riveting tests, we can conclude that;
  - Rivets where the crack occurs in Doduco process exhibit the contamination.
  - Rivets where the crack is caused by TE's riveting process do not show any signs of contamination.
  - The set-up of the press, where the silver and copper are welded together, is the root cause for possible crack in the rivet.
  - The contamination source is Doduco
  - This contamination has copper and sulphate on its composition as seen in the complained relay.

- Check 10 rivet per bag (10,000/bag) under a microscope for evidence of cracks at TE.
- Scrap first 1000 parts every time cold weld press starts up at Doduco. It was found that cracks occur when press first starts up.
- Clean feeder tube of any rivets after every set up/tool change after 1000 rivet scrap at Doduco. It was found that set up parts could potentially get into production.
- All actions implemented Aug 5, 2011 at TE/Doduco
  - Changes above implemented at assembly plants as follows:  
C346 - 1/9/2012, U502 w/o APA(48mm) - 1/17/2012, U502 w/APA (58mm) - 2/3/2012 low volume production, CD3 - 1/17/2012

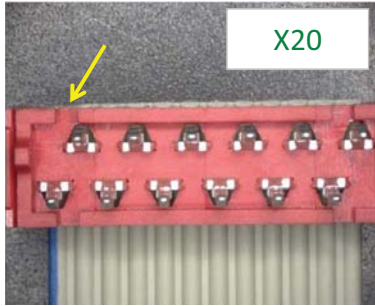
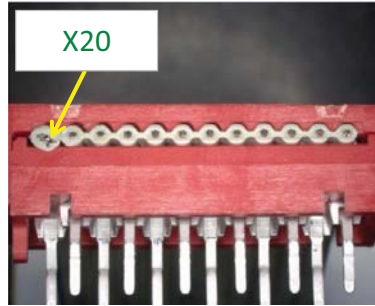
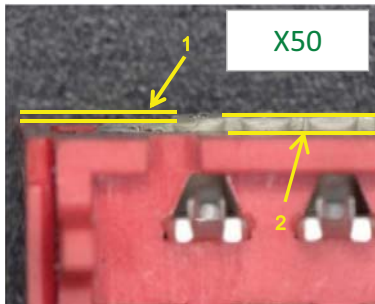
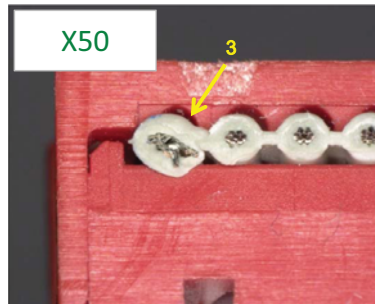
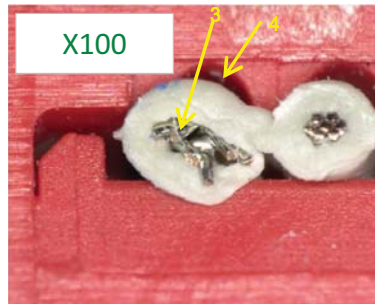
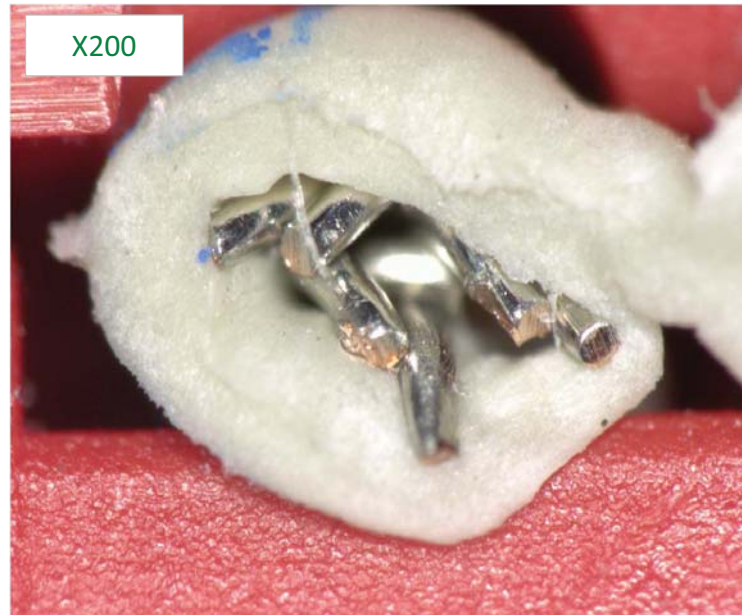
## New problem in TE 12way cable assy

TE date code 1563245-1A 14/12/11 (Dec 14th, 2011)

- 1 Cutting point No.1 (blue) is different from other lines
- 2 Other line insulation protruded
- 3 Strand of No.1 (blue) damaged and protruded
- 4 Misalignment
