PE12-019

MADZA

APPENDIX 11

2002-2004 Tribute Accelerator  
Cable Recall 2704L

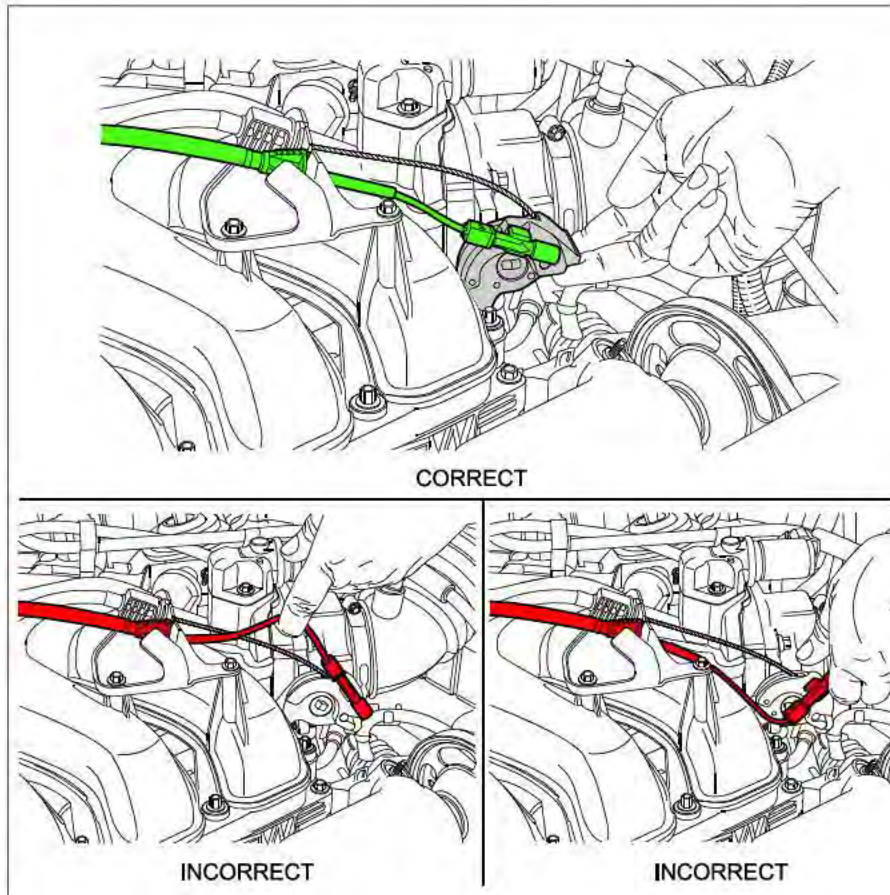
**CAUTION:** Damage to the speed control cable may result if the throttle body cam is rotated by lifting up on the speed control cable or the speed control cable connector end. When disconnecting the accelerator cable from the throttle body, rotate the throttle body cam only by lifting up on the cam itself. See Figure below.

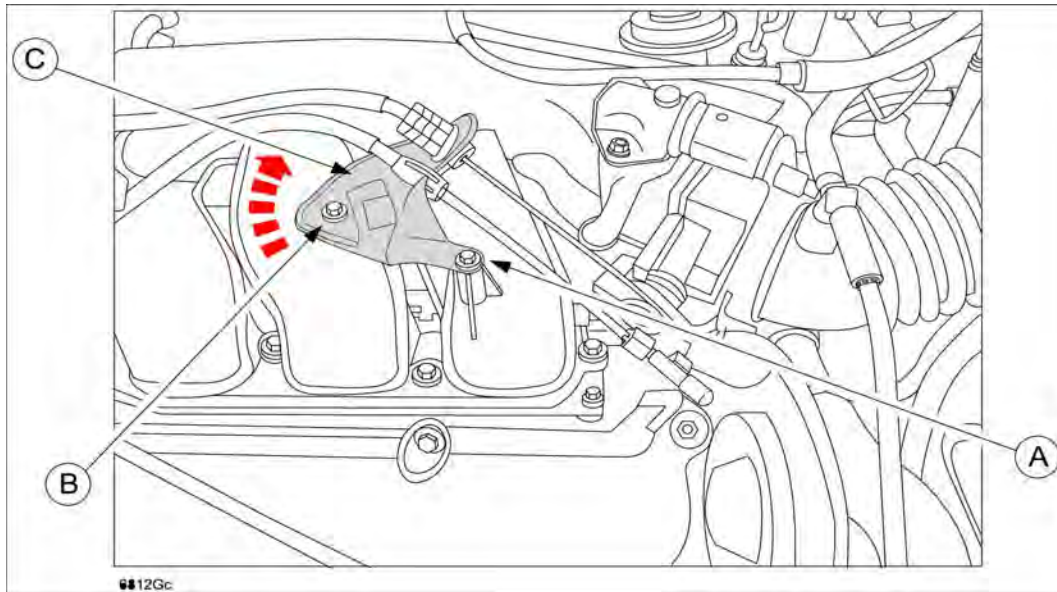
**NOTE:** Do not bend the speed control cable (A) in order to route it under the throttle cable bracket. The throttle cable bracket must be positioned aside or damage to the speed control cable may occur.

- Loosen the RH throttle cable bracket bolt (A) and remove the LH throttle cable bracket bolt (B). Rotate the bracket (C) to allow enough clearance for the speed control cable to be positioned under the bracket.
