PE12-019

APPENDIX 17

**SUBJECT:** Safety Recall 04S25: *Update*  
All 2002 through 2004 Model Year Left Hand Drive (LHD) Escape Vehicles Equipped  
with 3.0L Engines  
Accelerator Cable Replacement

**TO:** All Mazda Dealership General Managers, Service Managers, and Parts Managers

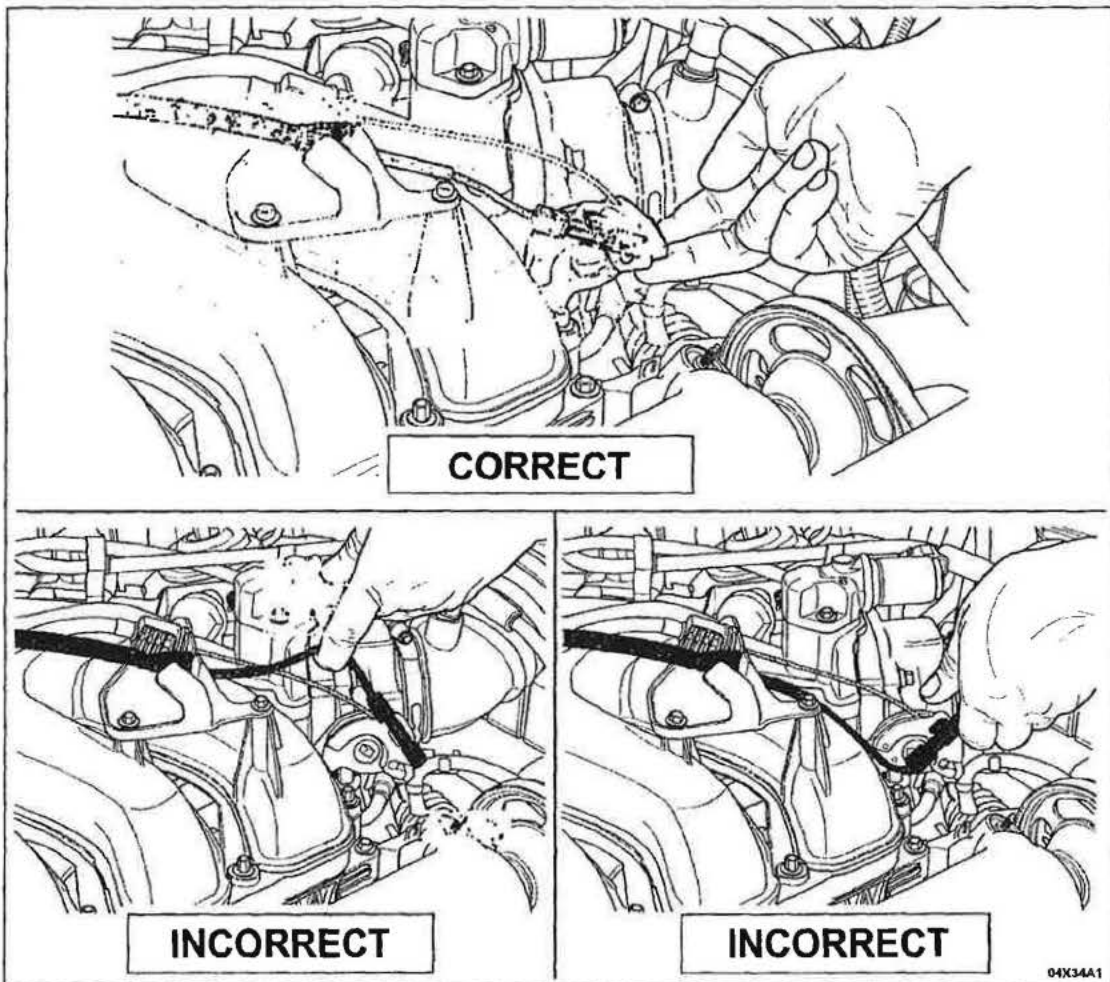
FIGURE 1

**CAUTION:** Damage to the speed control cable may result if the throttle body cam is rotated by lifting up on the speed control cable or the speed control cable connector end. When disconnecting the accelerator cable from the throttle body, rotate the throttle body cam only by lifting up on the cam itself. See Figure 1.

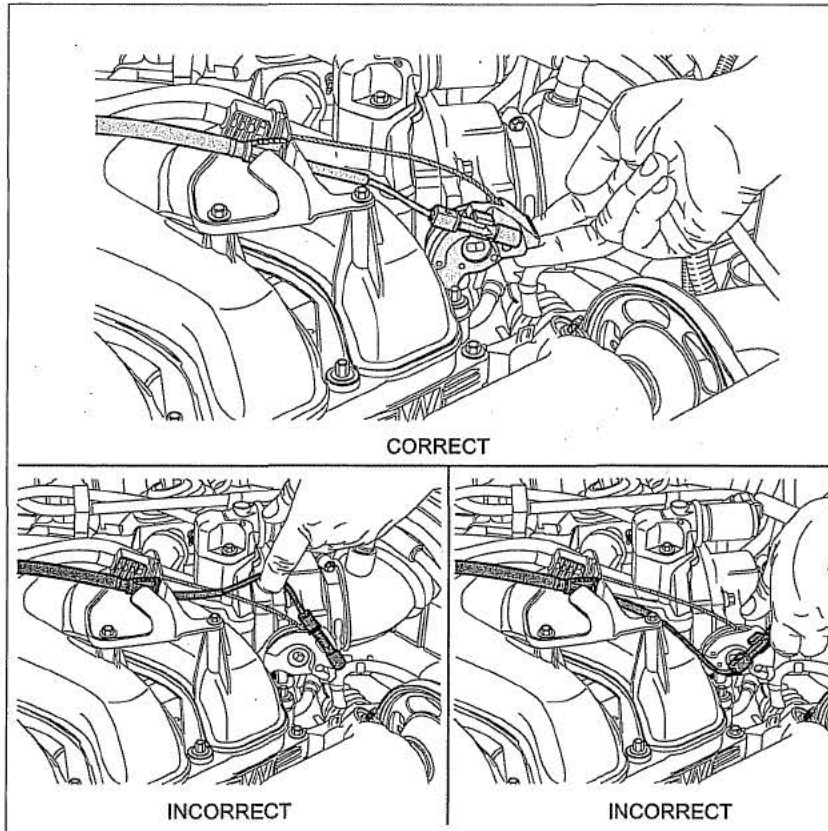
**CAUTION:** Damage to the speed control cable may result if the throttle body cam is rotated by lifting up on the speed control cable or the speed control cable connector end. When disconnecting the accelerator cable from the throttle body, rotate the throttle body cam only by lifting up on the cam itself. See Figure below.

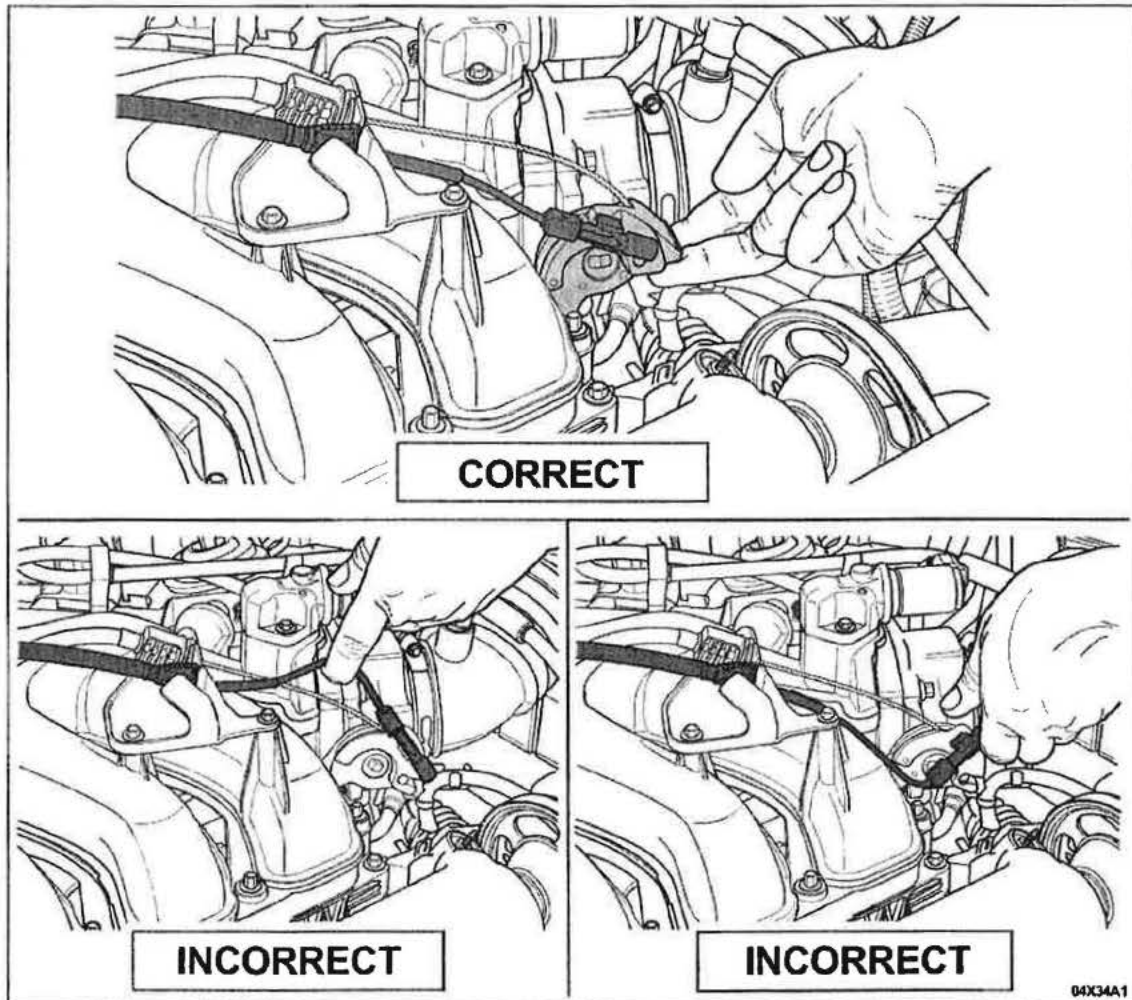
FIGURE 1

**CAUTION:** Damage to the speed control cable may result if the throttle body cam is rotated by lifting up on the speed control cable or the speed control cable connector end. When disconnecting the accelerator cable from the throttle body, rotate the throttle body cam only by lifting up on the cam itself. See Figure 1.
