RE: Audit of Safety Recall 12V-288
My Client: Chapman Chevrolet

Subject: **Safety Recalls 12081 and 12133 - Oil Spills or Leaks onto Hot Surfaces / Potential Missing Welds in Rear Compartment**

SUBJECT: Oil Spills or Leaks onto Hot Surfaces – Modify Engine Shield

SUBJECT: Potential Missing Welds in Rear Compartment

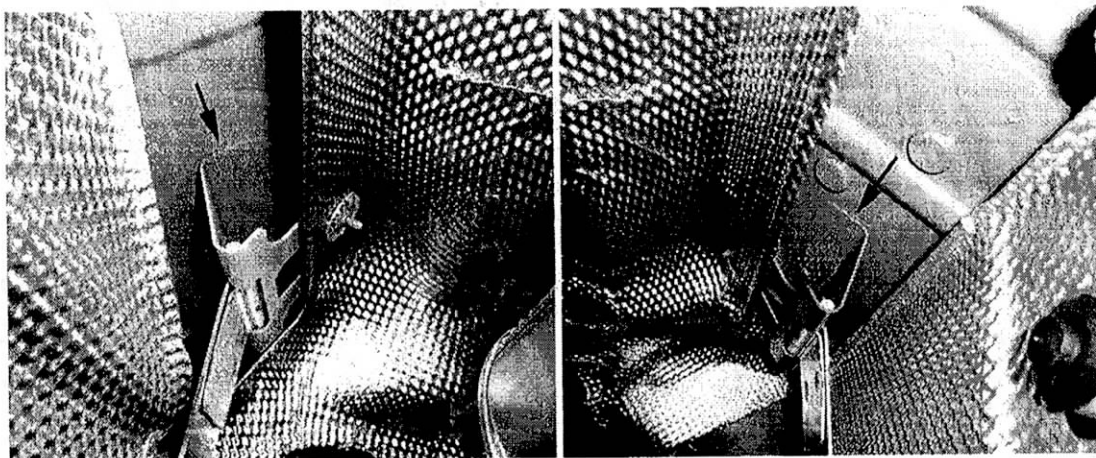
2877158

Note: The fuel tank strap must be spot welded flush to the floor pan to pass the inspection. Fuel tank straps that have been MIG welded to the floor pan **MUST** be repaired.

- If the fuel tank strap brackets are spot welded flush to the floor pan, no further action is required. Lower the vehicle. Refer to illustration. Arrow indicates fuel tank strap bracket to floor pan contact point.

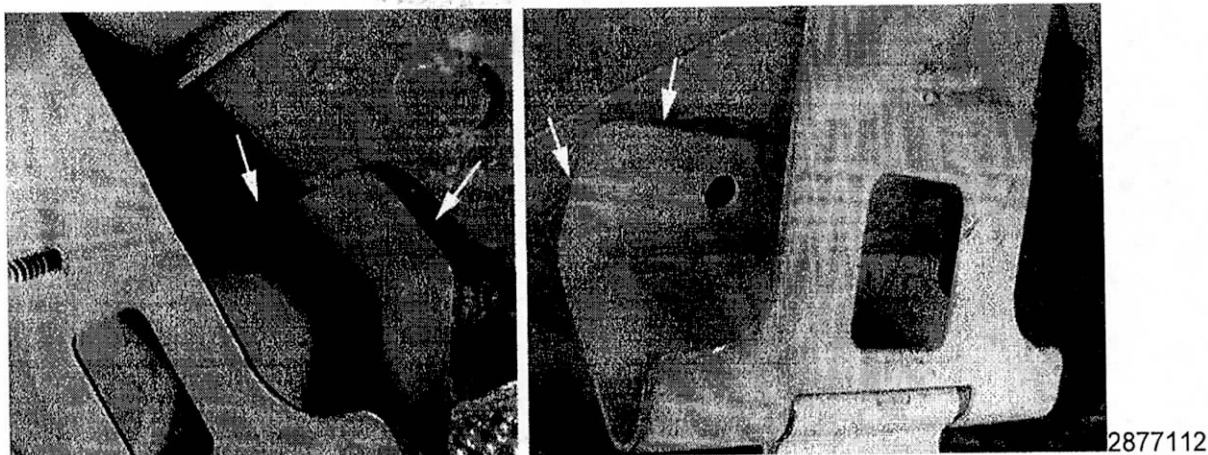
Note: If you cannot determine if there is a gap visually, use a business card or feeler gage to determine if there is a gap between the floor pan and fuel tank strap bracket.

- If you can see a gap between the fuel tank strap bracket and floor pan, the spot weld is missing, proceed to step 4. Refer to illustration. Arrow indicates fuel tank strap bracket to floor pan contact. Illustration show a gap between the fuel tank strap bracket and floor pan.

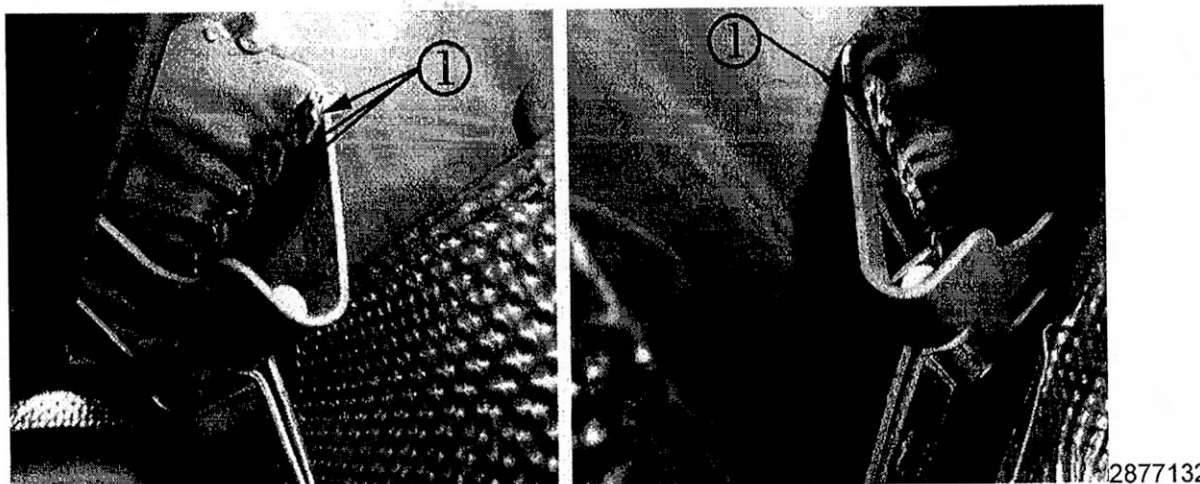
- If the fuel tank strap bracket is MIG welded (1) to the floor pan, proceed to step 4. Refer to illustration. Arrow indicates MIG welds and fuel tank strap bracket to floor pan contact. MIG welded fuel tank strap brackets require the service repair in this bulletin.

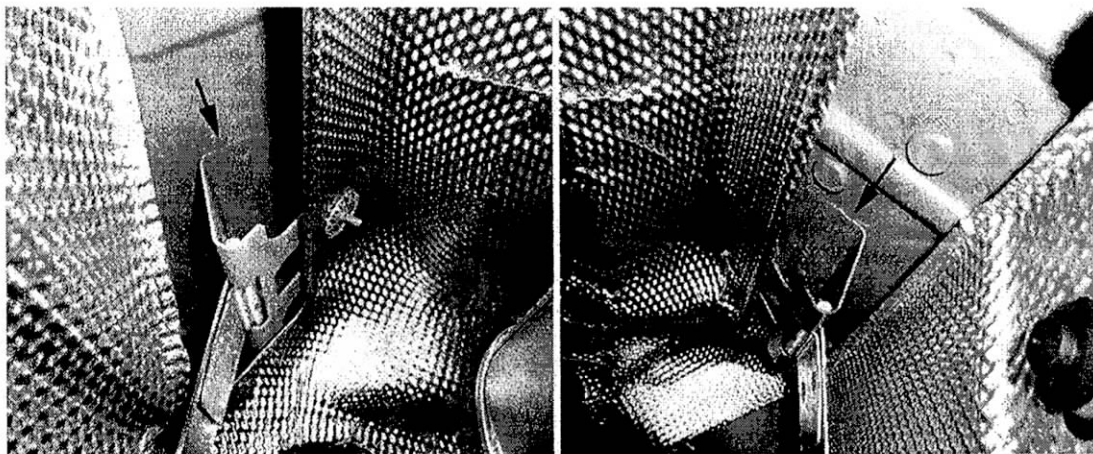
2877158

- If the fuel tank strap brackets are spot welded flush to the floor pan, no further action is required. Lower the vehicle. Refer to illustration. Arrow indicates fuel tank strap bracket to floor pan contact point.

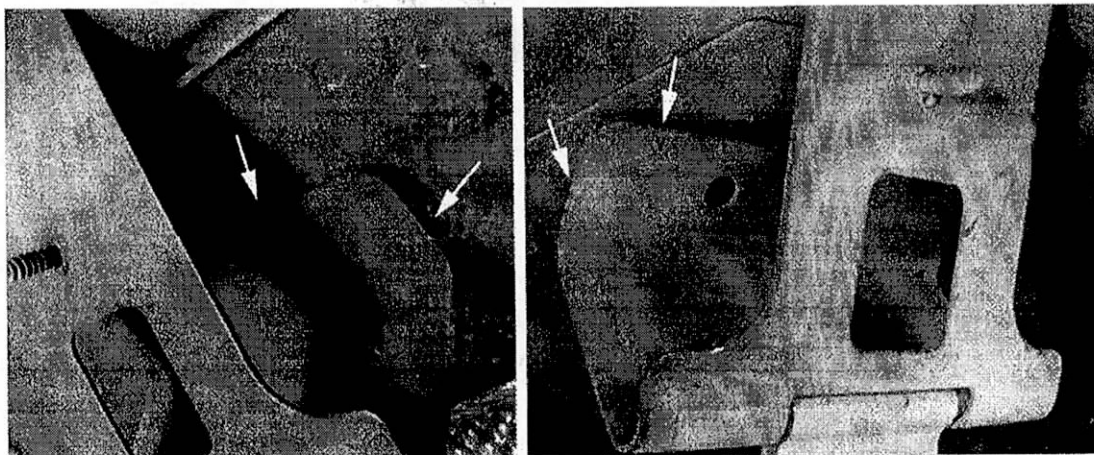
Note: If you cannot determine if there is a gap visually, use a business card or feeler gage to determine if there is a gap between the floor pan and fuel tank strap bracket.

- If you can see a gap between the fuel tank strap bracket and floor pan, the spot weld is missing, proceed to step 4. Refer to illustration. Arrow indicates fuel tank strap bracket to floor pan contact. Illustration show a gap between the fuel tank strap bracket and floor pan.

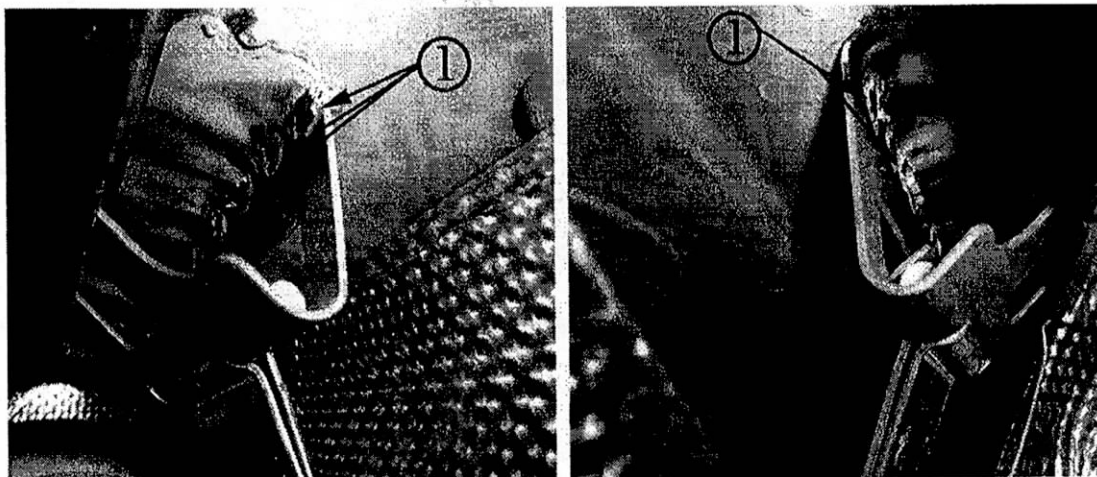
- If the fuel tank strap bracket is MIG welded (1) to the floor pan, proceed to step 4. Refer to illustration. Arrow indicates MIG welds and fuel tank strap bracket to floor pan contact. MIG welded fuel tank strap brackets require the service repair in this bulletin.
